# **Phase II Environmental Site Assessment**

Part of 1615 Orleans Boulevard Ottawa, Ontario

Orleans Garden Developments Inc.

Report: PE1962-4

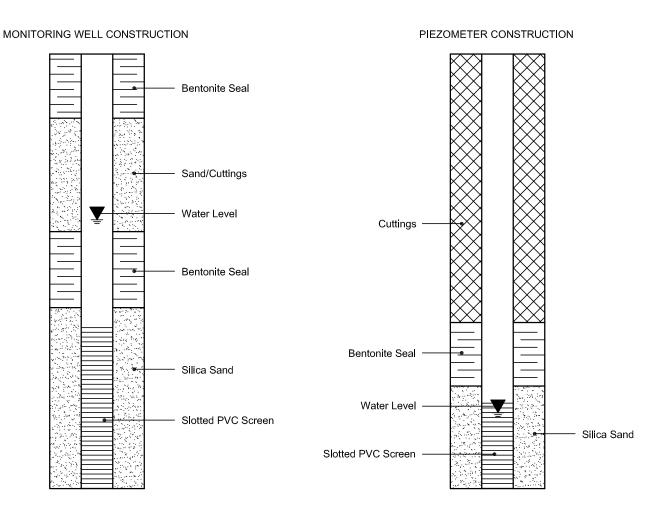
### MONITORING WELL AND PIEZOMETER CONSTRUCTION

Three (3) groundwater monitoring wells were installed on the subject site as part of the subsurface investigation. The monitoring wells consisted of 50 mm diameter, Schedule 40 threaded PVC risers and screens. Monitoring well construction details are listed below in Table 2 and are also presented on the Soil Profile and Test Data Sheets provided in Appendix 1.
