Phase Two Environmental Site Assessment 56 Capilano Drive, Ottawa, Ontario

Phase Two Environmental Site Assessment

OTT-22003851-A0

2022-04-27

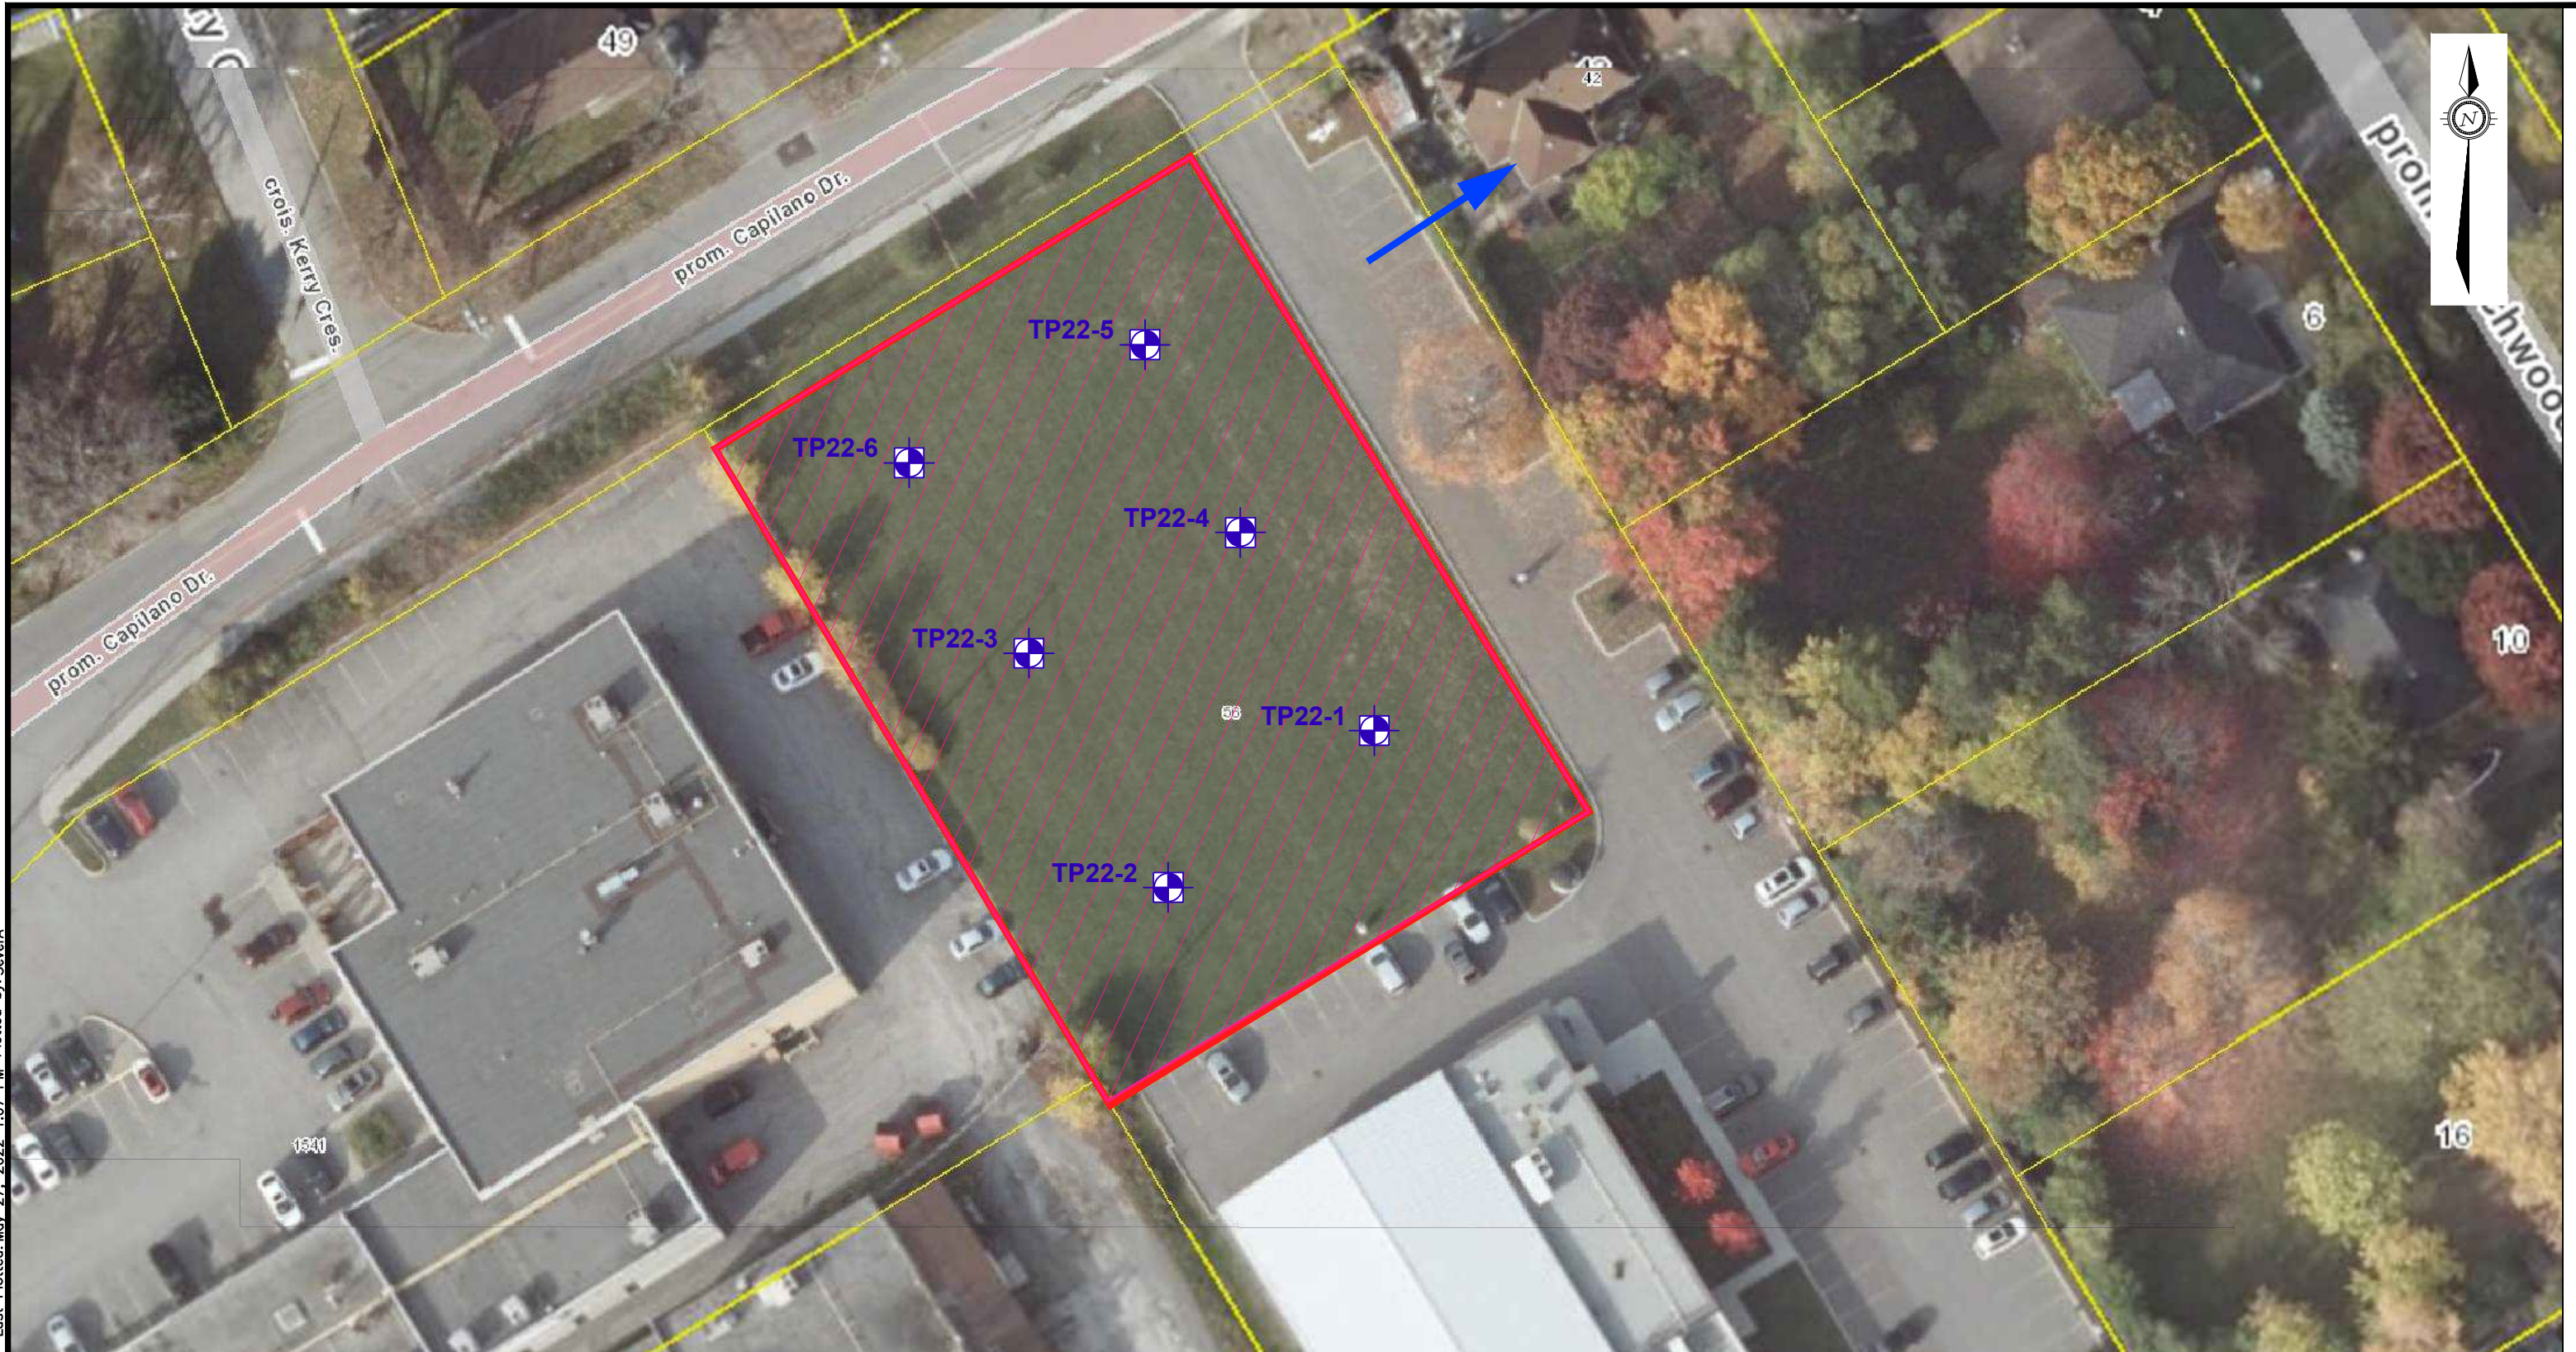
DATE MAY 2022	PHASE TWO ENVIRONMENTAL SITE ASSESSMENT	project no. OTT-22003851-A0
DESIGN LW		scale 1:500
CHECKED MM		
DRAWN BY AS	TITLE: TEST PIT LOCATION PLAN 56 CAPILANO DRIVE, OTTAWA, ONTARIO	FIG 2

On May 16, 2022, six test pits (TP22-1 to TP22-6) were advanced at the Phase Two property by Lacroix Equipment Rentals Ltd. (Lacroix) under the full-time supervision of EXP staff. Test pits were excavated to refusal on bedrock surface. Dedicated nitrile gloves (one pair per sample) were used during sample handling. No petroleum-based greases or solvents were used during excavation activities. EXP staff continuously monitored the excavating activities to log the stratigraphy observed from the pits, to record the depth of the samples, to record total depths of excavation, and to screen the samples by recording visual or olfactory observations of potential impacts and measuring petroleum vapours.

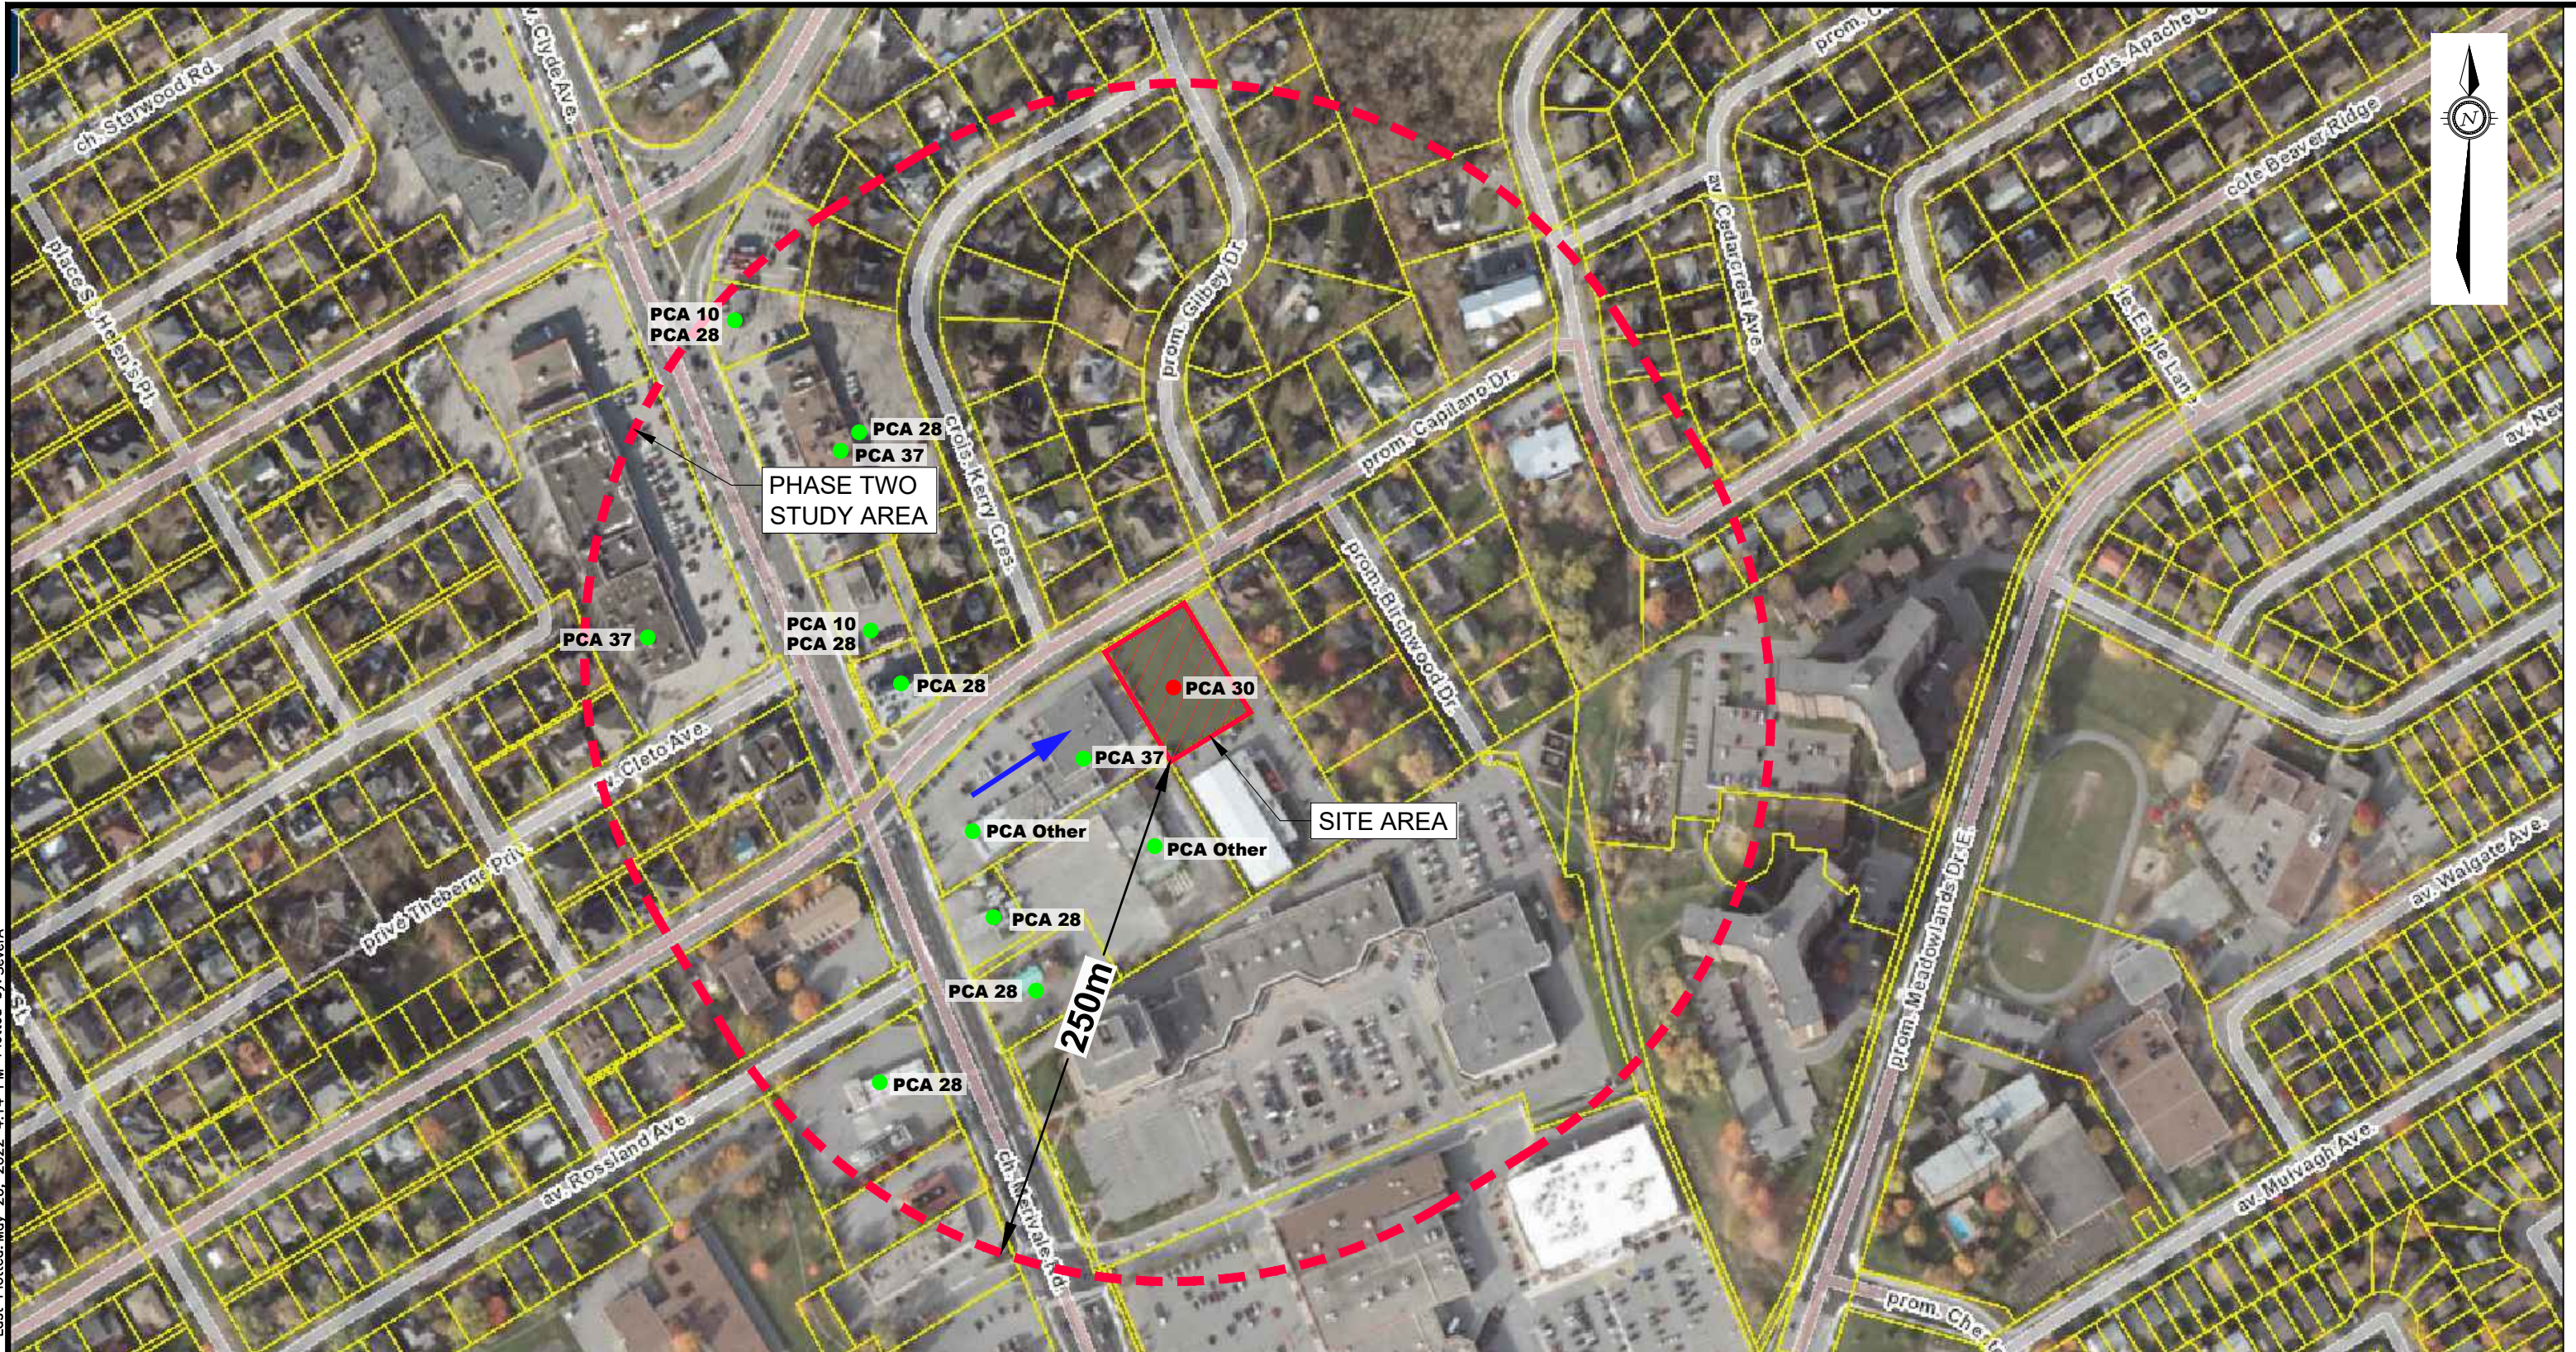
DATE MAY 2022	PHASE TWO ENVIRONMENTAL SITE ASSESSMENT	project no. OTT-22003851-A0
DESIGN LW		scale 1:3,000
CHECKED MM		
DRAWN BY AS	TITLE: CONCEPTUAL SITE MODEL – PHASE TWO STUDY AREA 56 CAPILANO DRIVE, OTTAWA, ONTARIO	FIG 3

LEGEND	
	PROPERTY BOUNDARY
	PHASE TWO STUDY AREA (250m)
	APEC 1 (PCA #30)
	INFERRED GROUNDWATER FLOW DIRECTION

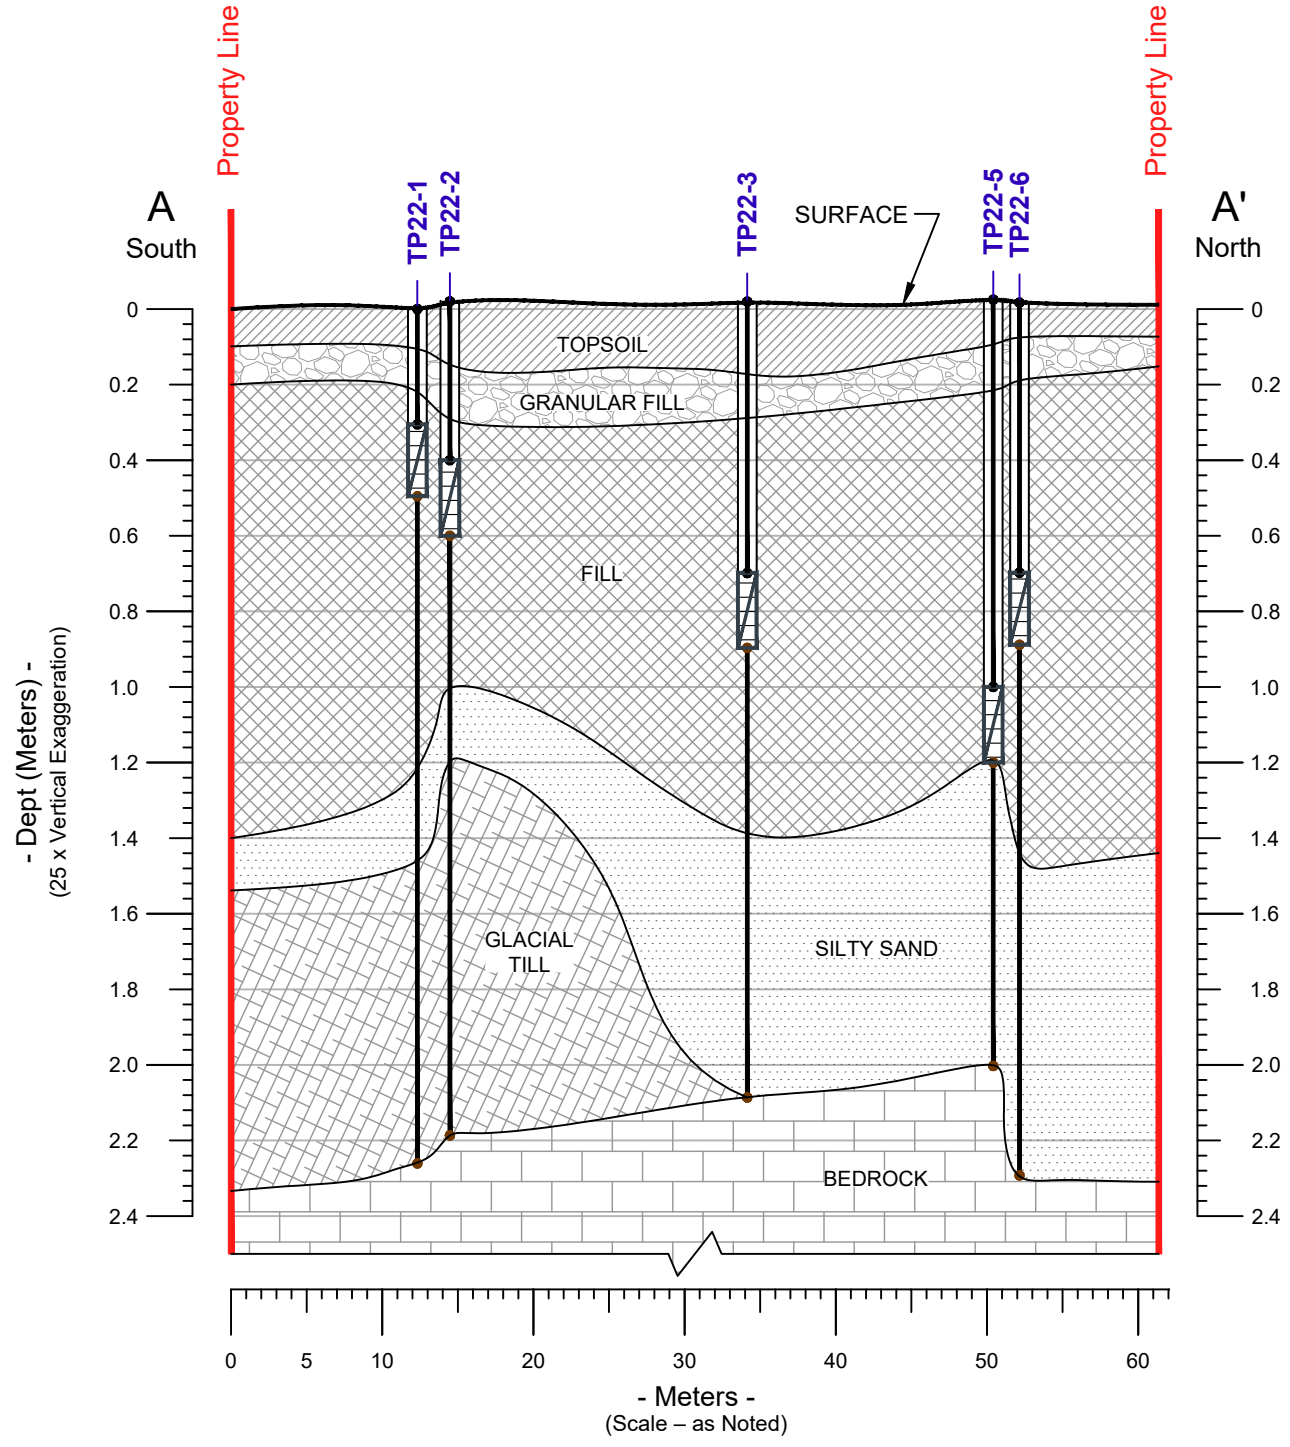
DATE MAY 2022	PHASE TWO ENVIRONMENTAL SITE ASSESSMENT	project no. OTT-22003851-A0
DESIGN LW		checked MM
DRAWN BY AS		scale 1:500
CROSS-SECTIONS A-A' & B-B' 56 CAPILANO DRIVE, OTTAWA, ONTARIO		FIG 5

There were no odours or staining observed in the fill or native material in any of the test-pits. Refusal was met in all the test pits at depths ranging between 2.0 m to 2.4 m.

Soil at the Phase Two property generally consisted of sandy clay and gravel fill material overlying silty clay and glacial till. Small amounts of debris material (bricks, concrete, rubber debris) were present in the fill material in TP22-5 and TP22-6. There were no odours or staining observed in the fill or native material in any of the test-pits. Refusal was met in all the test pits at depths ranging between 2.0 m to 2.4 m.

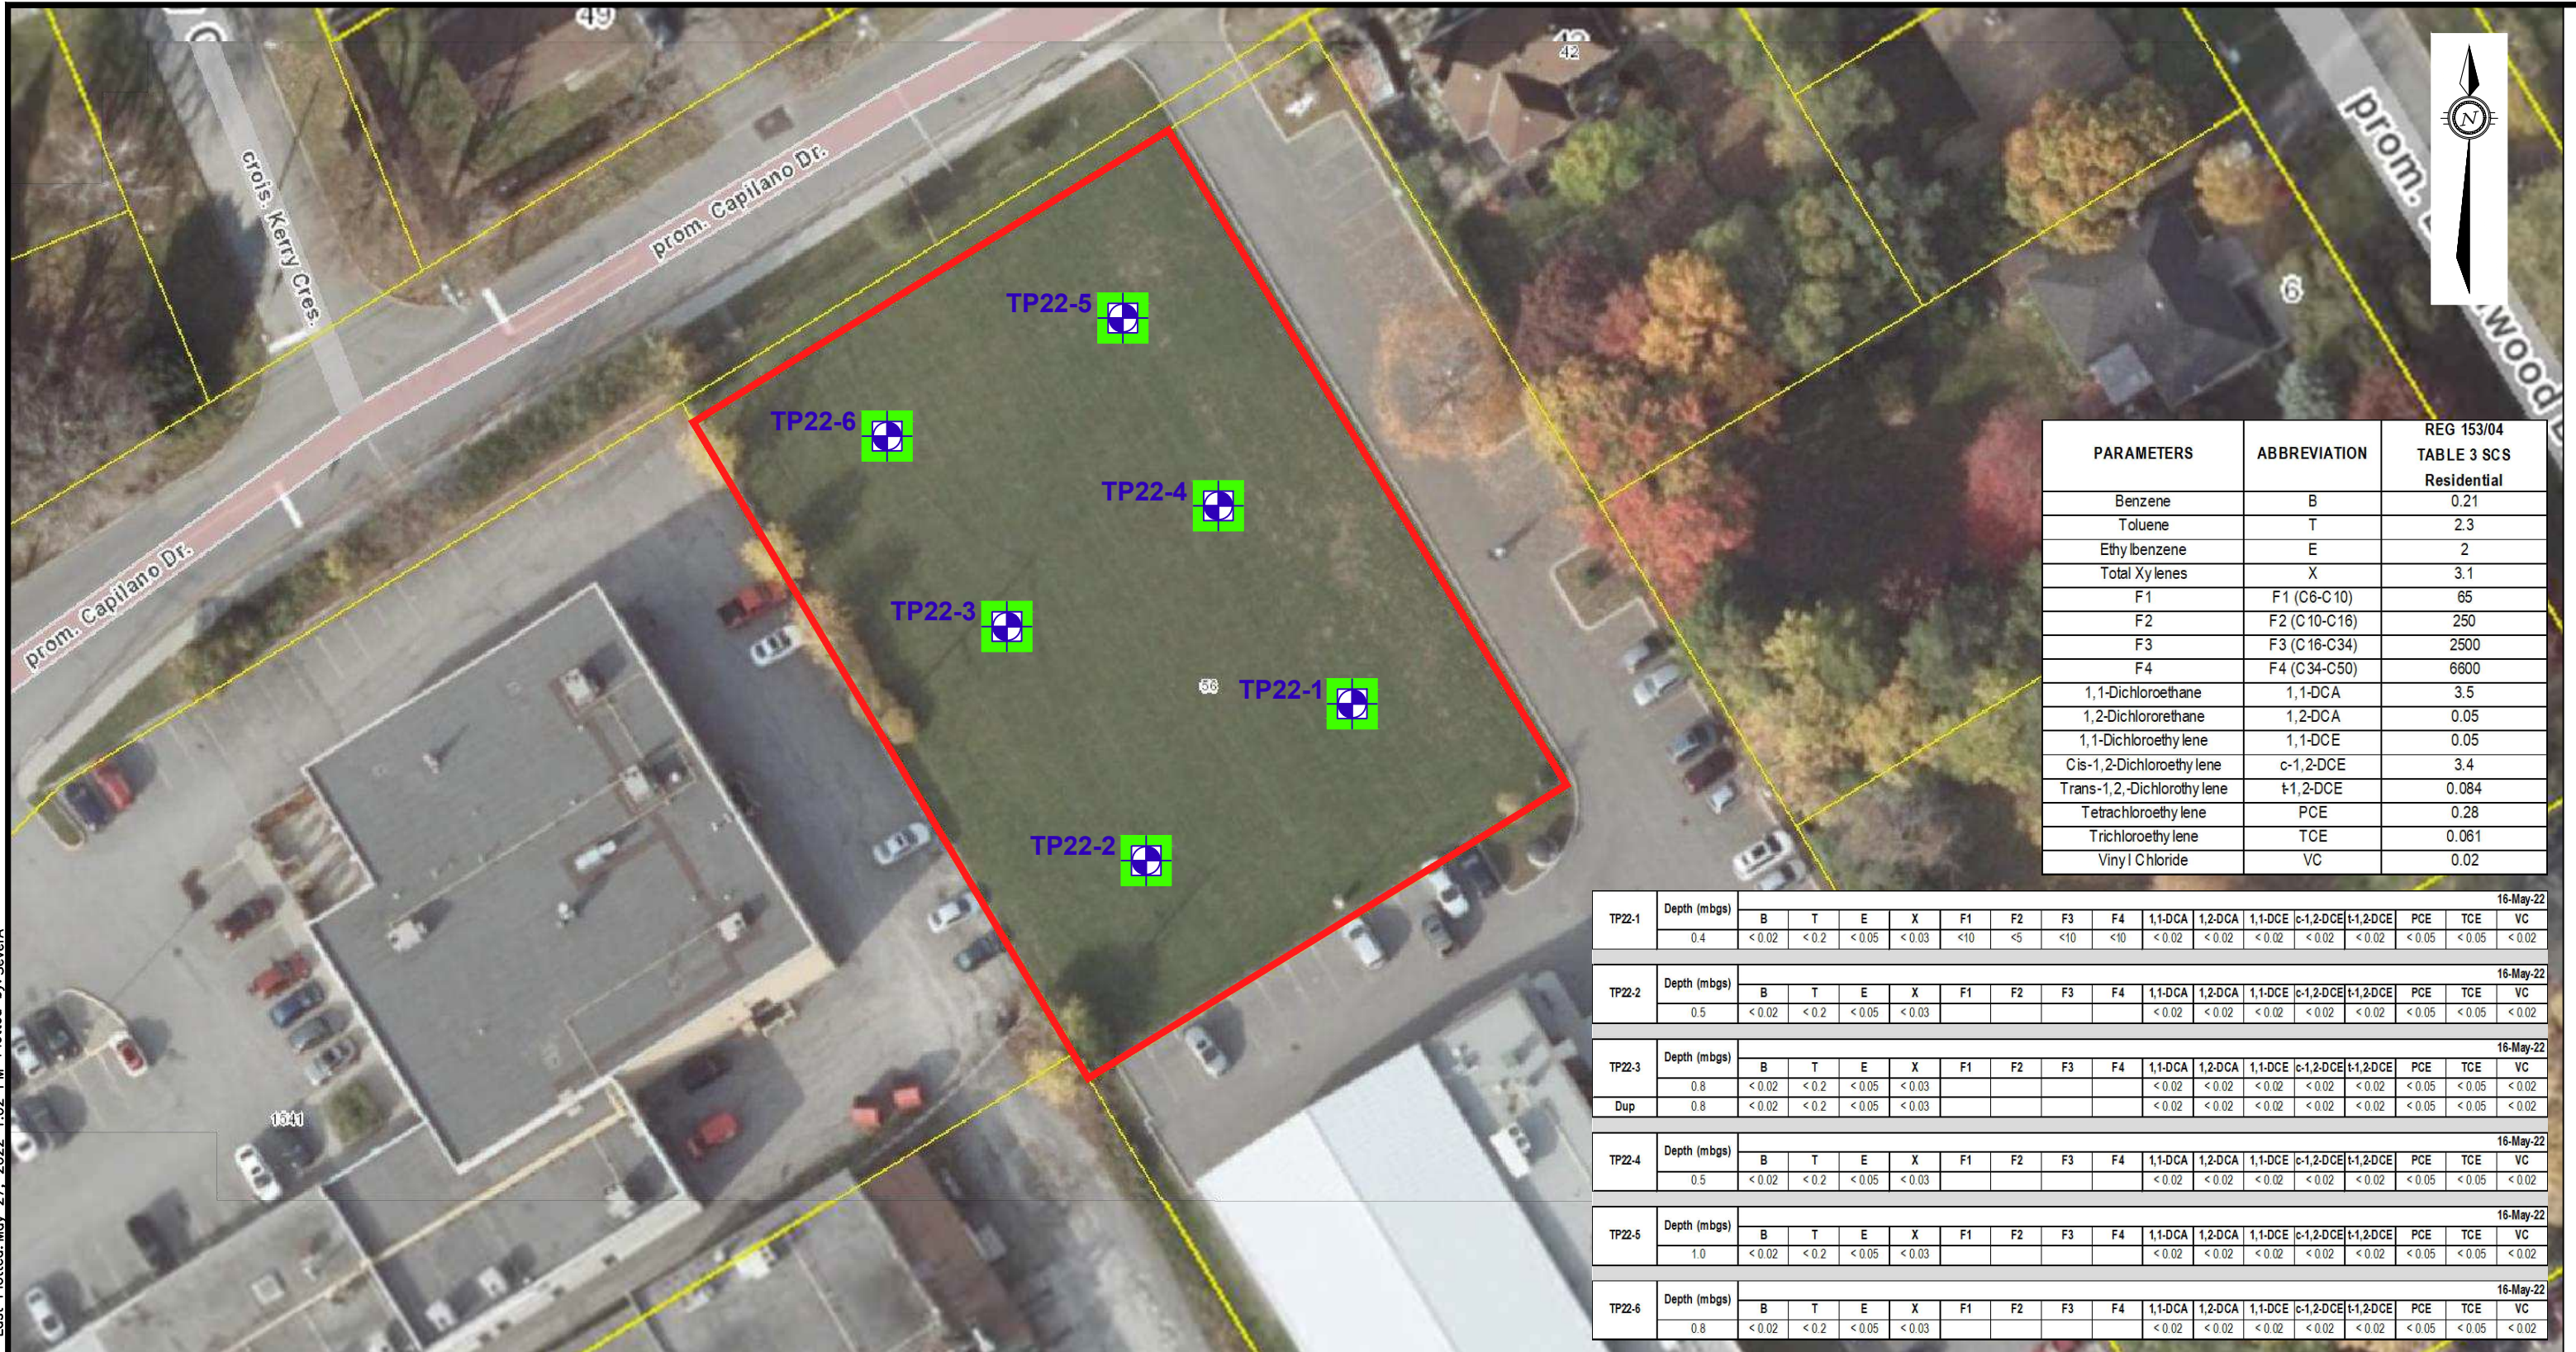
DATE	MAY 2022	PHASE TWO ENVIRONMENTAL SITE ASSESSMENT SOIL ANALYTICAL RESULTS – PHC & VOC 56 CAPILANO DRIVE, OTTAWA, ONTARIO	project no.	OTT-22003851-A0
DESIGN	LW		scale	1:500
DRAWN BY	AS			FIG 6

All of the fill samples had concentrations of VOC, PHC, PAH, and metals that were within the Table 3 residential Site Condition Standards (SCS), with the exception of the fill sample from TP22-06 which exceeded the Table 3 residential SCS for benzo(a)anthracene, benzo(a)pyrene, and fluoranthene.

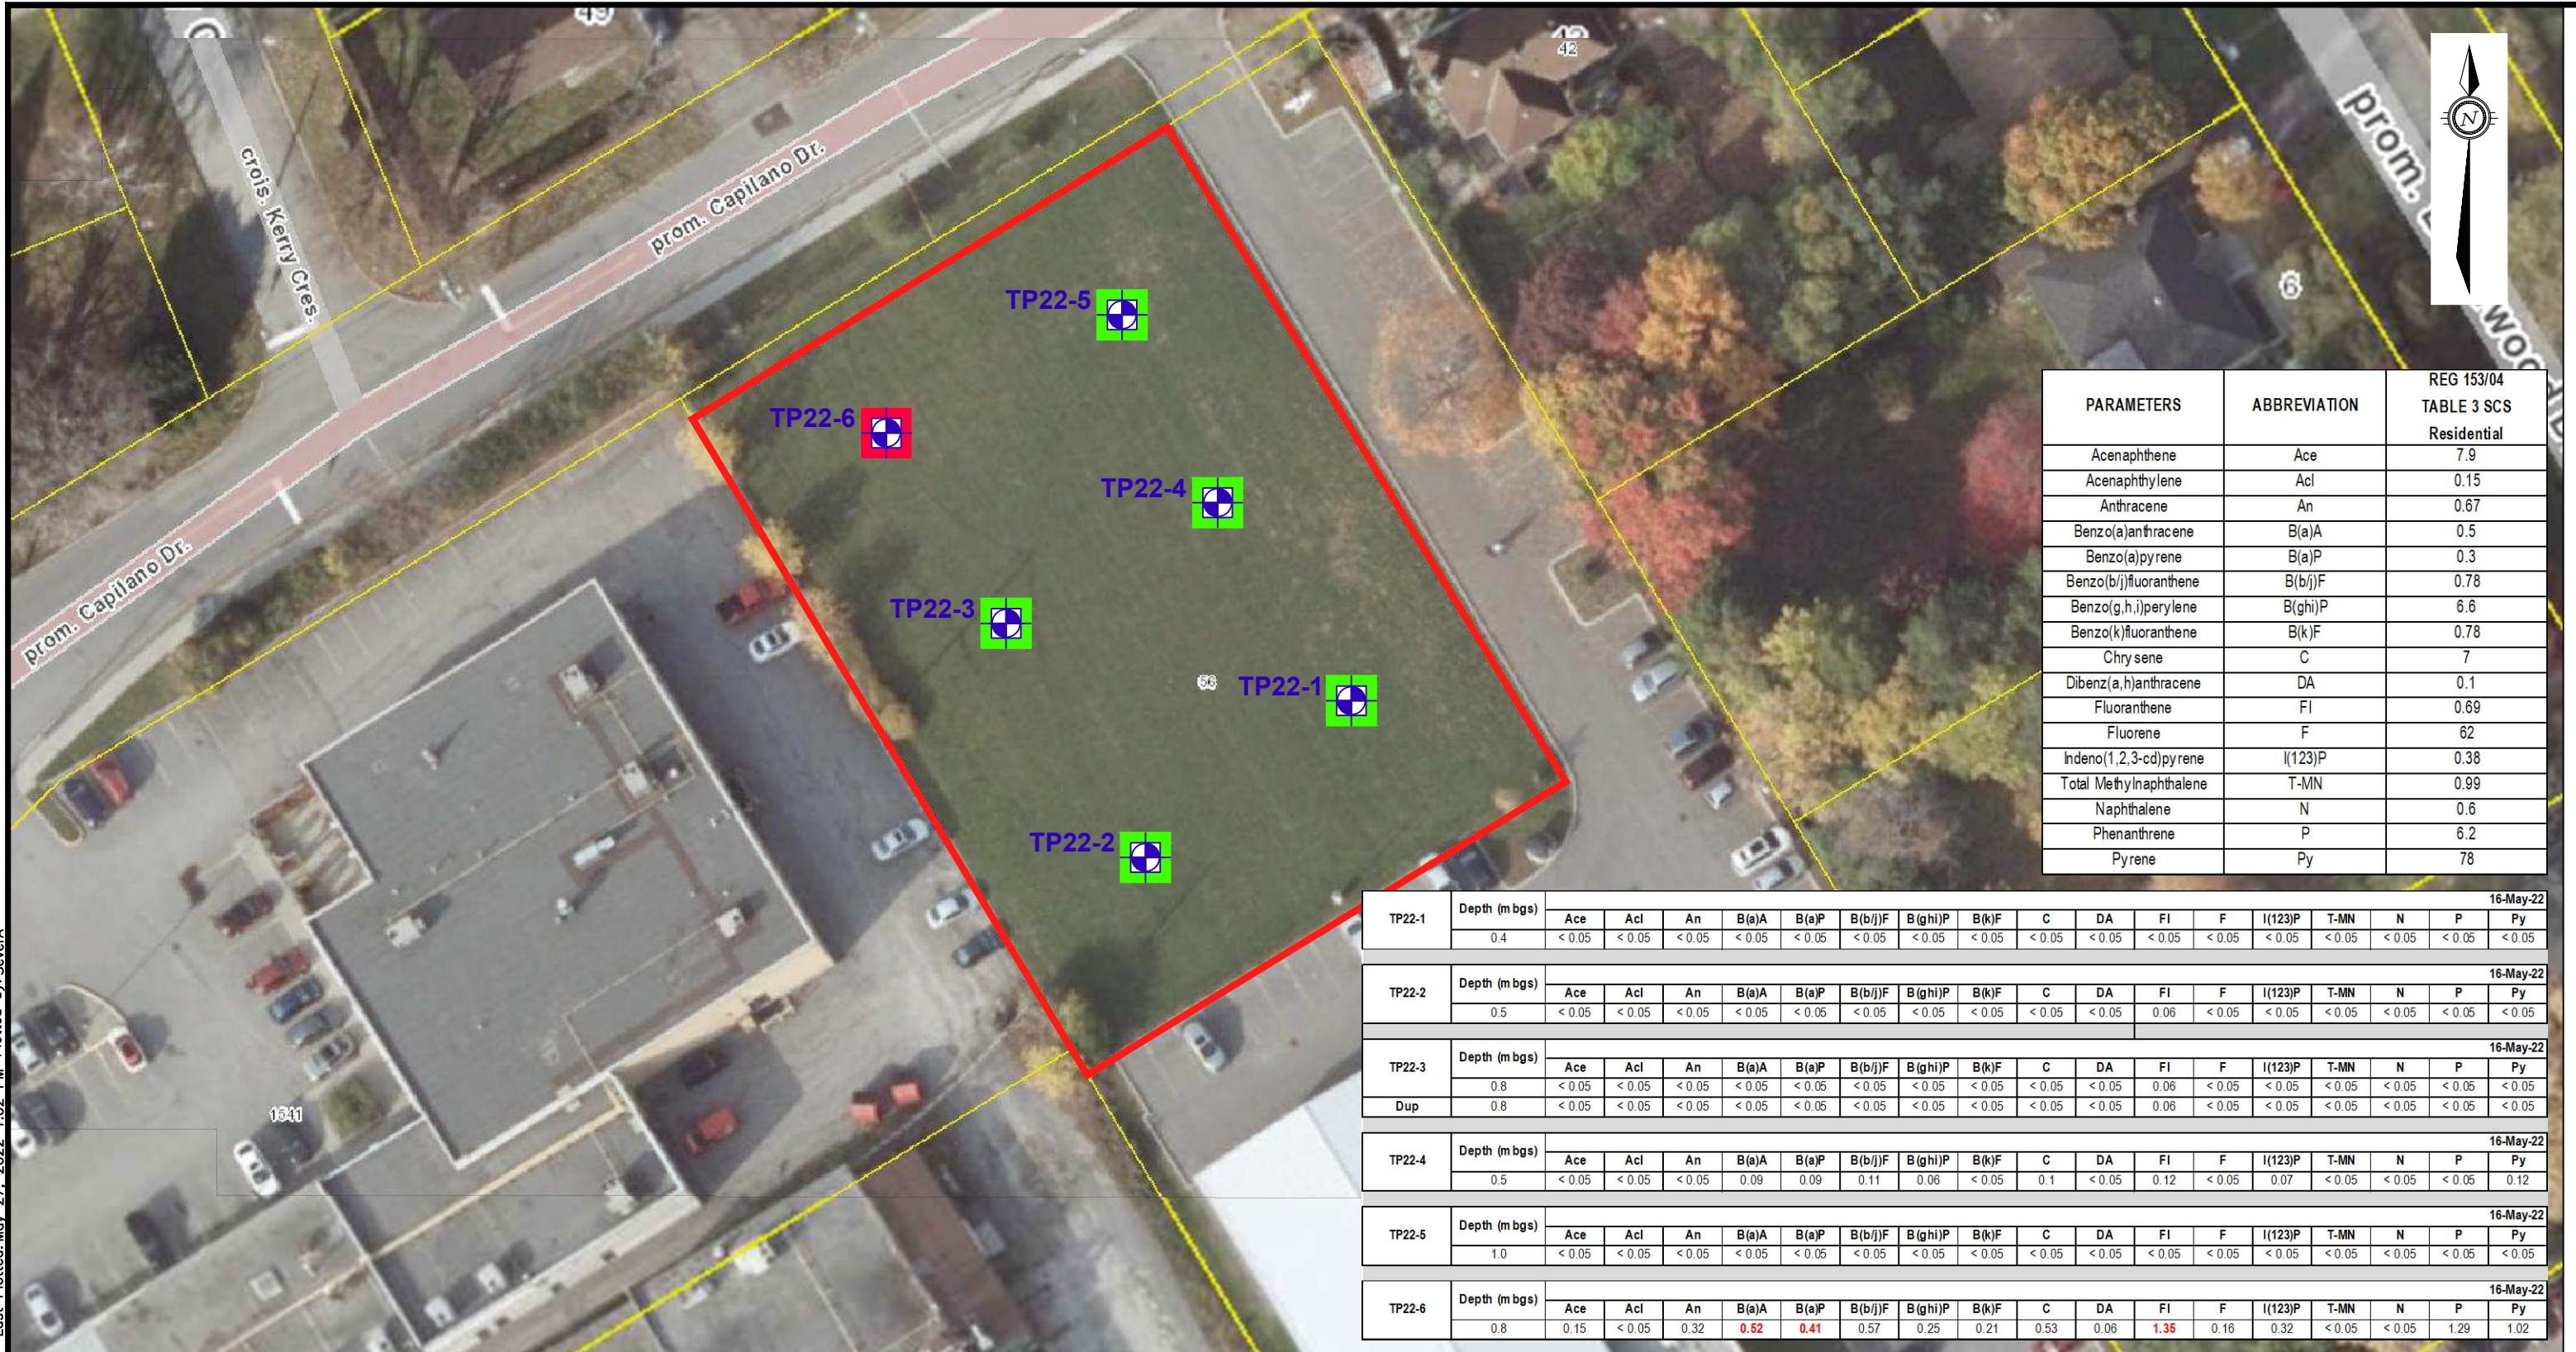
PAH impacted soil was identified in one fill sample from TP22-6 and is associated with poor fill quality, miscellaneous debris was also observed in the fill material at this location. The depth of fill at this location was 0.2 to 1.5 m bgs.

Only a small part of the Phase Two property appears to be impacted and the contaminants do not appear to be migrating. It is recommended that the impacted soil be removed from the Phase Two property when the property is re-developed.
