Phase Two Environmental Site Assessment 56 Capilano Drive, Ottawa, Ontario

Phase Two Environmental Site Assessment

OTT-22003851-A0

*McDonald Brothers Consulting Inc.
Phase Two Environmental Site Assessment
56 Capilano Drive, Ottawa, Ontario
OTT-22003851-A0
May 27, 2022*

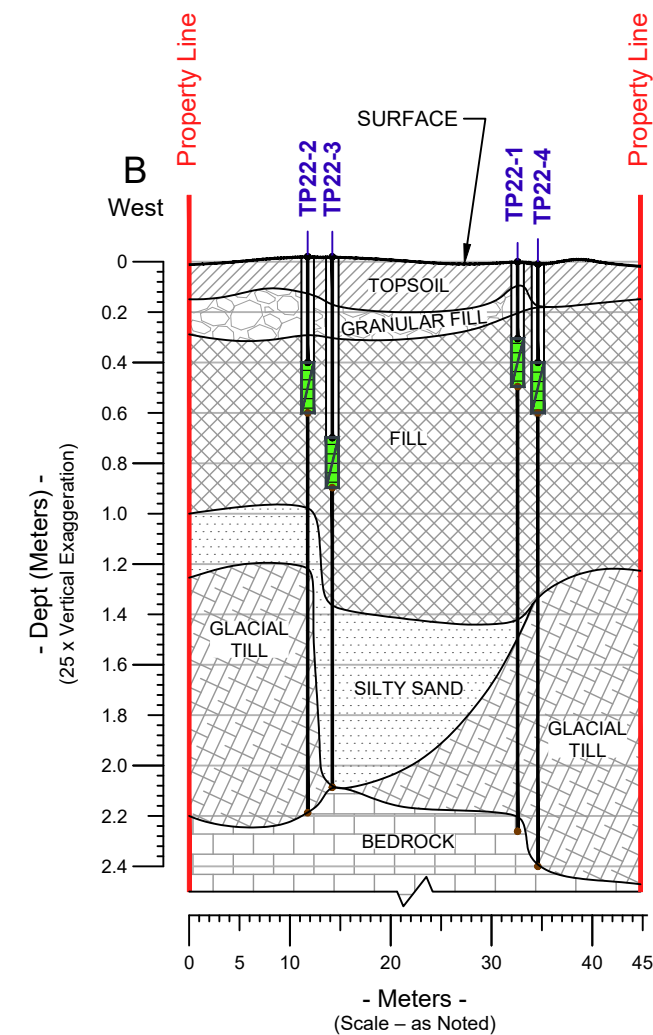
DATE	MAY 2022	PHASE TWO ENVIRONMENTAL SITE ASSESSMENT SOIL CROSS-SECTIONS A-A' & B-B' – PAH 56 CAPILANO DRIVE, OTTAWA, ONTARIO	project no.	OTT-22003851-A0		
DESIGN	LW		CHECKED	MM	scale	1:750
DRAWN BY	AS		TITLE:	FIG 10

PAH impacted soil was identified in one fill sample from TP22-6 and is associated with poor fill quality, miscellaneous debris was also observed in the fill material at this location. The depth of fill at this location was 0.2 to 1.5 m bgs.

PARAMETERS	ABBREVIATION	REG 153/04 TABLE 3 SCS Residential
Acenaphthene	Ace	7.9
Acenaphthylene	Acl	0.15
Anthracene	An	0.67
Benzo(a)anthracene	B(a)A	0.5
Benzo(a)pyrene	B(a)P	0.3
Benzo(b,j)fluoranthene	B(b/j)F	0.78
Benzo(g,h,i)perylene	B(ghi)P	6.6
Benzo(k)fluoranthene	B(k)F	0.78
Chrysene	C	7
Dibenz(a,h)anthracene	DA	0.1
Fluoranthene	Fl	0.69
Fluorene	F	62
Indeno(1,2,3-cd)pyrene	I(123)P	0.38
Total Methylnaphthalene	T-MN	0.99
Naphthalene	N	0.6
Phenanthrene	P	6.2
Pyrene	Py	78

TP	Depth (m bgs)	16-May-22																
		Ace	Acl	An	B(a)A	B(a)P	B(b/j)F	B(ghi)P	B(k)F	C	DA	Fl	F	I(123)P	T-MN	N	P	Py
TP22-1	0.4	< 0.05	< 0.05	< 0.05	< 0.05	< 0.05	< 0.05	< 0.05	< 0.05	< 0.05	< 0.05	< 0.05	< 0.05	< 0.05	< 0.05	< 0.05	< 0.05	< 0.05
TP22-2	0.5	< 0.05	< 0.05	< 0.05	< 0.05	< 0.05	< 0.05	< 0.05	< 0.05	< 0.05	< 0.05	0.06	< 0.05	< 0.05	< 0.05	< 0.05	< 0.05	< 0.05
TP22-3	0.8	< 0.05	< 0.05	< 0.05	< 0.05	< 0.05	< 0.05	< 0.05	< 0.05	< 0.05	< 0.05	0.06	< 0.05	< 0.05	< 0.05	< 0.05	< 0.05	< 0.05
Dup	0.8	< 0.05	< 0.05	< 0.05	< 0.05	< 0.05	< 0.05	< 0.05	< 0.05	< 0.05	< 0.05	0.06	< 0.05	< 0.05	< 0.05	< 0.05	< 0.05	< 0.05
TP22-4	0.5	< 0.05	< 0.05	< 0.05	0.09	0.09	0.11	0.06	< 0.05	0.1	< 0.05	0.12	< 0.05	0.07	< 0.05	< 0.05	< 0.05	0.12
TP22-5	1.0	< 0.05	< 0.05	< 0.05	< 0.05	< 0.05	< 0.05	< 0.05	< 0.05	< 0.05	< 0.05	< 0.05	< 0.05	< 0.05	< 0.05	< 0.05	< 0.05	< 0.05
TP22-6	0.8	0.15	< 0.05	0.32	0.52	0.41	0.57	0.25	0.21	0.53	0.06	1.35	0.16	0.32	< 0.05	< 0.05	1.29	1.02

Only a small part of the Phase Two property appears to be impacted and the contaminants do not appear to be migrating. It is recommended that the impacted soil be removed from the Phase Two property when the property is re-developed.
