## Phase One Environmental Site Assessment 5254 Bank Street, Ottawa, Ontario

Phase One Environmental Site Assessment

OTT-21026156-B0

2023-10-20

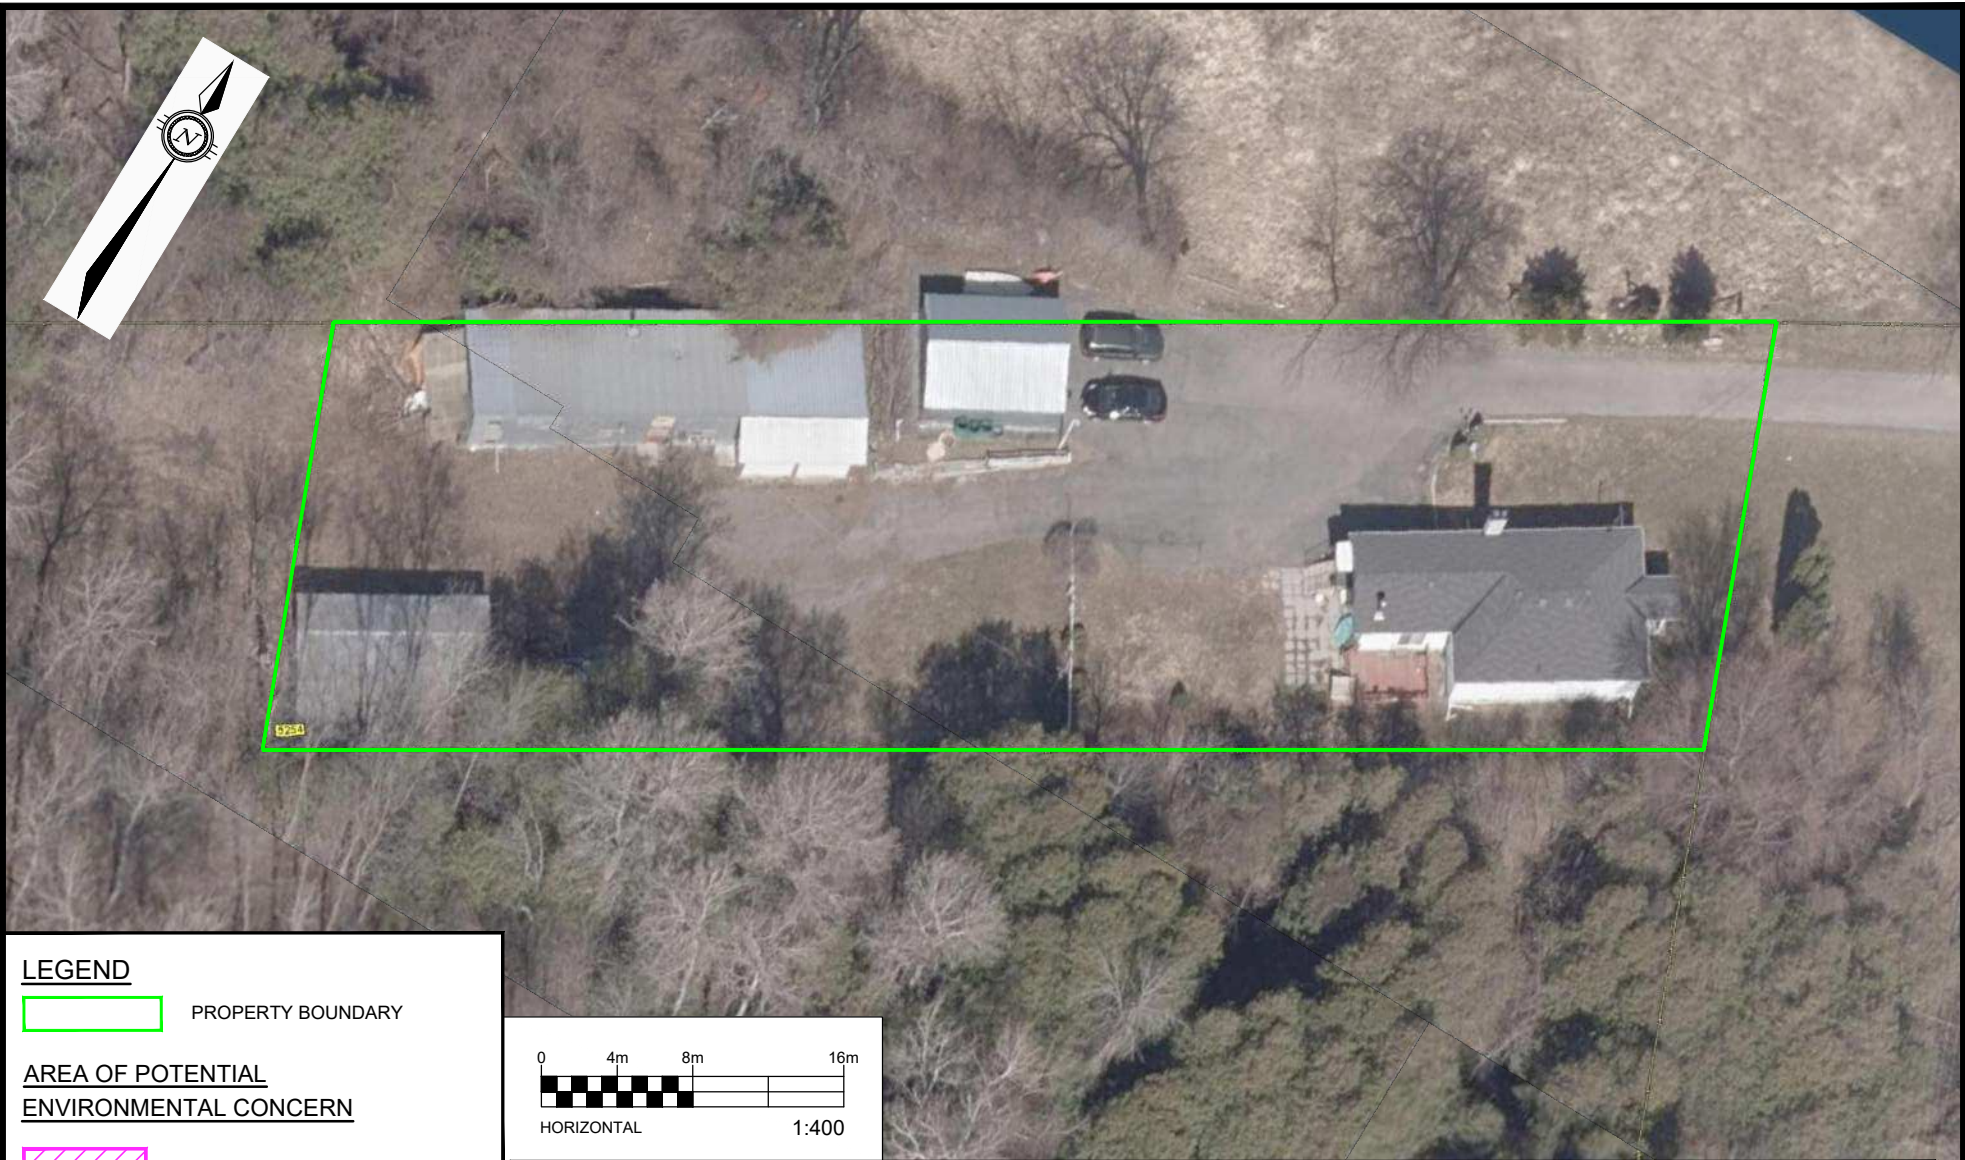
DATE FEBRUARY 2023	PROJECT: <b>PHASE ONE ENVIRONMENTAL SITE ASSESSMENT</b> 5254 BANK STREET, OTTAWA, ONTARIO	project no. OTT-21026156-B0
DESIGN LW	TITLE: <b>PHASE ONE ESA STUDY AREA</b>	scale 1:3,000
CHECKED LW		FIG 2
DRAWN BY AS

The Phase One study area is shown on Figure 2 in Appendix C.

A visual inspection of the adjacent properties and properties within 250 m of the Phase One property was conducted from publicly accessible areas to identify the occupants and document the uses and sources of potential environmental concerns that may impact the Phase One property. Refer to Figure 2 in Appendix C for the adjacent land uses.

To develop a conceptual model for the Phase One property, the following physical characteristics and pathways were considered. A conceptual site model (CSM) showing the topography of the site, inferred groundwater flow, general site features, APEC, and PCA is shown in Figure 2.

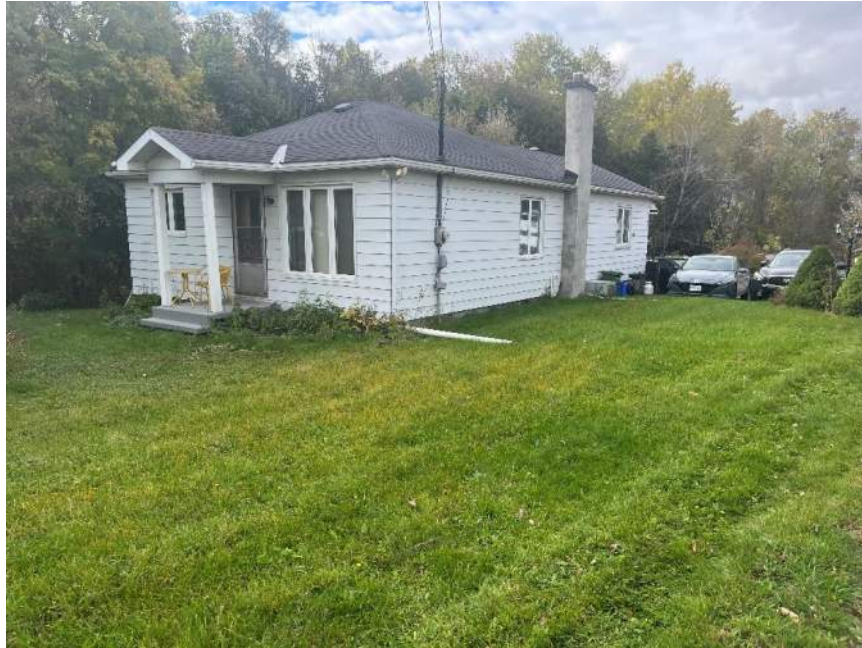
**Photograph No. 1**

View of the front of the residence.

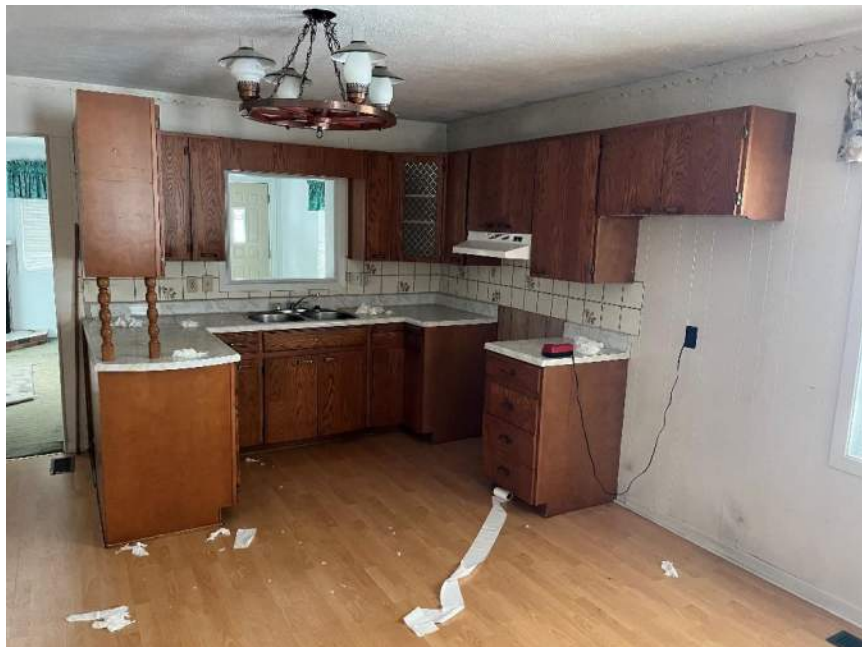
**Photograph No. 2**

The vacant residence was noted to be in a general state of disrepair, with some water damaged observed.

View of the interior of the residence.

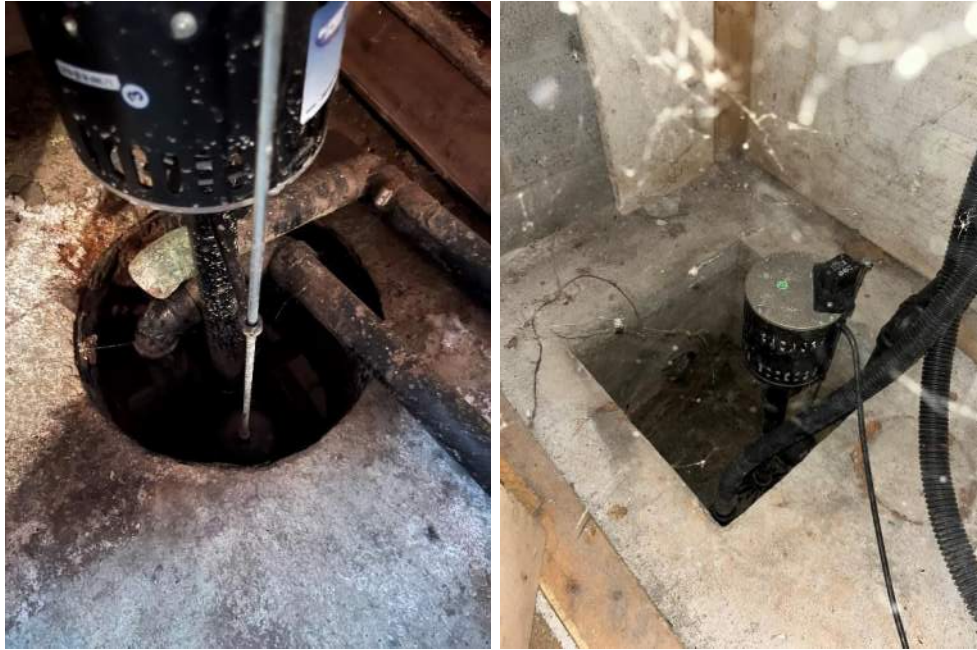
**Photograph No. 3**

There were two sumps present in the basement of the residence. Water was present one of the sumps, no sheen was observed. The other sump was dry.

Sumps located in the basement. The sump in the left photo was dry.

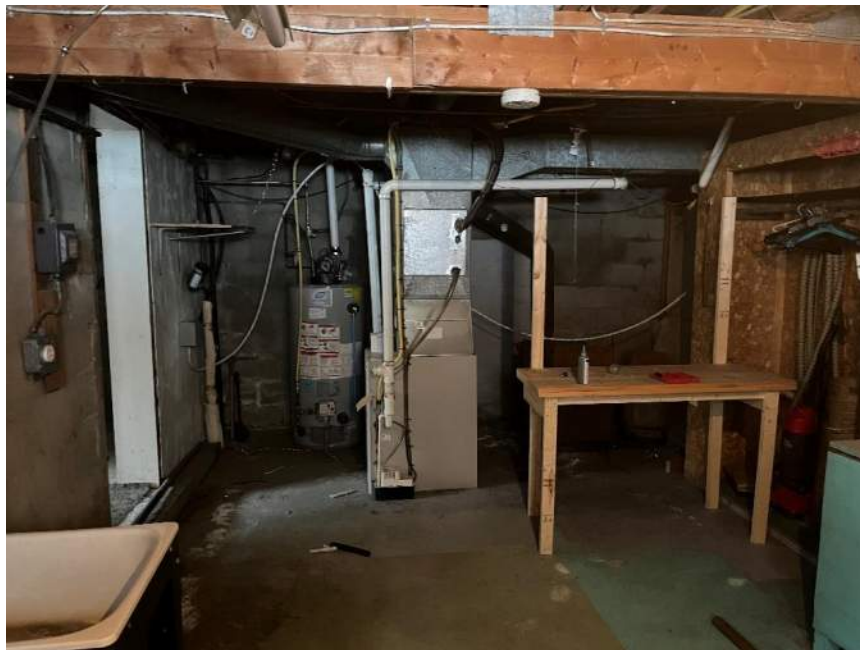
**Photograph No. 4**

Natural gas fired furnace and hot water tank.

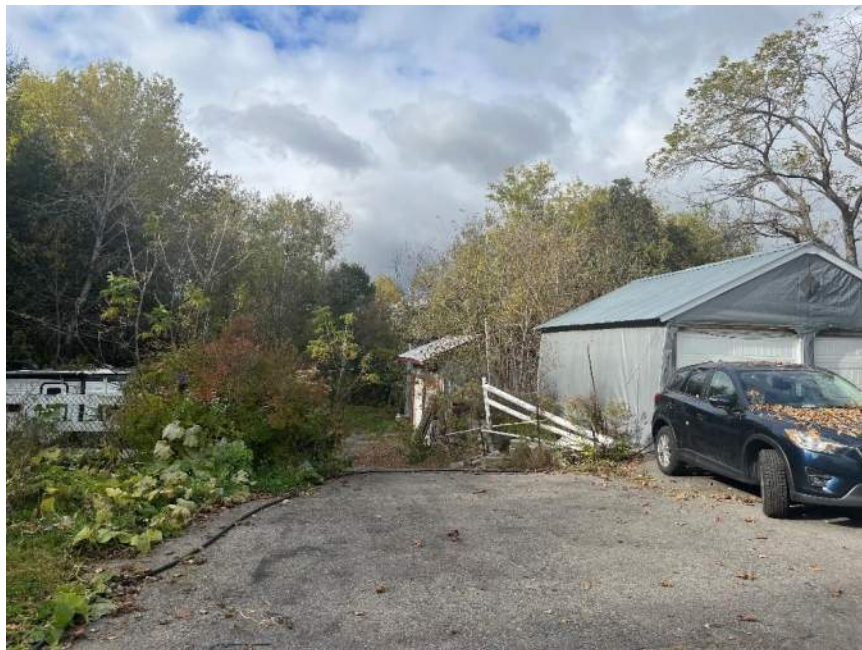
**Photograph No. 6**

View of the storage sheds and detached garage on the Phase One property.
