Phase Two Environmental Site Assessment 381 Kent Street, Ottawa, Ontario

Type of Document:
Final

Project Number:
OTT-21019154-A0

Prepared By:
EXP Services Inc.
100-2650 Queensview Drive
Ottawa, ON K2B 7H6
Canada
T: +1.613-688-1899
F: +1.613-225-7337
www.exp.com

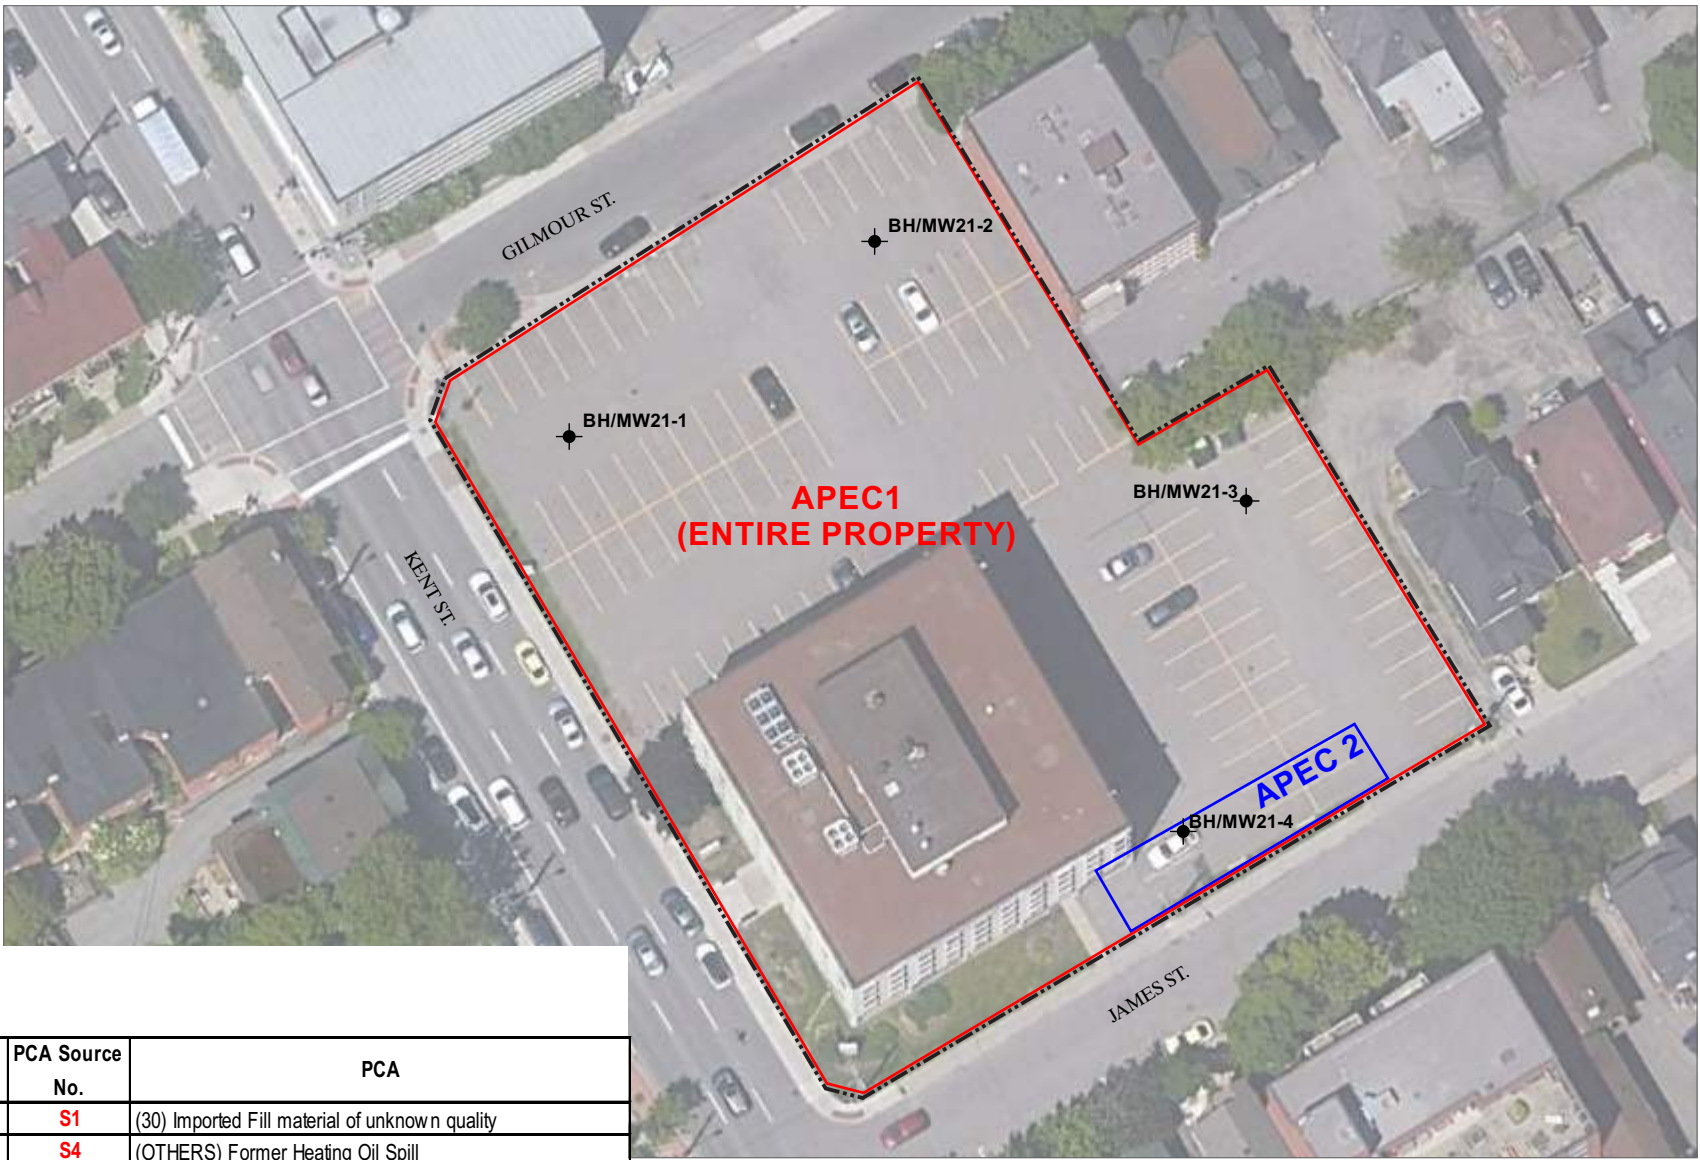
AREAS OF POTENTIAL ENVIRONMENTAL CONCERN 381 KENT STREET, OTTAWA, ONTARIO	FIGURE 3
	PROJECT NUMBER: 21019154 DATE: JANUARY 2022

APEC	PCA Source No.	PCA
1	S1	(30) Imported Fill material of unknown quality
2	S4	(OTHERS) Former Heating Oil Spill

The above APECs were identified on the Phase Two property as shown on Figures 4 and 5 in Appendix A. It is noted that any uncertainty or absence of information has the ability to affect the Phase One Conceptual Site Model. However, based on the information and findings presented within the Phase One ESA, it is EXP's opinion that any uncertainty would be minimal, and it would not alter the validity of the model presented above.

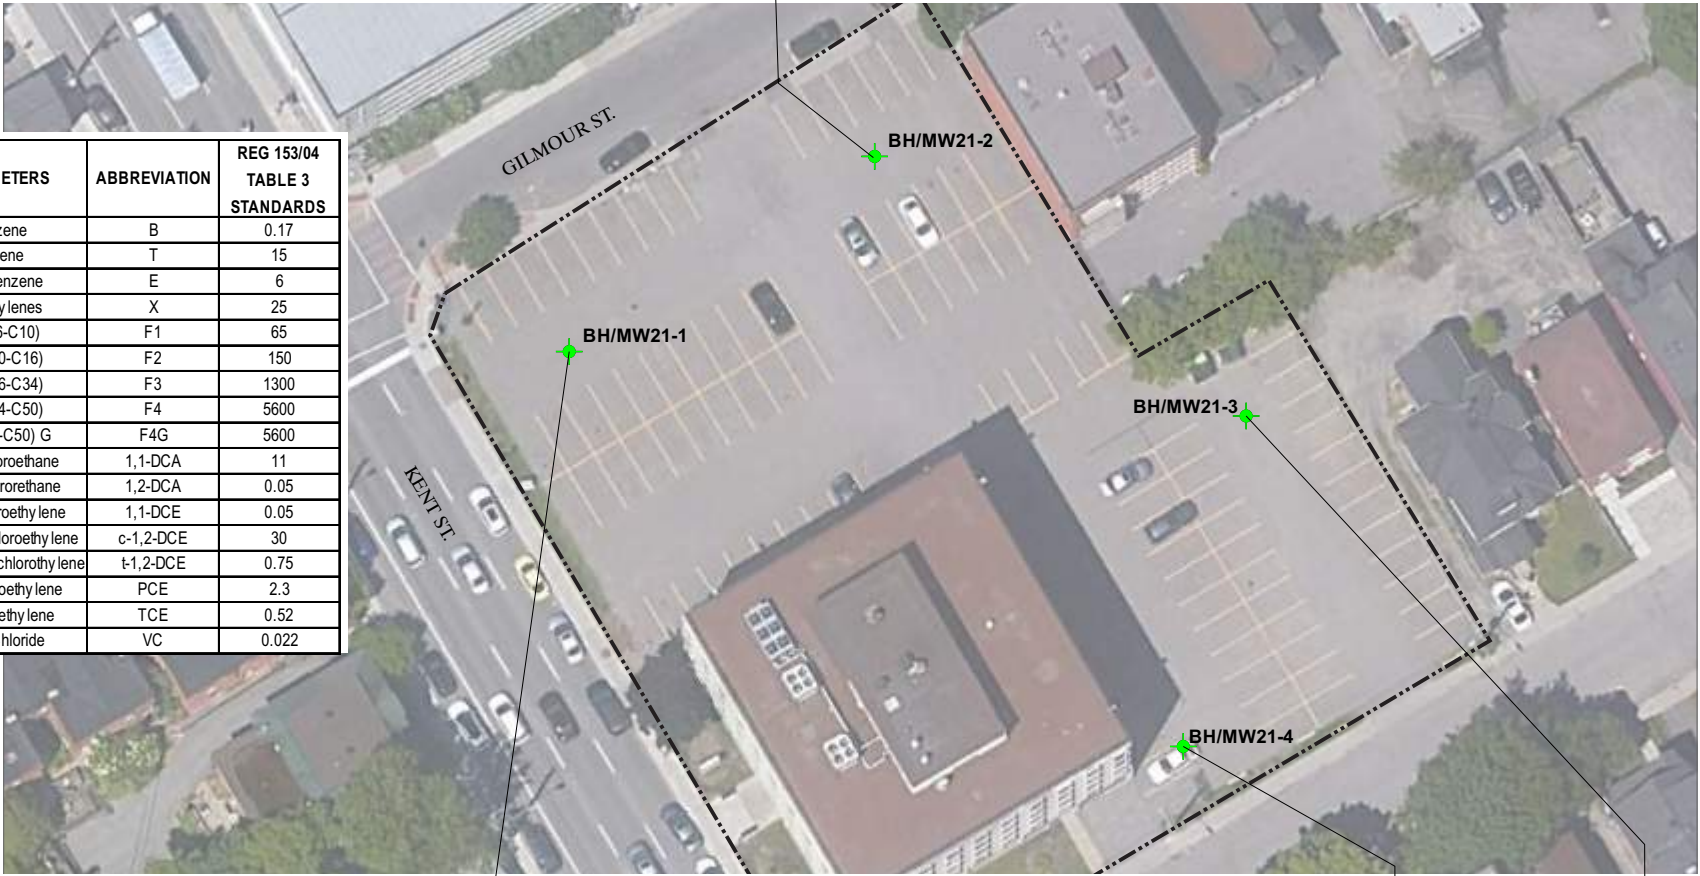
PARAMETERS	ABBREVIATION	REG 153/04 TABLE 3 STANDARDS
Benzene	B	0.17
Toluene	T	15
Ethylbenzene	E	6
Total Xylenes	X	25
F1 (C6-C10)	F1	65
F2 (C10-C16)	F2	150
F3 (C16-C34)	F3	1300
F4 (C34-C50)	F4	5600
F4 (C34-C50) G	F4G	5600
1,1-Dichloroethane	1,1-DCA	11
1,2-Dichloroethane	1,2-DCA	0.05
1,1-Dichloroethylene	1,1-DCE	0.05
Cis-1,2-Dichloroethylene	c-1,2-DCE	30
Trans-1,2-Dichloroethylene	t-1,2-DCE	0.75
Tetrachloroethylene	PCE	2.3
Trichloroethylene	TCE	0.52
Vinyl Chloride	VC	0.022

Sample ID	Date	Depth (m)	B	T	E	X	F1	F2	F3	F4	F4G	1,1-DCA	1,2-DCA	1,1-DCE	c-1,2-DCE	t-1,2-DCE	PCE	TCE	VC
BH/MW21-1	12/02/21	3.0 - 3.6	<0.0060	<0.010	<0.020	<0.020	<10	<20	<100	<100	NA	<0.040	<0.049	<0.040	<0.040	<0.040	<0.040	<0.010	<0.019

Sample ID	Date	Depth (m)	B	T	E	X	F1	F2	F3	F4	F4G	1,1-DCA	1,2-DCA	1,1-DCE	c-1,2-DCE	t-1,2-DCE	PCE	TCE	VC
BH/MW21-4	29/11/2021	5.3 - 5.9	<0.0060	<0.010	<0.020	<0.020	<10	<20	<100	<100	NA	<0.040	<0.049	<0.040	<0.040	<0.040	<0.040	<0.010	<0.019

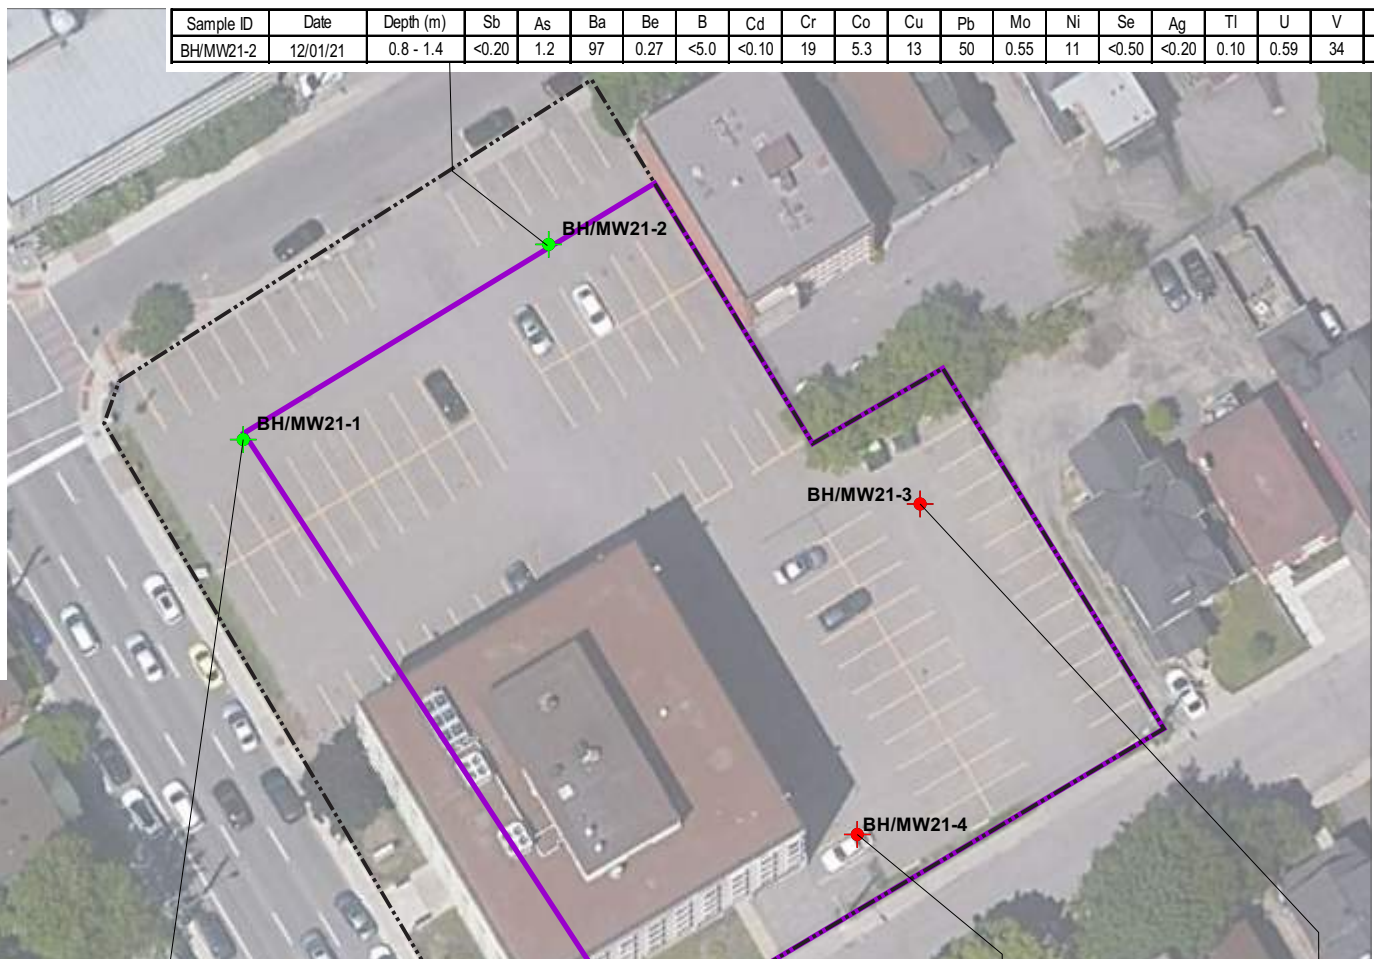
PARAMETERS	ABBREVIATION	REG 153/04 TABLE 3 STANDARDS
Antimony	Sb	7.5
Arsenic	As	18
Barium	Ba	390
Beryllium	Be	5
Boron	B	120
Cadmium	Cd	1.2
Chromium	Cr	160
Cobalt	Co	22
Copper	Cu	180
Lead	Pb	120
Molybdenum	Mo	6.9
Nickel	Ni	130
Selenium	Se	2.4
Silver	Ag	25
Thallium	Tl	1
Uranium	U	23
Vanadium	V	86
Zinc	Zn	340
Conductivity	Conductivity	0.7
SAR	SAR	5
Cyanide	Cyanide	0.051
Chromium VI	Cr VI	10
Mercury	Hg	1.8

Sample ID	Date	Depth (m)	Sb	As	Ba	Be	B	Cd	Cr	Co	Cu	Pb	Mo	Ni	Se	Ag	Tl	U	V	Zn
BH/MW21-2	12/01/21	0.8 - 1.4	<0.20	1.2	97	0.27	<5.0	<0.10	19	5.3	13	50	0.55	11	<0.50	<0.20	0.10	0.59	34	56

Sample ID	Date	Depth (m)	Sb	As	Ba	Be	B	Cd	Cr	Co	Cu	Pb	Mo	Ni	Se	Ag	Tl	U	V	Zn
BH/MW21-1	12/02/21	0.1 - 0.6	0.63	2.1	170	0.34	7.0	0.20	29	7.4	27	100	1.9	17	<0.50	<0.20	0.17	0.56	36	100

Sample ID	Date	Depth (m)	Sb	As	Ba	Be	B	Cd	Cr	Co	Cu	Pb	Mo	Ni	Se	Ag	Tl	U	V	Zn
BH/MW21-4	29/11/2021	0.8 - 1.4	<0.20	430	0.88	<5.0	0.11	140	25	54	6.9	<0.50	73	<0.50	<0.20	0.54	0.96	130	150	
~	29/11/2021	0.8 - 1.4	<0.20	3.7	150	0.41	7.2	0.15	13	7.2	20	8.0	3.6	24	<0.50	<0.20	0.23	1.7	21	30

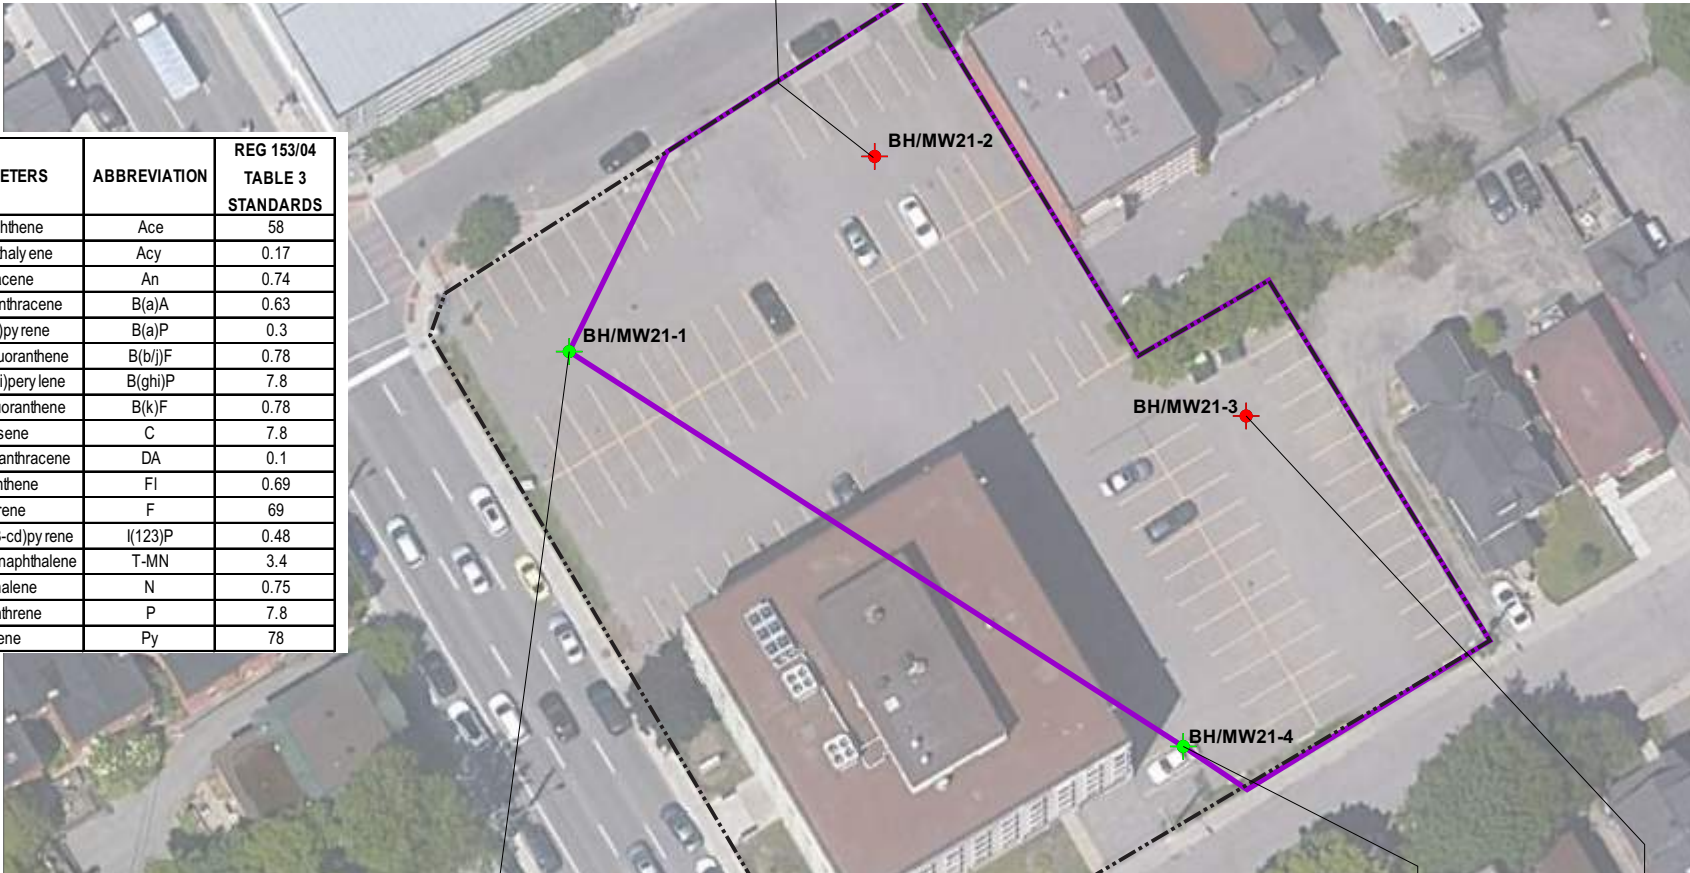
PARAMETERS	ABBREVIATION	REG 153/04 TABLE 3 STANDARDS
Acenaphthene	Ace	58
Acenaphthylene	Acy	0.17
Anthracene	An	0.74
Benzo(a)anthracene	B(a)A	0.63
Benzo(a)pyrene	B(a)P	0.3
Benzo(b/j)fluoranthene	B(b/j)F	0.78
Benzo(g,h,i)perylene	B(ghi)P	7.8
Benzo(k)fluoranthene	B(k)F	0.78
Chrysene	C	7.8
Dibenz(a,h)anthracene	DA	0.1
Fluoranthene	Fl	0.69
Fluorene	F	69
Indeno(1,2,3-cd)pyrene	I(123)P	0.48
Total Methylnaphthalene	T-MN	3.4
Naphthalene	N	0.75
Phenanthrene	P	7.8
Pyrene	Py	78

Sample ID	Date	Depth (m)	Ace	Acy	An	B(a)A	B(a)P	B(b/j)F	B(ghi)P	B(k)F	C	DA	Fl	F	I(123)P	T-MN	N	P	Py
BH/MW21-1	12/02/21	0.1 - 0.6	<0.050	<0.050	0.052	0.25	0.26	0.33	0.20	0.12	0.21	<0.050	0.50	<0.050	0.17	<0.071	<0.050	0.26	0.45

Sample ID	Date	Depth (m)	Ace	Acy	An	B(a)A	B(a)P	B(b/j)F	B(ghi)P	B(k)F	C	DA	Fl	F	I(123)P	T-MN	N	P	Py
BH/MW21-4	29/11/2021	0.8 - 1.4	<0.0050	<0.0050	<0.0050	<0.0050	<0.0050	<0.0050	<0.0050	<0.0050	<0.0050	<0.0050	<0.0050	<0.0050	<0.0050	<0.0071	<0.0050	<0.0050	<0.0050
~	29/11/2021	0.8 - 1.4	<0.0050	<0.0050	<0.0050	<0.0050	<0.0050	<0.0050	0.0058	0.016	<0.0050	<0.0050	<0.0050	0.0056	<0.0050	<0.0071	<0.0050	<0.0050	0.0092
