Muncaster  
Environmental  
Planning Inc.

September 19, 2022

**RE: Natural Environmental Update  
1650 Shea Road**

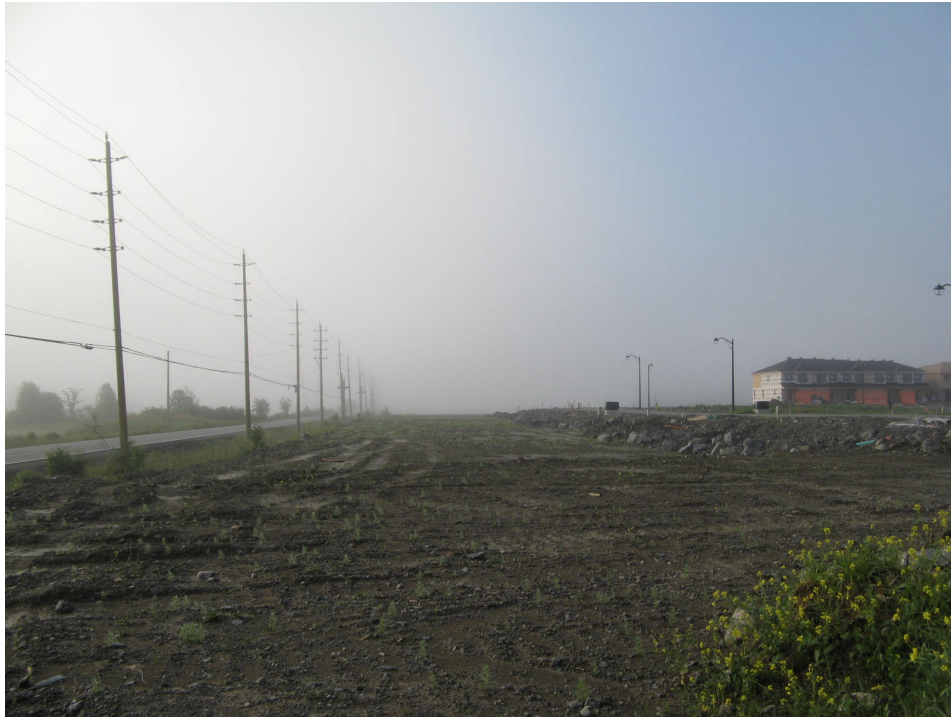
The site has been cleared of trees and grubbed (Photo 1). No trees at least 10cm diameter at breast height (dbh) were observed on the site in June, 2022. The current vegetation on the site would be described as a combination of regenerating cultural meadow (Photo 2) and thicket communities (Photo 3). Regenerating woody vegetation includes areas of trembling aspen stems less than 10cm dbh, with small ash stems also present. Shrubs in the thicket habitat include glossy buckthorn, red raspberry, slender willow, and Bebb's willow.

*Photo 1 – Current site conditions on the south portion of the 1650 Shea Road lands, south of Cosanti Drive. View looking south from Cosanti Drive*

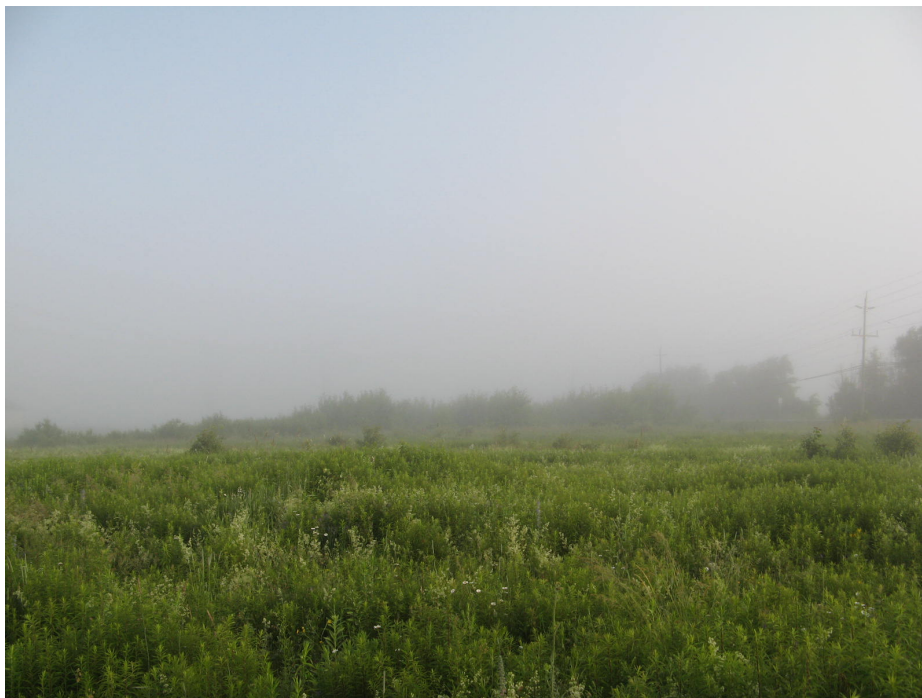
*Photo 2 – Cultural meadow habitat dominates the central and north portions of the 1650 Shea Road lands. View looking north from Cosanti Drive with off-site trees on the north side of Fernbank Road in the background*

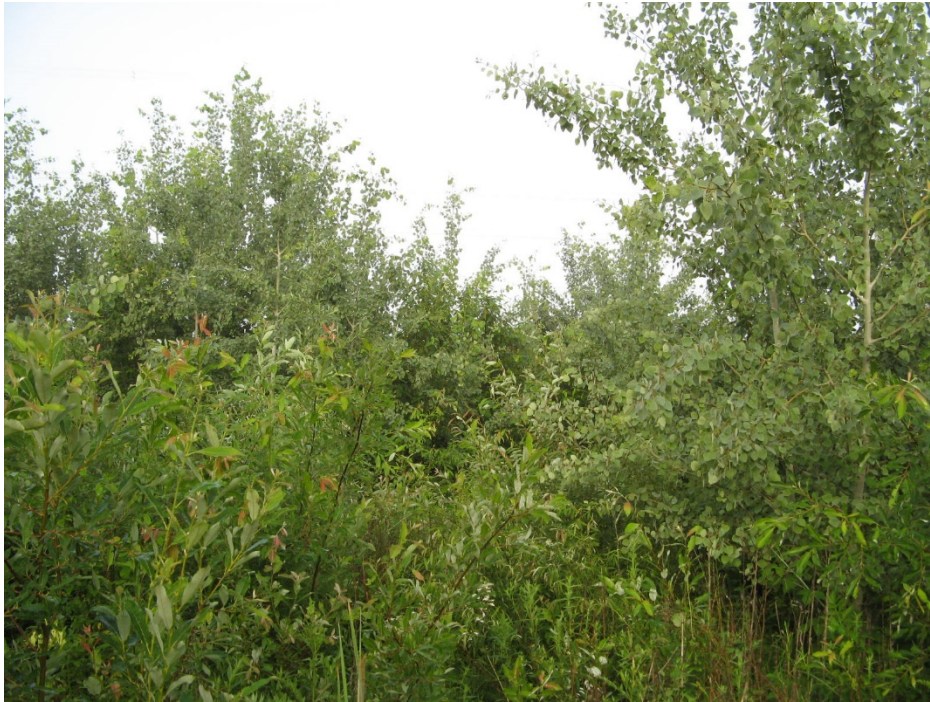
*Photo 3 – Cultural thicket vegetation, including regenerating poplar stems in the north-central portion of the 1650 Shea Road lands. View looking north.*

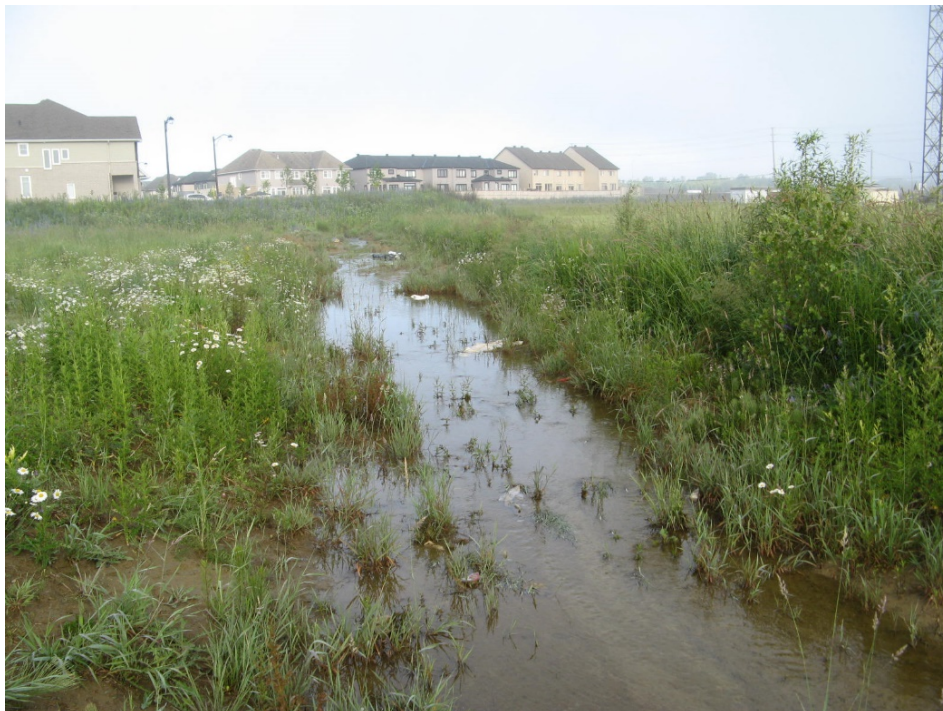
The dug channel leading south from Fernbank Road (Photo 4) was first diverted around Phase 1 of the residential development to the west and then again for Phase 2, per approvals from MOEE as part of the subdivision designs. Once the approved stormwater management plan for the lands to the north is implemented by others, the dug ditches will be filled in as they will no longer be required. The stormwater management plan for the lands to the north includes the capture, entombment, and diversion of the upstream flows from the dug channel on and adjacent to the site. The dug ditches lack aquatic habitat characteristics due to their recent dug nature, typical trapezoid ditch cross-section with a lack of diversity in morphological forms, and lack of natural features such as riparian woody vegetation, coarse substrate, woody debris, low flow channel, or undercut banks.

*Photo 4 – West -east section of dug channel at west property line of the 1650 Shea Road lands, View looking west to recent residential construction*

Flowing water was observed in the dug ditch during the June, 2022 survey. Although there were no visual observations of fish (detailed fish sampling was not completed), if there is water present during the removal of the ditch, prior to removal the wetted portions of the ditch are to be de-fished by a qualified biologist. A sampling permit will be required from the MNDMNR and the permit has taken up to one month to obtain.
