# Phase One Environmental Site Assessment

265 Centrum Boulevard, Orléans, ON K1E 3X7

**Bayview Orleans Inc.**  
Final Report

March 2023  
02300762.000

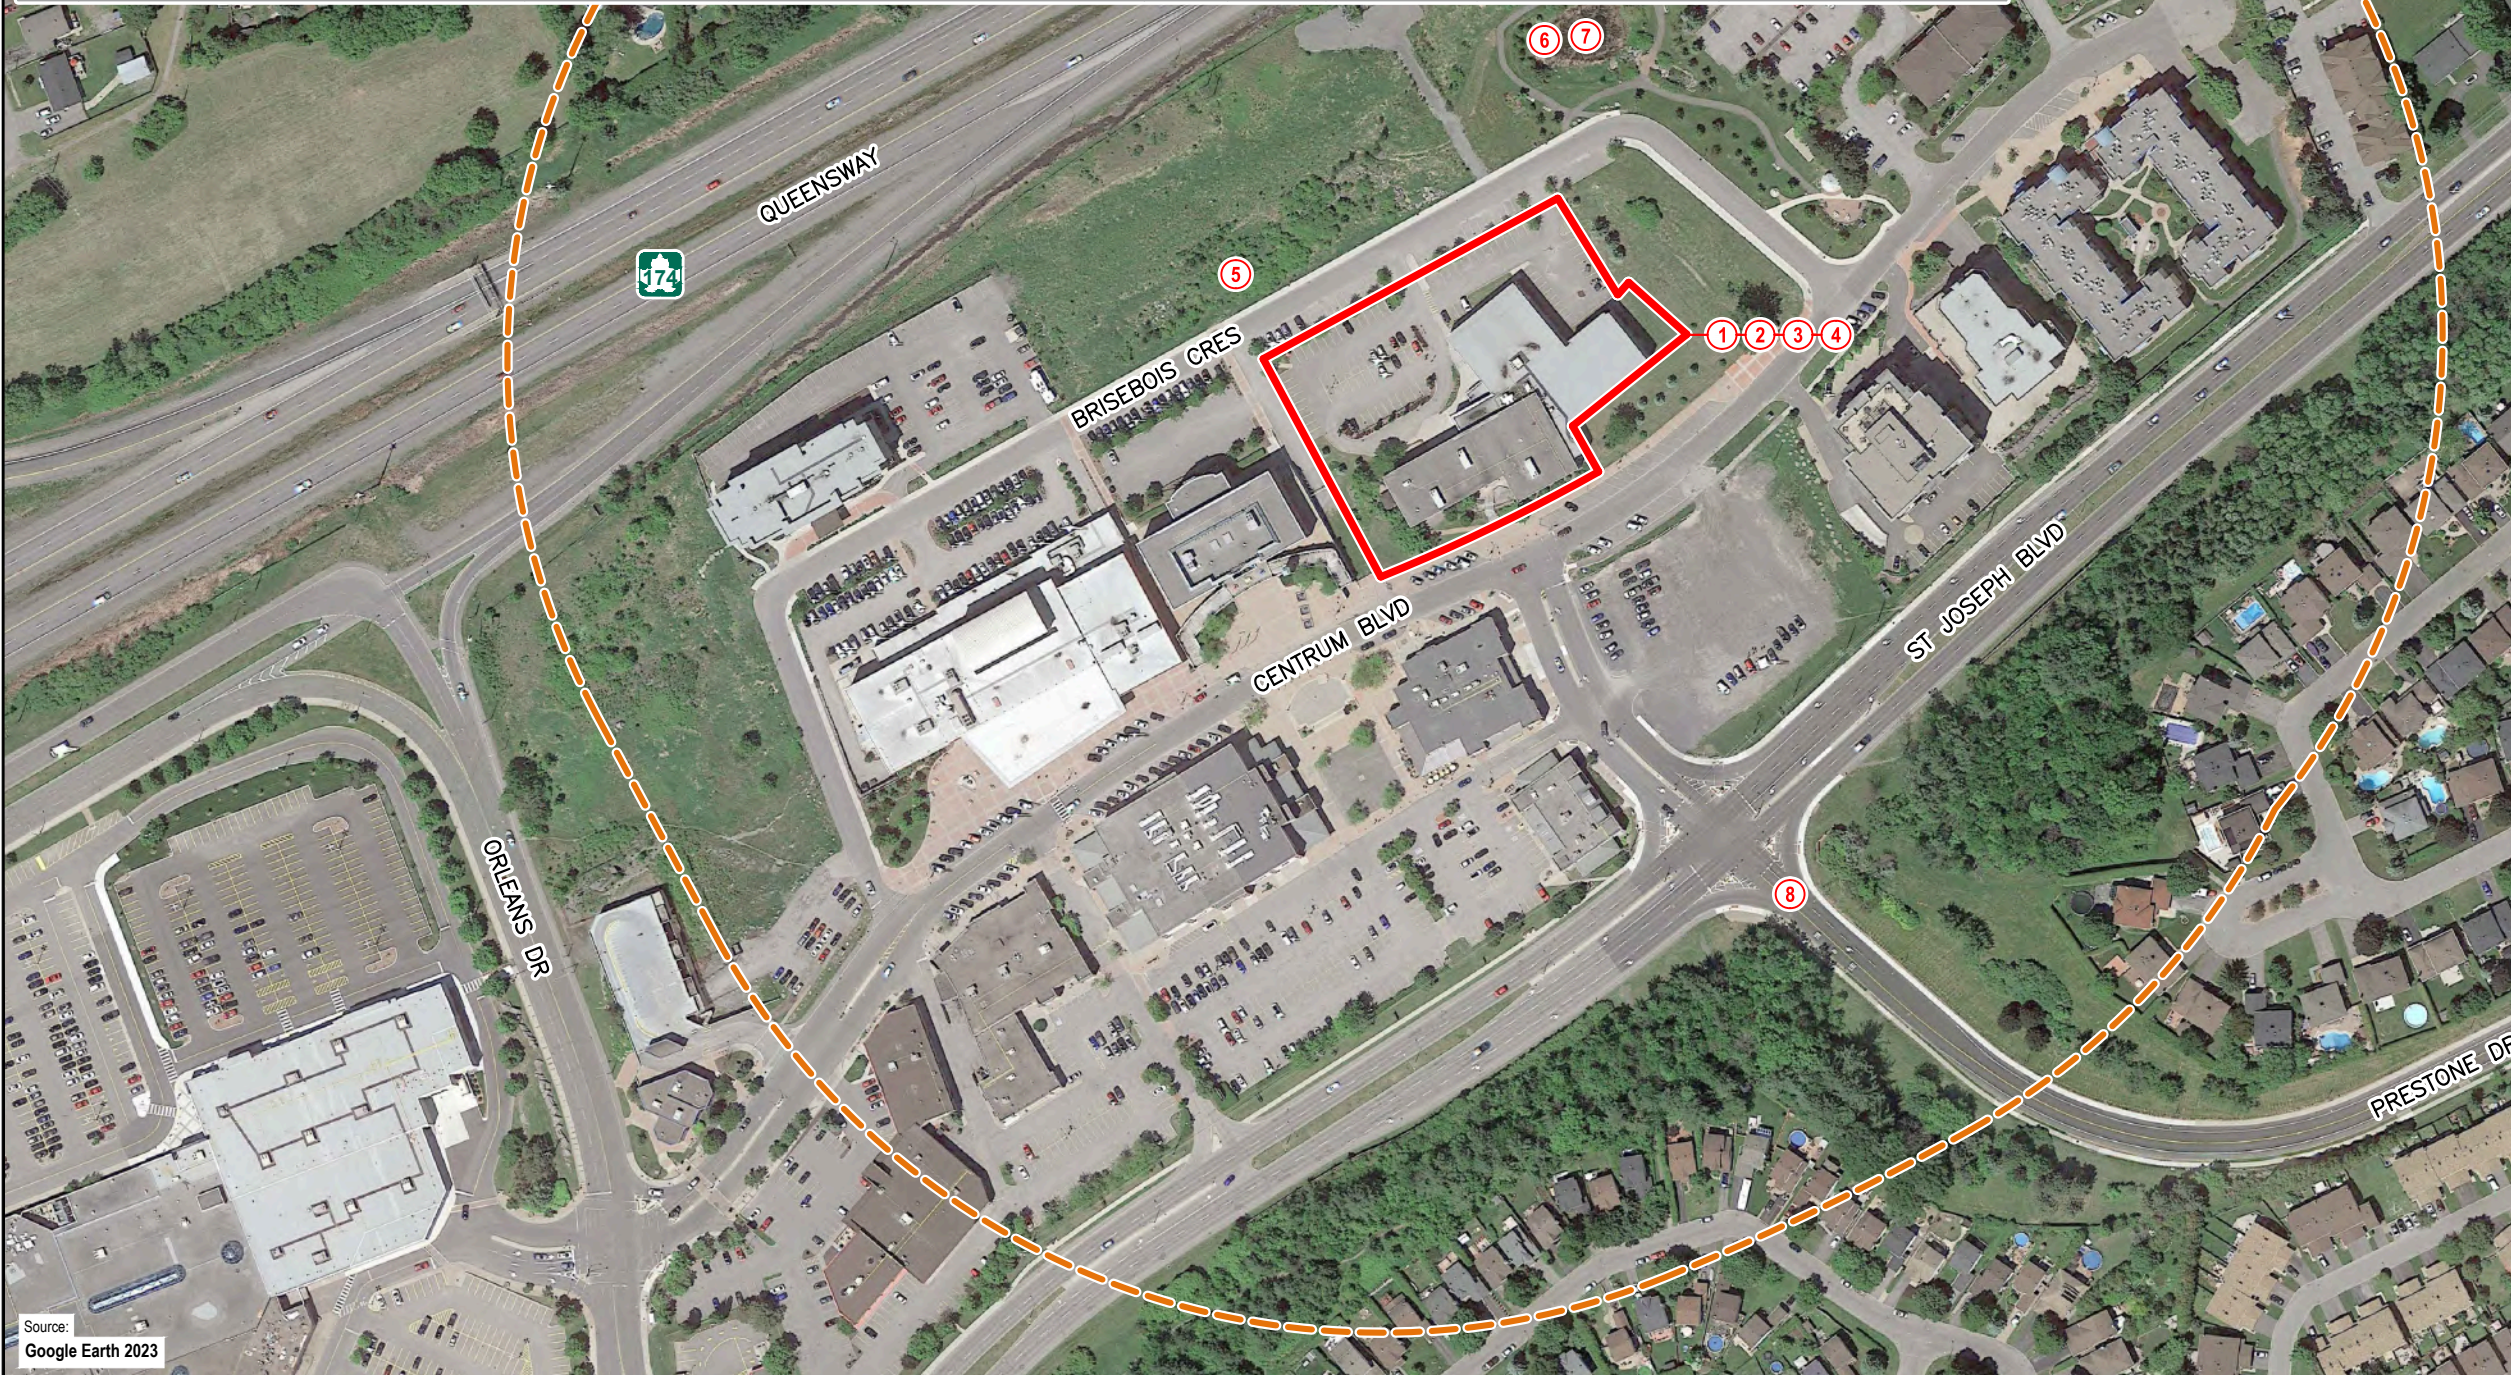
Figure No. **3**

**Legend**  
 Approximate Property Boundary  
 Phase One Study Area, 250 m Buffer  
 Potentially Contaminating Activities (PCAs)

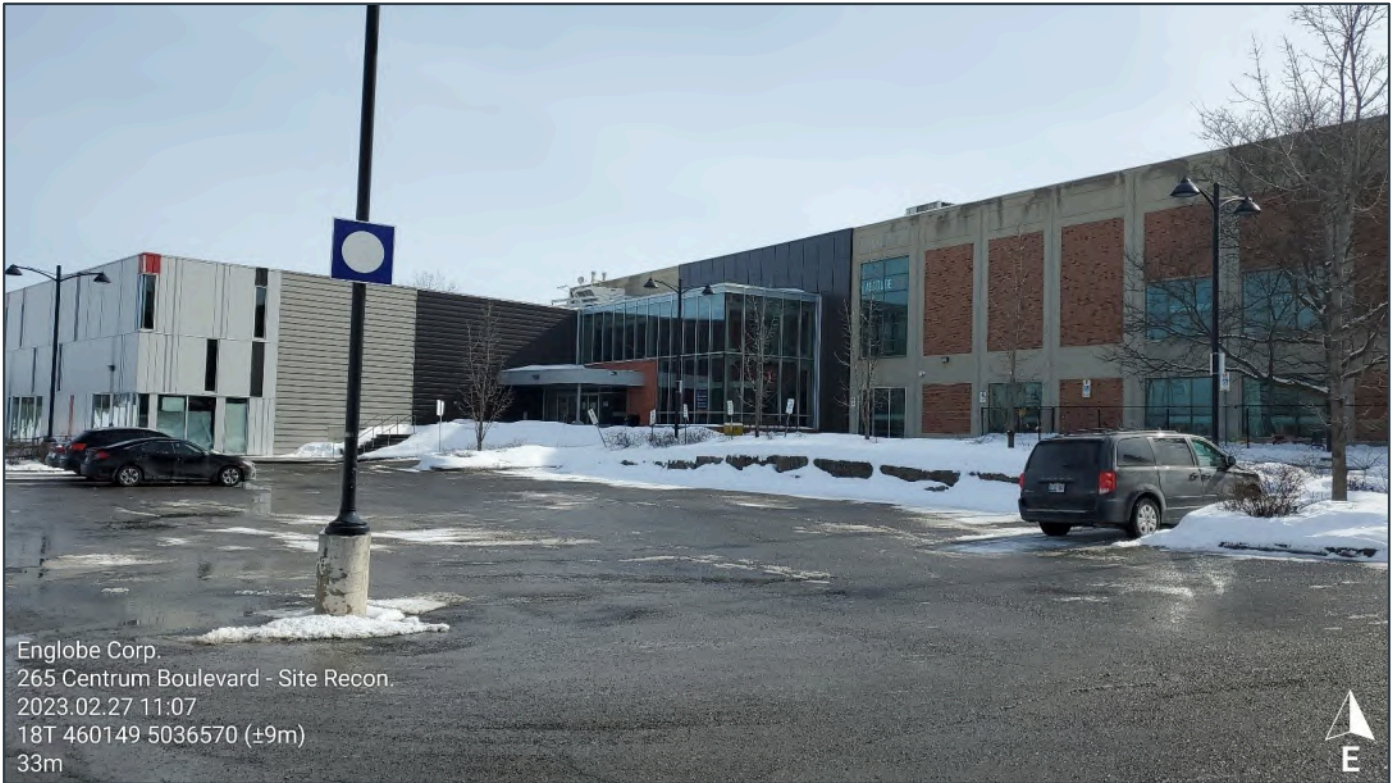
Site Photograph 1: Overview of the Entrance to the Site building (original build and new addition).

One two-storey building, and one small one-storey shed with vinyl siding was observed at the Phase One Property at the time of Englobe's Site Reconnaissance. The original building footprint consists of a brick and mortar exterior, meanwhile the exterior of the new addition mainly consisted of metal siding.

The main building was observed to have one main entrance, along the north facing wall, at the Phase One Property at the time of Englobe's Site Reconnaissance. Several other miscellaneous/staff entrances along the eastern and southern facing walls of the building were also noted.

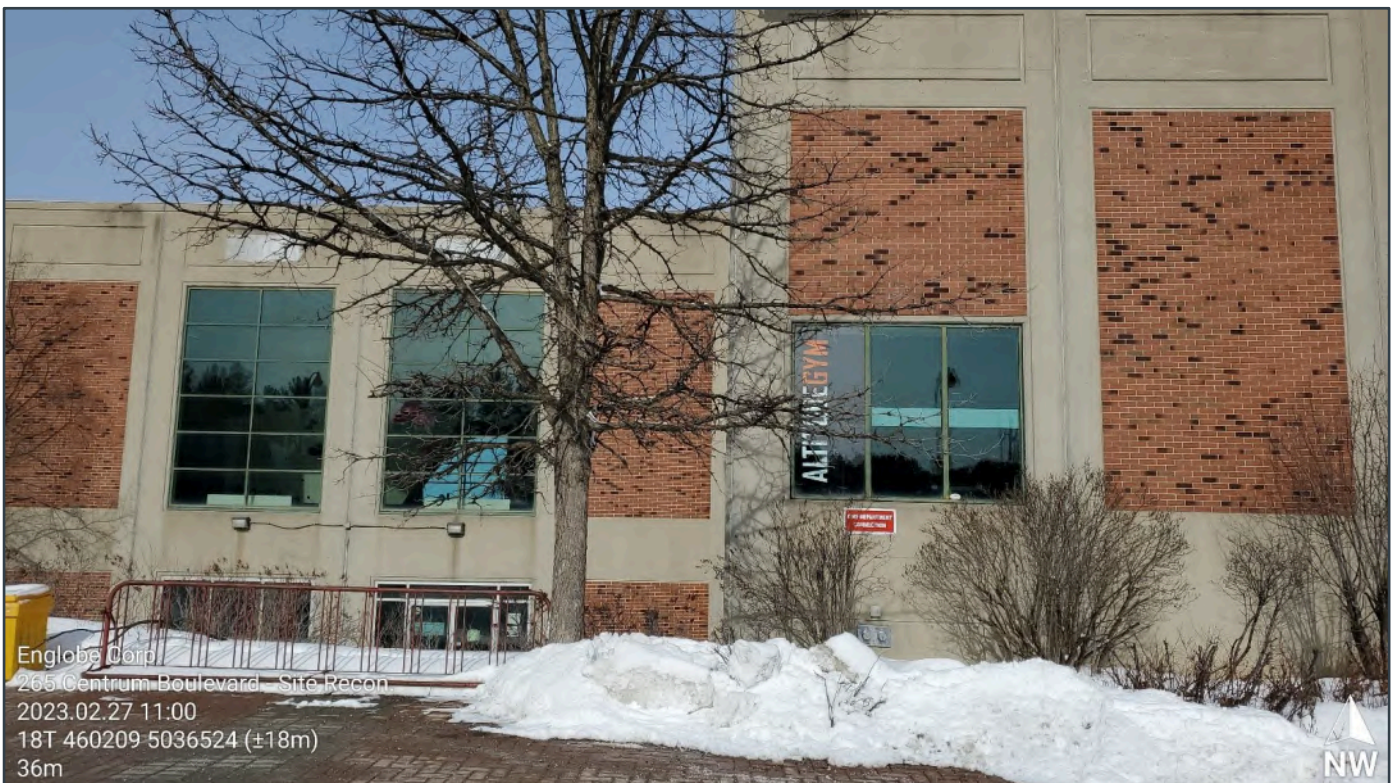
Site Photograph 2: Overview of the Site building (original build).

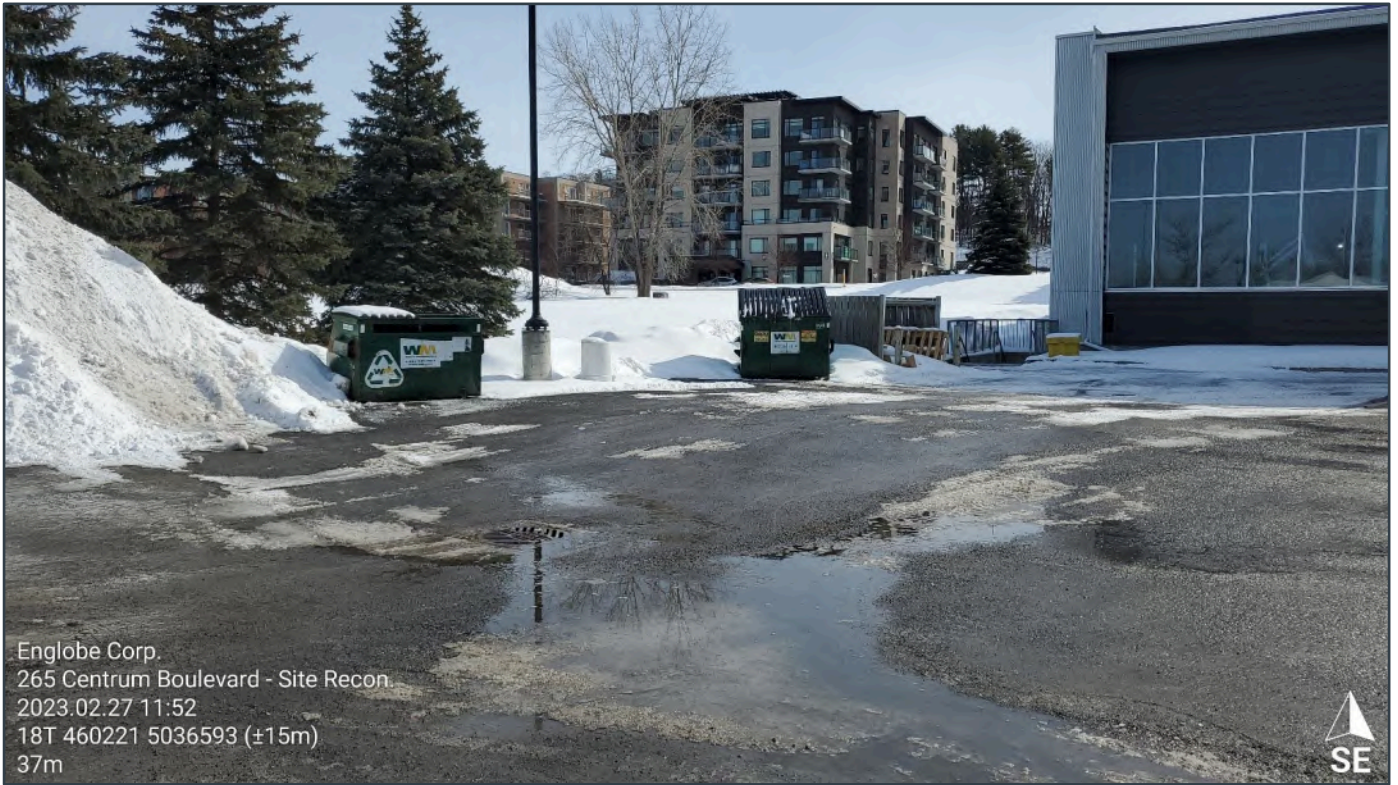
**Site Photograph 3: Overview of the Site building (new addition) and waste collection areas.**

Generic solid wastes were observed to be stored at the Phase One Property at the rear of the building at the time of Englobe’s Site Reconnaissance. No staining in the vicinity of the solid waste storage area was observed.

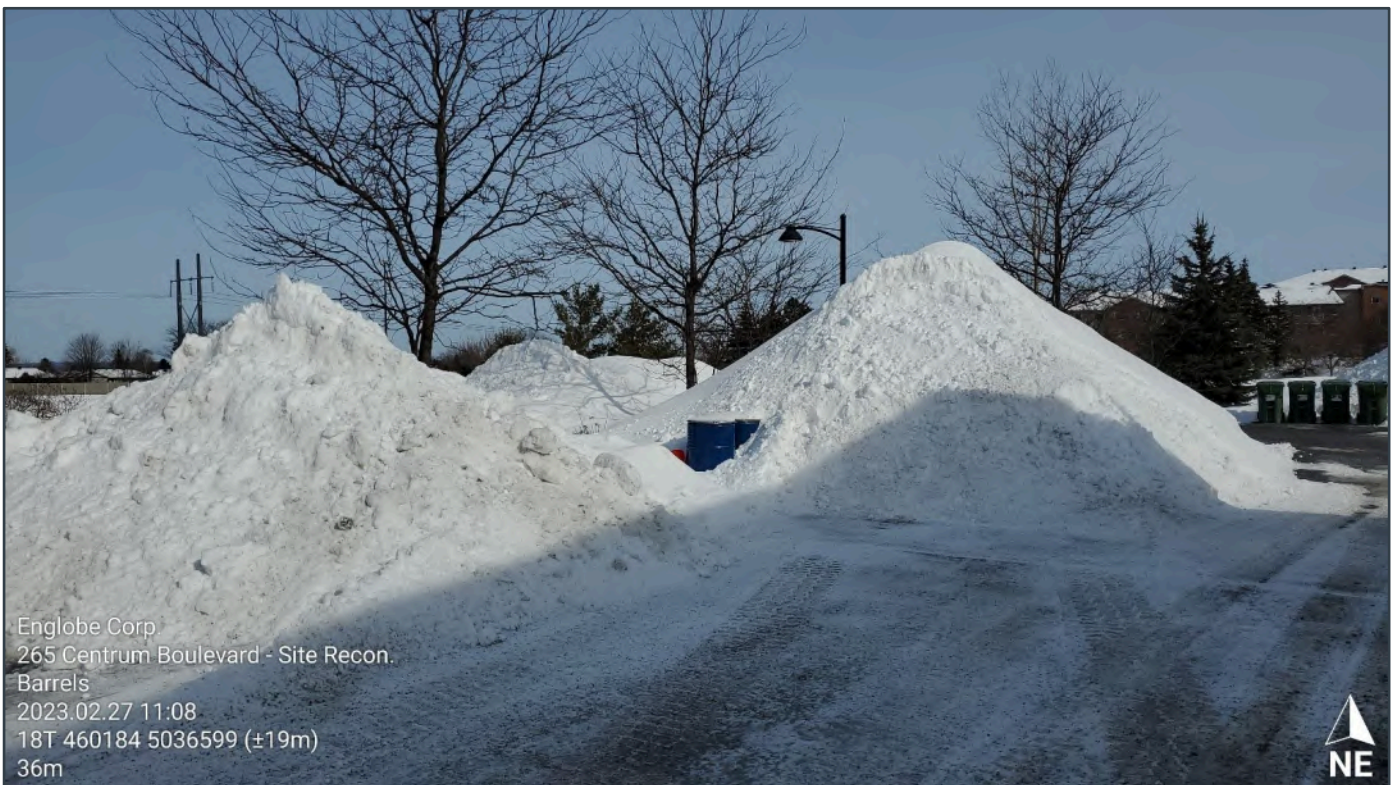
**Site Photograph 4: Two steel 250-L drums noted along northern property boundary, presumably containing the soil cuttings from Yuri Mendez Engineering subsurface investigation in May 2022.**

No fuel storage tanks were observed at the Phase One Property at the time of Englobe's Site Reconnaissance. Two steel 250-L drums were noted along northern property boundary, presumably containing the soil cuttings from Yuri Mendez Engineering subsurface investigation in May 2022. De-icing salt storage containers were noted along the exterior of the Phase One Property, in the vicinity of walk path and driving/parking areas.

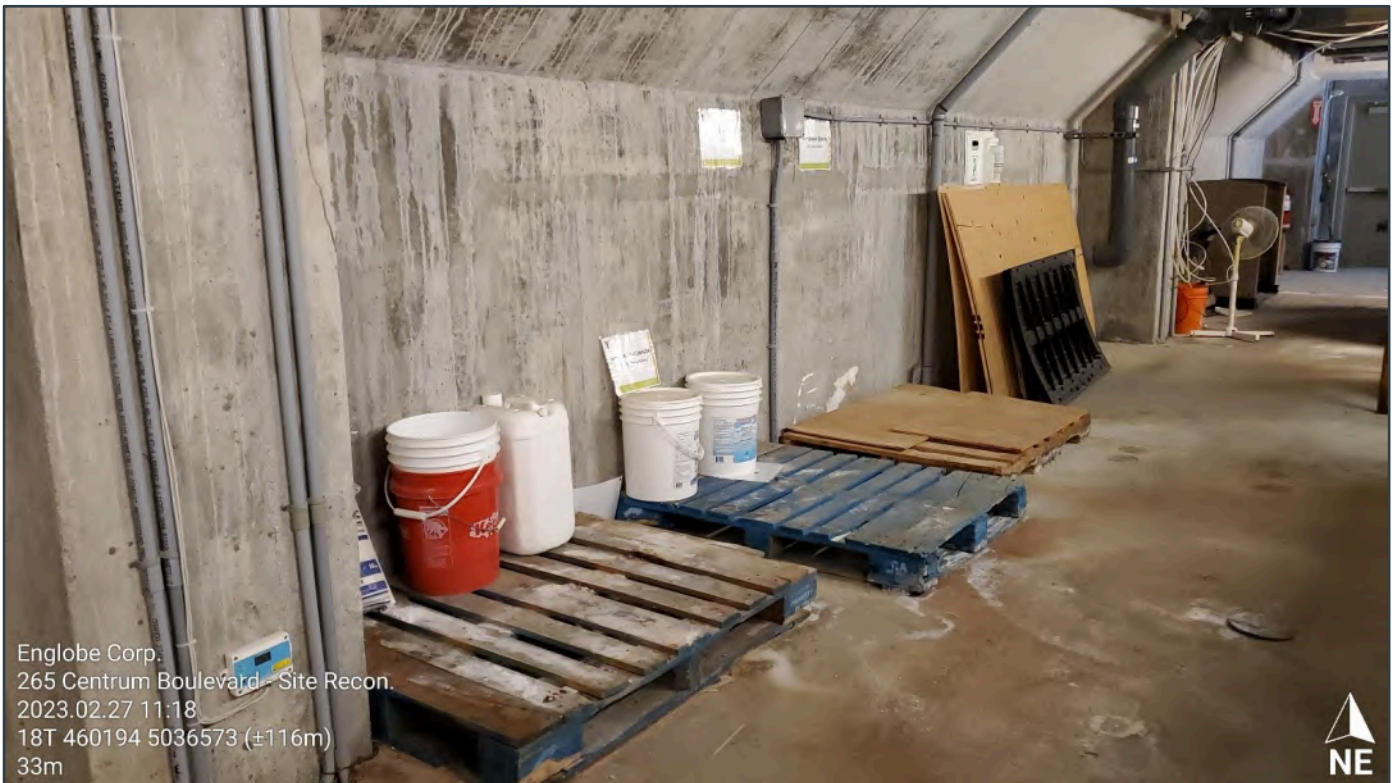
Site Photograph 6: Overview of the pool chemical storage area in the pool valve room (basement).

Pool chemical storage was observed in the basement pool valve room. This generally consisted of an empty plastic chlorine tank and miscellaneous pool chemicals stored on pallets (i.e., calcium plus, sodium sulfite, sedum bicarbonate, and pH+). Generic janitorial chemical storage in the ground floor janitor's closet at the Phase One Property at the time of Englobe's Site Reconnaissance. A small hydraulic oil reservoir for the building elevator was noted within the elevator maintenance room on the

ground floor of the building. It is of the opinion of the QP that the noted chemical storage areas, do not constitute “bulk” storage, and such, have not been identified as a PCA in this report.

In the basement pool valve room, minor white and/or rust-coloured staining was noted on the concrete floor slab in the vicinity of the chemical storage area. Minor dark-coloured staining and absorbent pads were noted in the elevator maintenance room in the vicinity of the hydraulic oil reservoir. No staining was observed near the lowest level floor in the vicinity of the elevator. No other notable stains were observed within the interior areas of the Site buildings.
