## Phase I - Environmental Site Assessment

201 Friel Street  
Ottawa, Ontario

Ottawa Community Housing Corporation

Report: PE4033-1

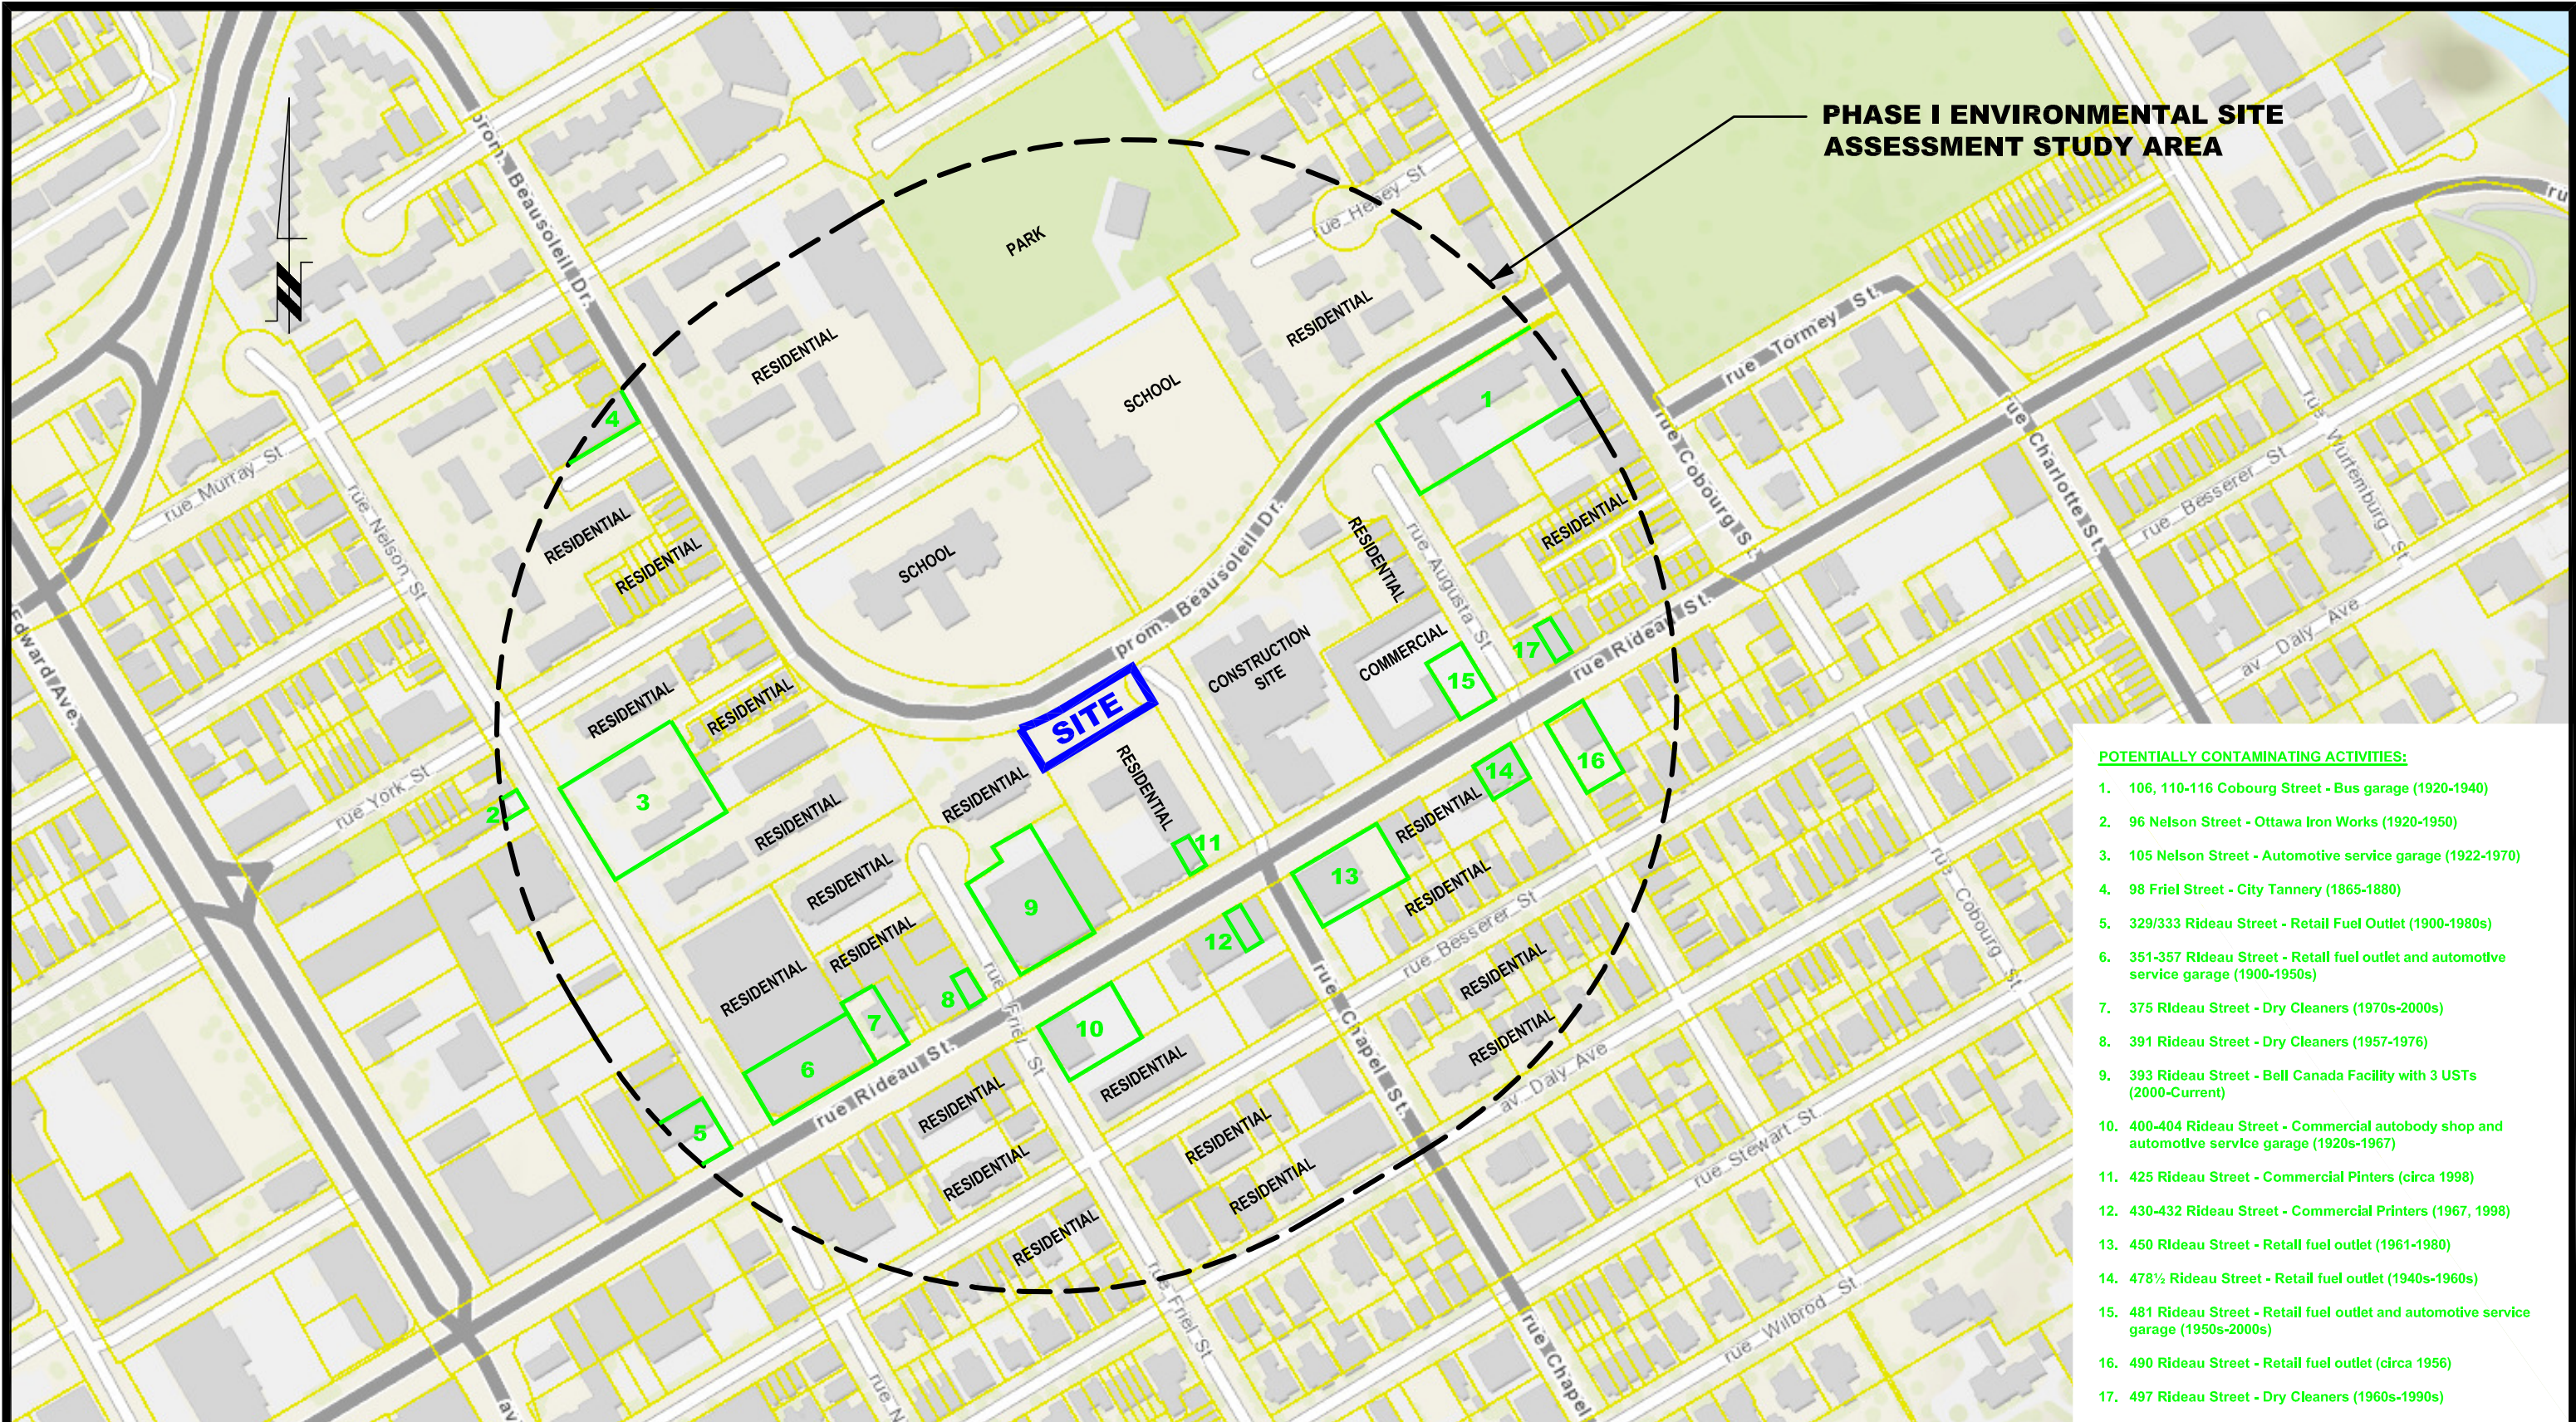
**DRAWING PE4033-2 – SURROUNDING LAND USE PLAN**

**PHASE I ENVIRONMENTAL SITE ASSESSMENT STUDY AREA**

- POTENTIALLY CONTAMINATING ACTIVITIES:**
1. 106, 110-116 Cobourg Street - Bus garage (1920-1940)
  2. 96 Nelson Street - Ottawa Iron Works (1920-1950)
  3. 105 Nelson Street - Automotive service garage (1922-1970)

No Potentially Contaminating Activities were identified at the Phase I property. A total of 17 Potentially Contaminating Activities (PCAs) outside of the subject property but within the Phase I study area are shown on Drawing PE4033-2 - Surrounding Land Use Plan, however, these PCAs do not pose a concern to the subject site based on their distance and down- or cross-gradient location from the Phase I property. The above noted PCAs are presented in Table 3 below.
