Phase I – Environmental Site Assessment

266 Park Street
Ottawa, Ontario

Prepared for Concorde Properties

Report: PE5651-2
May 14, 2024

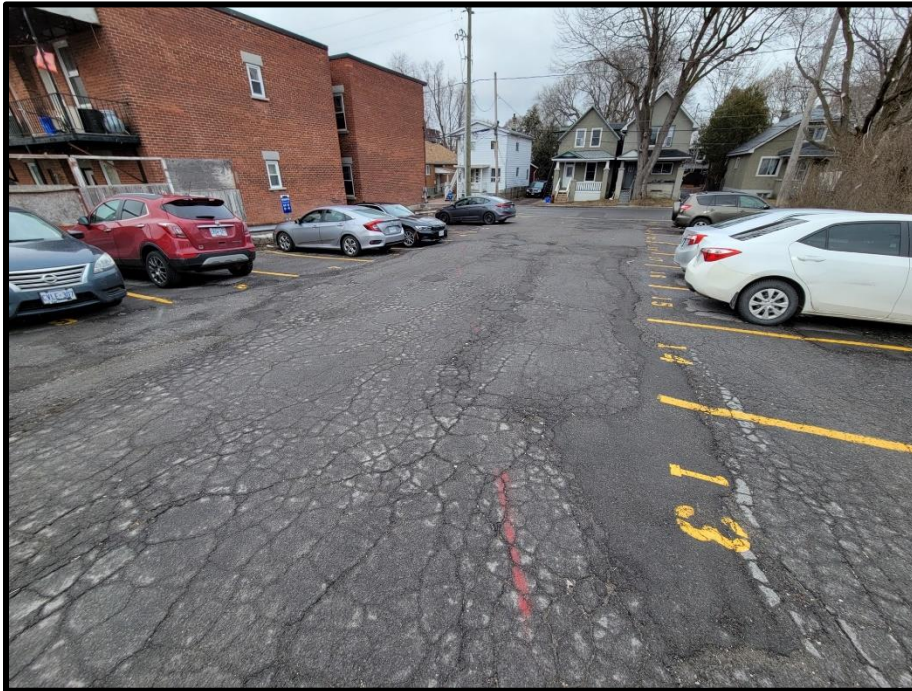
Photograph 1: View of the western portion of the Phase I Property, facing east.

Water drainage on the Phase I Property occurs primarily via surface runoff towards catch basins located on the adjacent street. No ponded water, stressed vegetation, surficial staining, or any other indications of potential sub-surface contamination were observed on the Phase I Property at time of the site inspection.
