**Preliminary Environmental Impact Study for the Proposed Parking Lot
Expansion at the Ottawa-Carleton Detention Centre, 2244 Innes Road,
Ottawa**

Final Report

December 22, 2022

Prepared for:
Jeff Muir
Vice President - Environmental, ECOH Management Inc.

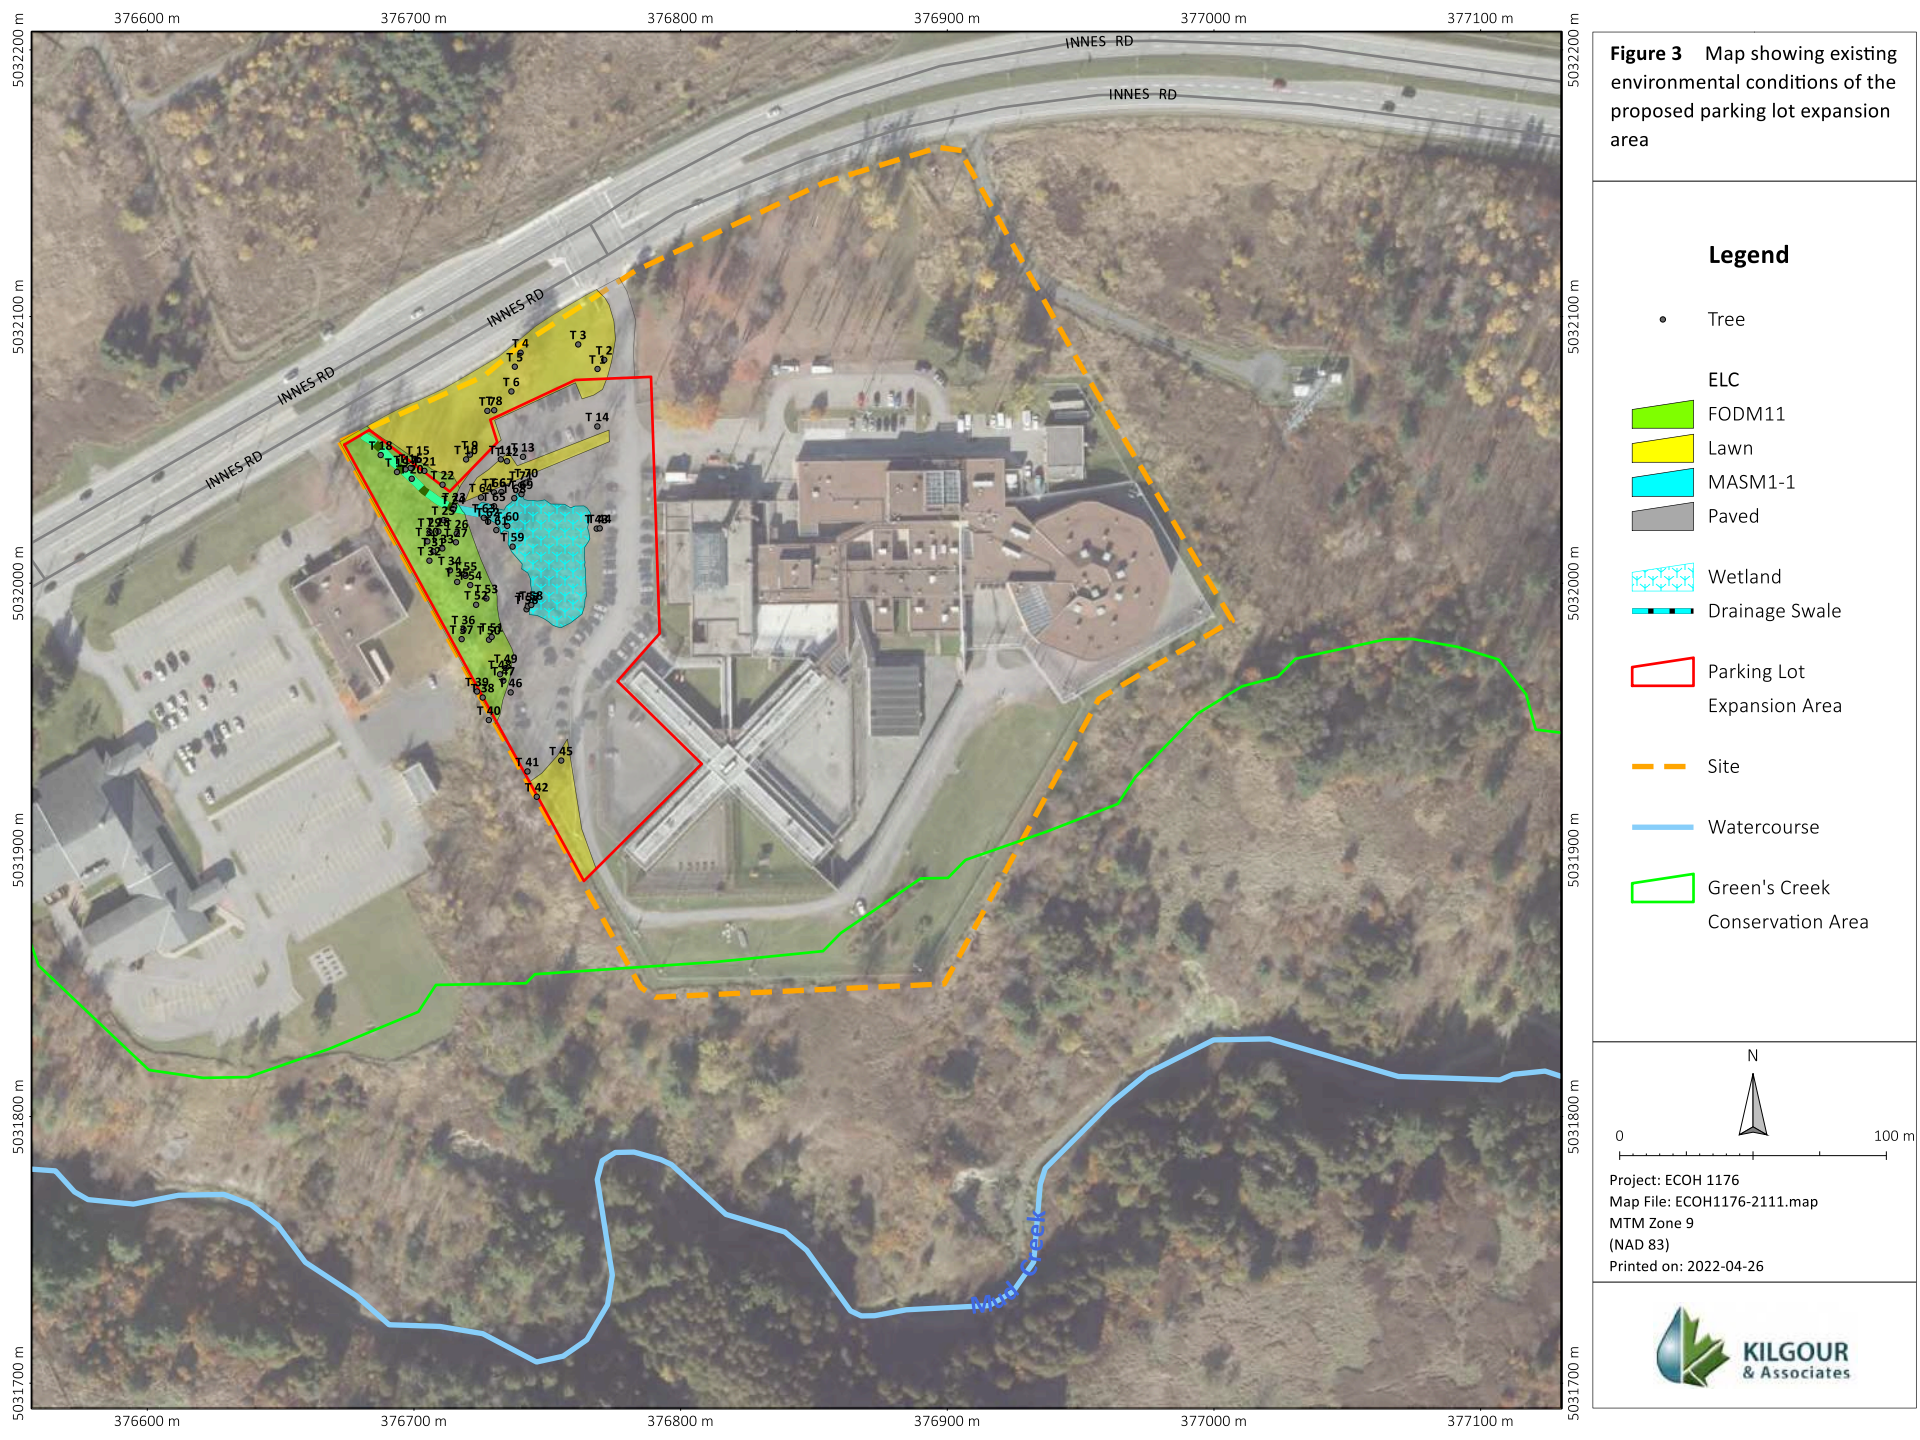
Figure 3 Map showing existing environmental conditions of the proposed parking lot expansion area

Four distinct ELC units (ecosites, vegetation types, or other) were delineated within the proposed parking lot expansion area (Figure 3). Two of the four ELC units are of anthropogenic nature (i.e., open lawn and parking areas) consistent with the lack of natural features in the existing parking lot. The other two ELC units consist of a deciduous hedgerow and a small wetland.

Details from the tree inventory are presented in Appendix E. In general, the parking lot expansion area contains 71 trees with DBH ≥ 10 cm from 11 species (Figure 3), with over 70% of trees observed dominated by two species: Silver Maple and Basswood (Table 1). Fifty-six trees were assessed as “wildlife” trees (Appendix E).

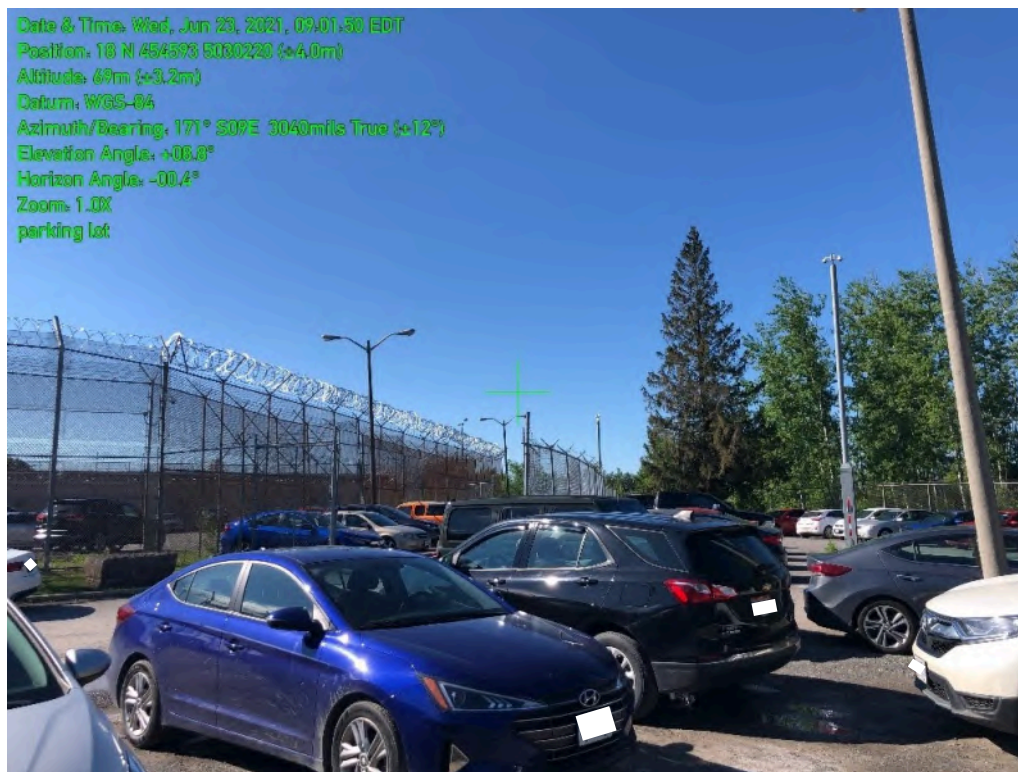
Figure 4 Photo of the existing parking lot on the Site (taken June 23, 2021)

The proposed parking lot expansion area is dominated by packed gravel and paved surfaces associated with the existing parking lot and the entrance to the Ottawa-Carleton Detention Centre (Figure 4).

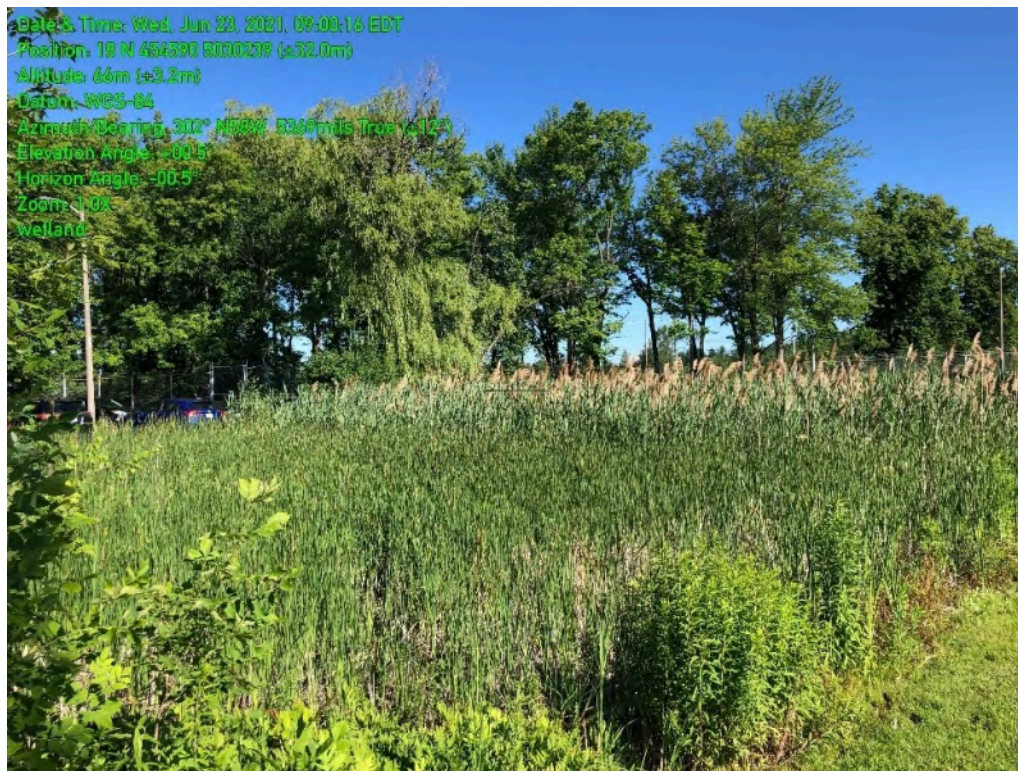
Figure 7 Photo of the Cattail Mineral Shallow Marsh Type towards the centre of the existing parking lot on the Site (taken June 23, 2021)

Towards the centre of the existing parking lot is a wet depression approximately 0.1 ha in size that is dominated by emergent wetland vegetation. The northern portion of this feature consists of a dense stand of Common Reed (*Phragmites australis*; an invasive species) while the southern portion is dominated by Common Cattail (*Typha latifolia*; Figure 7). The fringes of this feature are highly disturbed given its location within the existing parking lot. Some edges of the depression contain weeds and invasive species such as Perennial Sow-thistle (*Sonchus arvensis*), Common Buckthorn, and Purple Loosestrife (*Lythrum salicaria*), while other edges consist of mowed lawn and gravel.

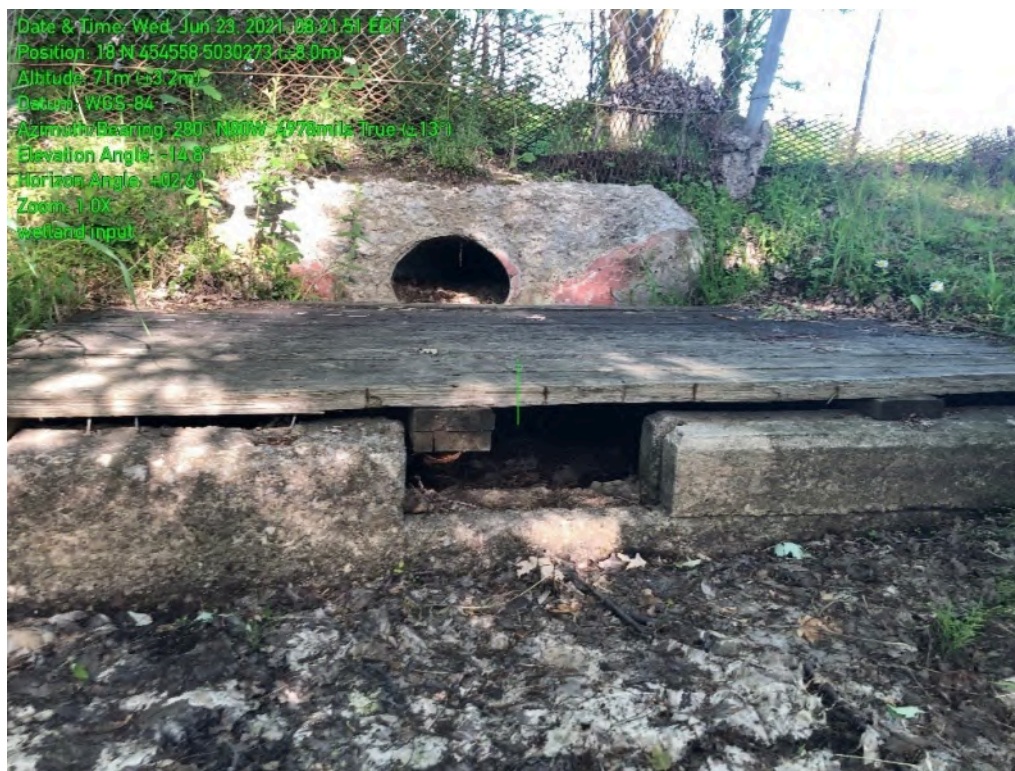
Figure 8 Photo showing the remnants of a dike in the northwestern portion of the wetland on Site (taken June 23, 2021)

The feature has soils reflective of poor drainage, with approximately 40 cm of organic soils underlain by sand and clay with signs of gley, an indication of prolonged water saturation. The soil surface was dry in the late spring and early summer, suggesting that the water table is rarely or only briefly above the substrate surface in the spring, but with soil water remaining in the rooting zone for most of the growing season. According to Ottawa-Carleton Detention Centre staff, this feature is a result of a pond that was originally dug in the 1970s, which is visible in geoOttawa imagery from 1976 through the early 2000s. Water was held in the pond via a dike (Figure 8) that was eventually released to allow water to drain from the pond, resulting in current shallow marsh conditions. The feature is currently used as a snow management area which would contribute to higher water levels during the spring freshet. Gravel and stumps were observed throughout the feature, likely a result of being pushed in from snow plows.

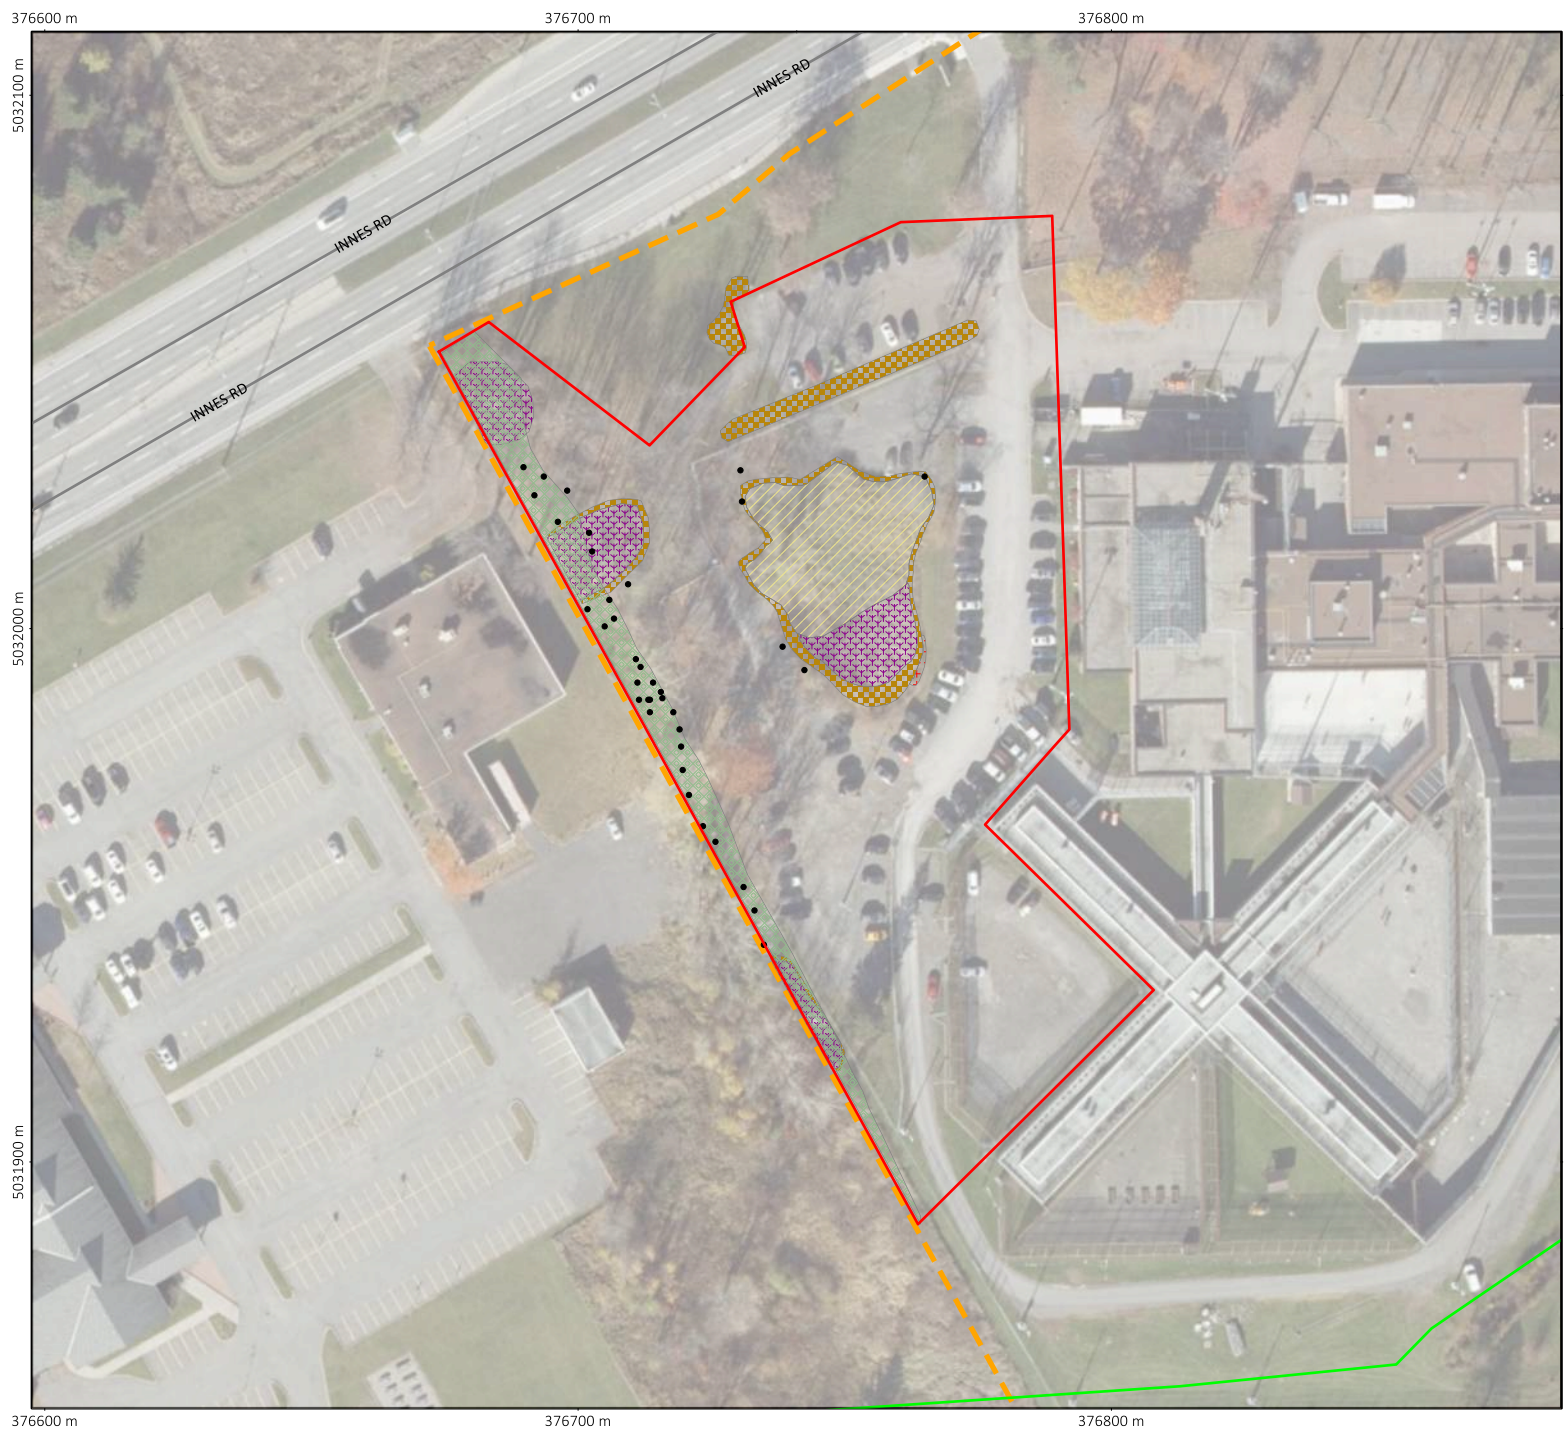
Figure 9 Map showing the distribution of exotic, invasive, and noxious plants in the proposed parking lot expansion area

The proposed parking lot expansion area contained six plant species considered exotic, invasive, or noxious (Figure 9, Table 2).

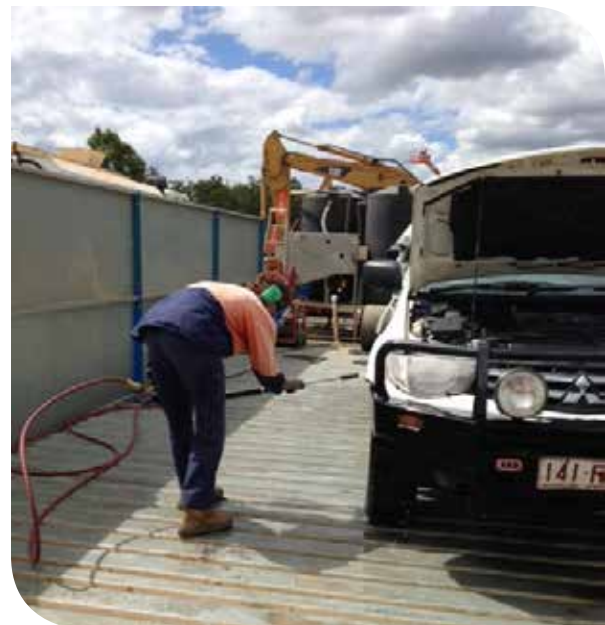
Hosing down a vehicle in Queensland, Australia

For equipment such as water trucks that may be exposed to aquatic invasive species, trucks should be disinfected with bleach solution before conducting work in a new area. For further information please refer to the Invading Species Awareness Program's Technical Guidelines listed under Contacts and Resources.

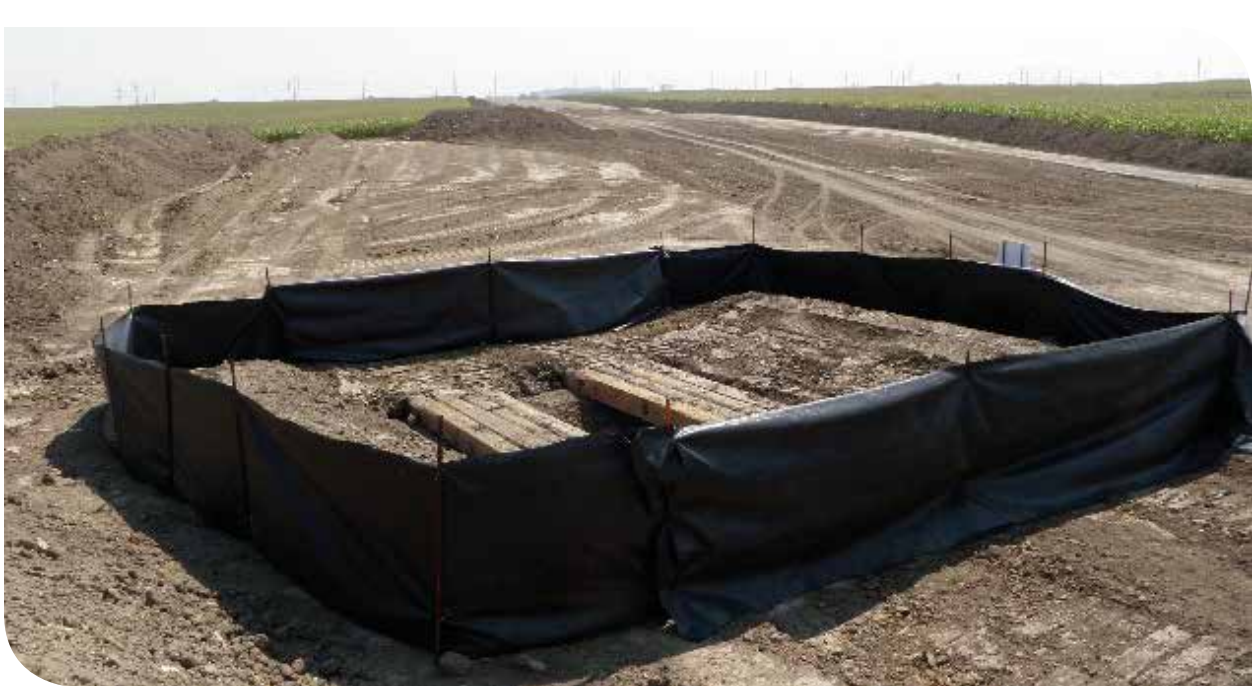
Cleaning station at construction site.

- A pump and high pressure hose OR high pressure water unit
- Minimum water pressure for vehicle cleaning should be at least 90 pounds per square inch. Water can be supplied as high volume/low pressure or low volume/high pressure (NOAA Fisheries Service).
- Air compressor and blower OR vacuum
- Shovel
- Pry bar
- Stiff brush or broom

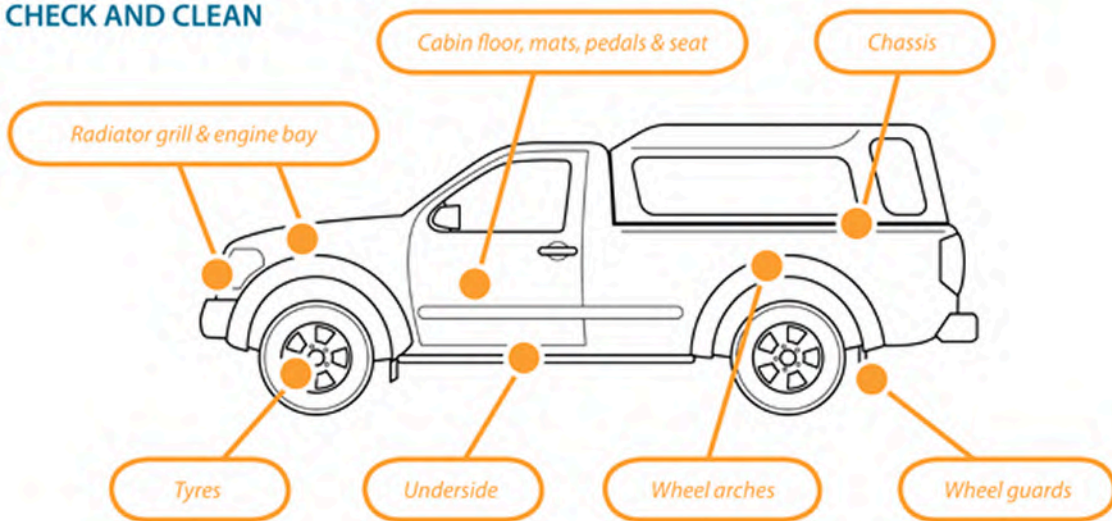
4WD VEHICLE WITH KEY SPOTS TO CHECK AND CLEAN

✓
Cabin	Floor, mats, pedals, seats	
Engine	Radiators, engine bay, grill	
Body	Underside, chassis, crevices, ledges, bumper bars	
Wheels	All wheels (including spare), wheel arches, guards	
Tray	Floor, canopy (if included)

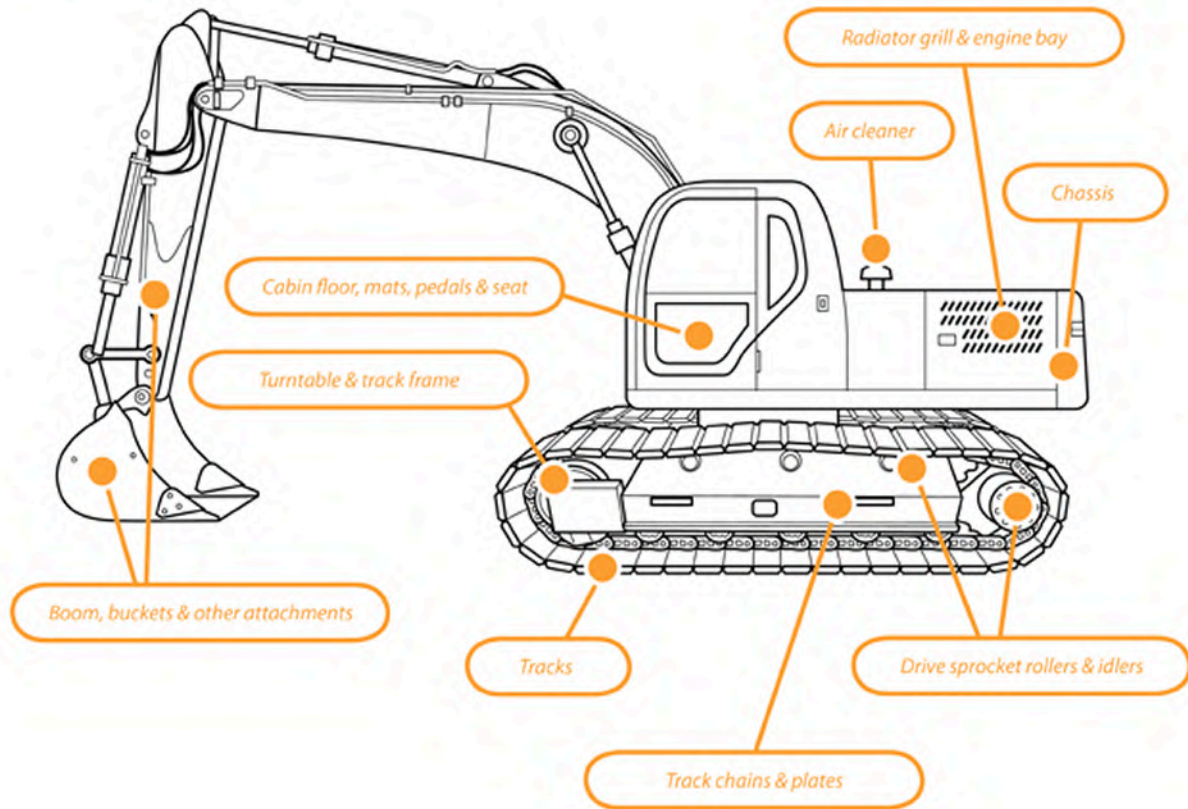
EXCAVATOR WITH KEY SPOTS TO CHECK AND CLEAN

✓
Cabin	Floor, mats, pedals, seats	
Engine	Radiators, engine bay, grill, air cleaner	
Tracks	Tracks, track frame, drive sprocket rollers, idlers	
Body Plates	Plates of cabin	
Body	Ledges, channels	
Bucket		
Booms		
Turret Pivot

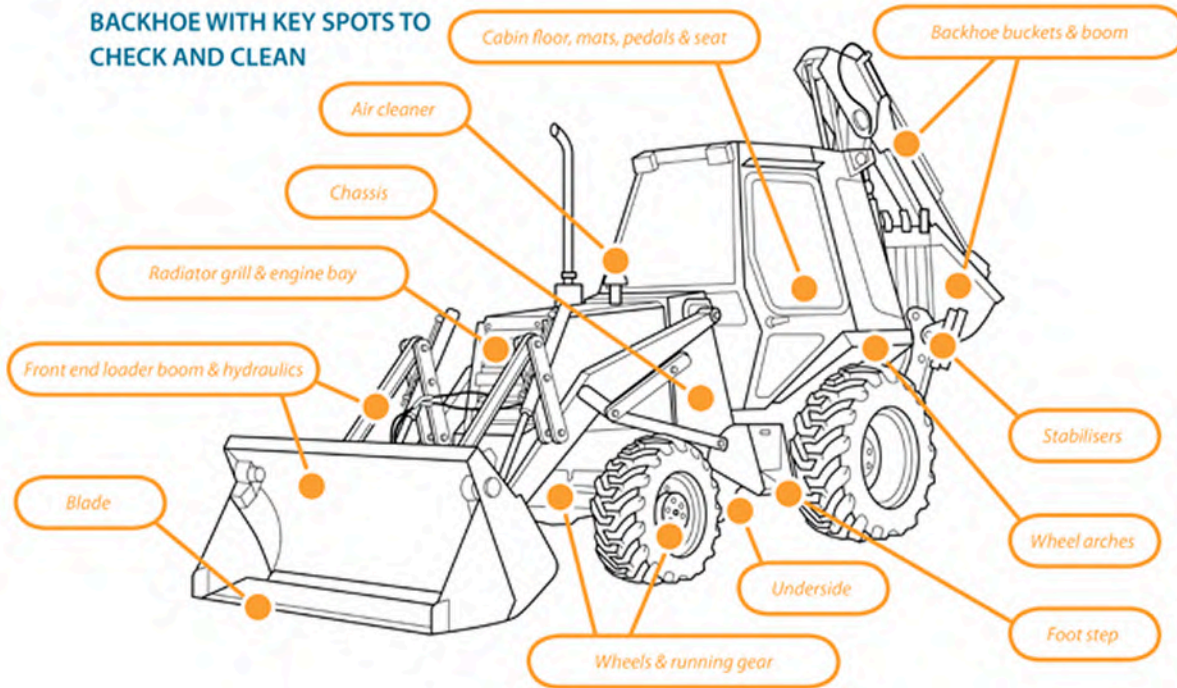
BACKHOE WITH KEY SPOTS TO CHECK AND CLEAN

✓
Cabin	Floor, mats, pedals, seats, foot step	
Engine	Radiators, engine bay, grill, air cleaner	
Wheels	All wheels (including spare), wheel arches, guards	
Front end loader	Blade, hydraulics, booms	
Backhoe	Buckets, boom, hydraulics, stabilisers

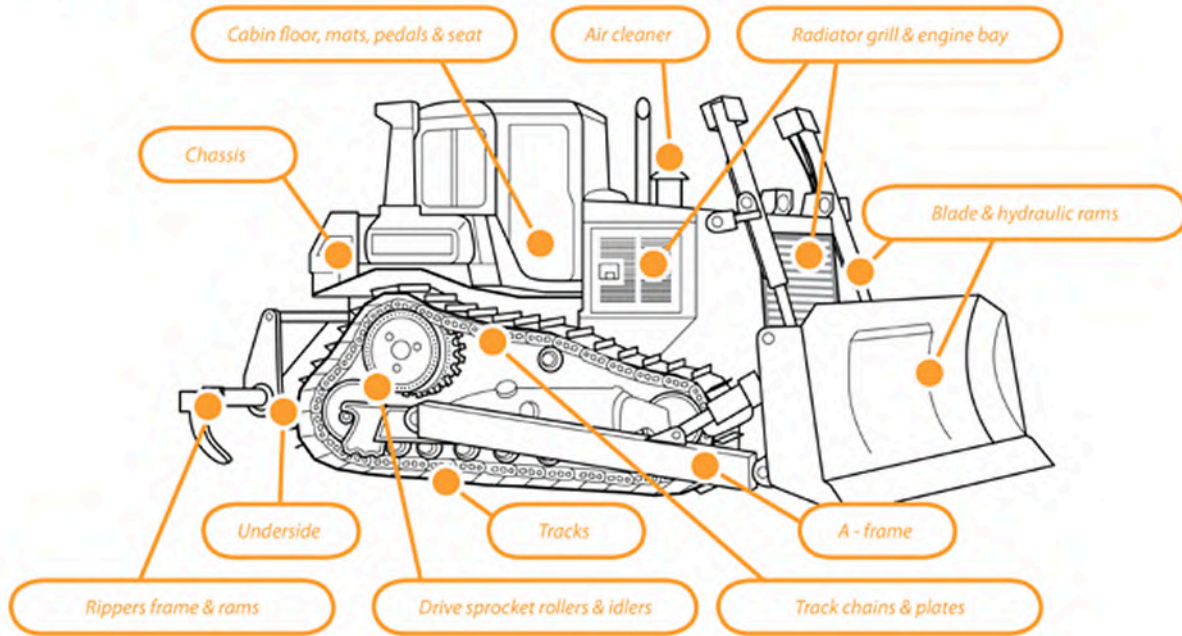
BULLDOZER WITH KEY SPOTS TO CHECK AND CLEAN

✓
Cabin	Floor, mats, pedals, seats	
Engine	Radiators, engine bay, grill, air cleaner	
Tracks	Tracks, track frame, drive sprocket rollers, idlers	
Body Plates	Belly plates, rear plates	
Body	Ledges, channels	
Blade	Pivot points, hydraulic rams, a-frame	
Ripper	Ripper frame, ripper points
