**1184-1196 CUMMINGS AVENUE
SERVICING AND STORMWATER
MANAGEMENT REPORT**

Prepared for:
TCU Development Corporation

Prepared by:
Stantec Consulting Ltd.

Project Number:
160401787

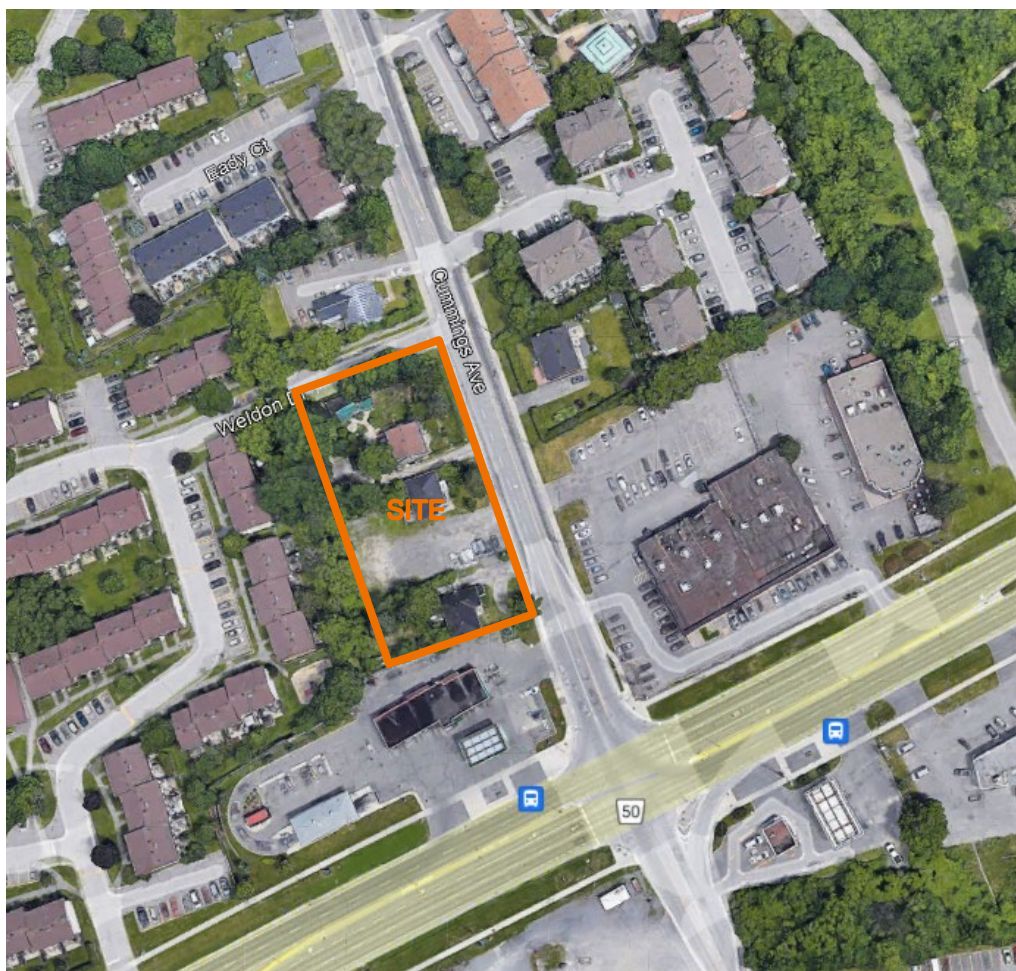
Figure 1-1: Key Plan of Site

The 0.35 ha site is situated along the west side of Cummings Avenue, at the southwest corner of the intersection between Cummings Avenue and Weldon Drive. The site is currently zoned R3Y [708] and contains an existing two-storey residential building and two single-storey residential buildings with sheds, trees, and surface parking. The site is bound by Weldon Drive to the north, Cummings Avenue to the east, an existing commercial development to the south and an existing residential development to the west as shown in **Figure 1-1** below.

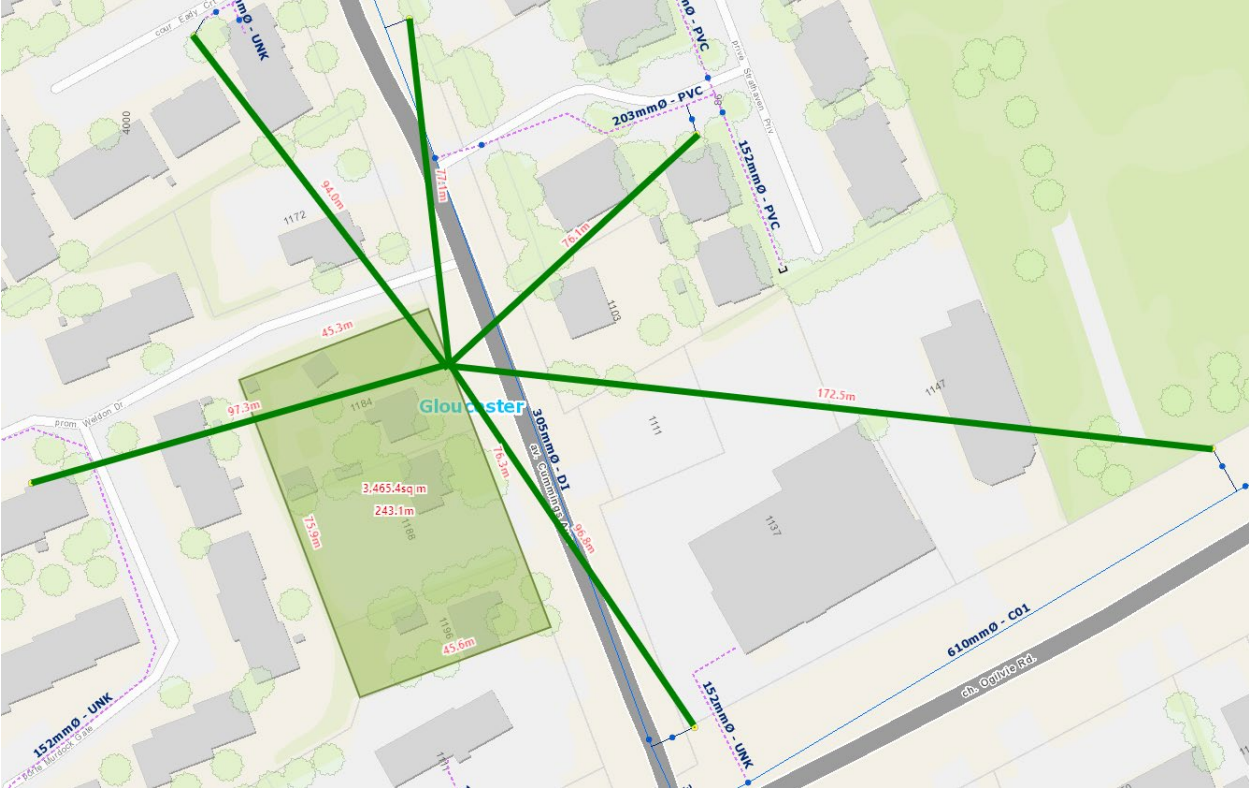
Figure 3-1: Existing Fire Hydrant Coverage Map

According to the NFPA 1 Table 18.5.4.3 in Appendix I of the City of Ottawa Technical Bulletin ISTB-2018-02, a hydrant situated less than 76 m away from a building can supply a maximum capacity of 5,678 L/min, while a hydrant situated between 76 m and 152 m away from a building can supply a maximum capacity of 3,785 L/min. Given the large fire flow demands from the site, it is proposed that a new fire hydrant be placed to be within 45 metres from the Siamese connection to reduce the number of fire hydrants needed to service the site's fire flow demand. It is suggested that the new hydrant be located to the east of Cummings Avenue within the road right of way as shown on **Drawing SSP-1 in Appendix G**. See **Appendix A.5** for fire hydrant coverage table calculations and NFPA Table 18.5.4.3.

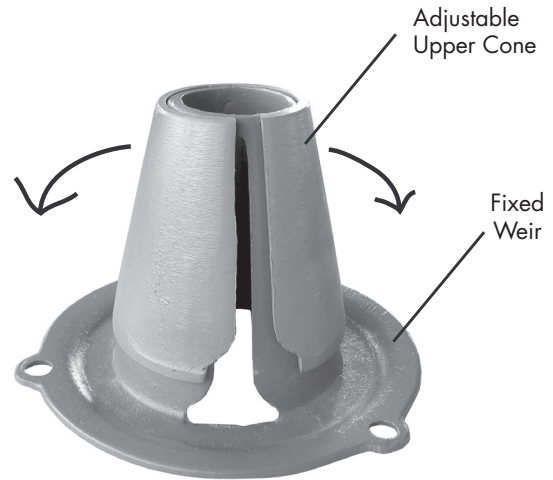
1/2 Weir Opening Exposed Shown Above

For example, if the adjustable upper cone is set to cover 1/2 of the weir opening, flow rates above 2" of head will be restricted to 2-1/2 gpm per inch of head.

Therefore, at 3" of head, the flow rate through the Accutrol Weir that has 1/2 the slot exposed will be:
 [5 gpm (per inch of head) x 2 inches of head] + 2-1/2 gpm (for the third inch of head) = 12-1/2 gpm.

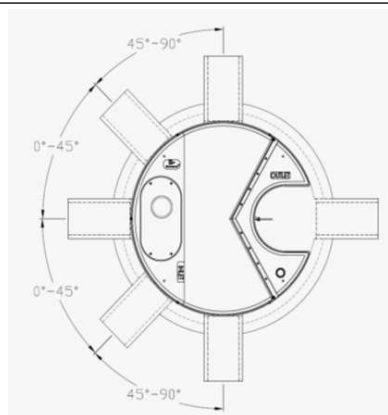
INLET-TO-OUTLET DROP

Elevation differential between inlet and outlet pipe inverts is dictated by the angle at which the inlet pipe(s) enters the unit.
