**1184-1196 CUMMINGS AVENUE  
SERVICING AND STORMWATER  
MANAGEMENT REPORT**

March 5, 2024

Prepared for:  
TCU Development Corporation

Prepared by:  
Stantec Consulting Ltd.

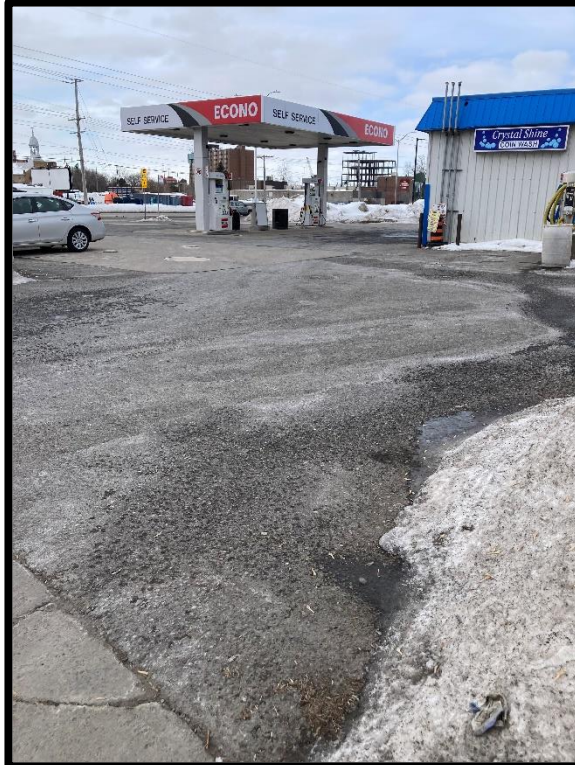
Photograph 8: View of the retail fuel outlet on the 1111 Ogilvie Road property from the southeast corner of the Phase I Property, facing northwest.
