Phase I Environmental Site Assessment

Vacant Property
3735 St. Joseph Boulevard
Ottawa, Ontario

May 6, 2014

Report: PE3204-2

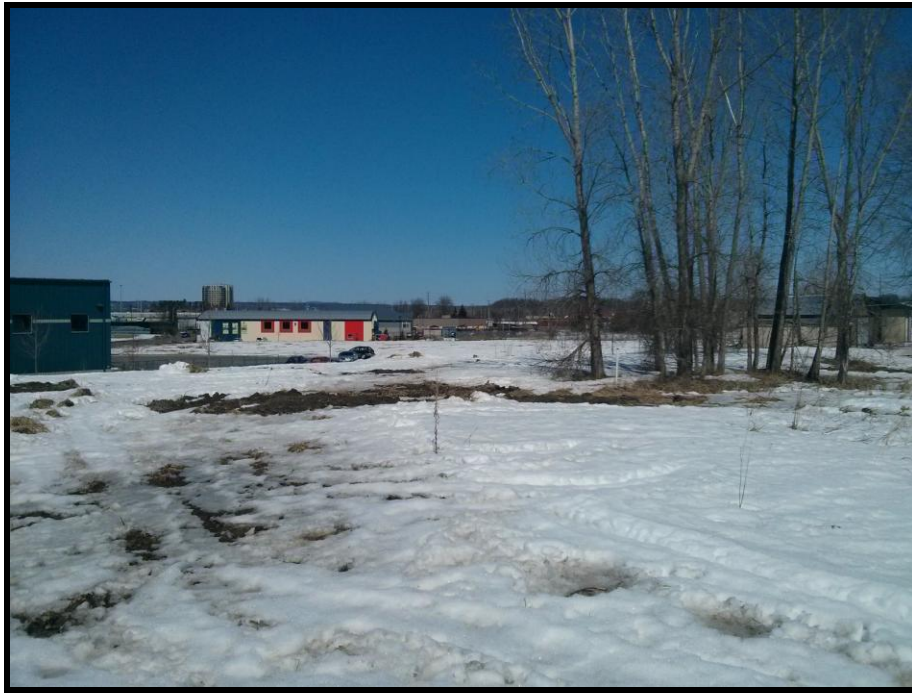
The subject site is flat, vacant and covered partially with short brush and trees. The site is at grade with adjacent properties to the east and west, and slopes gently downwards the north. Drainage consists primarily of infiltration. The site was snow covered at the time of the site visit.

Photograph 1: View of northeast portion of the subject site, facing northeast.

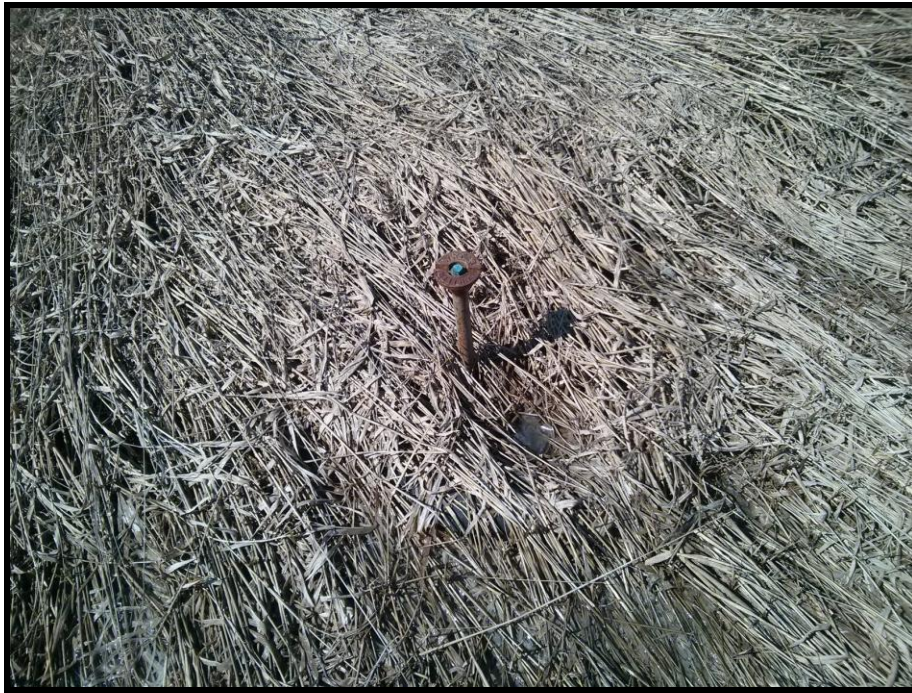
Photograph 3: View of a water shutoff valve located in the southwest corner of the site.

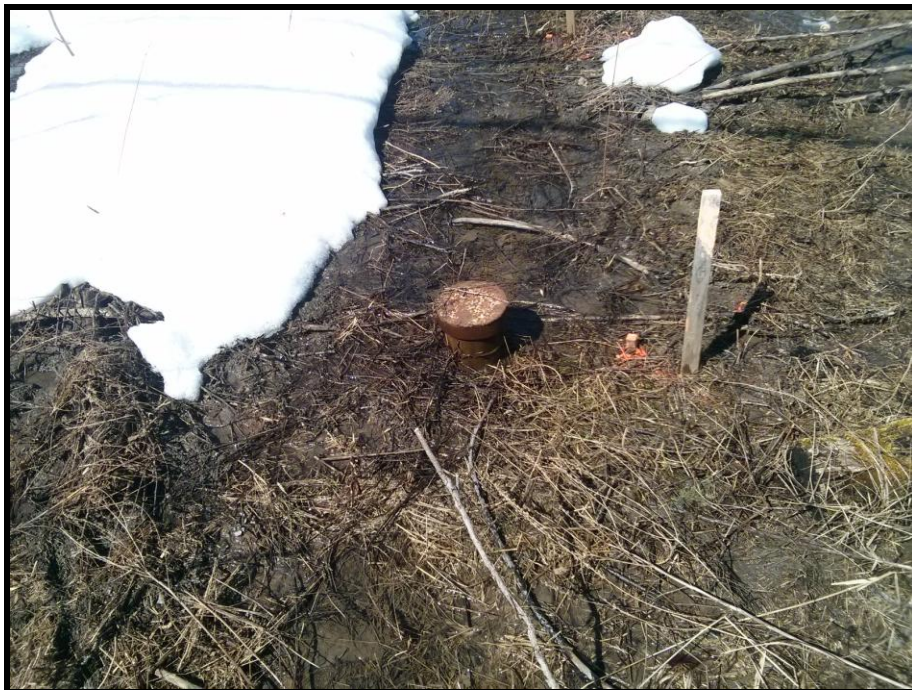
A well with a steel casing was observed on the southwest portion of the subject site; south of the footprint of the former residential dwelling. This well is believed to be the private water well that serviced the residential dwelling.

A drilled water well was observed on the subject site during the site visit, and is believed to have serviced the former residential dwelling. It is not known whether the well has been properly abandoned.

Photograph 4: View of a drilled water well located in the southwest portion of the site.

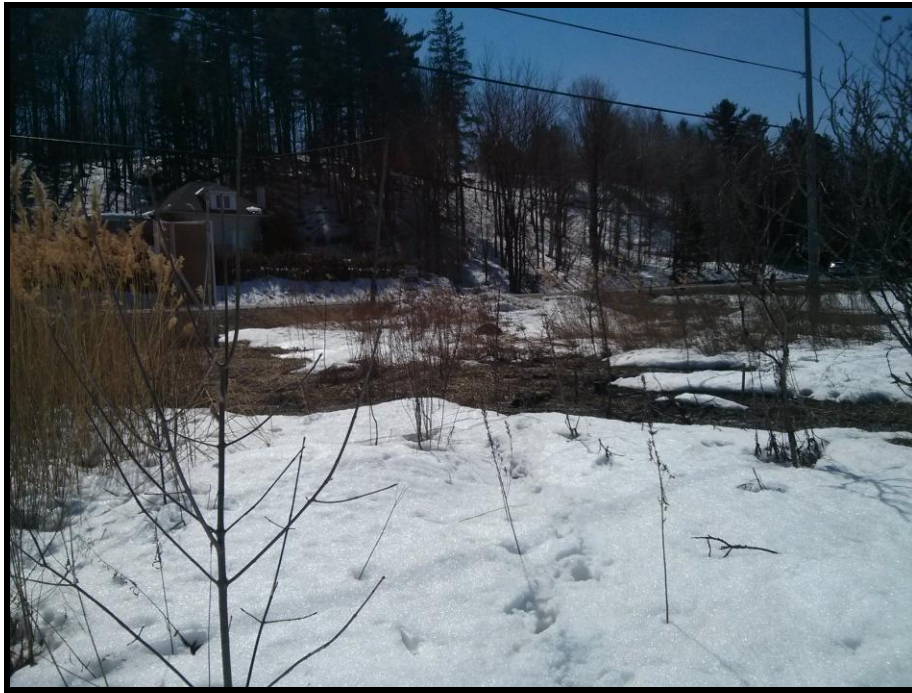
Photograph 5: View of southwest portion of the subject site, facing southwest.

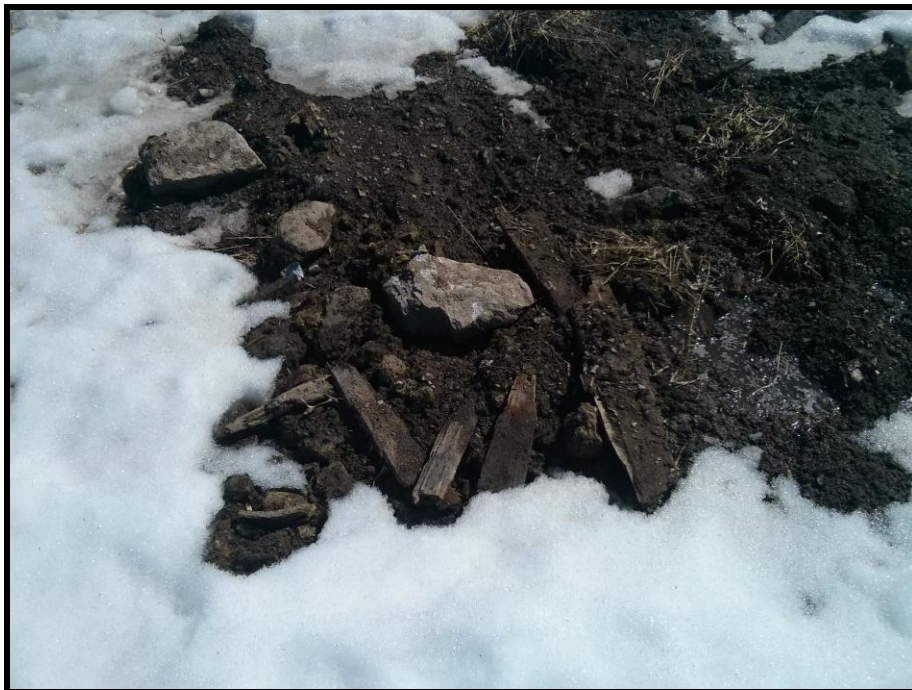
A geotechnical investigation conducted by Trow Associates Inc. (Trow), which included the placement of four (4) boreholes and eighteen (18) test pits on the subject site, identified heterogeneous fill material containing demolition debris. The fill material was present in the northeast corner of the property in the footprint of a former barn. A Phase I ESA conducted by Trow noted that the fill material in the northeast corner of the property was a potential environmental concern. A fill material sampling program was subsequently conducted by Trow which placed six (6) test pits in the northeast corner of the subject site. The six (6) soil samples and one (1) groundwater sample submitted for analysis did not exceed MOE Table 3 (2011) standards for volatile organic compounds (VOCs), metals or petroleum hydrocarbons (PHC F1 to F4). No further work was recommended at the time.

The fill assessment program conducted by Paterson verified the previous engineering results. The fill material does not contain contaminant concentrations in excess of the MOE Table 3 standards. No further investigation was recommended.

Photograph 6: View of recent soil disturbance from test pits (demolition debris present in the fill)
