# **Phase II Environmental Site Assessment**

40 Frank Nighbor Place, Kanata, ON

**API Consultants Inc.**  
Final Report

May 8, 2023  
02211293.000

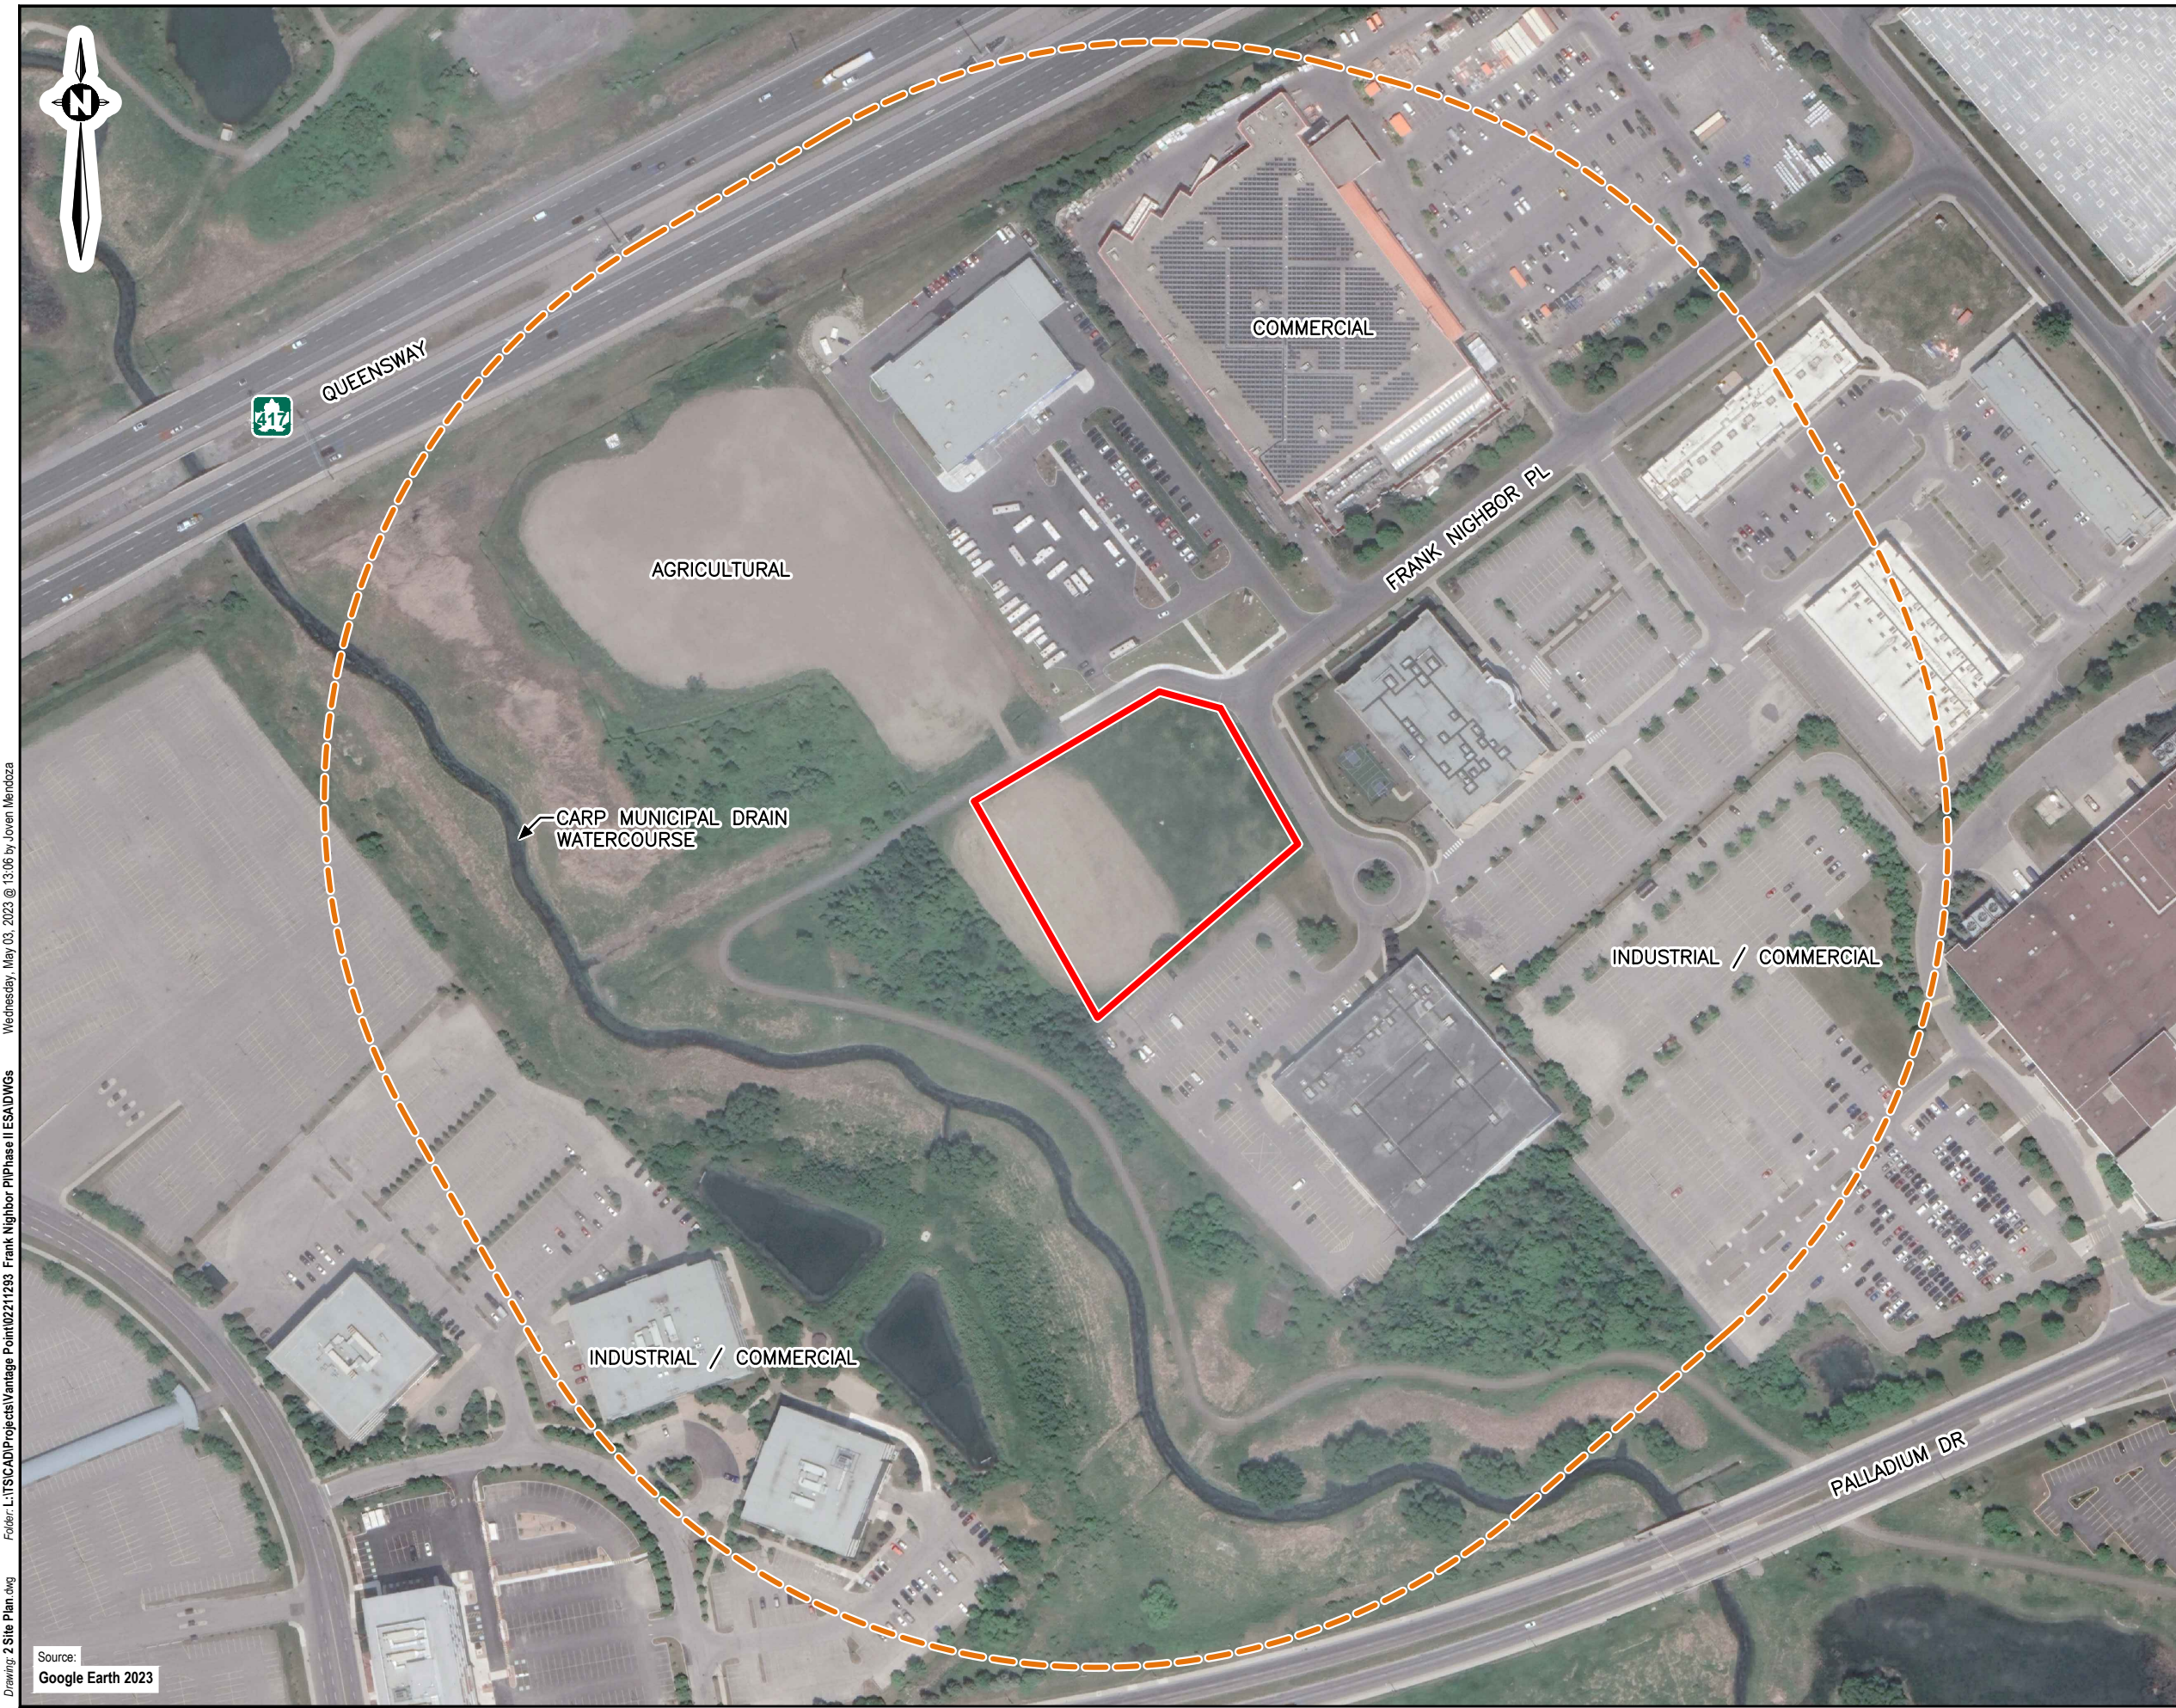
Figure No. **2**

Drawing: 2 Site Plan.dwg  
 Folder: L:\ITS\CAD\Projects\Vantage Point\02211293 - Frank Nighbor Pl\Phase II ESA\DWGs  
 Wednesday, May 03, 2023 @ 13:06 by Joven Mendoza

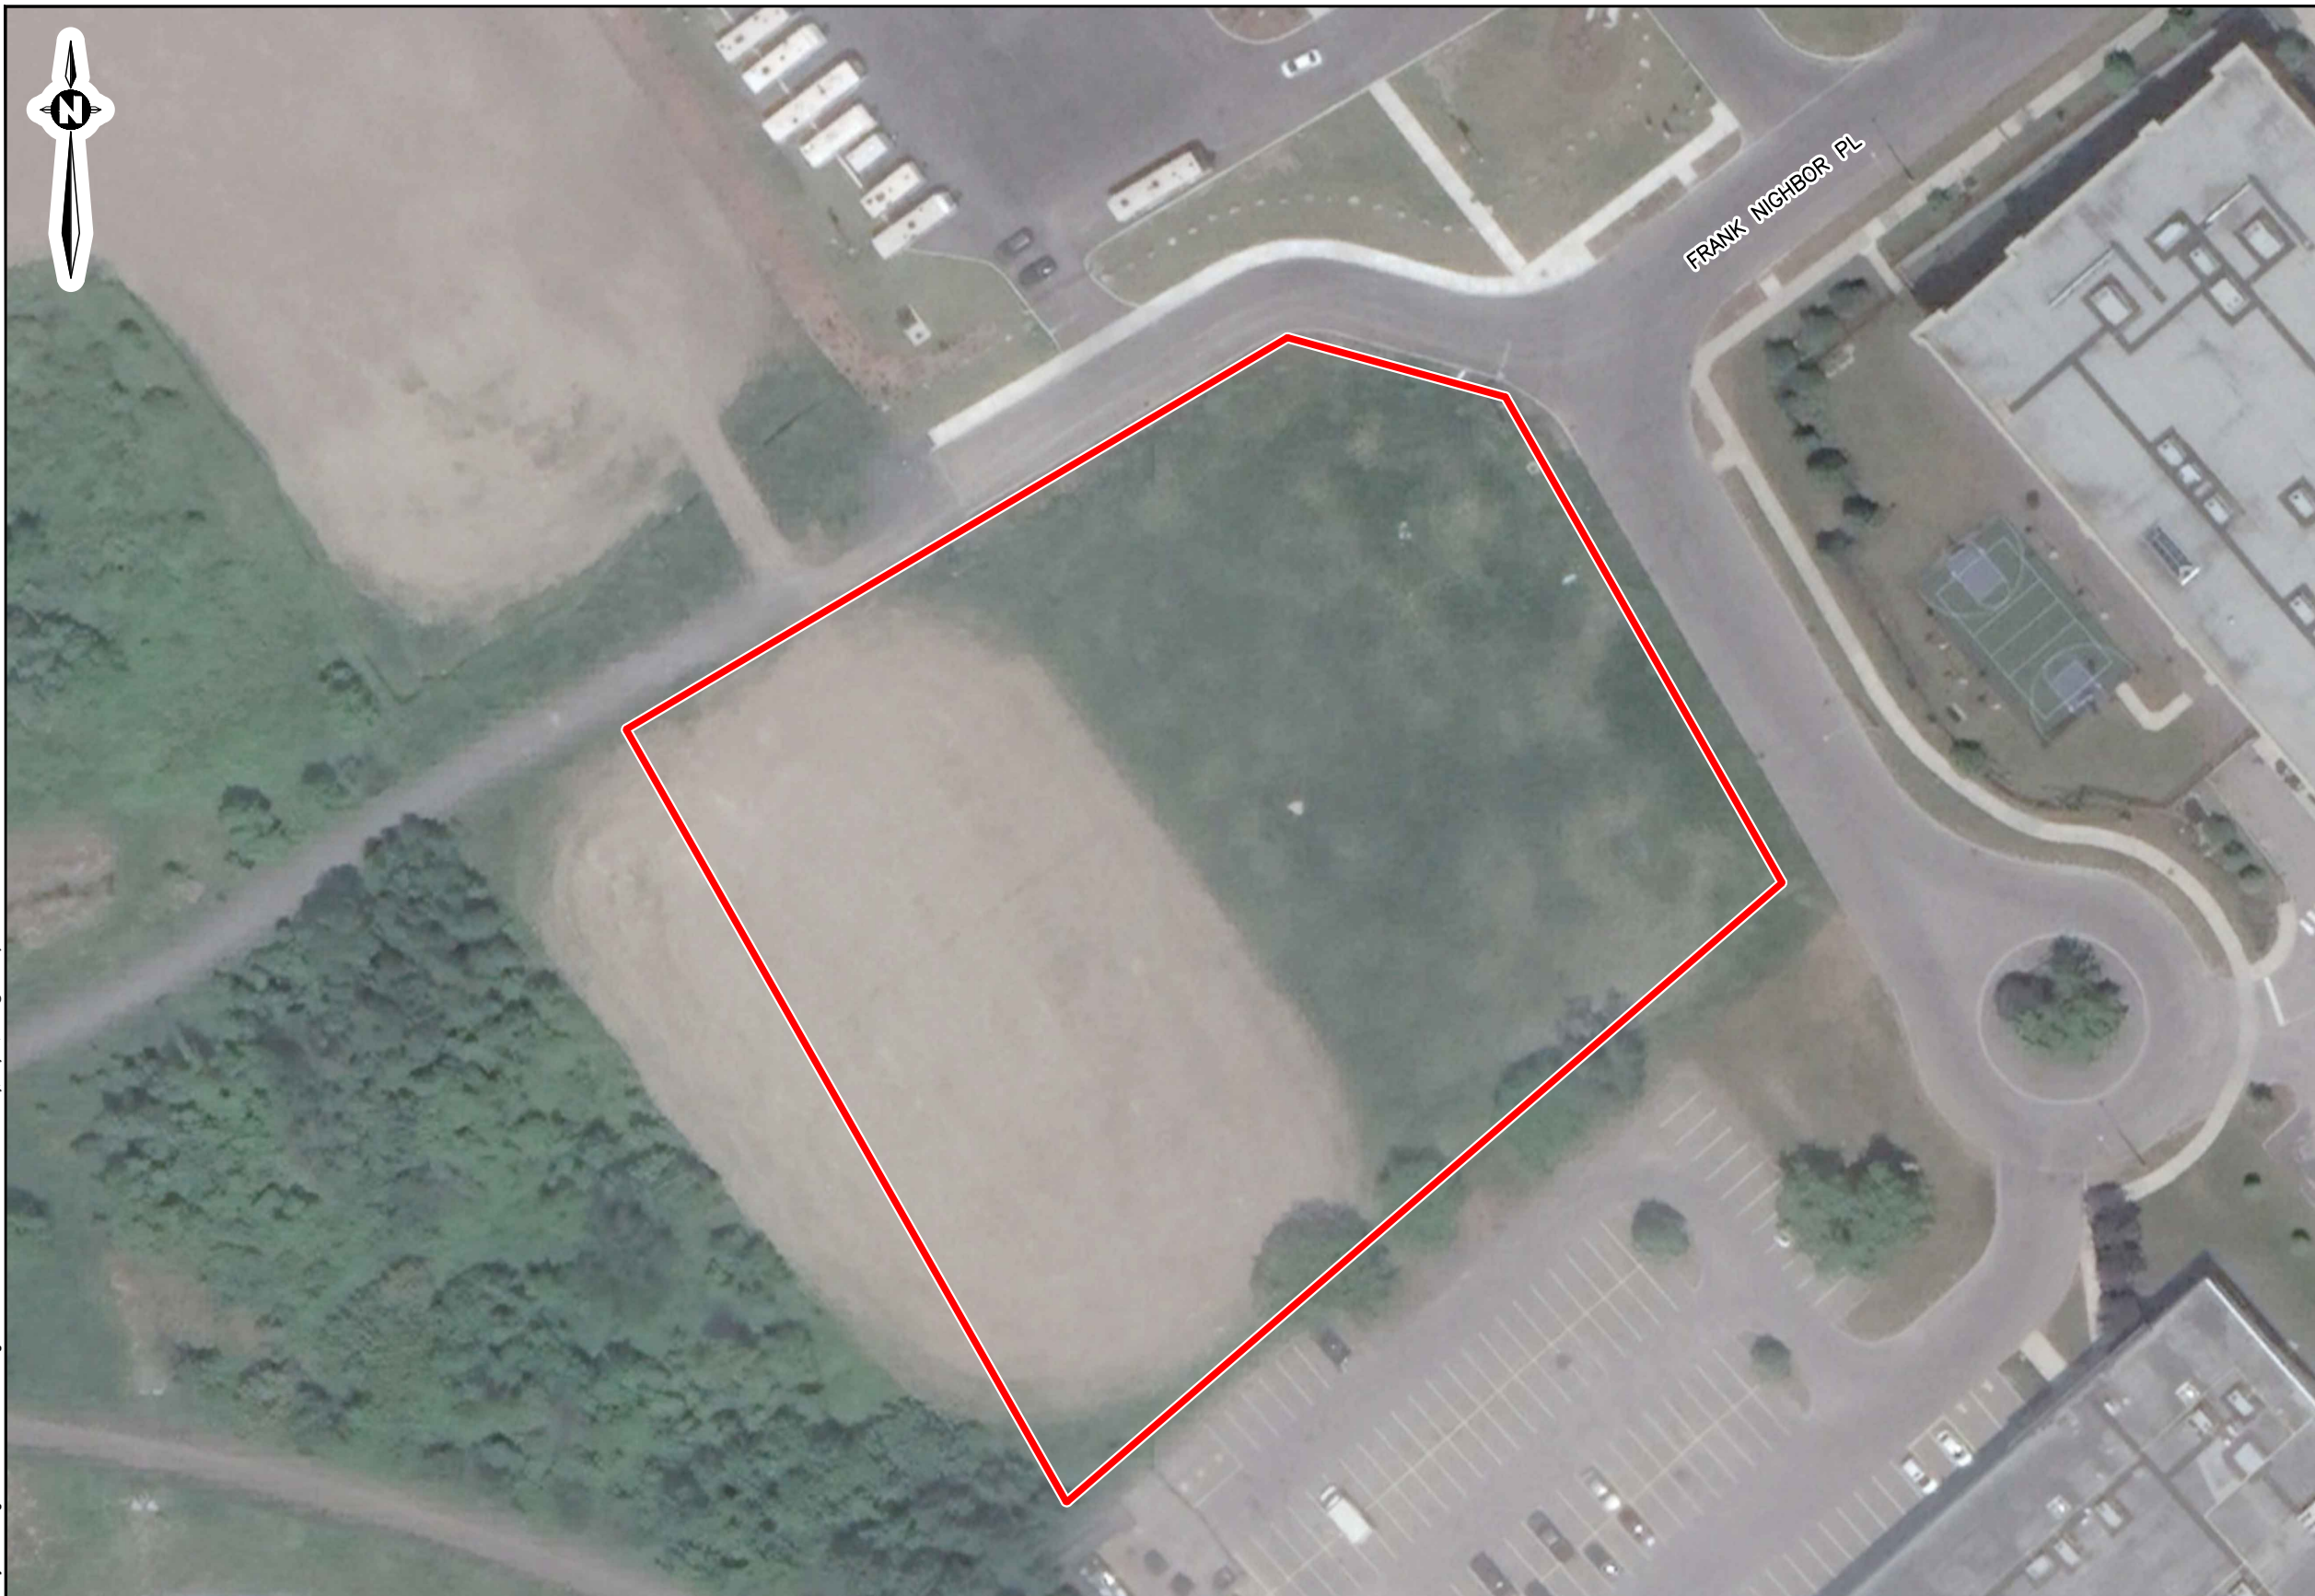
Figure No. **4**

Drawing: 4 APEC.dwg Folder: L:\TSCAD\Projects\Vantage Point\02211293 - Frank Nighbor PIP\Phase II ESA\DWGs Wednesday, May 03, 2023 @ 13:06 by Joven Mendoza

Potentially Contaminating Activities (PCAs)					Areas of Potential Environmental Concern (APECs)				
PCA No.	O. Reg. 153/04 PCA Item No.	Property Address	Historical and/or Current Activities	PCA Proximity to Site (m)	PCA Relative Direction to the Site	APEC No.	Location of APEC on the Site	Contaminants of Potential Concern (COPCs)	Potentially Impacted Media (Groundwater, Soil, and/or Sediment)
1	40. Pesticides (including Herbicides, Fungicides and Anti-Fouling Agents) Manufacturing, Processing, Bulk Storage and Large-Scale Applications	Onsite	Historic agricultural use and assumed pesticide application	Onsite	Onsite	1	Entire Phase I Property	OC Pesticides	Soil and Groundwater

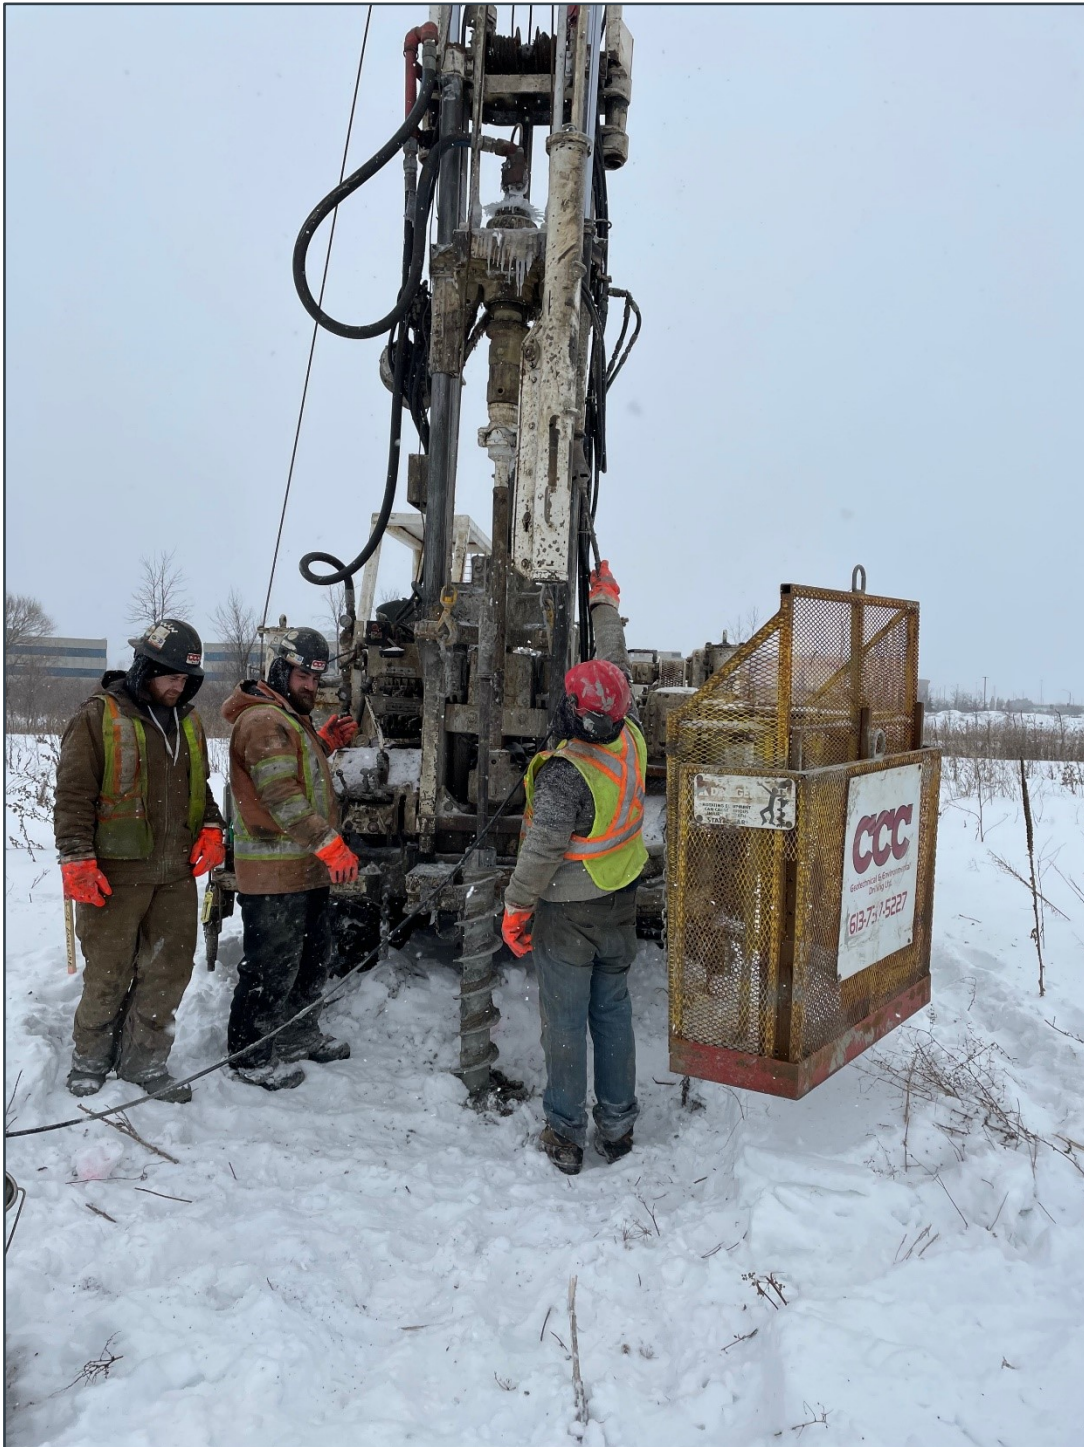
Site Photograph 1. Overview of drilling operations (February 21 to February 24, 2023).

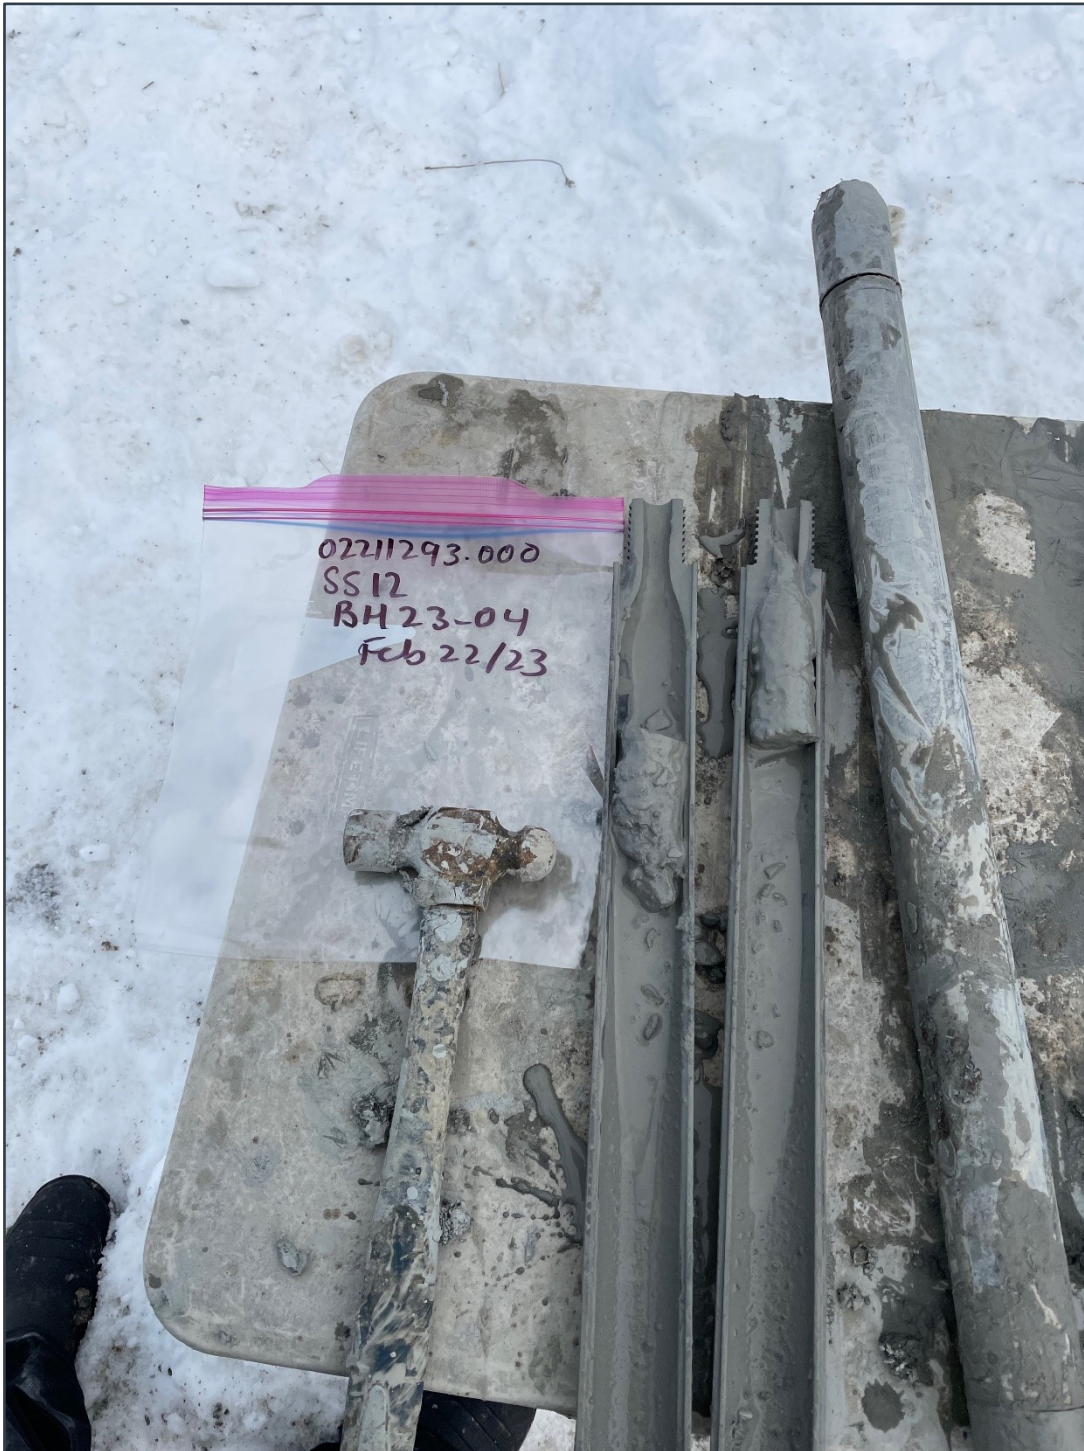
Site Photograph 2. Overview of split spoon sampling (February 22, 2023).

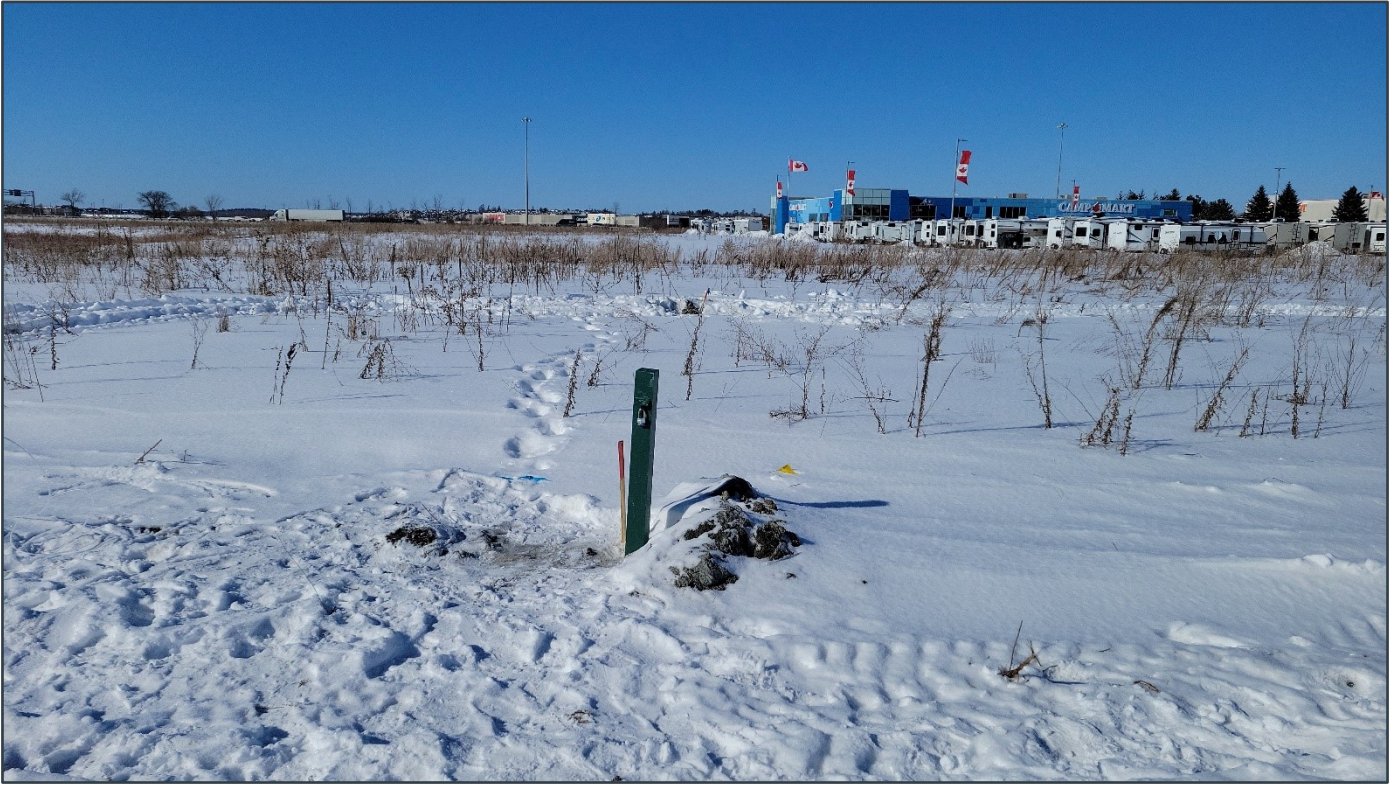
**Site Photograph 3. Overview of MW23-02. Photo taken by Englobe personnel on February 24, 2023 facing northeast.**

Additionally, it is recommended that the monitoring well installed at MW23-02 be abandoned within 180 days of its installation date, in accordance with Ontario Water Resource Act, Regulation 903 - Wells (as amended).
