CTR-442 - Phase One Environmental Site Assessment

**2501 Greenbank Road
Barrhaven, Ontario**

Canadian Tire Real Estate Limited

1 May 2023

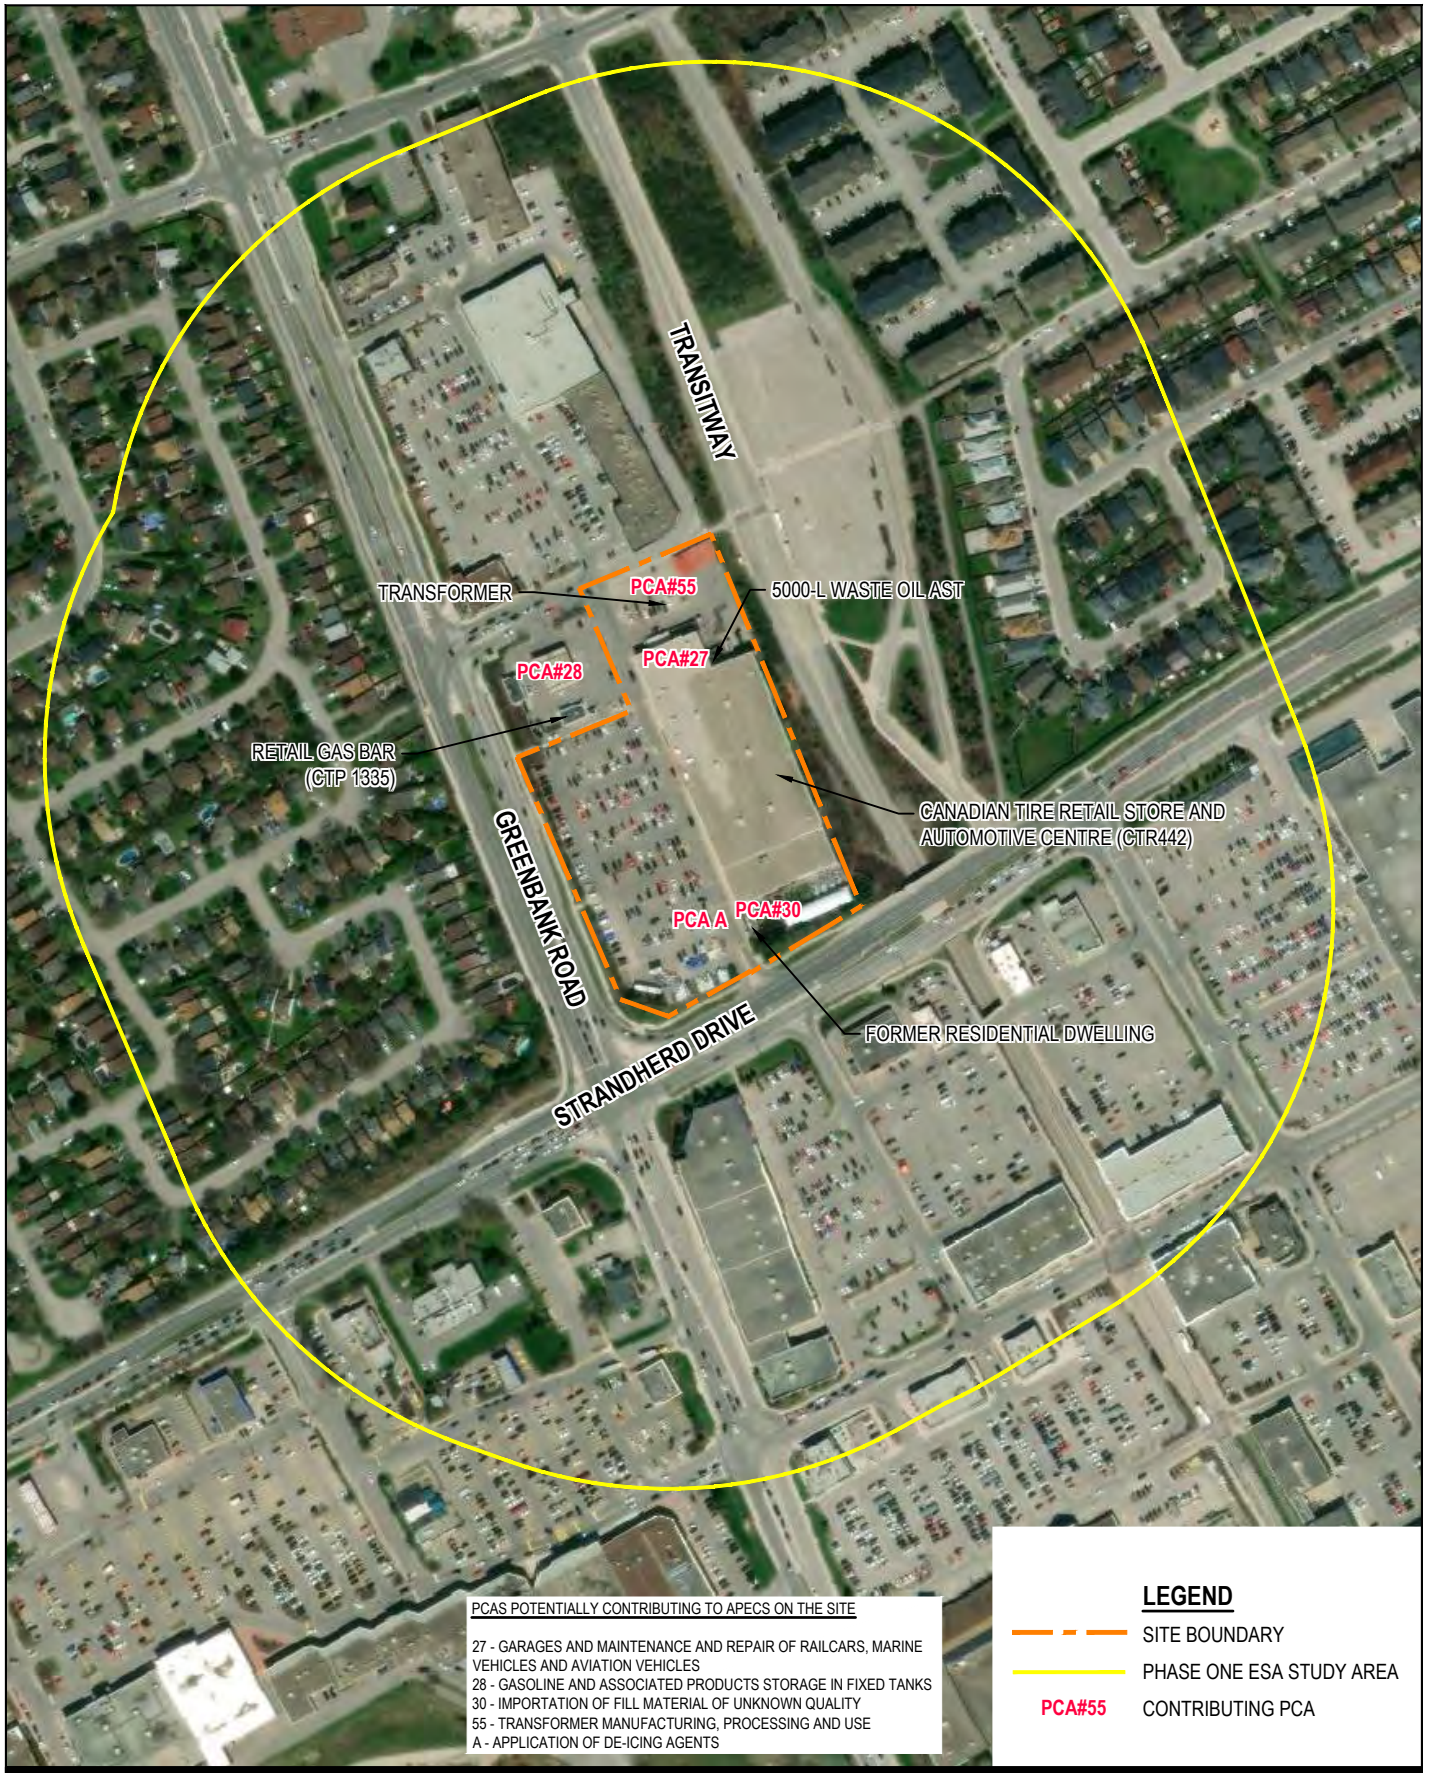
FIGURE 2

PHASE ONE CONCEPTUAL SITE MODEL

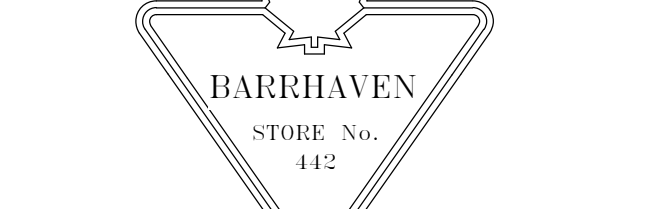
1 SITE PLAN
1: 300

REQUIRED	EXISTING	PROPOSED
RETAIL STORE	3.4 PER 100 S.M. OF GFA	177 CARS	199 CARS
SERVICE AND REPAIR SHOP	3.4 PER 100 S.M. OF GFA	28 CARS	26 CARS
OFFICE	2.4 PER 100 S.M. OF GFA	5 CARS	4 CARS
GAS BAR	NO REQUIREMENT	0	0
CAR WASH	NO REQUIREMENT	0	0
TOTAL PARKING REQUIRED		210 CARS	284 SPACES
TOTAL PARKING PROVIDED		354 CARS	309 CARS

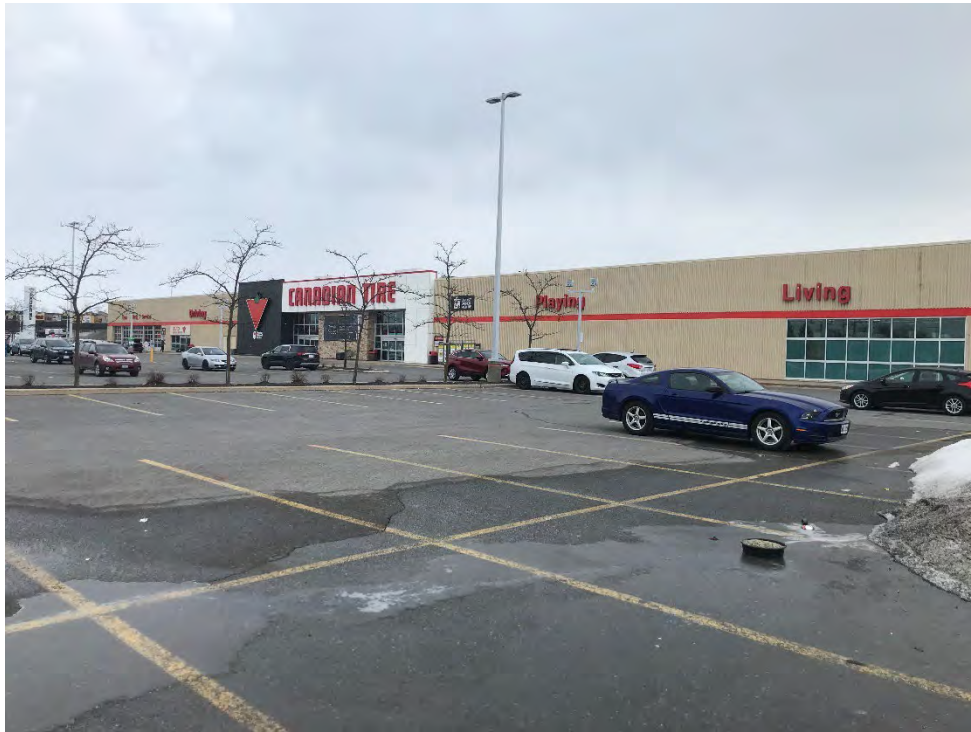
Photo 1 View of Canadian Tire Retail Store (CTR 442) at 2501 Greenbank Road, Ottawa, Ontario, facing northeast. March 29, 2023.

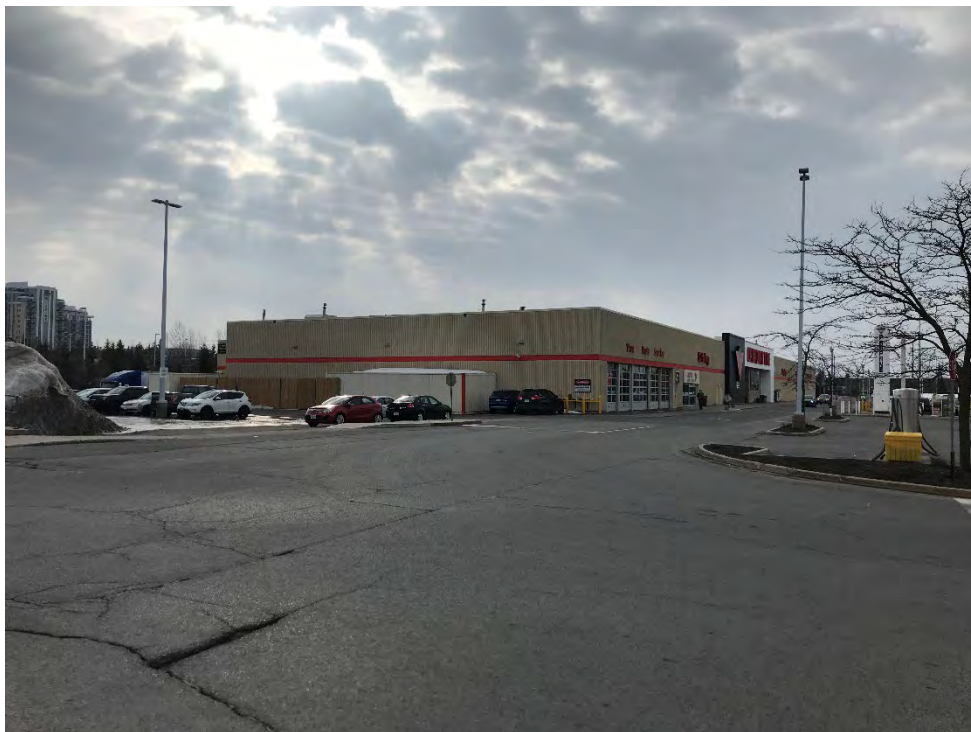
Photo 2 View of Automotive Service Centre at 2501 Greenbank Road, Ottawa, Ontario at the northern portion of the Site, facing southeast. March 29, 2023.

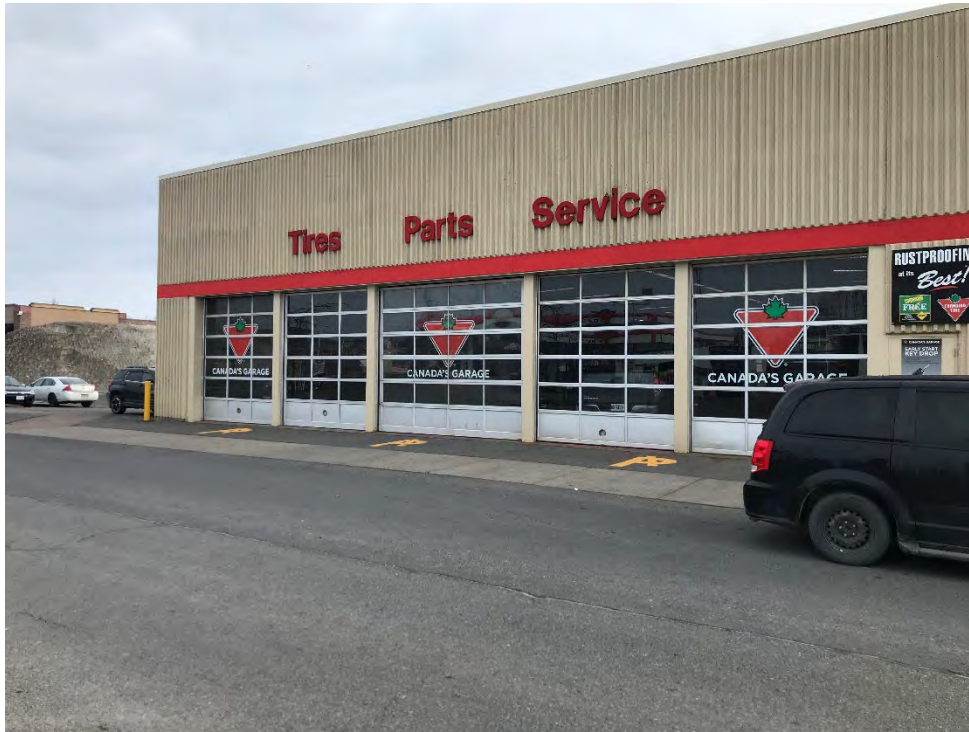
Photo 3 Outside view of the Automotive Service Centre, facing northeast. March 29, 2023.

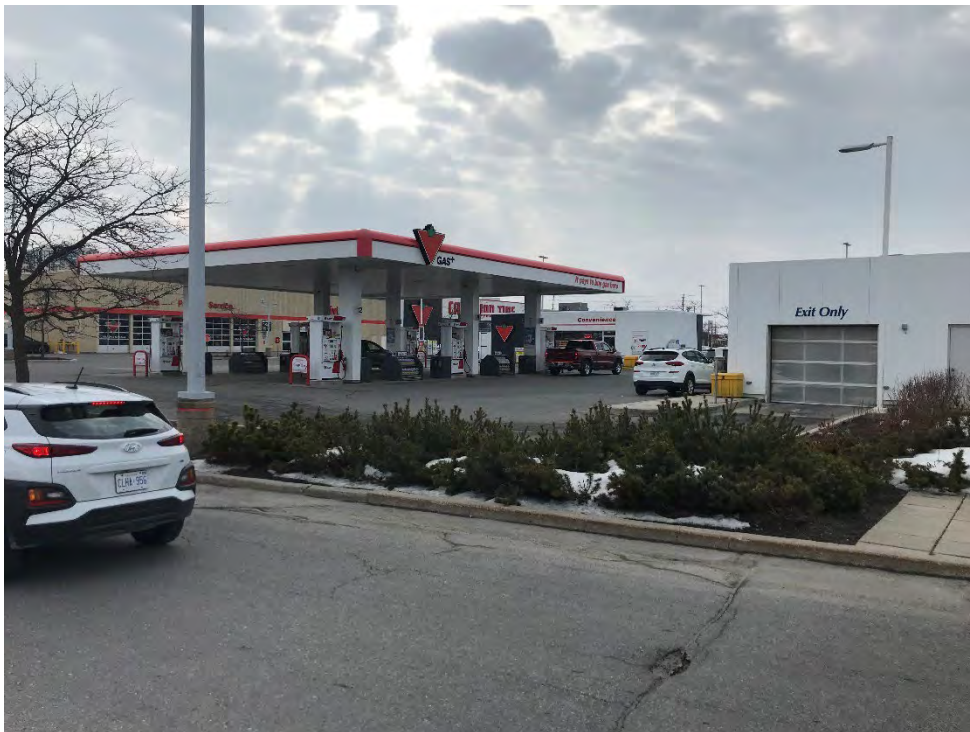
Photo 12 View of the Canadian Tire Gas Bar (CTP 1335) located at the northwest portion of the larger Canadian Tire Property adjacent to the Site, facing southeast. March 29, 2023.

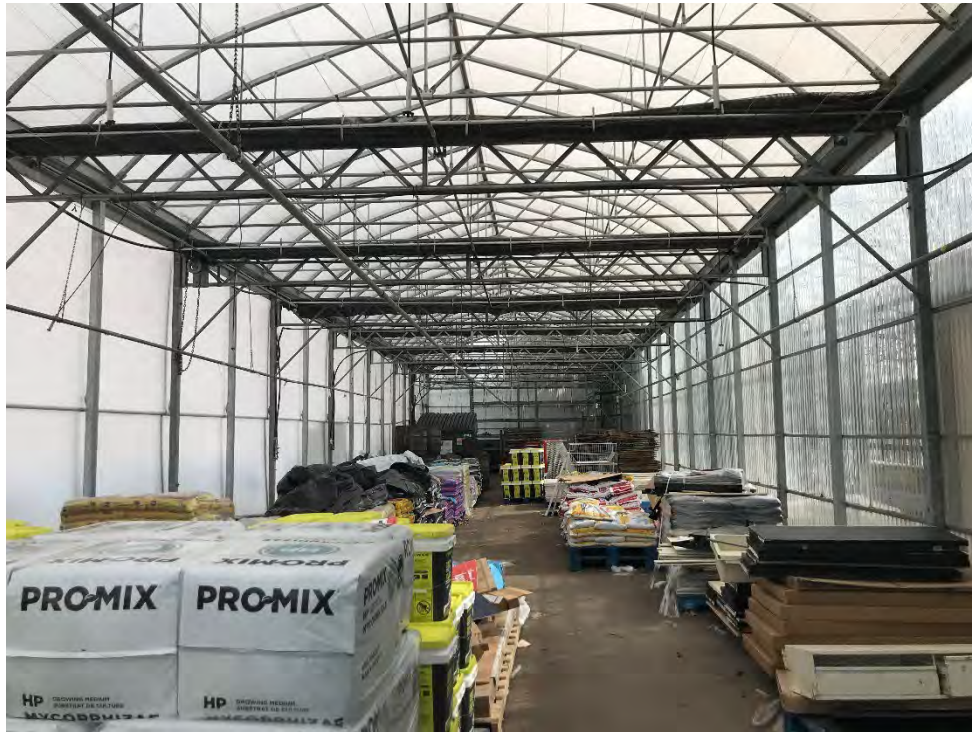
Photo 13 View of the fenced in Garden Centre at the southern portion of the Site. March 29, 2023.

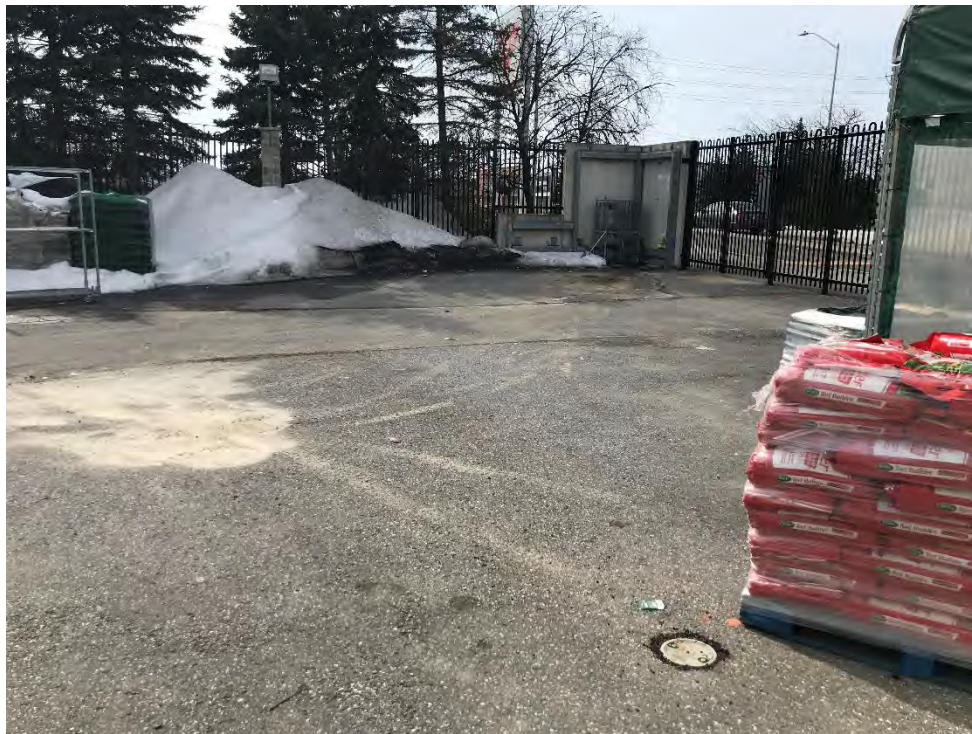
Photo 14 View of a monitoring well in the fenced in Garden Centre at the southern portion of the Site, facing south. March 29, 2023.

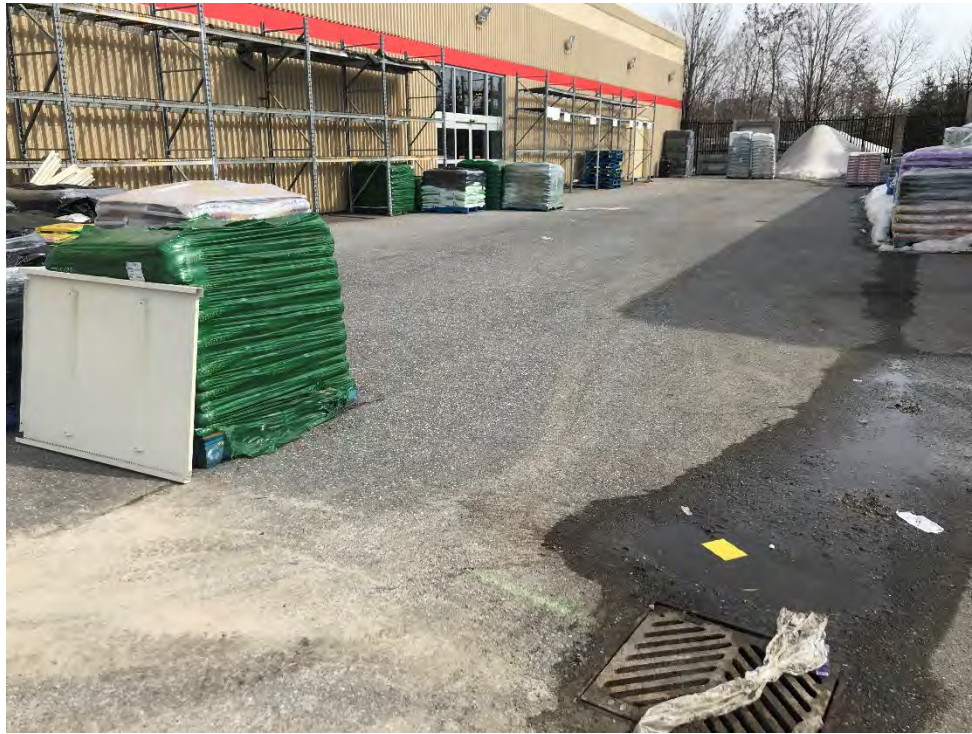
Photo 15 View of the Canadian Tire Retail Store from the Garden Centre at the southern portion of the Site, facing northeast. March 29, 2023.

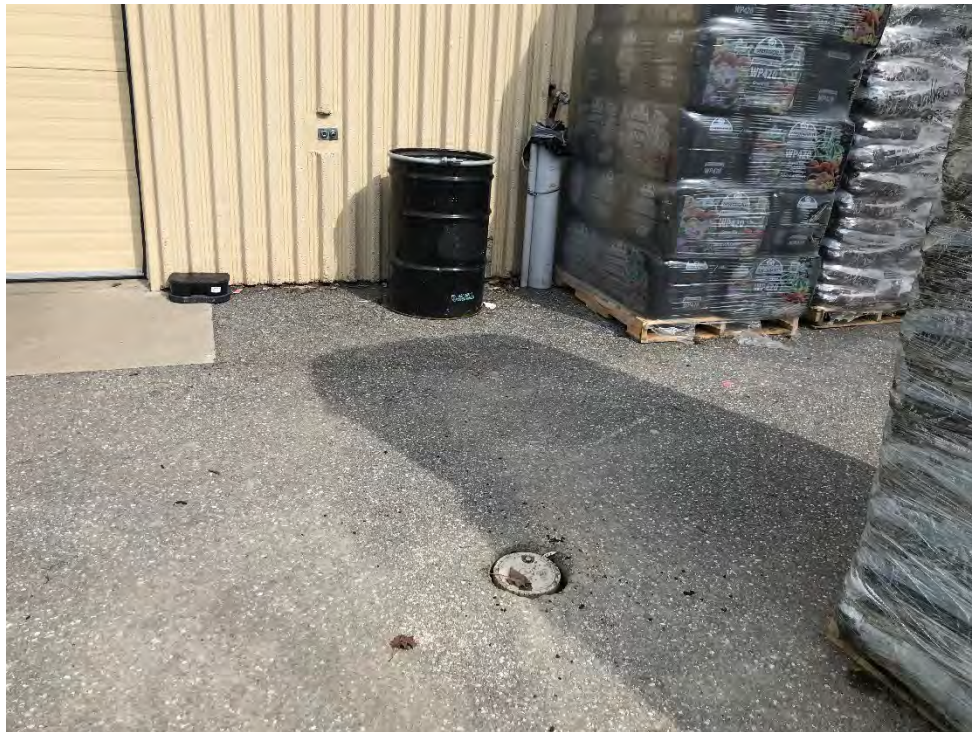
Photo 16 View of soil drum and a monitoring well in the Garden Centre outside the Canadian Tire Retail Store at the southern portion of the Site, facing northeast. March 29, 2023.

was observed on Site in the Garden Centre area. Metal objects are stored for disposal in drums in the automotive service centre. Used oil filters are stored for disposal in garbage bins on Site.

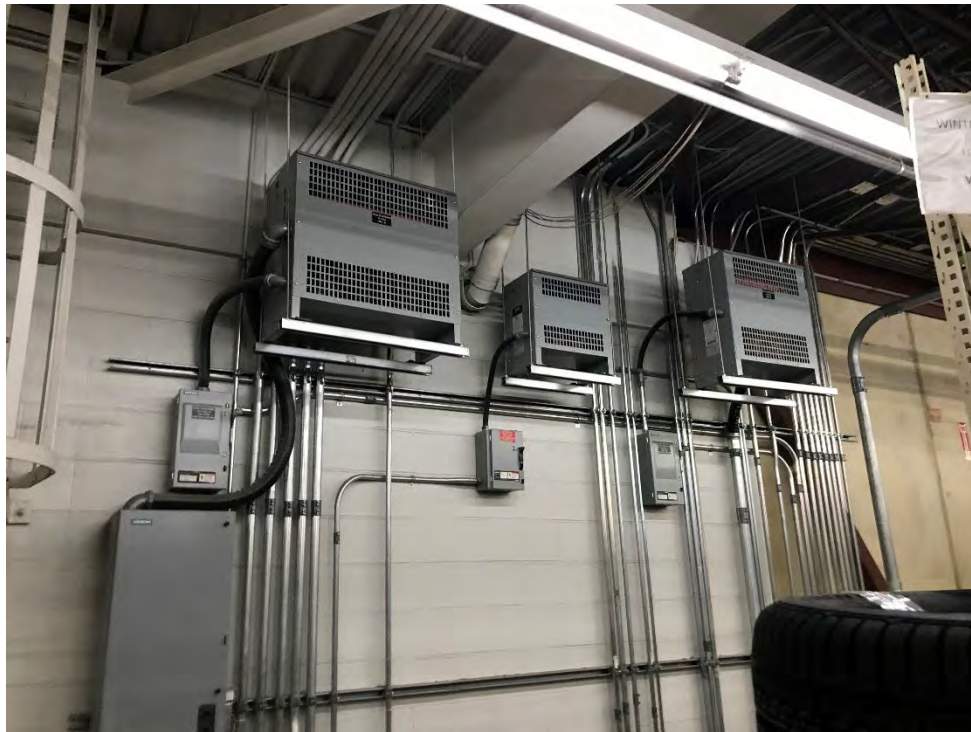
Photo 18 View of transformers located in the northeast corner of the Canadian Tire Warehouse. March 29, 2023.

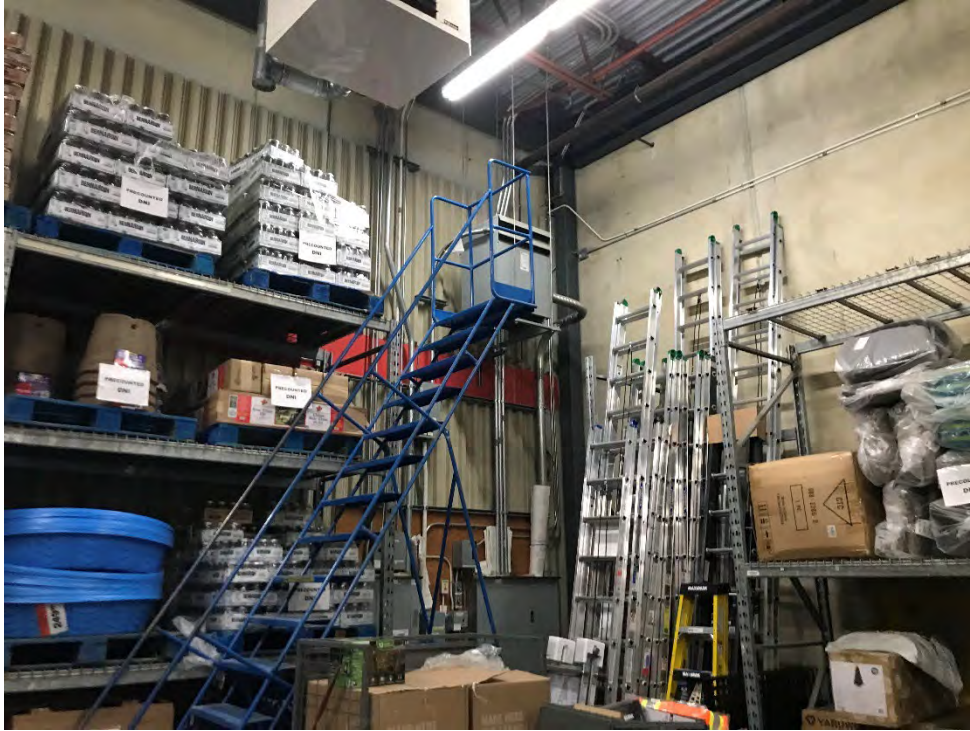
Photo 19 View of transformers located in the southeast corner of the Canadian Tire Warehouse. March 29, 2023.

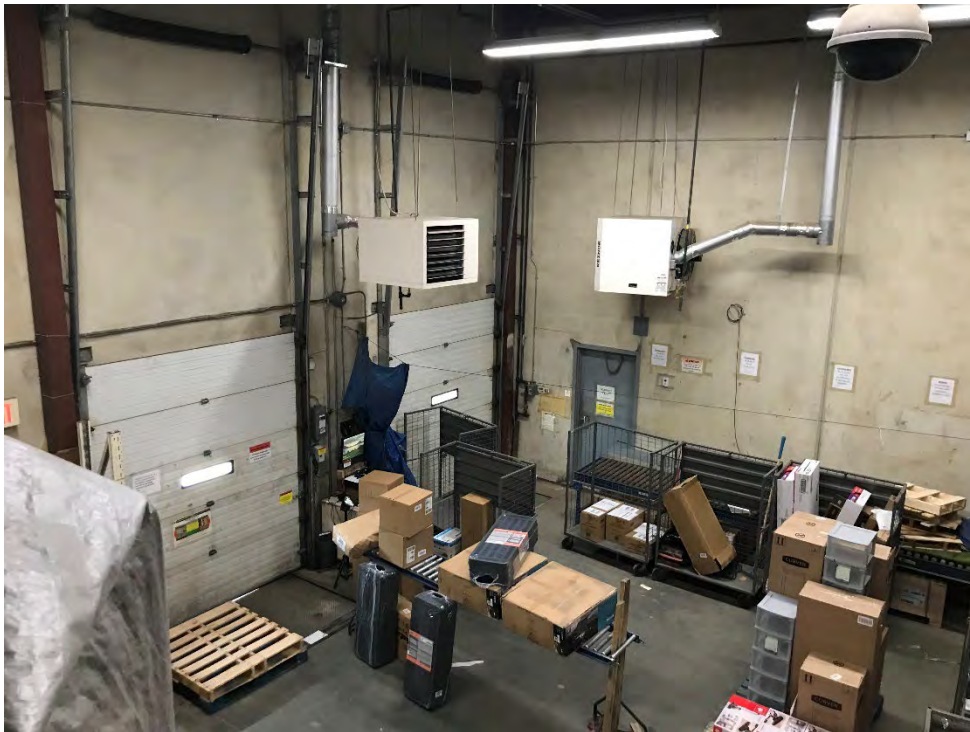
Photo 20 View of the loading area within the Warehouse in the Canadian Tire Retail Store. March 29, 2023.

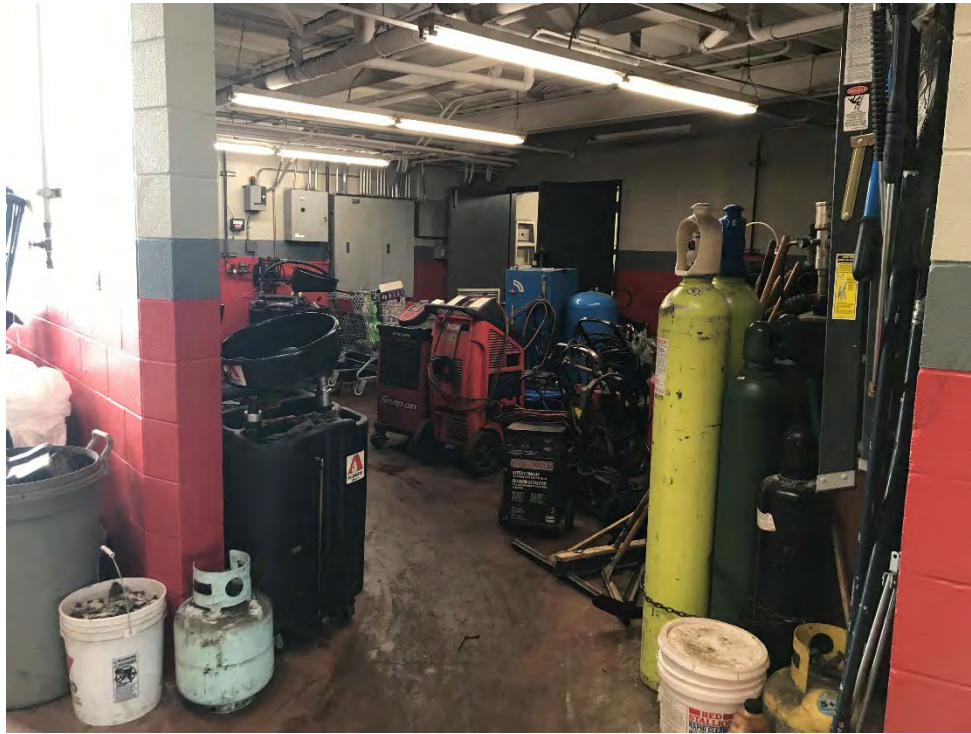
Photo 31 View of helium, oxygen, and Acetylene gas cannisters in the Automotive Service Centre. Staining on the floor is visible. March 29, 2023.

GHD did not observe any evidence of staining in the chemical storage areas, with the exception of some oil staining in the waste compound associated with the automotive service centre/used oil AST.

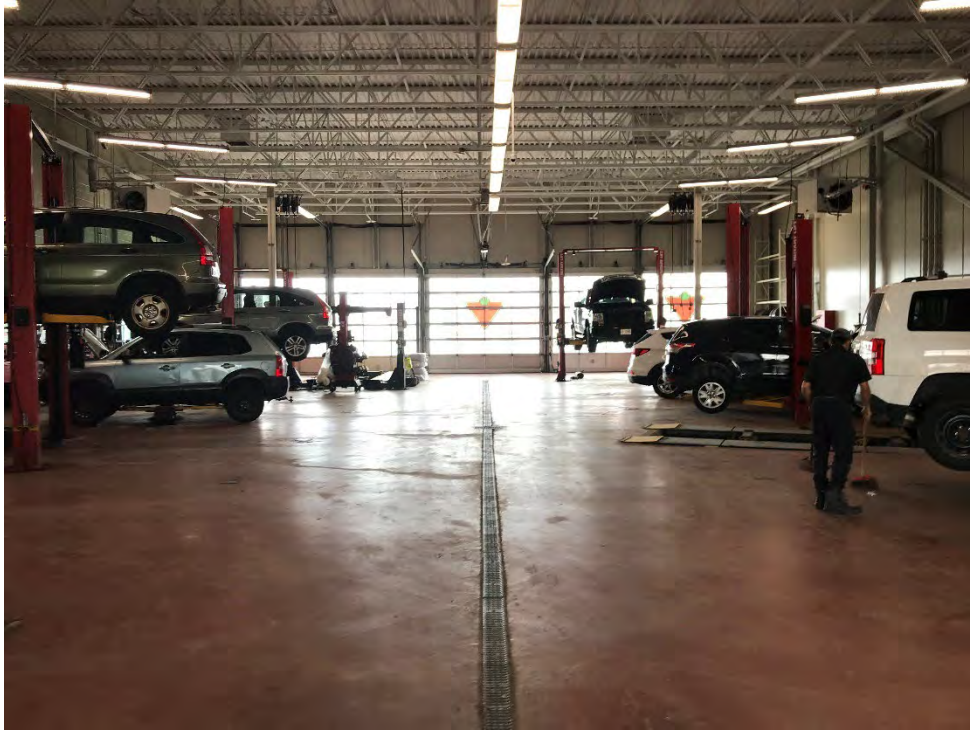
Photo 53 Interior view of the Automotive Service Centre. March 29, 2023.

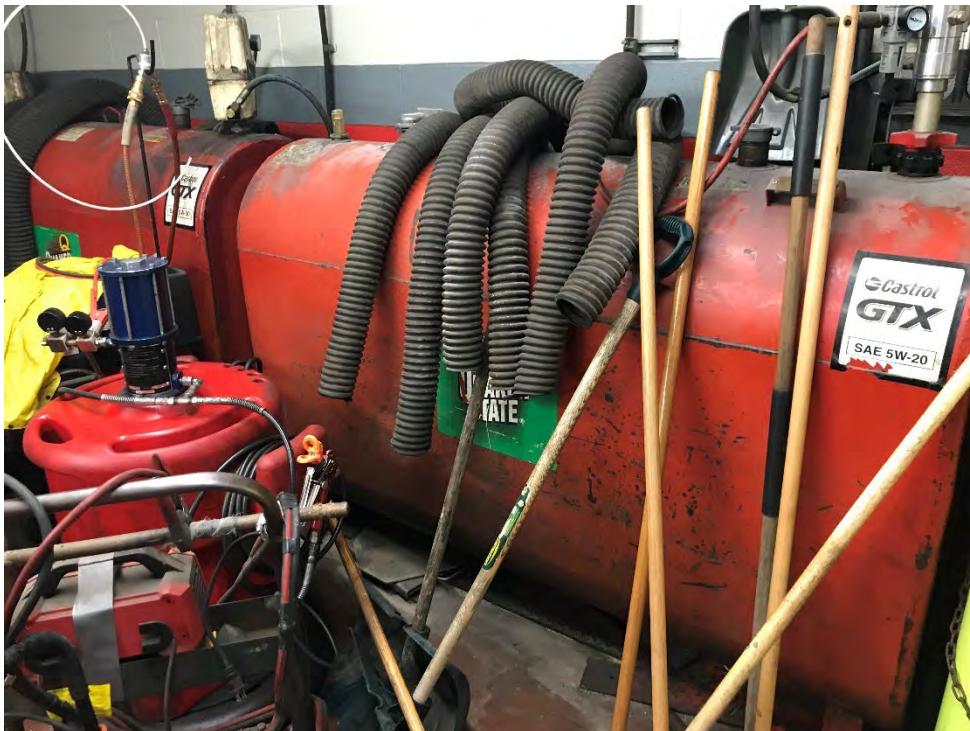
Photo 64 View of bulk oil tanks in the Automotive Service Centre. March 29, 2023.

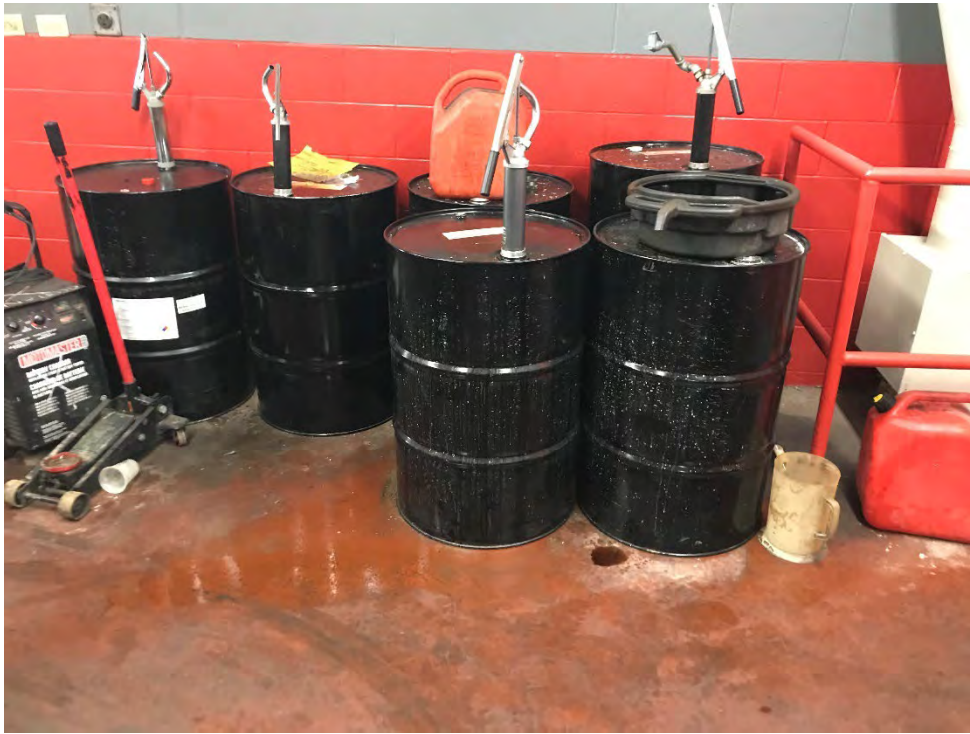
Photo 75 View of drums containing oil in the Automotive Service Centre. Staining/oily surface on the floor is visible. March 29, 2023.

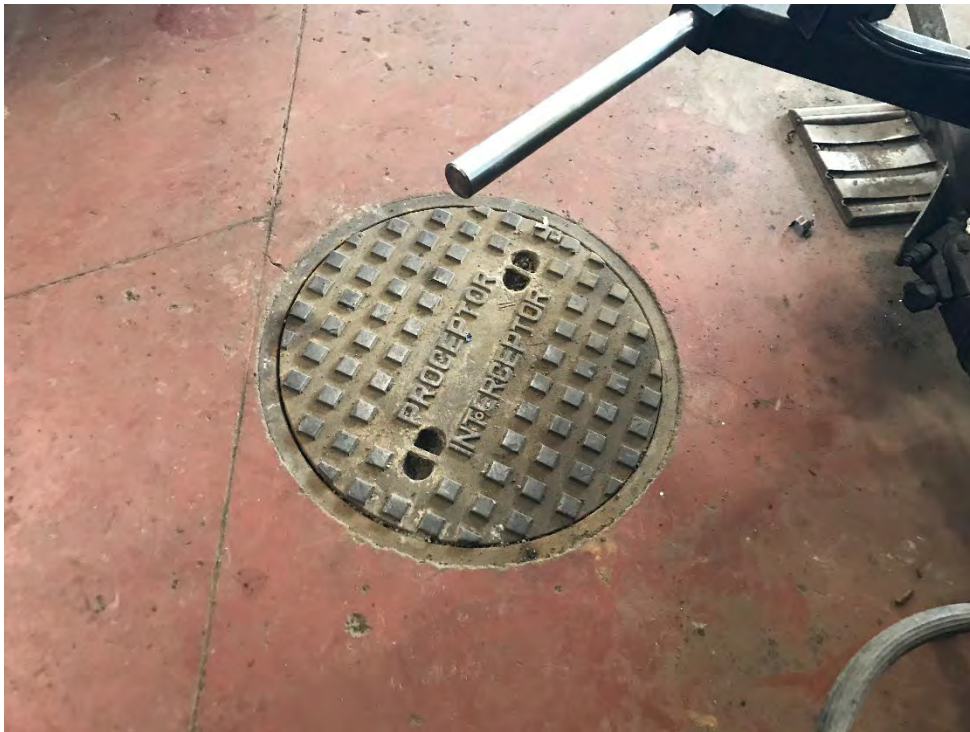
Photo 26 View of oil-water interceptor in the Automotive Service Centre. March 29, 2023.

At the time of the Site inspection, floor drains and a trench drain were observed within the automotive service centre which lead to an oil/water separator prior to discharge to the municipal sanitary sewer system.

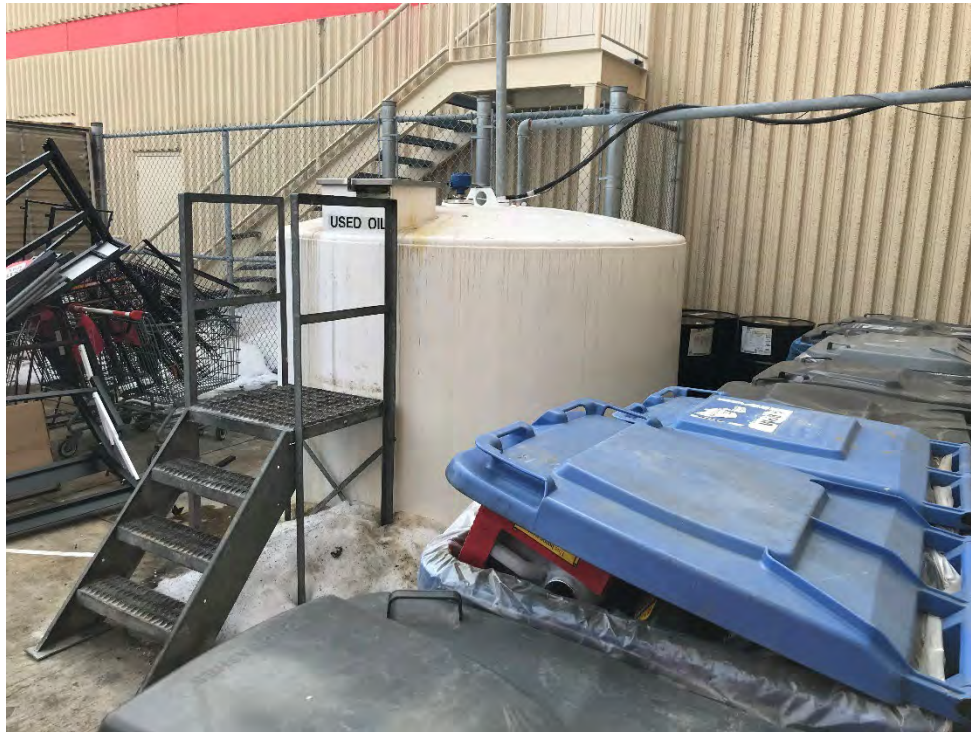
Photo 27 View of waste oil AST with a 3,000 L capacity located at the exterior of the Automotive Service Centre, facing southwest. March 29, 2023.

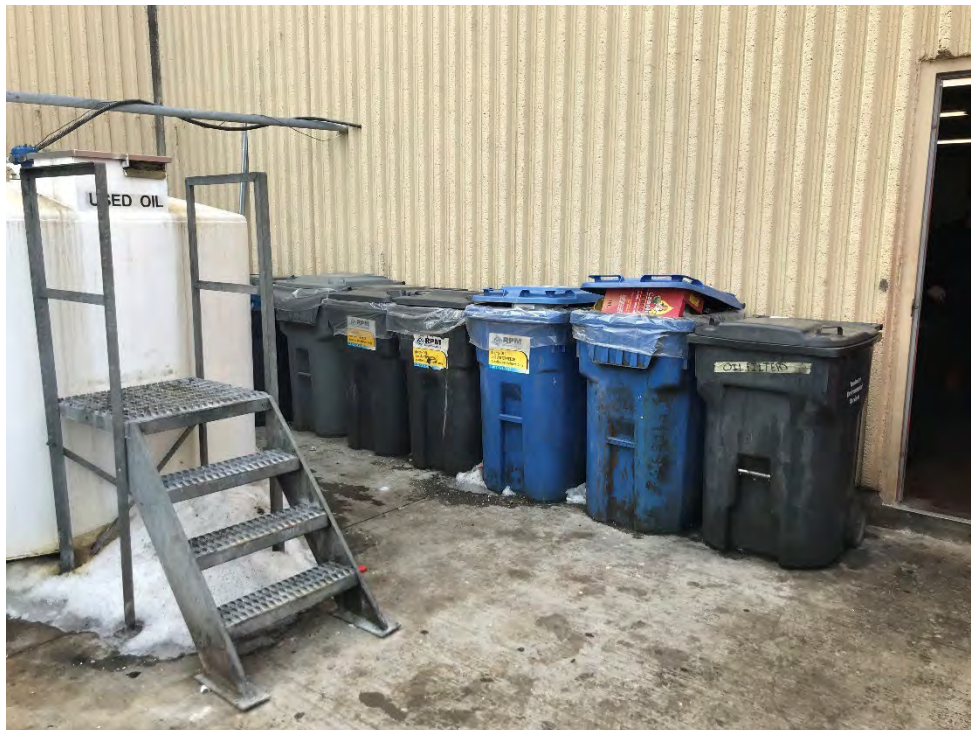
Photo 28 View of empty oil and antifreeze containers and used oil filters in containers for disposal located at the exterior of the Automotive Service Centre, facing northwest. Staining on the floor is visible. March 29, 2023.

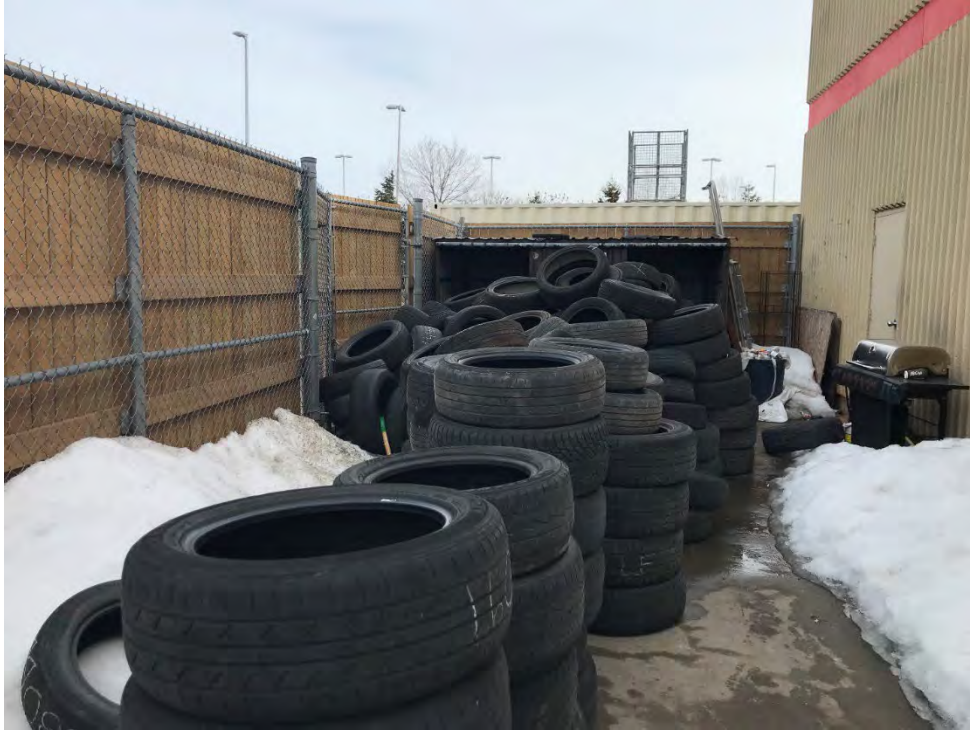
Photo 29 View of used tires located at the exterior of the Automotive Service Centre, facing east. March 29, 2023.

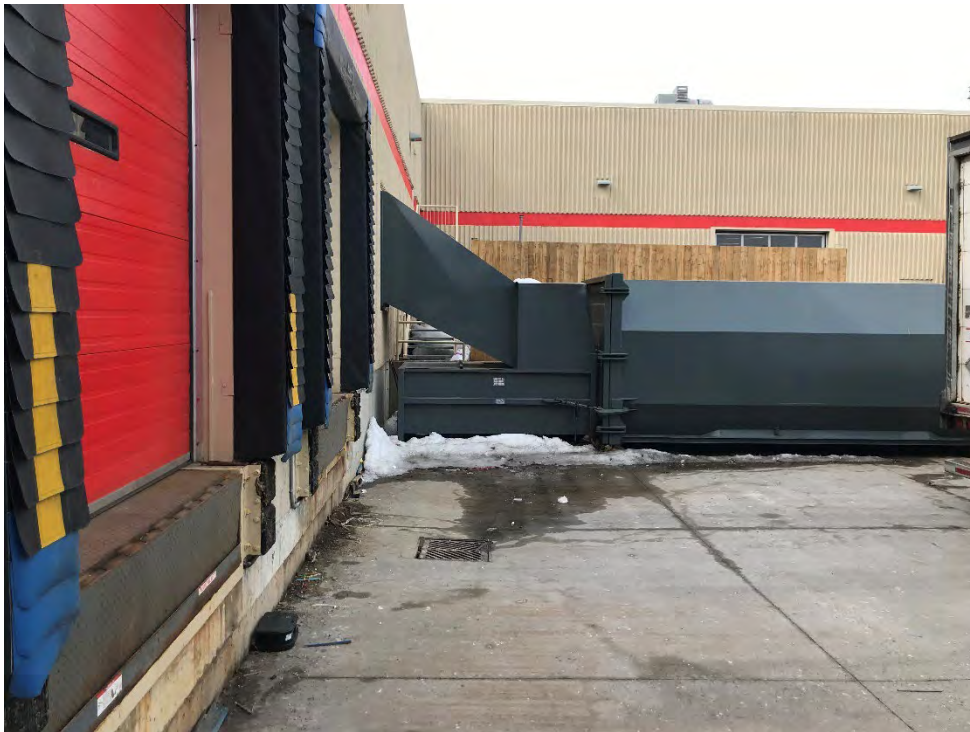
Photo 30 View of loading dock and catch basin located at the exterior of the Automotive Service Centre, facing west. March 29, 2023.

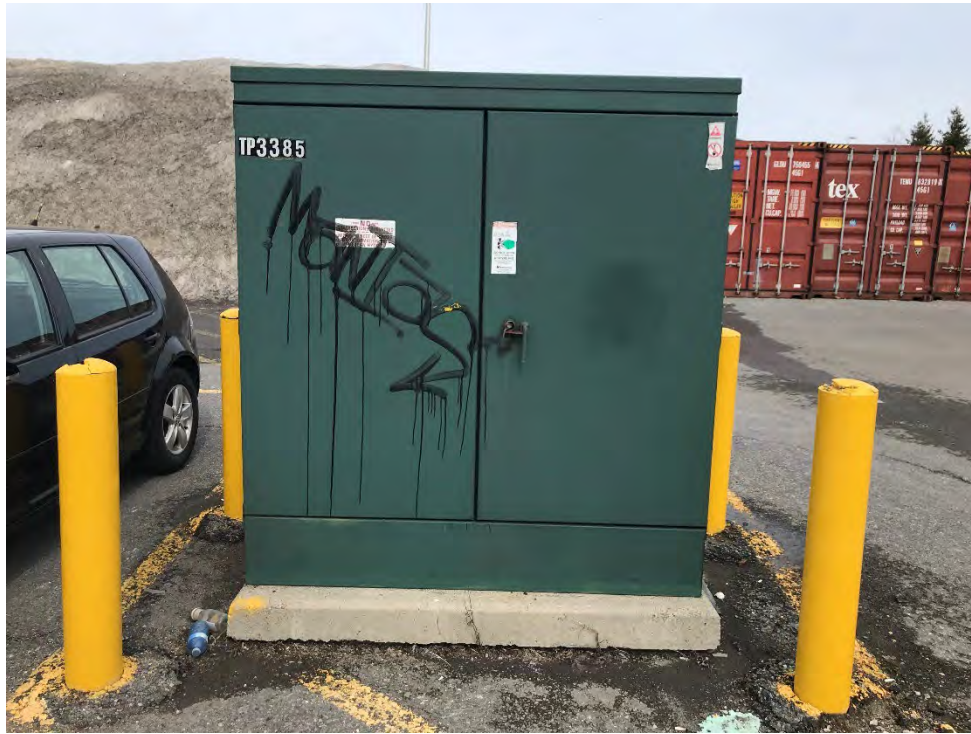
Photo 31 *View of transformer located in the parking lot at the northern portion of the Site, facing north. March 29, 2023.*

No evidence of PCB waste storage was observed by GHD at the time of the Site reconnaissance. PCBs are not suspected to be present within the CTR 442 commercial building due to the construction date of 2000. One pad-mounted transformer is located in the parking area, adjacent to the north of the automotive service centre (**APEC #5**).
