## **Phase II – Environmental Site Assessment**

2865 F Walkley Road  
Ottawa, Ontario

Prepared for Richcraft Properties Ltd.

Report: PE5930-2  
February 7, 2023

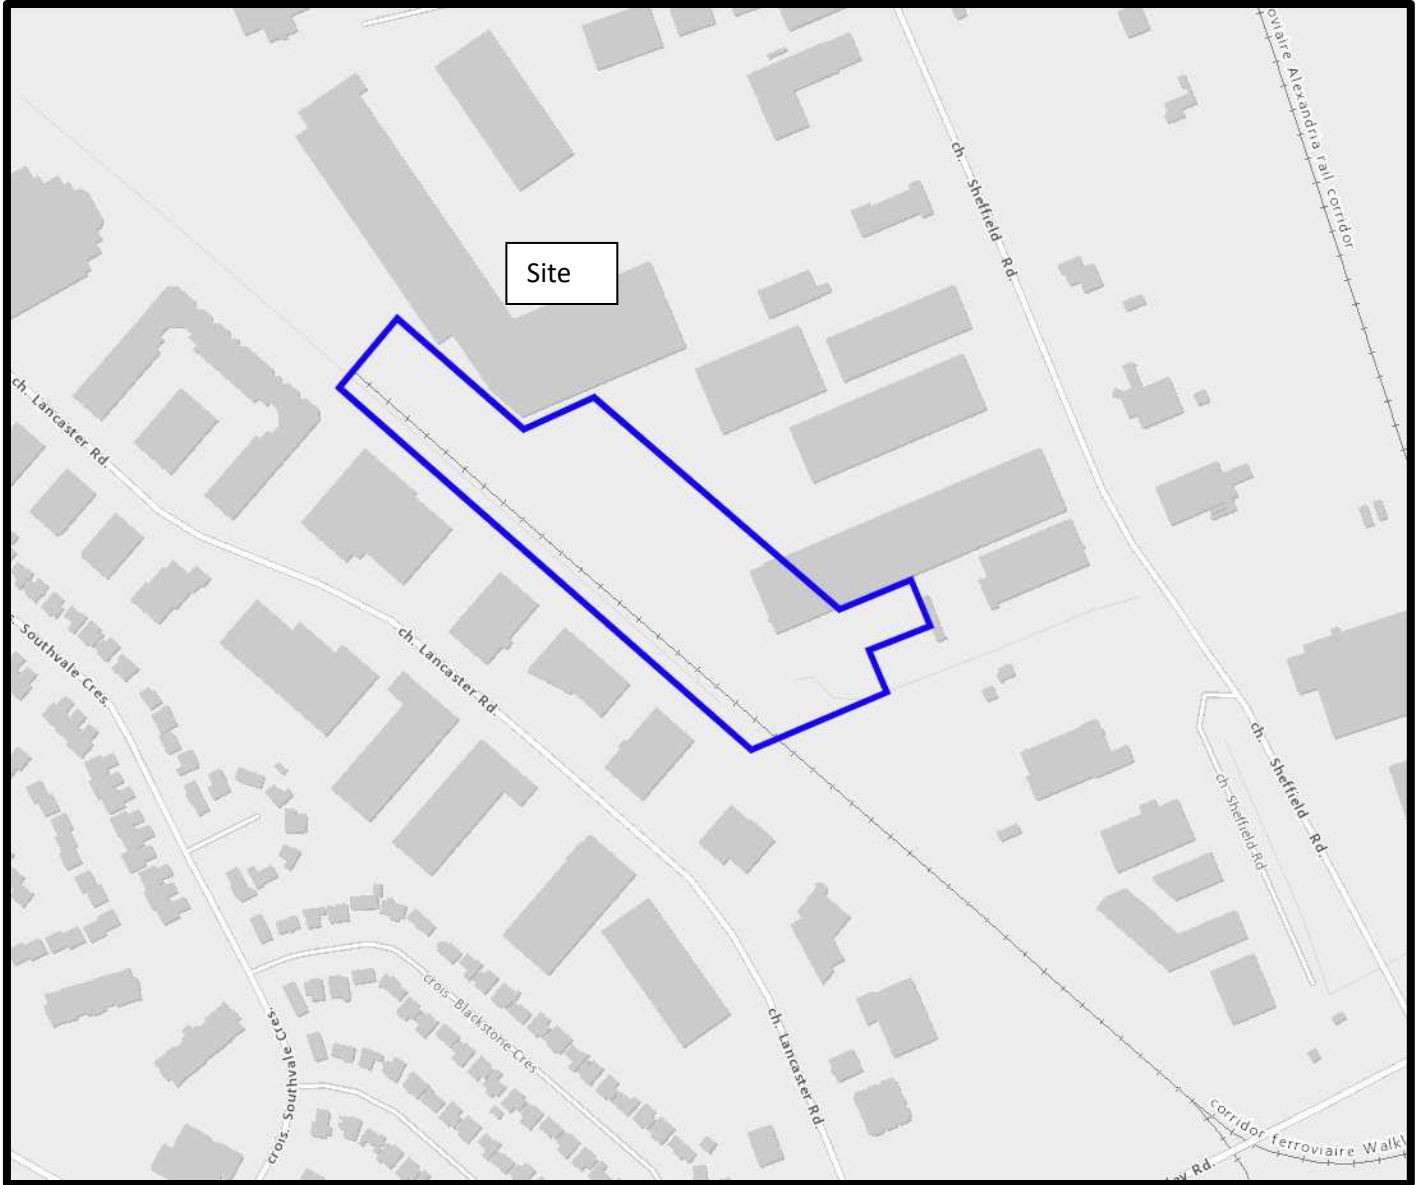
FIGURE 1  
KEY PLAN

**Location:** The Phase I Property is located between Sheffield Road and Lancaster Road, approximately 410m north of Walkley Road, in the City of Ottawa, Ontario. Refer to Figure 1 - Key Plan in the Figures section following the text.
