Phase One Environmental Site Assessment

506 Kent Street
Ottawa, Ontario

Prepared for:
11034936 Canada Inc.

LOP25-038A

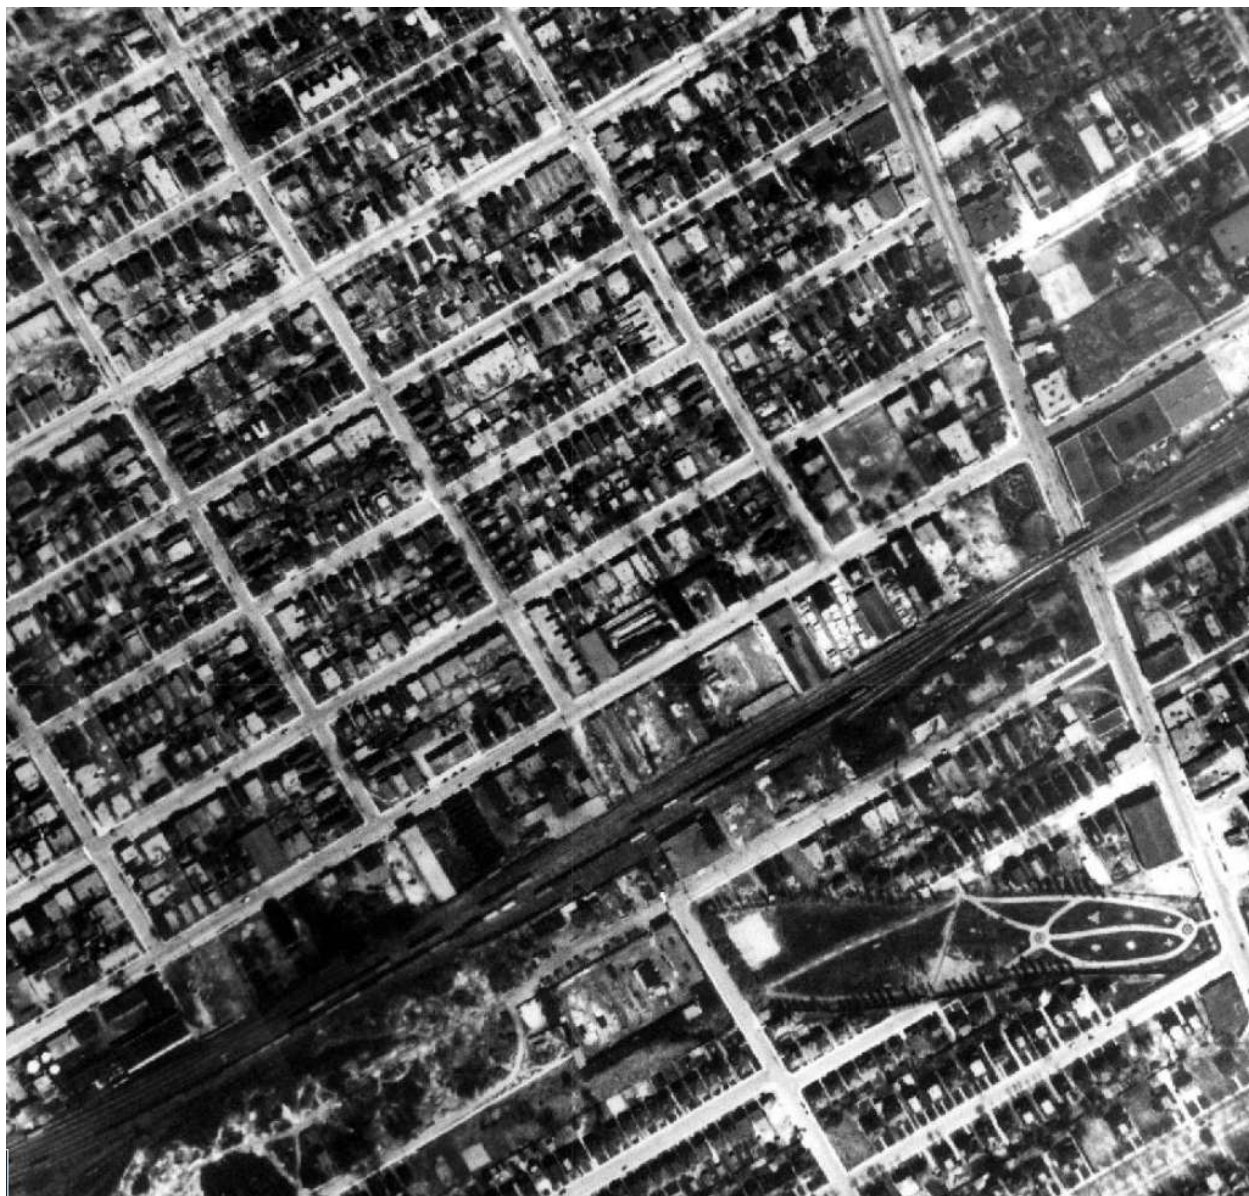
1928 Aerial Photograph

previously identified, represents PCA #11. The land use associated with these PCAs is evident as early as 1928 as observed through historical aerial photographs.

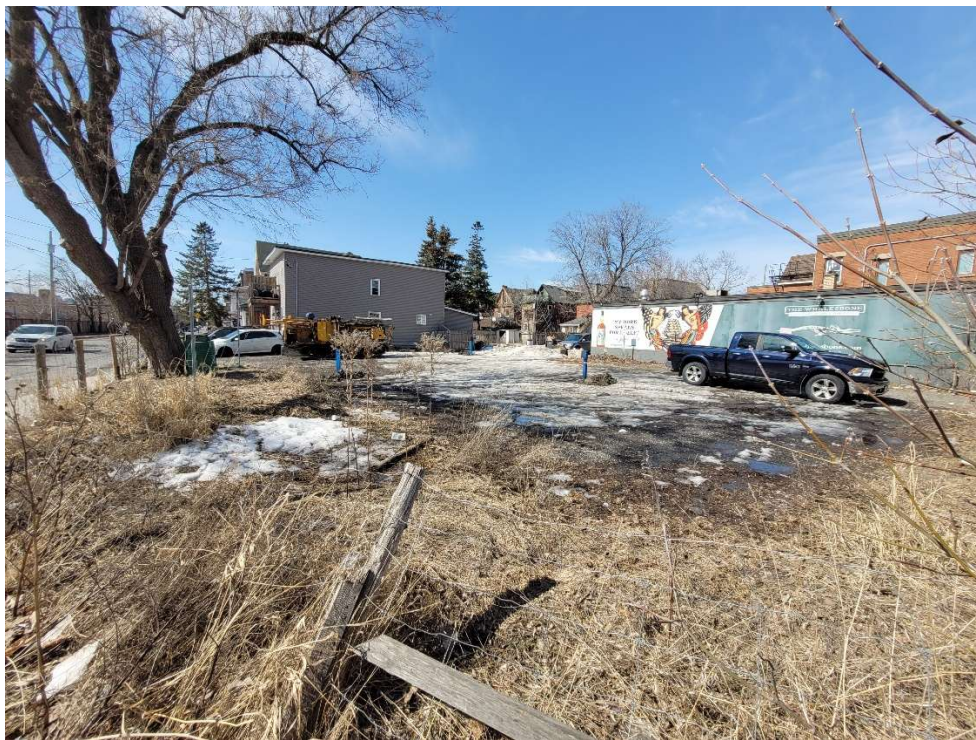
Photograph 1: View of the of the south portion of the Phase One Property looking west. View shows monitoring wells from recent (2025) Phase Two ESA.

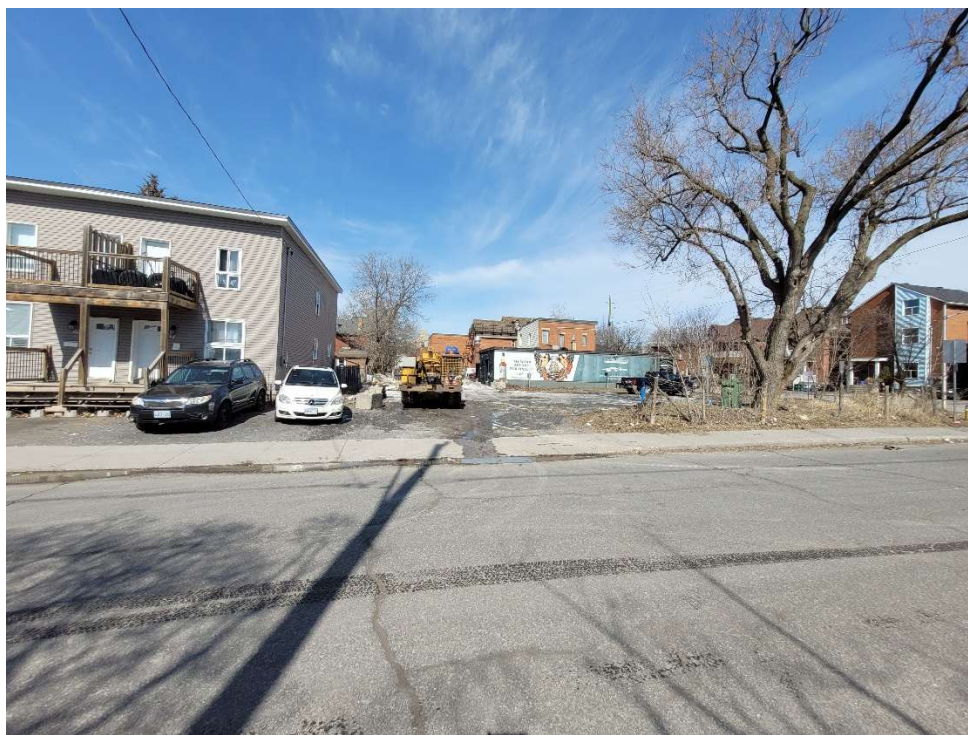
Photograph 2: View of the of the west portion of the Phase One Property looking north. View shows drill rig and monitoring wells from recent (2025) Phase Two ESA and access to the Site from Arlington Avenue to the south.

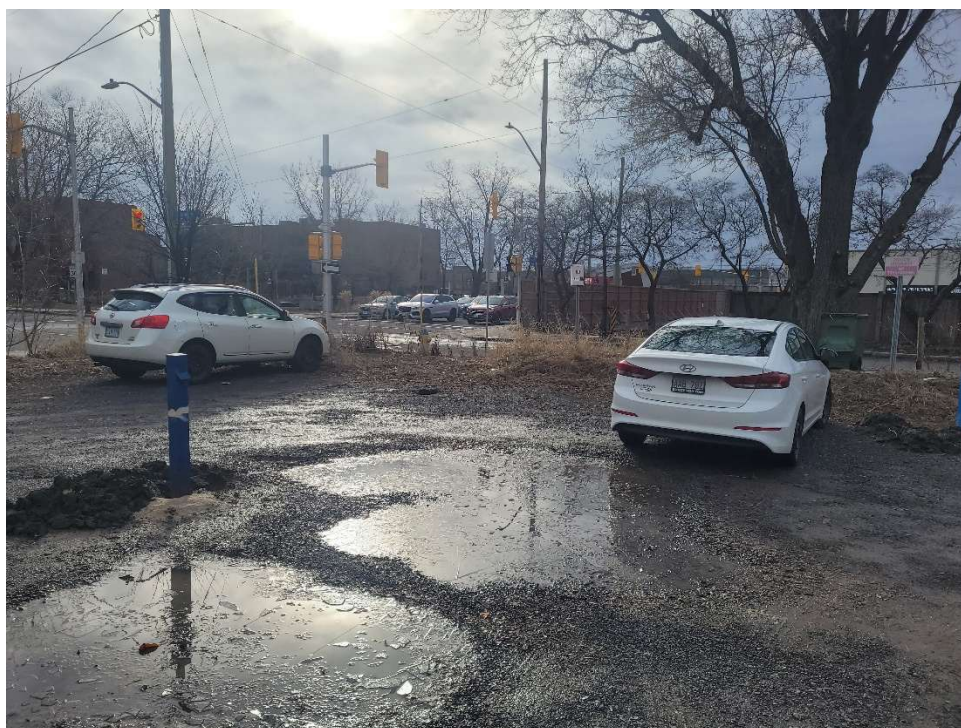
Photograph 4: View of the of the south portion of the Phase One Property looking southeast. View shows monitoring wells from recent (2025) Phase Two ESA and generally gravel surfaced parking.
