# Phase One Environmental Site Assessment

265 Catherine Street  
Ottawa, Ontario

Prepared for:  
11034936 Canada Inc.

LOP21-018A

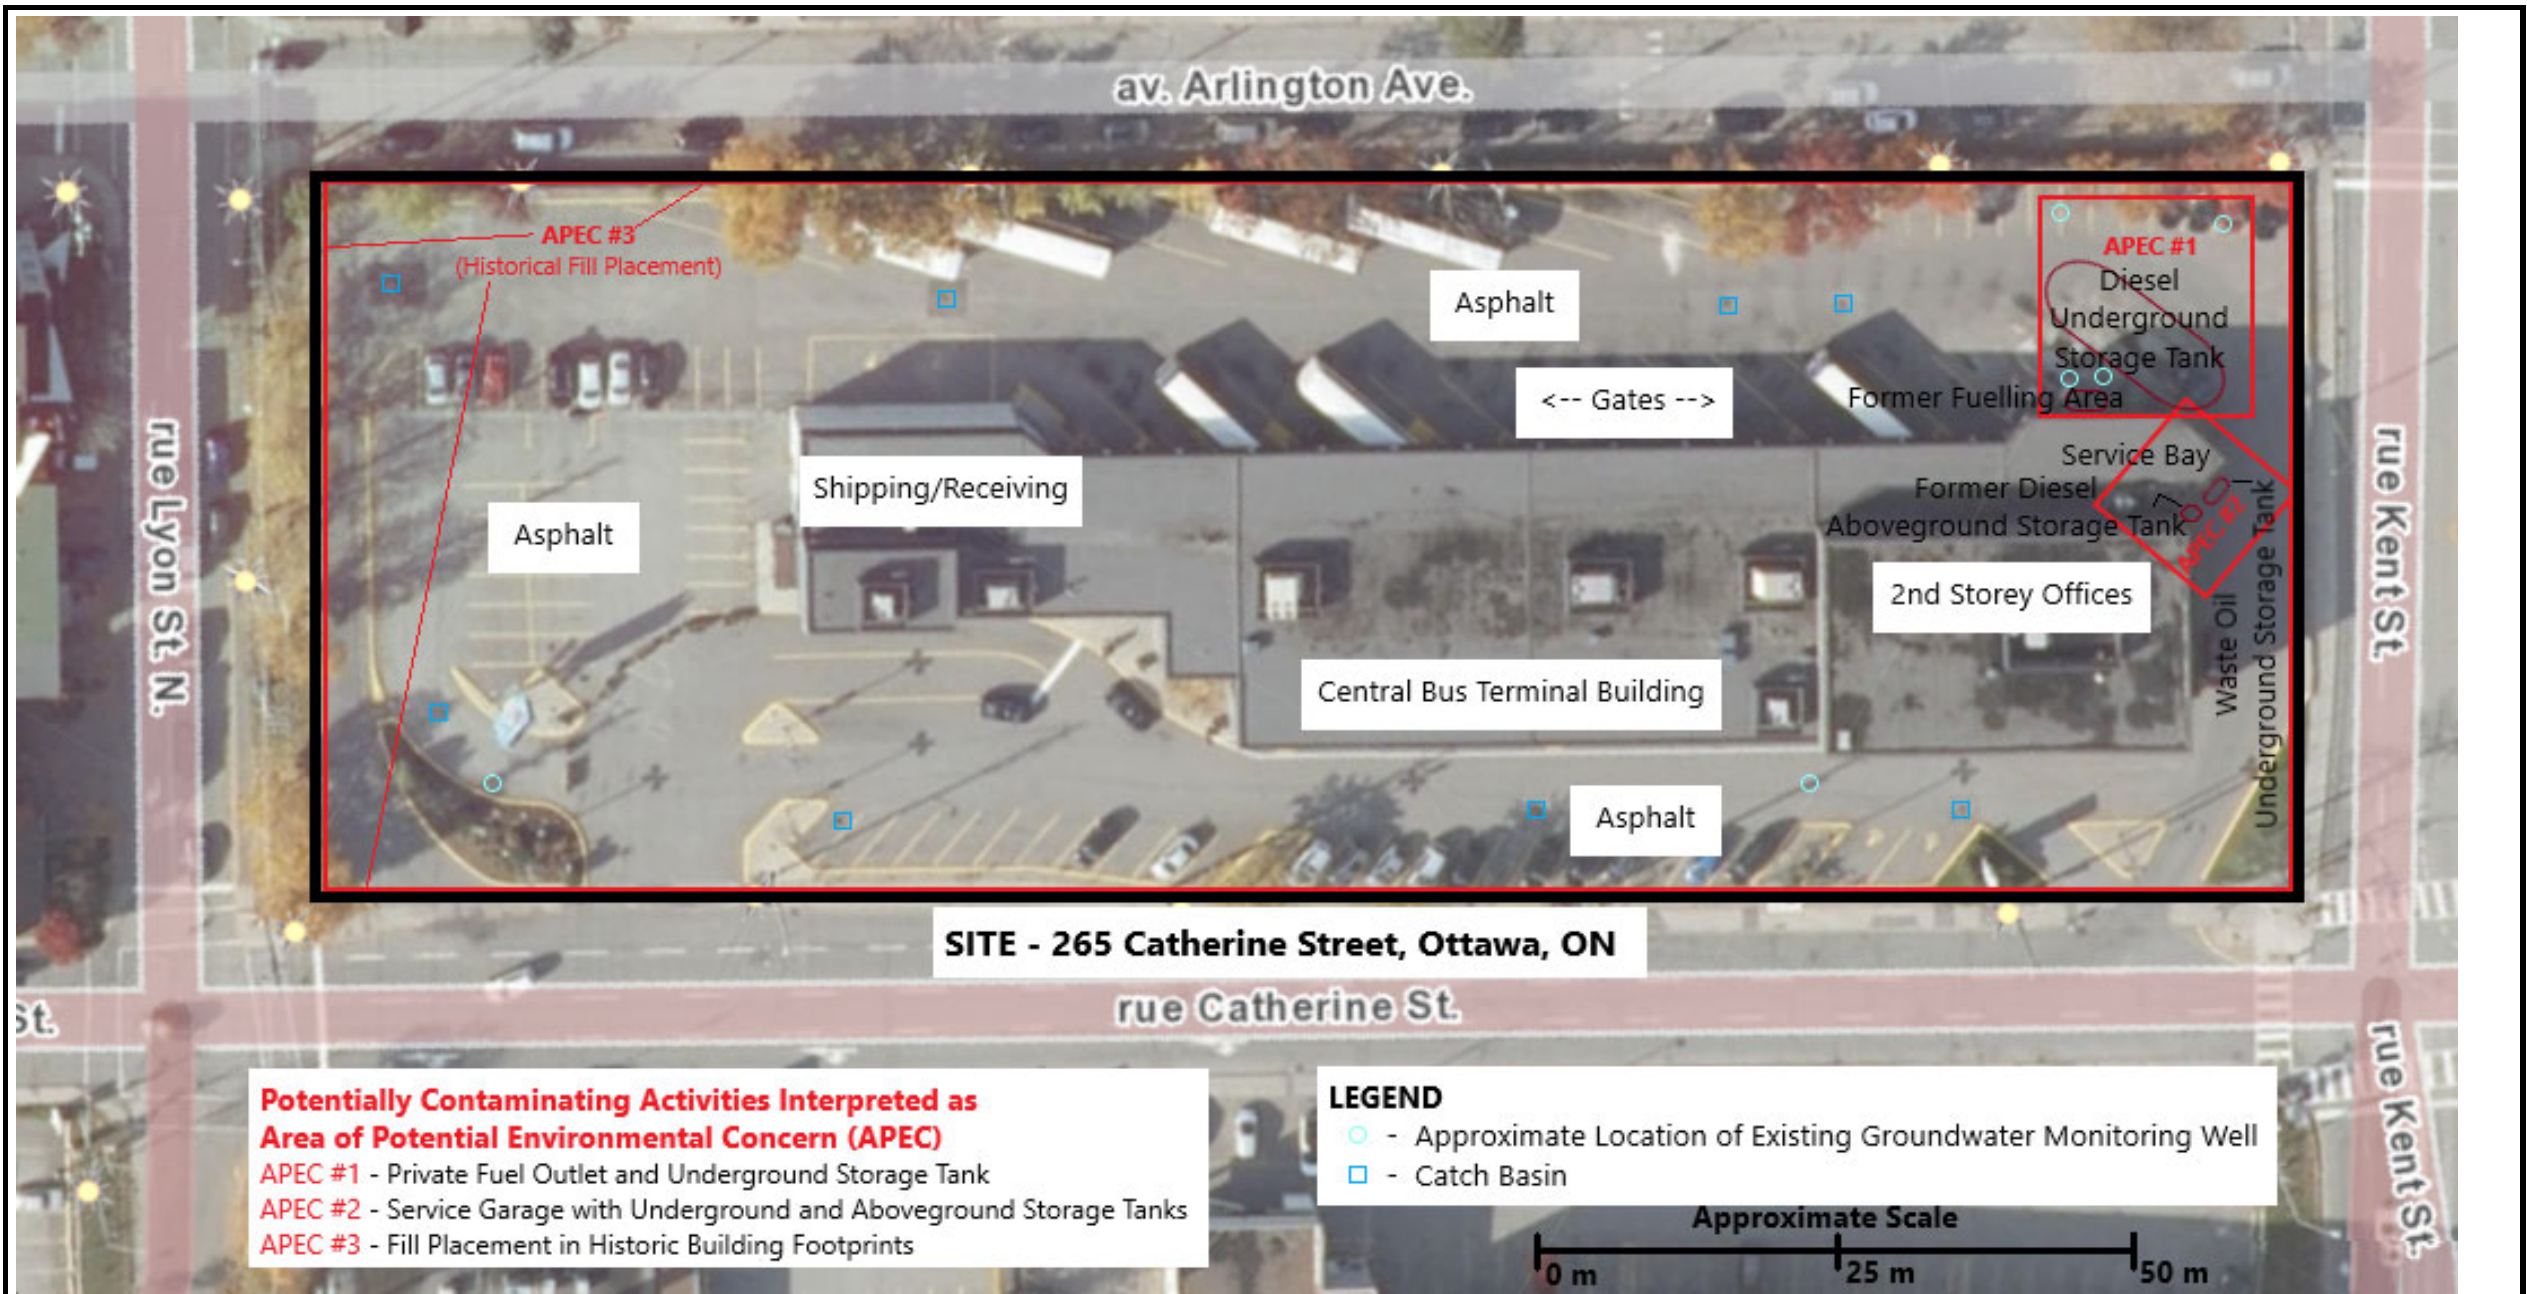
**Figure 1: Key Plan**  
 Phase One Environmental Site Assessment  
 265 Catherine Street, Ottawa, Ontario  
 11034936 Canada Inc.

Project Reference No: LOP21-018A  
 Drawing No.: LOP21-018A-1  
 Date: August 20, 2021  
 Author: L. Lopers  
 Source: geoOttawa

Three Figures are provided to visually depict the Conceptual Site Model. Figure 1: Key Plan shows the location of the Phase One Property within the City of Ottawa. Figure 2: Site Plan, which is provided with an overlay of the 2019 aerial imagery, which depicts the current configuration of the Phase One Property, the locations of historical monitoring wells, PCAs and APECs. Figure 3: Surrounding Land Use shows the current uses of properties in the Phase One Study Area and the location of off-Site PCAs.

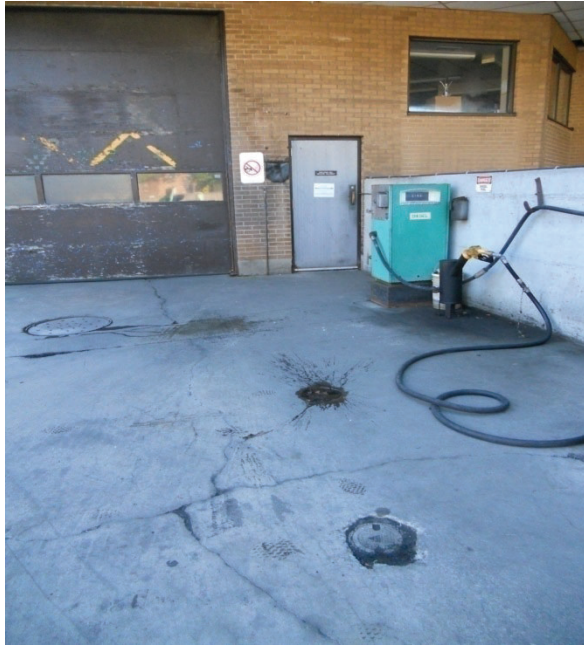
**PUMP ISLAND BEFORE INSTALLATION OF BOLLARDS AND “NO SMOKING” SIGNAGE**

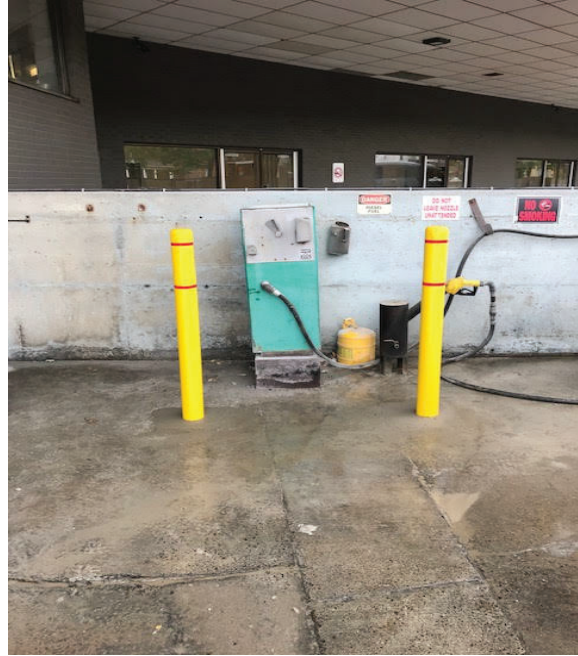
**PUMP ISLAND AFTER INSTALLATION OF BOLLARDS AND “NO SMOKING” SIGNAGE**

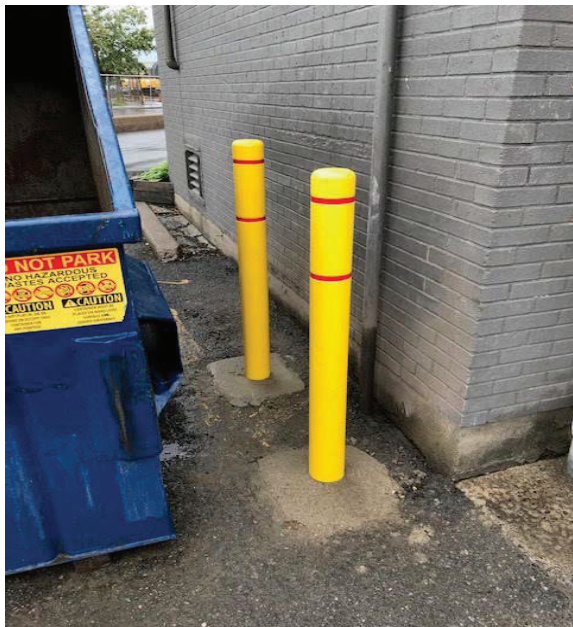
**VENT AREA AFTER INSTALLATION OF BOLLARDS**

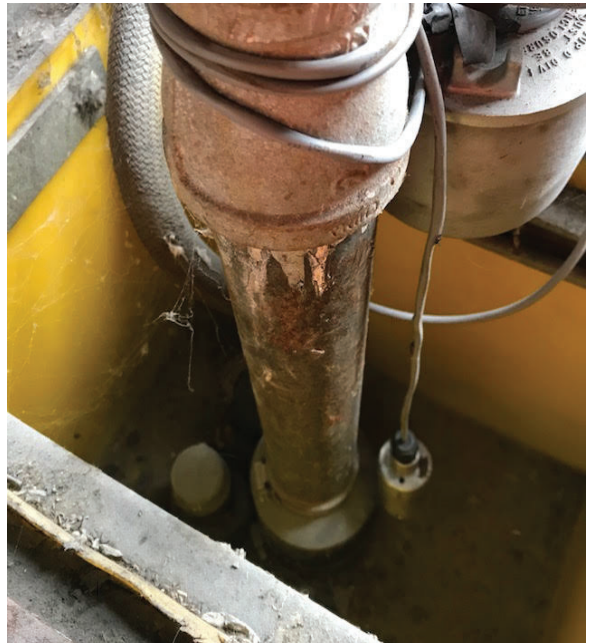
**SENSOR LOCATED BENEATH DISPENSER**

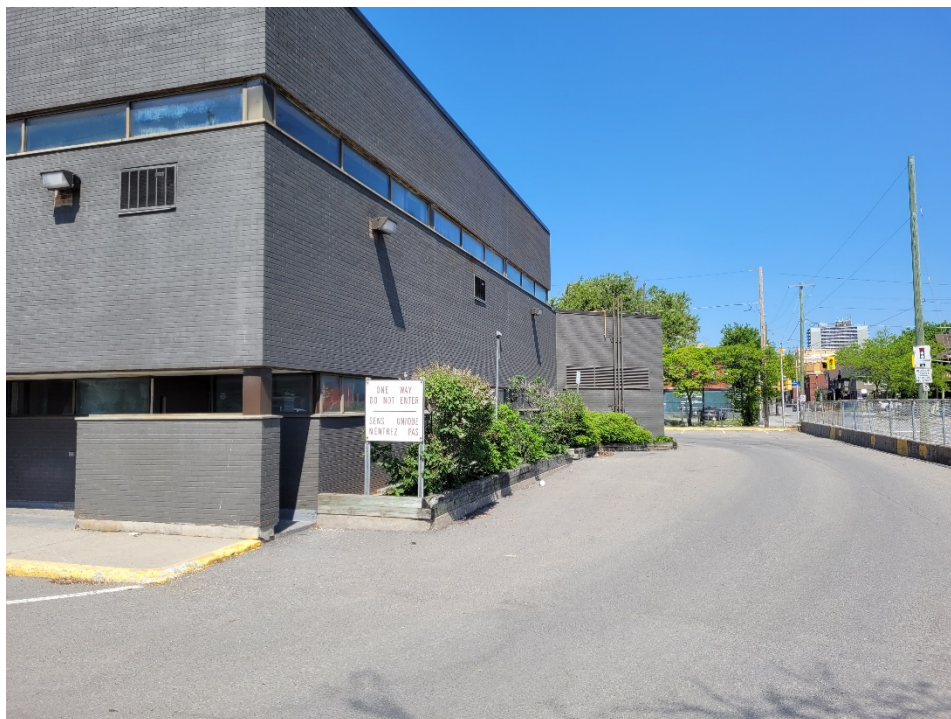
Photograph 2: View of Phase One Property looking north from the southeast corner of the Property. View shows the vent pipes associate with a former aboveground fuel storage tank and an underground waste oil storage tank, associated with the service garage on the east portion of the Property.

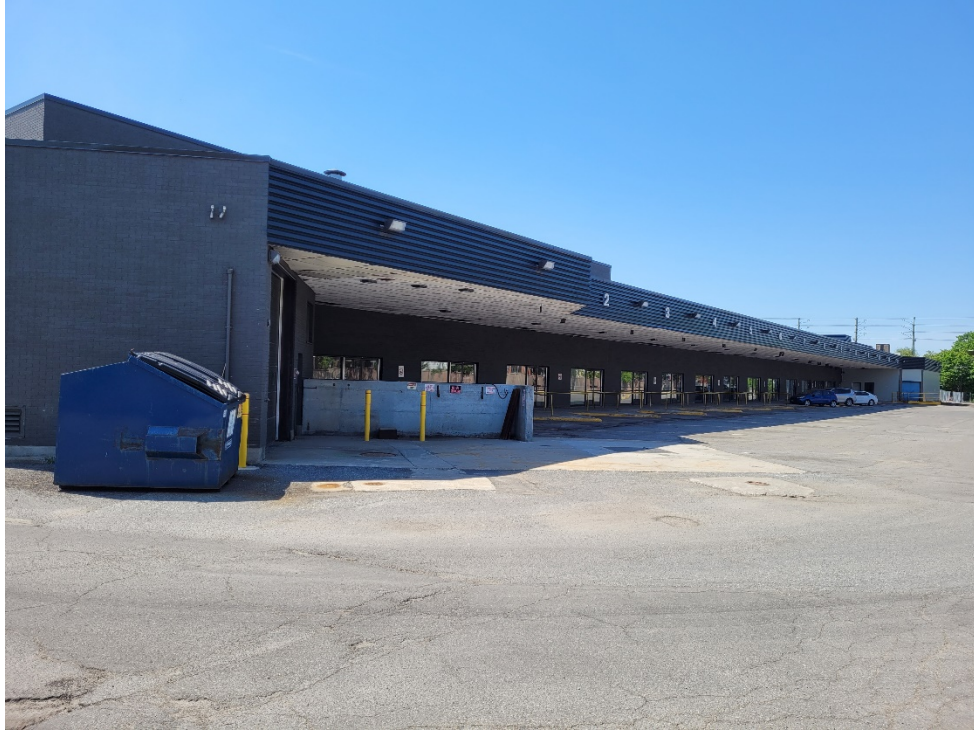
Photograph 3: View of the north side of the Phase One Property looking west. View shows the terminals for the former central bus station. The diesel underground storage tank and former fueling area is visible in this photograph.

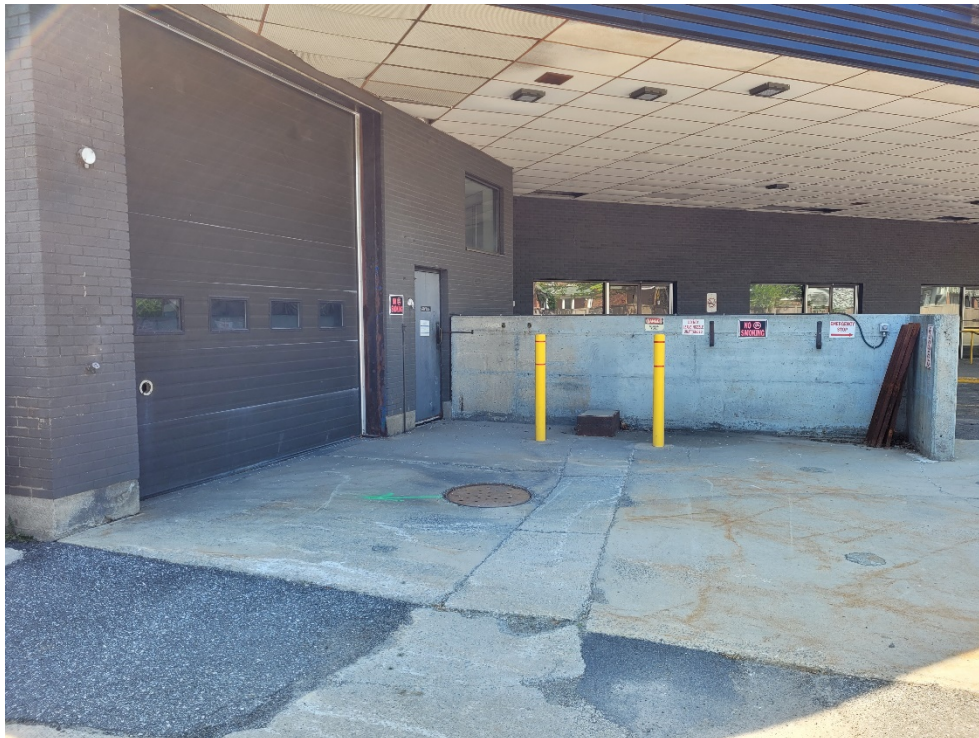
Photograph 4: View of the service garage entrance and former fueling area at the Property.

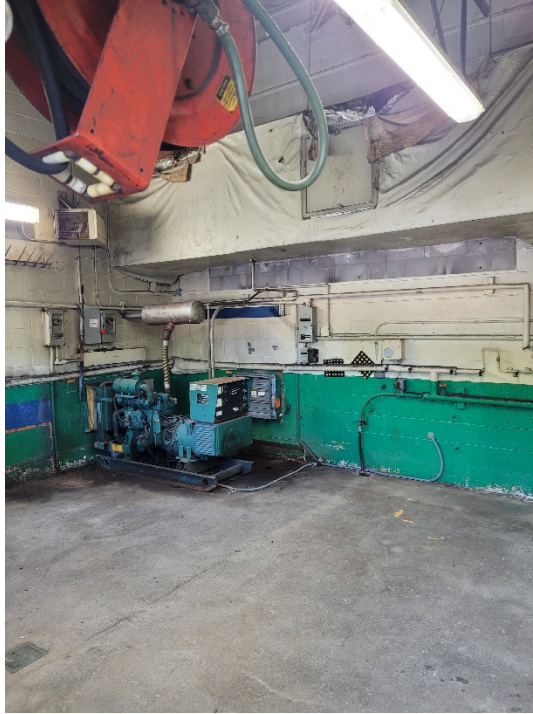
A service/garage bay was present in the northeast portion of the building. The service bay was reportedly most recently used for cleaning and washing of buses, however, historic maintenance and repair operations are evident. There was a 2-stage oil/water separator in the service bay, which was approximately 1.2 m by 1.2 m; the separator was filled with an oily water mixture, so a depth was not determined. A diesel fuelled generator was present on the interior of the service bay; based on its condition, this generator had not been in operation in several years. A former AST, historically used to store fuel for the generator, was reported to have been present to the

Photograph 5: View of the interior of the service bay, on the east portion of the Property. The diesel generator is visible in this photograph.

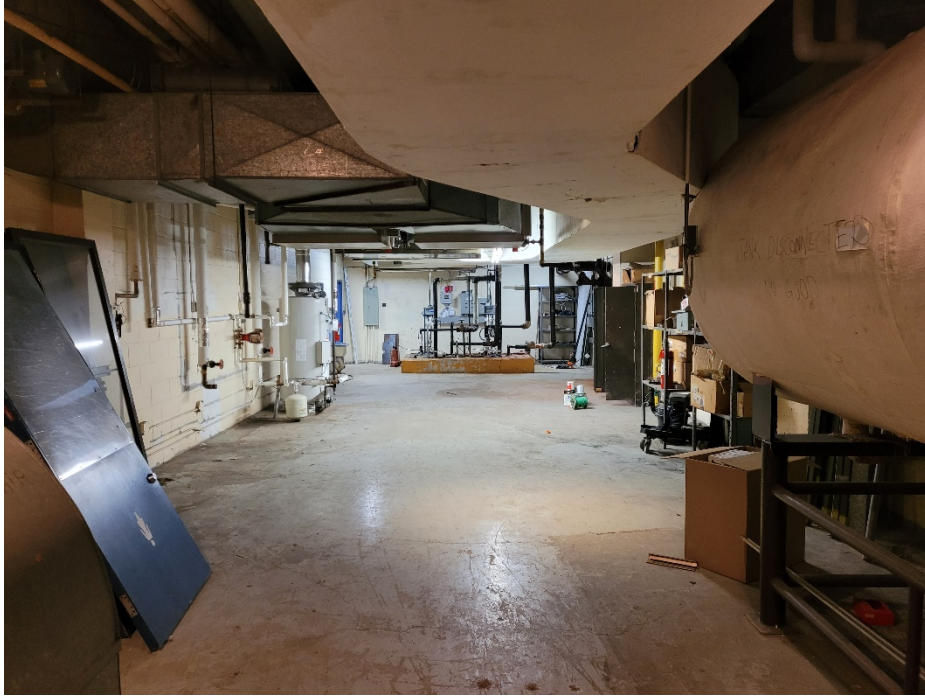
A sump was identified in the northeast portion of the basement of the building. The sump extended approximately 1.8 m below the floor slab and had some standing water at the time of the Site Investigation. There were no odours or sheen observed on the water in the sump, which discharges to the municipal sanitary sewer system.

Photograph 7: View of the basement level mechanical room in the east portion of the building. The sump is visible at the rear wall in this photograph.

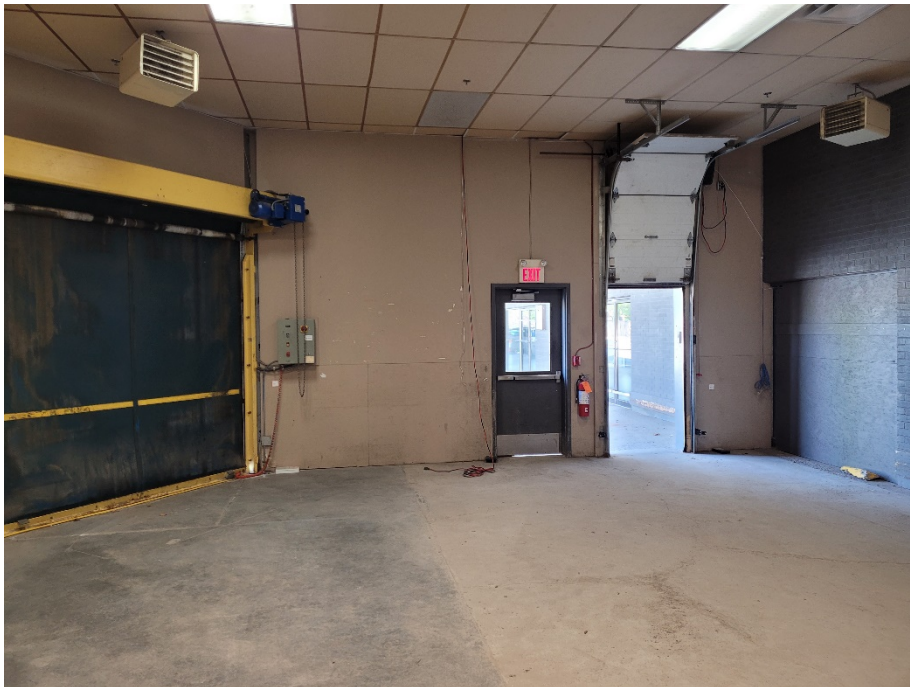
Photograph 8: View of interior of the shipping and receiving area in the northwest portion of the Site building.
