Phase I Environmental Site Assessment

1815 Montreal Road
Ottawa, Ontario

Report: PE6021-1
April 19, 2023

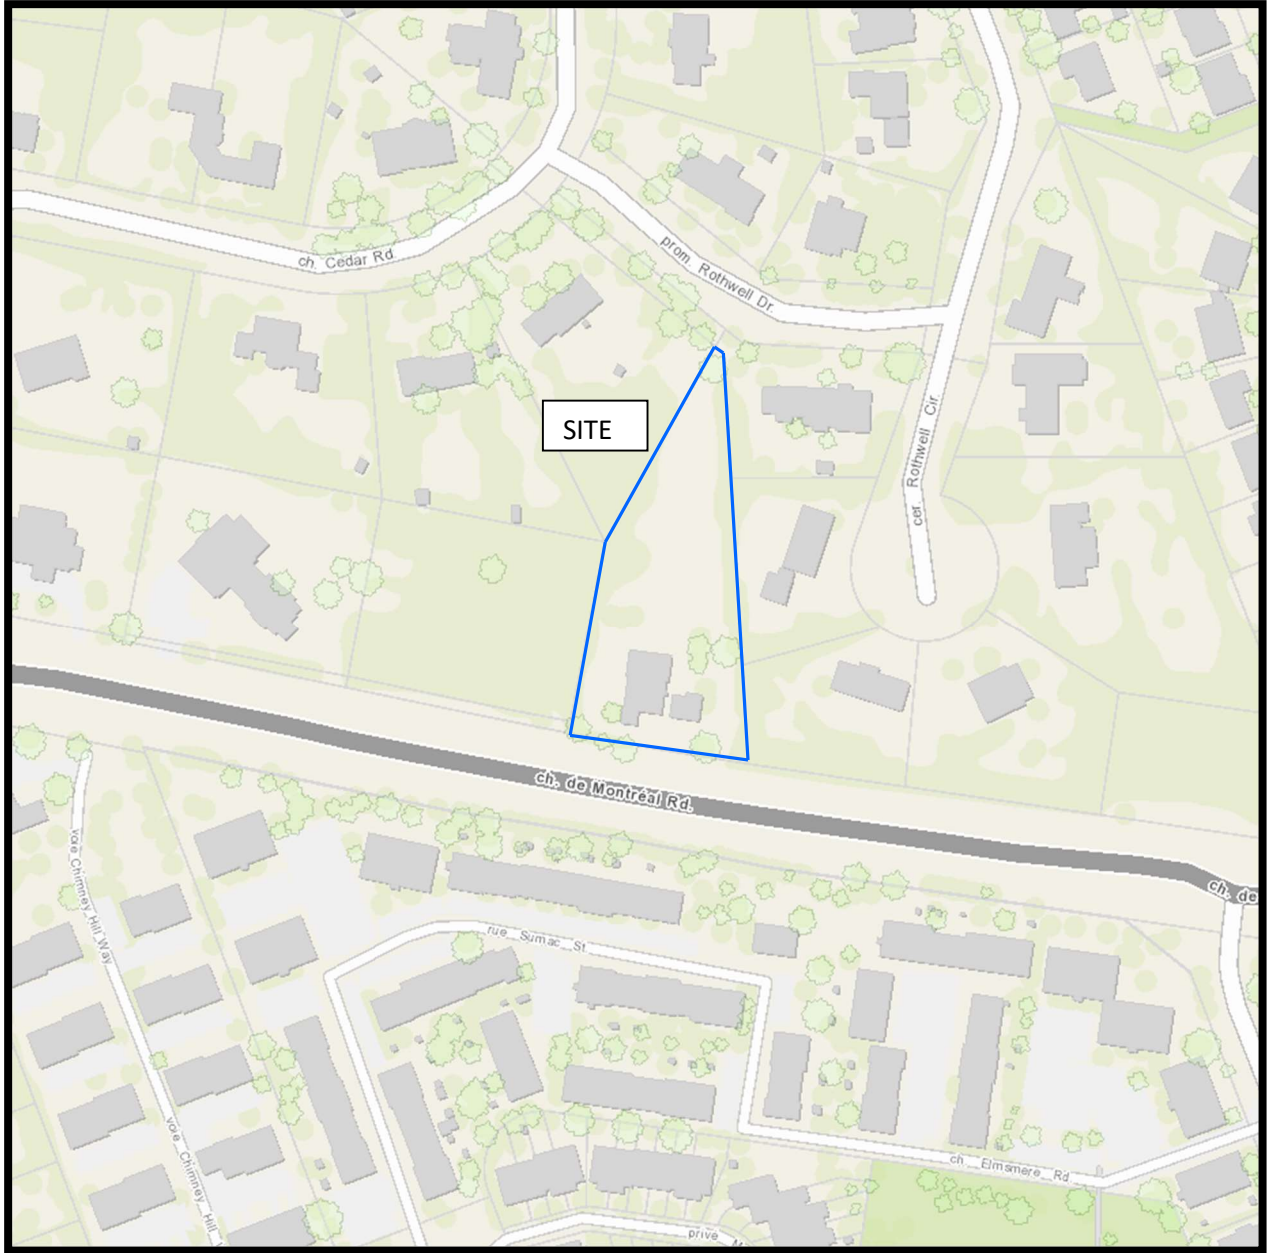
FIGURE 1
KEY PLAN

Address:	1815 Montreal Road, Ottawa, Ontario
Legal Description:	Lot 141, Registered Plan 652; City of Ottawa.
Location:	The site is located on the north side of Montreal Road, east of Beckenham Lane, in the City of Ottawa, Ontario. Refer to Figure 1 - Key Plan in the Figures section following the text.
PIN:	04375-0013
Latitude and Longitude:	45° 26' 45.86" N, 75° 36' 20.67" W

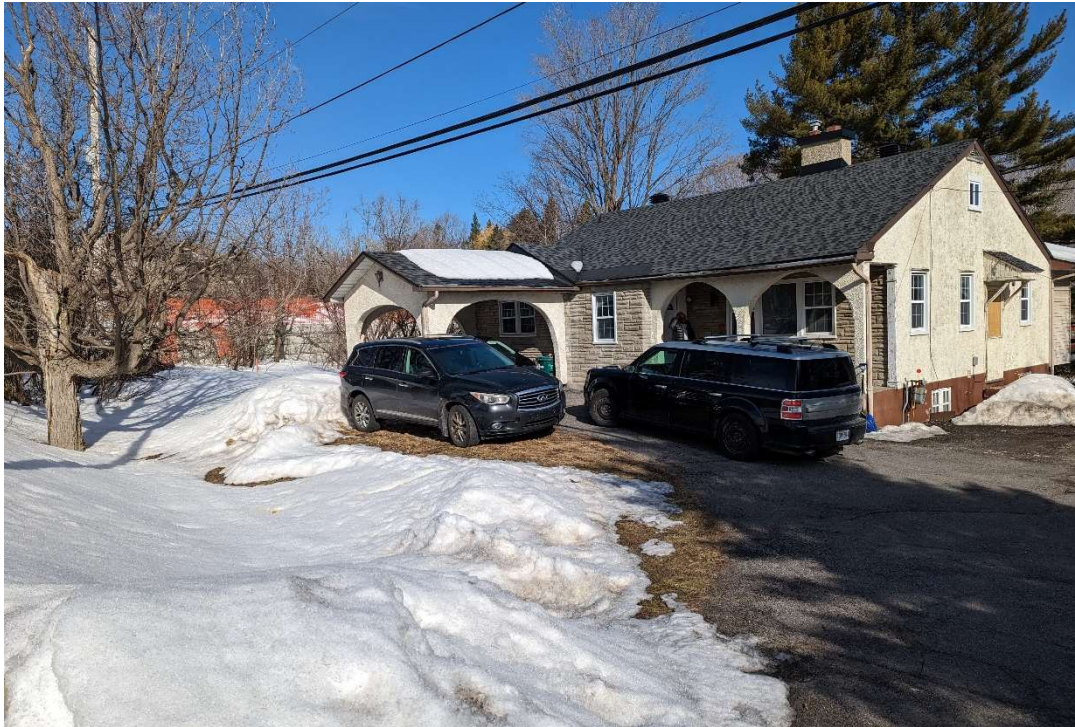
Photograph 1: View of 1815 Montreal Road from the roadway, looking northwest.

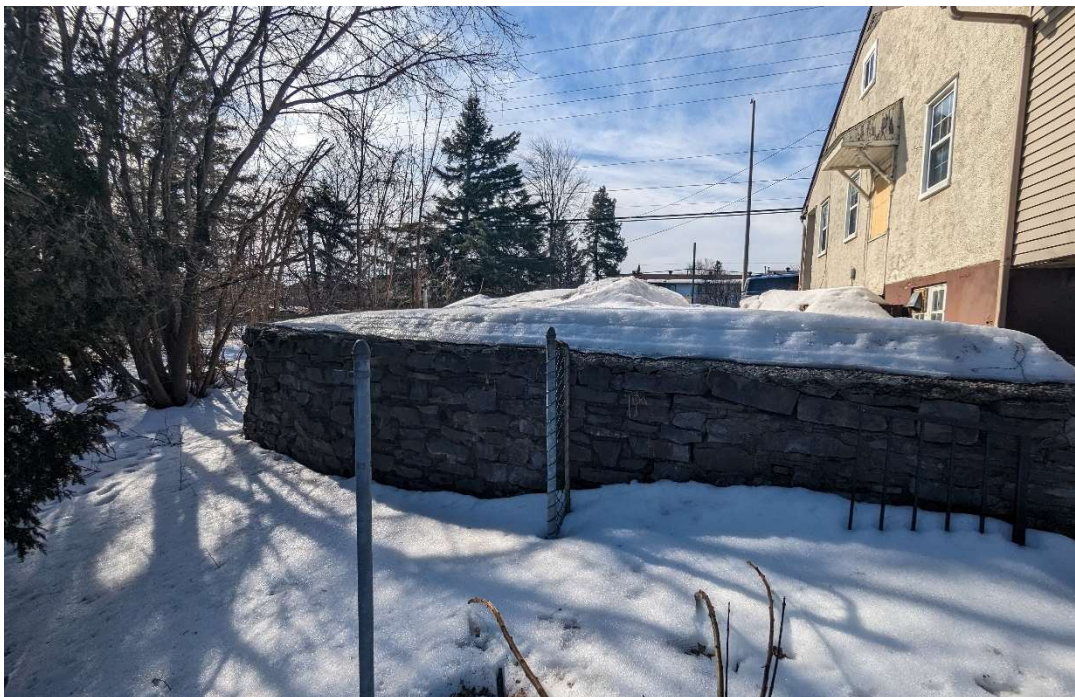
No imported fill is suspected on the Phase I Property. Based on the observed slope of the site, engineered fill material is likely present on the south-eastern portion of the Phase I Property in the area supported by the retaining wall near the former private garage.

Photograph 2: View of retaining wall north of former private garage, looking south.

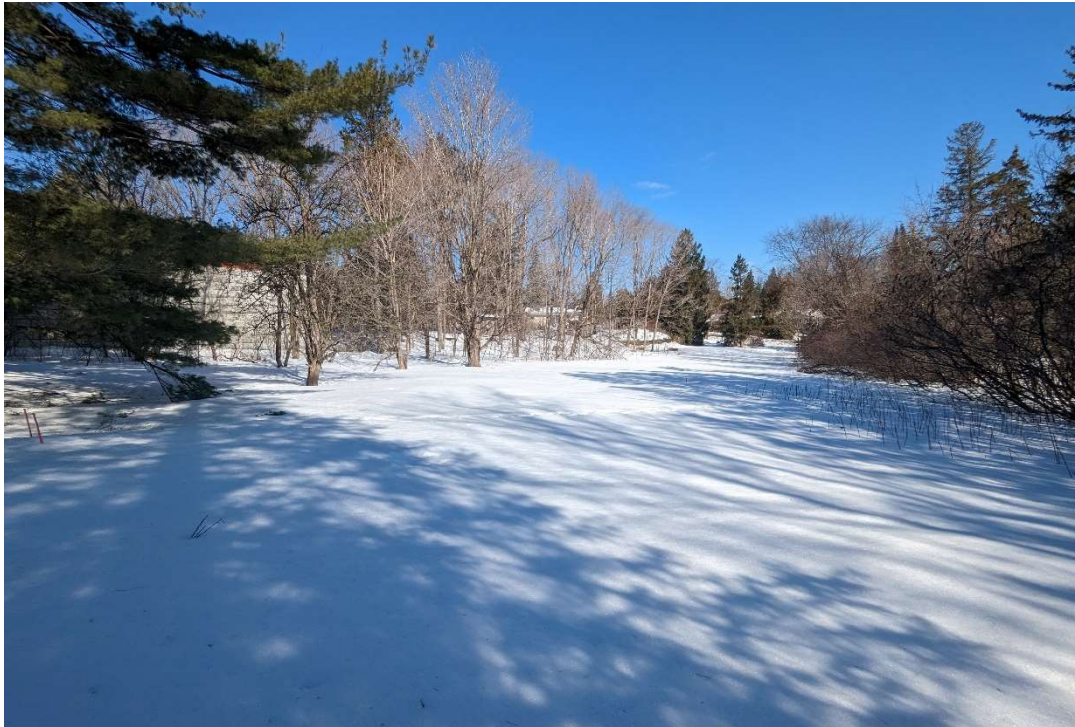
Photograph 3: View of northern portion of the Phase I Property, looking north.

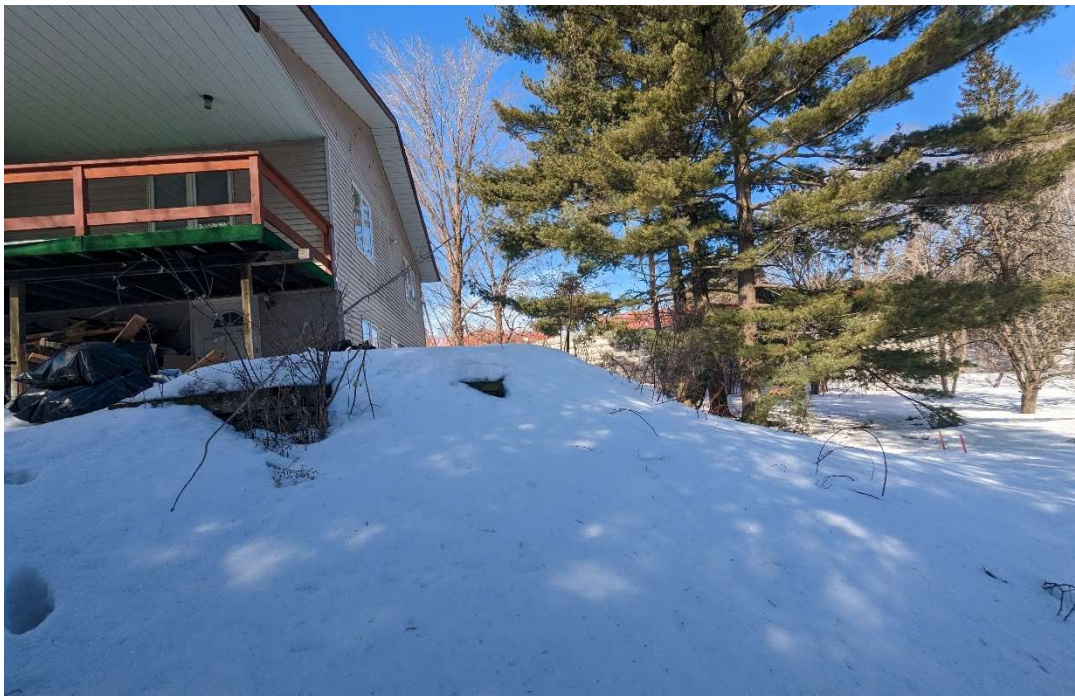
Following the historical research, a site visit was conducted. The Phase I ESA Property is currently occupied by a residential dwelling. The foundation of the former on-site private garage is present, along with the demolition debris. No PCAs were identified on the Phase I ESA Property.

Photograph 4: Rear of building, looking west. Construction debris visible below the deck.

As the demolition debris from the former private garage was observed on-site during the site visit, it is recommended that the debris be removed and transported to an approved waste facility.

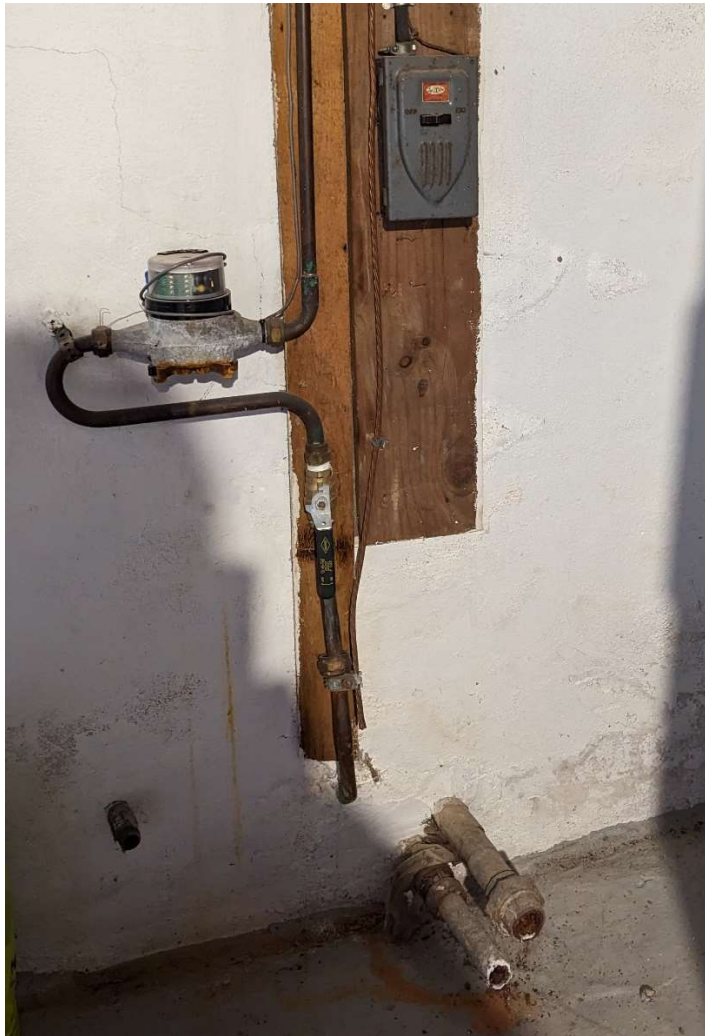
Pipes were observed on the interior of an exterior wall in the basement of the building (southwest corner), though there was no evidence of them on the exterior of the building. These pipes are located near the water line and hot water tank and, although they could have been associated with a former fuel oil tank, given the location and position of the pipes as well as evidence of staining caused by oxidation, it is likely that these are the original water lines associated with a former domestic well. There were no other indications of fuel or chemical storage in the building.

Photograph 5: Original pipes and water meter in basement.

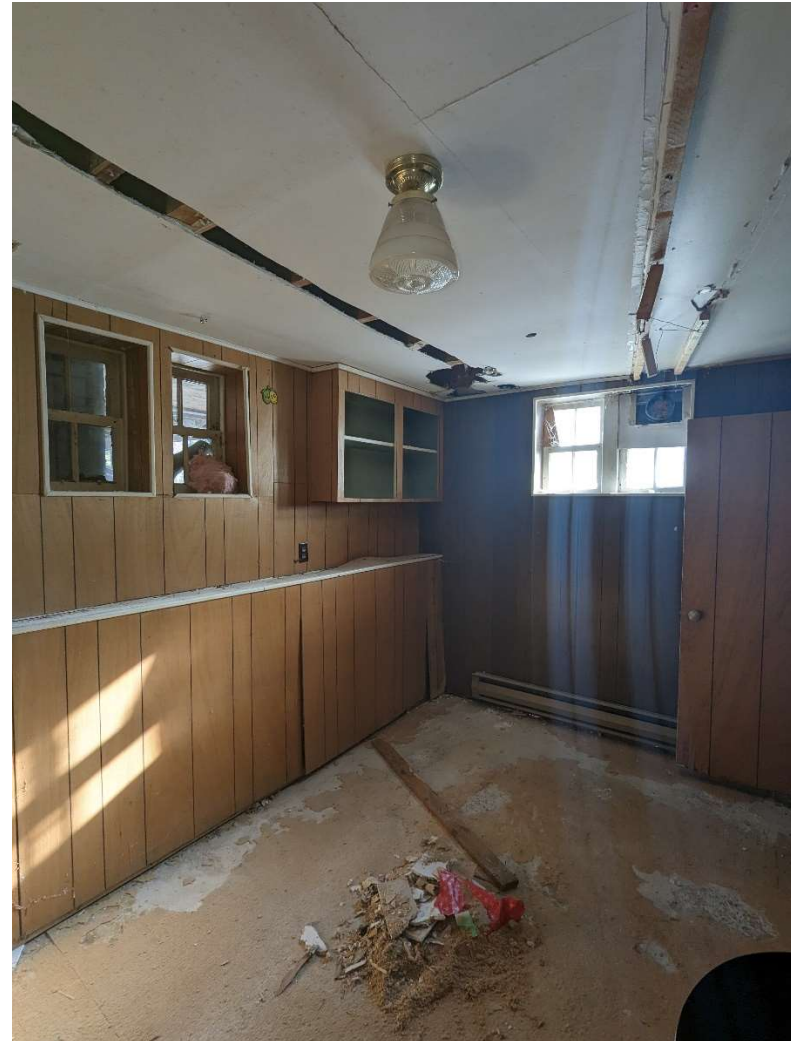
A general assessment of the building's interior noted that the floors were finished with a combination of hardwood, ceramic tiles, concrete, and laminate flooring. Carpet was also observed on the stairs. The walls generally consisted of painted drywall, although wood panelling as well as ceramic tiles were also observed. The ceilings were painted drywall. Ceilings also had a stipple finish in some areas. The observed lighting was provided primarily by LEDs in areas that have recently been renovated. Some incandescent fixtures are still present in some areas of the basement that have not been recently renovated. The house is heated by a natural gas-fired furnace as well as electric baseboard heaters in the basement. A fireplace is present in the main floor living room. There are 2 attic spaces: one associated with the original residential dwelling and one associated with the addition at the rear.

Photograph 6: Unrenovated room in basement.
