Phase One Environmental Site Assessment 7-9 Hilliard Avenue, Ottawa, Ontario

780 Baseline Inc.

OTT-21011499-E0

June 29, 2023

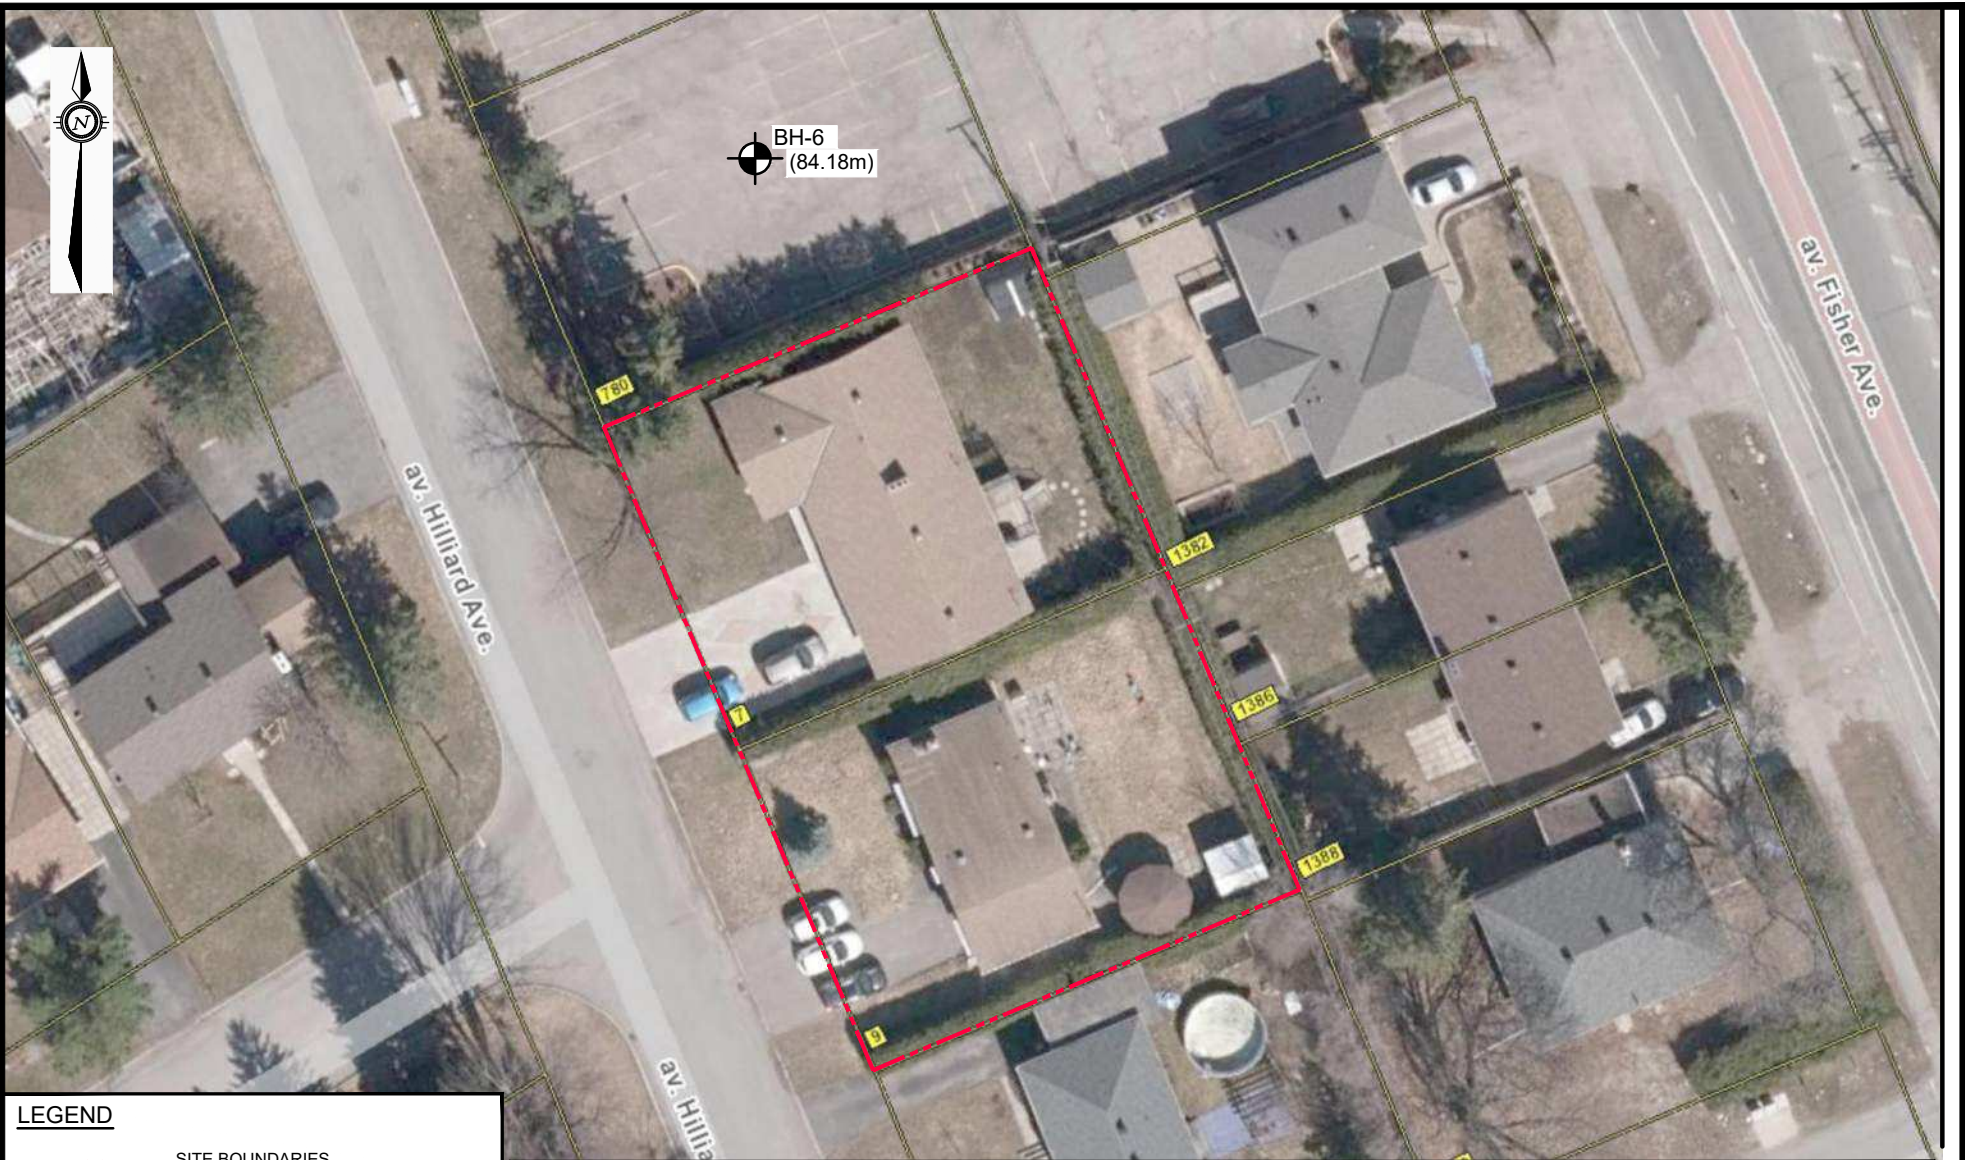
<small>DATE</small> JUNE 2023	PROPOSED MULTI-USE TOWERS 7-9 HILLIARD AVENUE, OTTAWA, ONTARIO	<small>project no.</small> OTT-21011499-E0
<small>DESIGN</small> LW	<small>CHECKED</small> MM	<small>scale</small> 1:500
<small>DRAWN BY</small> AS	PHASE ONE ENVIRONMENTAL SITE ASSESSMENT BOREHOLE / MONITORING WELL LOCATION PLAN	FIG 2

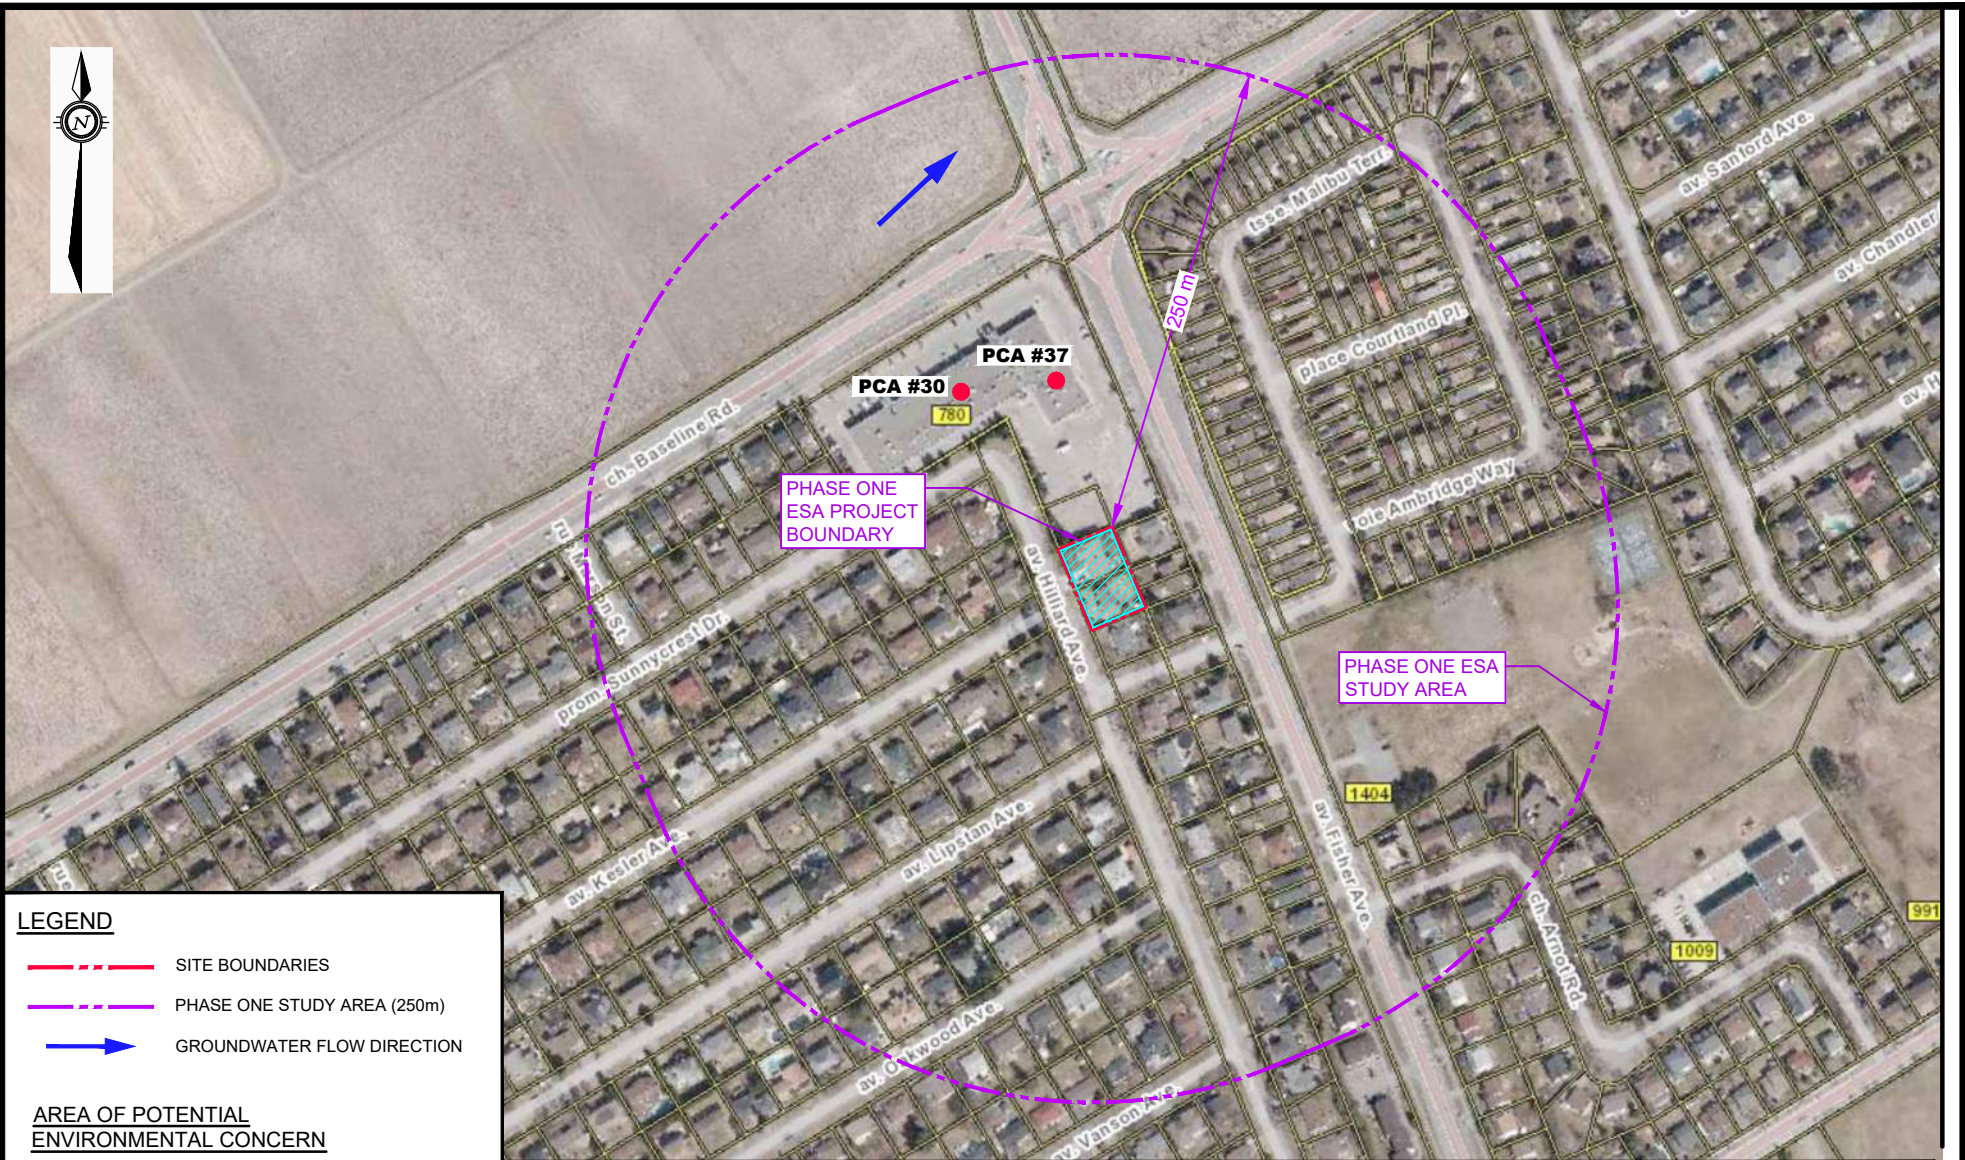
- AREA OF POTENTIAL ENVIRONMENTAL CONCERN**
- APEC #1 - PCA #30 IMPORTED ALL MATERIAL OF UNKNOWN QUALITY (ENTIRE SITE)
 - APEC #2 - PCA #37 OPERATION OF DRY CLEANING EQUIPMENT
 - PCA #30 POTENTIALLY CONTAMINATING ACTIVITY (PCA)

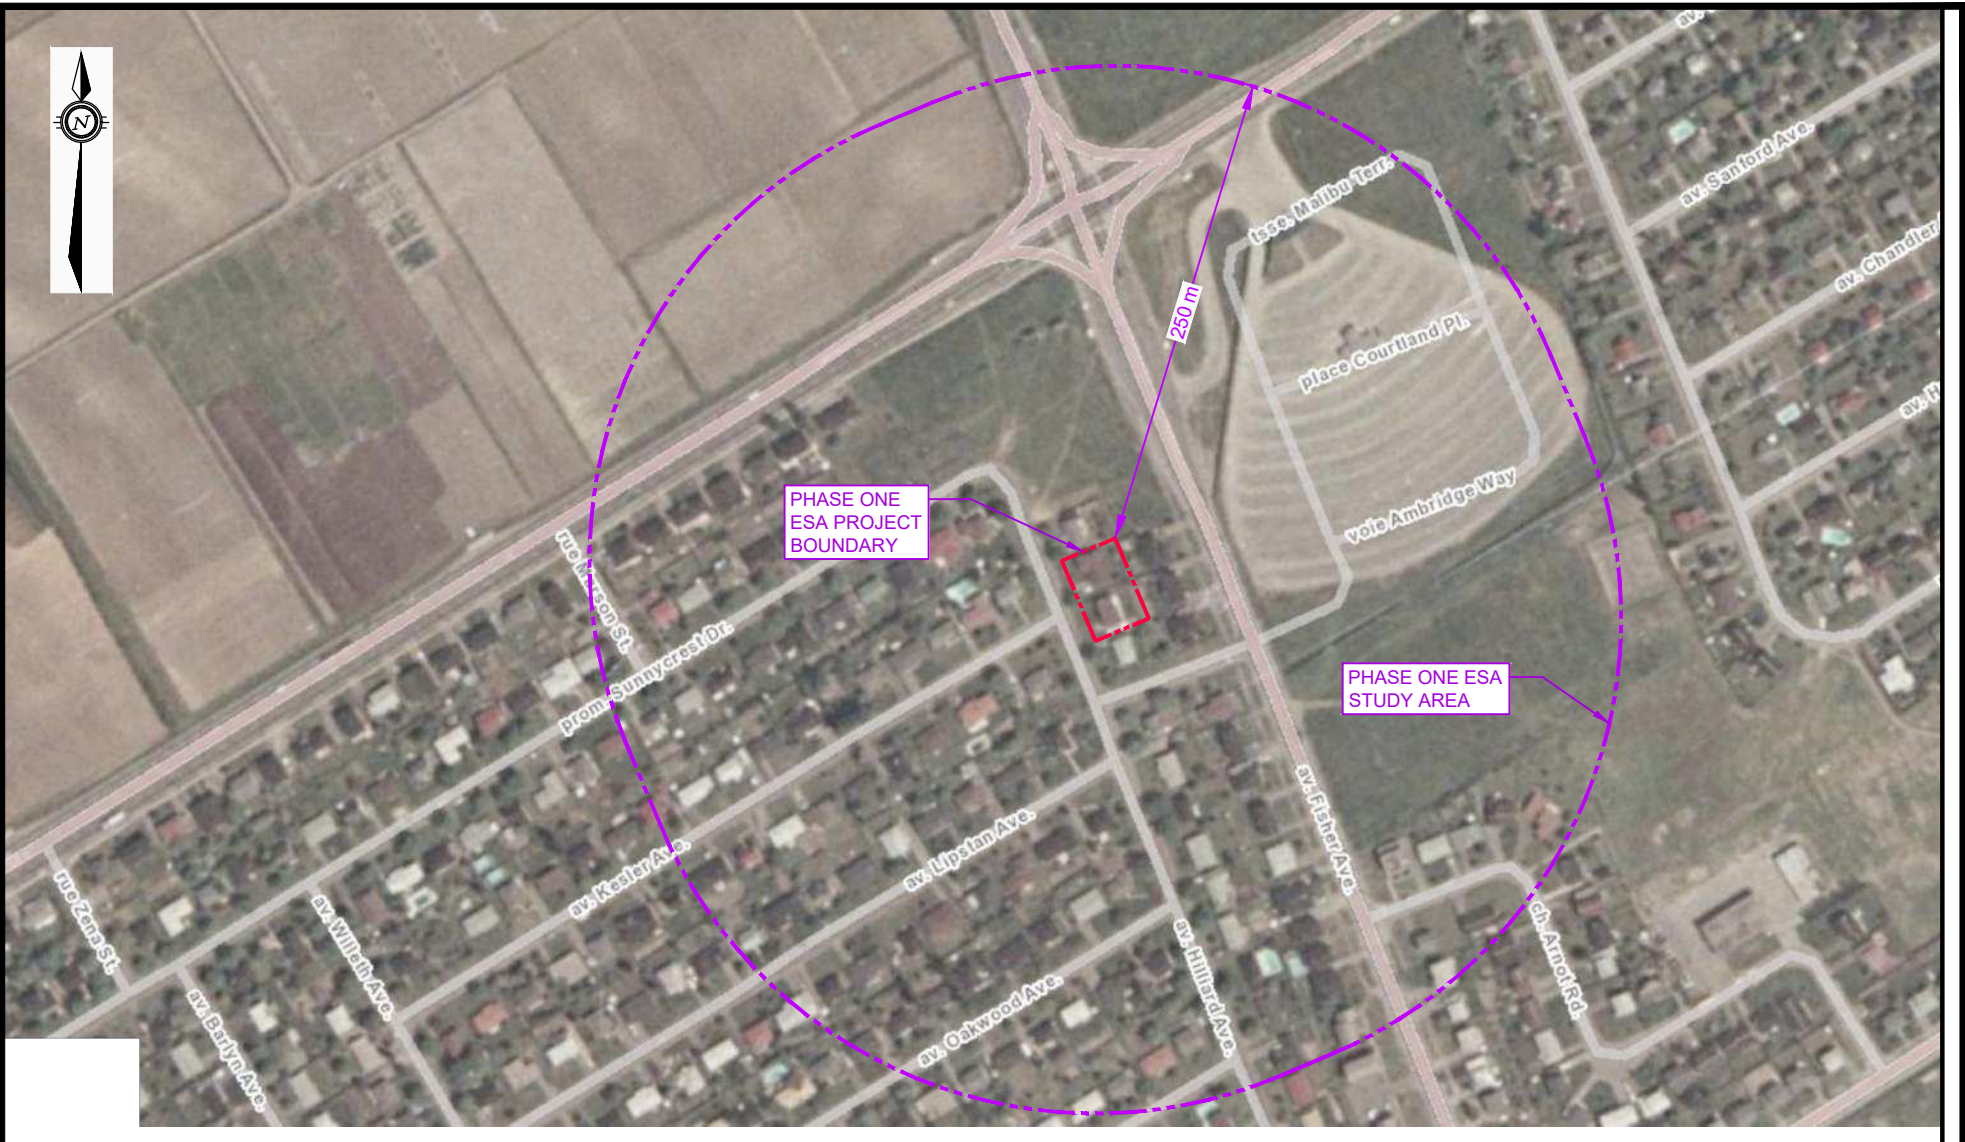
DATE JUNE 2023		PROPOSED MULTI-USE TOWERS 7-9 HILLIARD AVENUE, OTTAWA, ONTARIO	project no. OTT-21011499-E0
DESIGN LW	CHECKED MM		scale 1:4,000
DRAWN BY AS		PHASE ONE ENVIRONMENTAL SITE ASSESSMENT 1976 AERIAL PHOTOGRAPH	FIG E-2

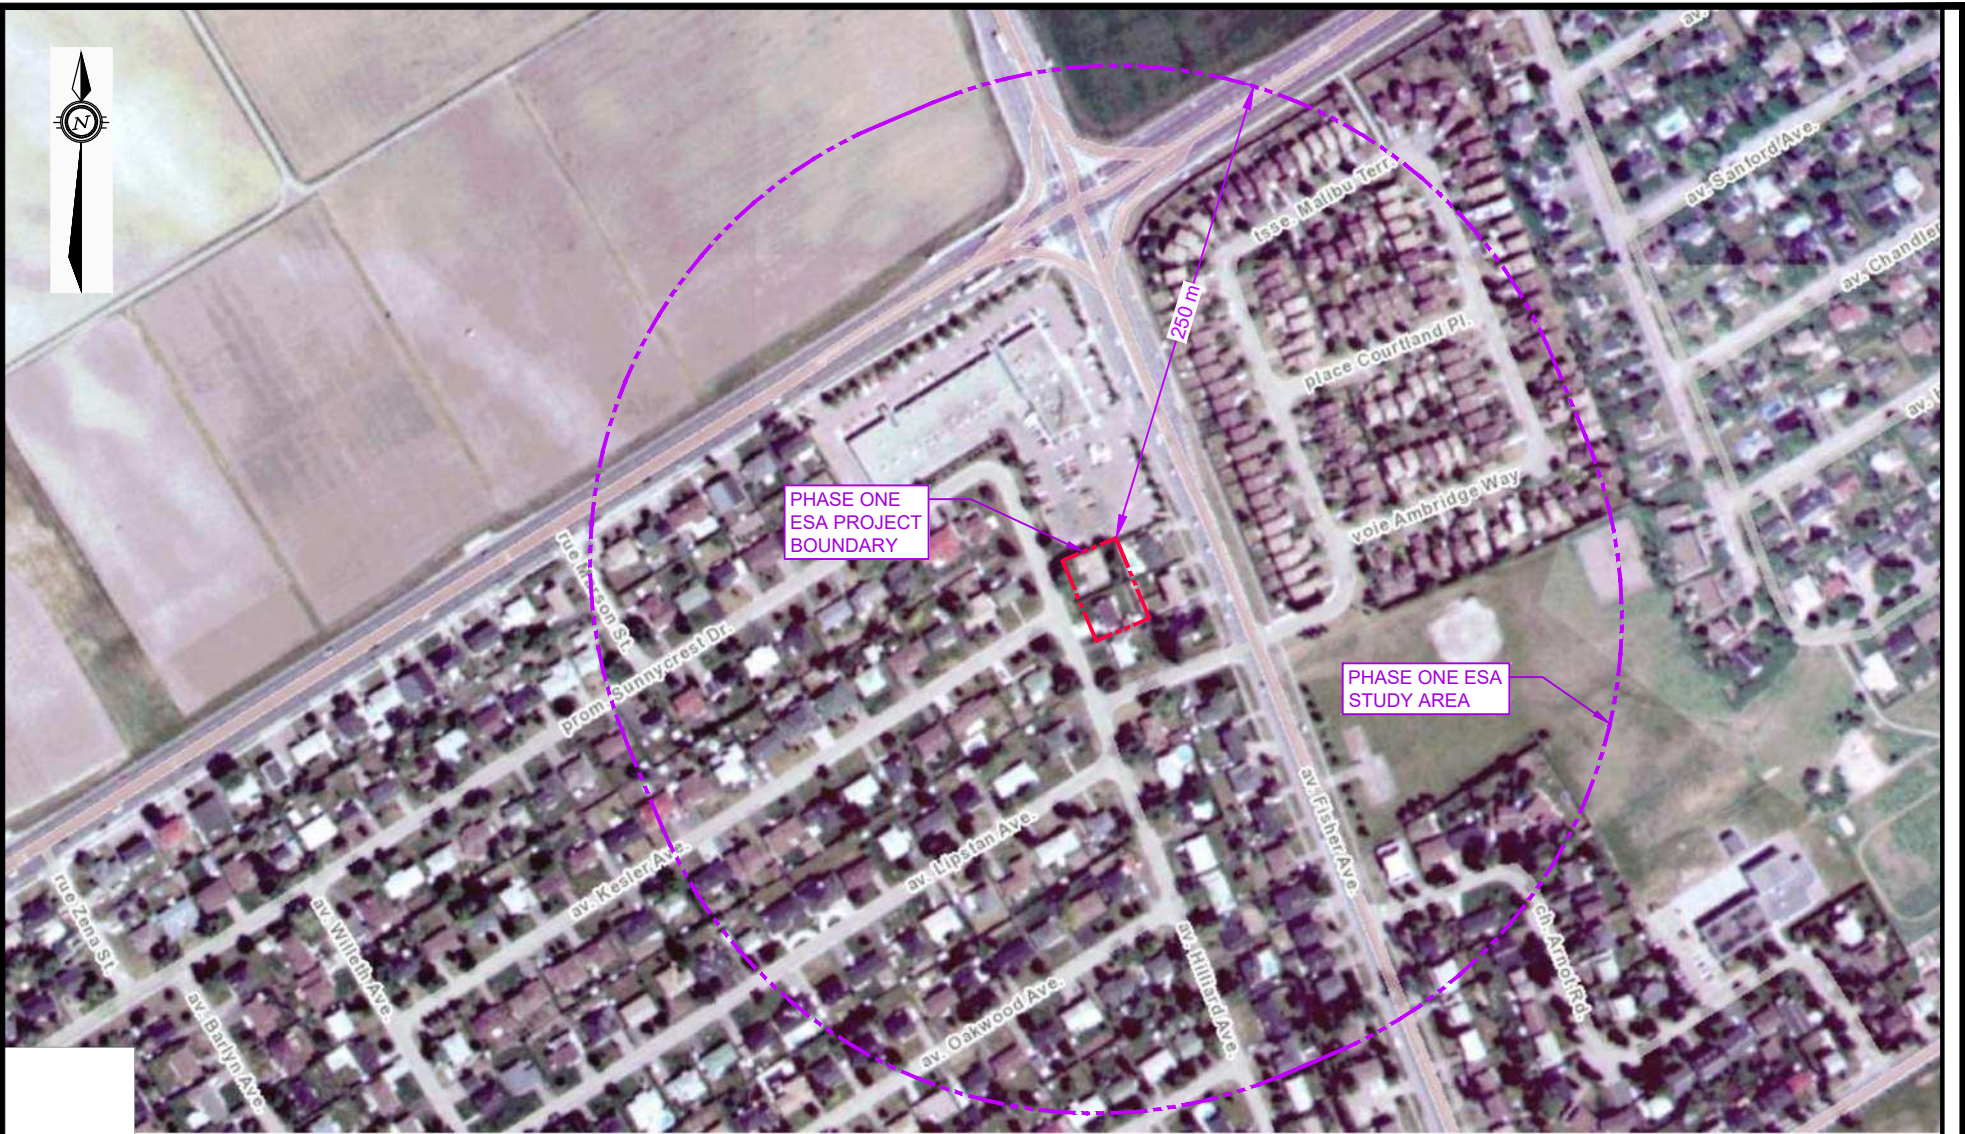
DATE JUNE 2023		PROPOSED MULTI-USE TOWERS 7-9 HILLIARD AVENUE, OTTAWA, ONTARIO PHASE ONE ENVIRONMENTAL SITE ASSESSMENT 1999 AERIAL PHOTOGRAPH	project no. OTT-21011499-E0
DESIGN LW	CHECKED MM		scale 1:4,000
DRAWN BY AS			FIG E-4

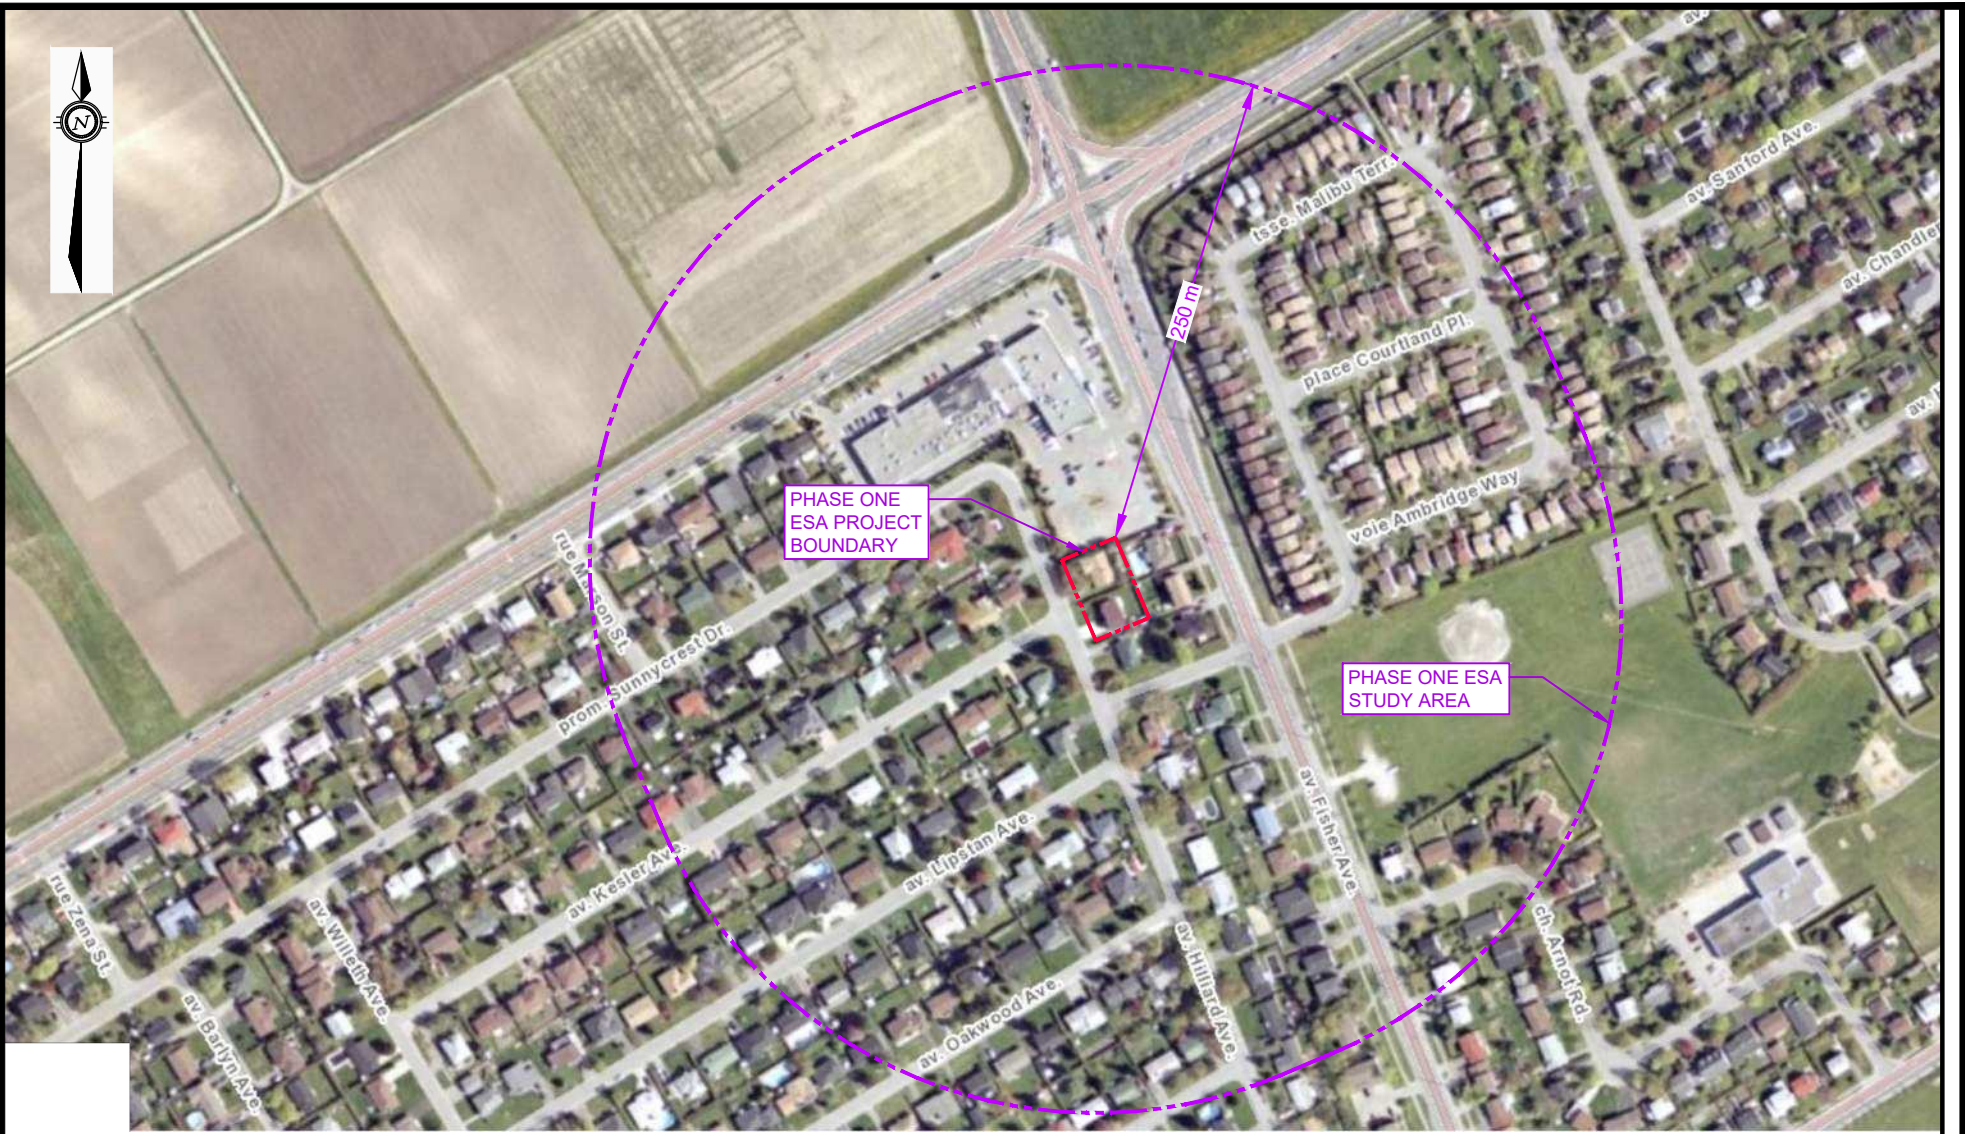
DATE JUNE 2023		PROPOSED MULTI-USE TOWERS 7-9 HILLIARD AVENUE, OTTAWA, ONTARIO	project no. OTT-21011499-E0
DESIGN LW	CHECKED MM		scale 1:4,000
DRAWN BY AS		PHASE ONE ENVIRONMENTAL SITE ASSESSMENT 2002 AERIAL PHOTOGRAPH	FIG E-5

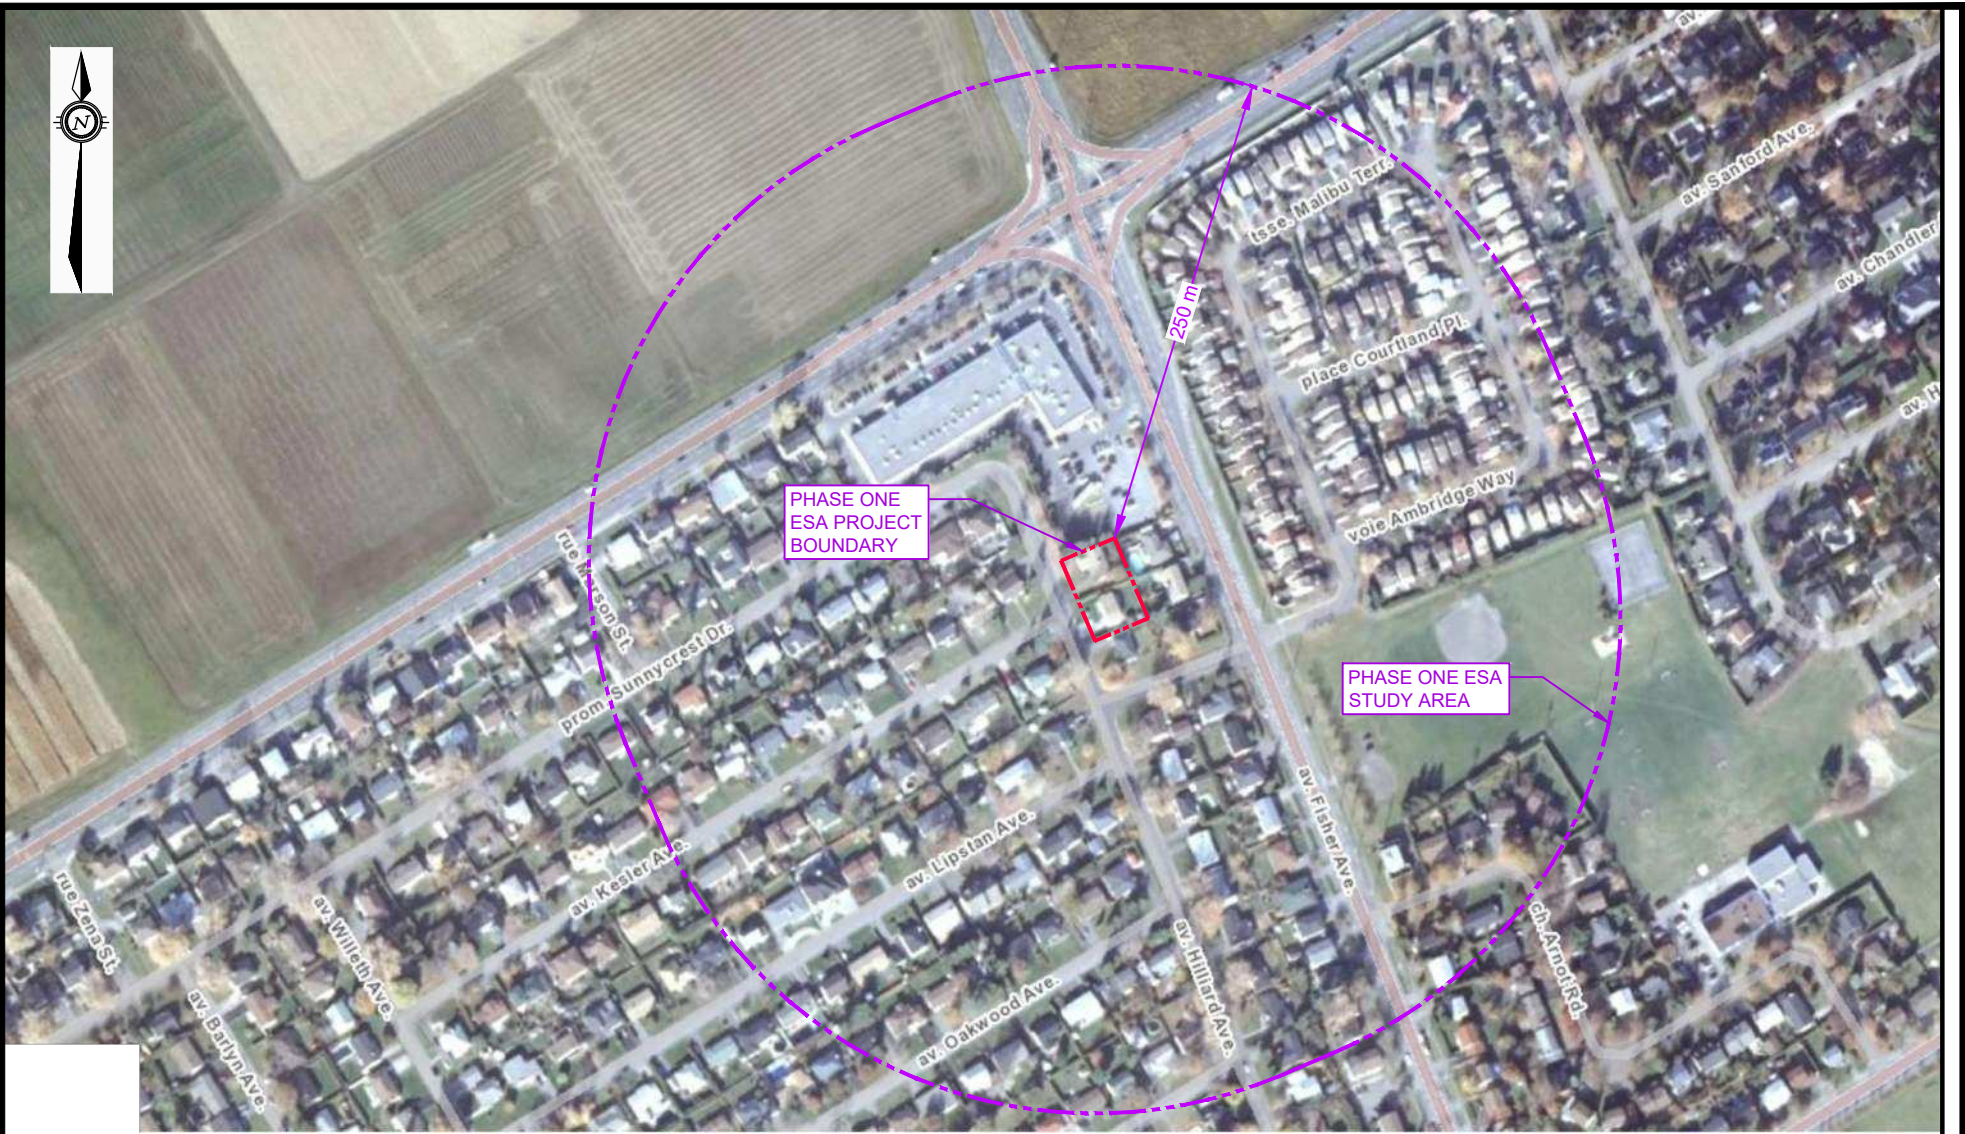
DATE JUNE 2023		PROPOSED MULTI-USE TOWERS 7-9 HILLIARD AVENUE, OTTAWA, ONTARIO PHASE ONE ENVIRONMENTAL SITE ASSESSMENT 2008 AERIAL PHOTOGRAPH	project no. OTT-21011499-E0
DESIGN LW	CHECKED MM		scale 1:4,000
DRAWN BY AS			FIG E-6

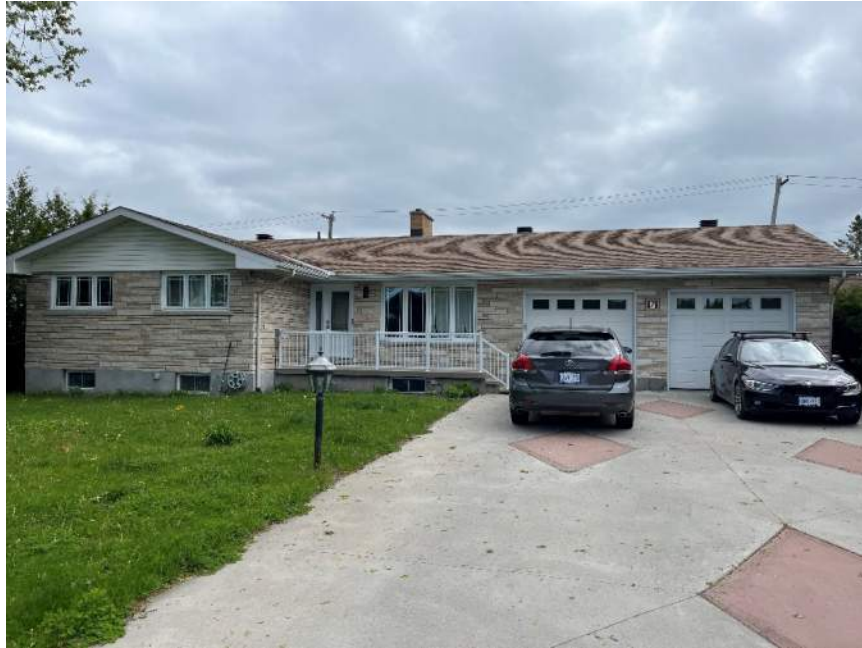
Photograph No. 1

View of the front of 7 Hilliard Avenue.

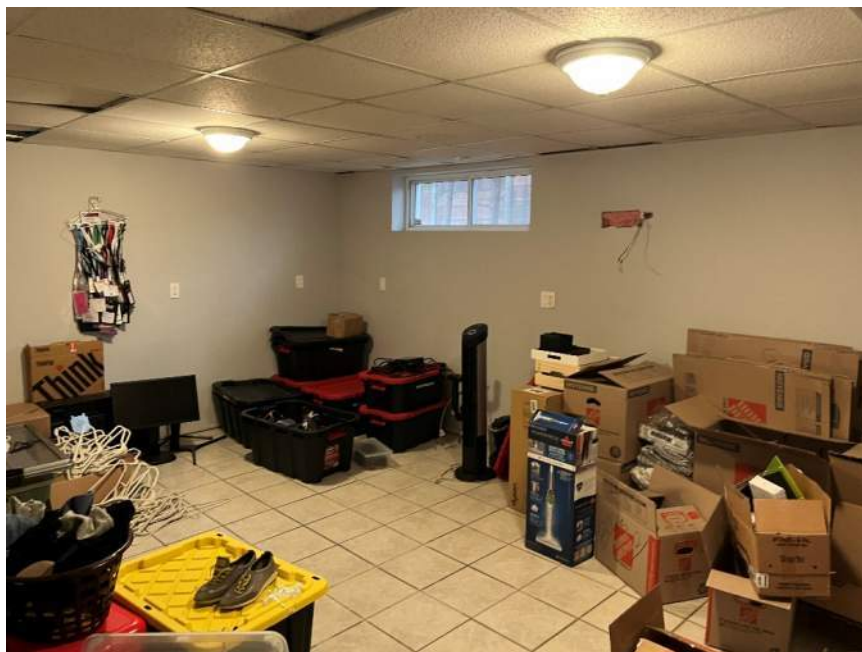
Photograph No. 2

No above ground storage tanks (ASTs) were observed at the Phase One property. It is possible based on the age of the residences that the buildings were historically heated with oil. No evidence of a former AST was observed at 7 Hilliard Avenue. A disconnected pipe, and a patched wall which may have been associated with vent/fill pipes for an AST were observed in the basement of 9 Hilliard Avenue. No staining was observed on the floor in the basement of 9 Hilliard Avenue.

View of the basement of 7 Hilliard Avenue.

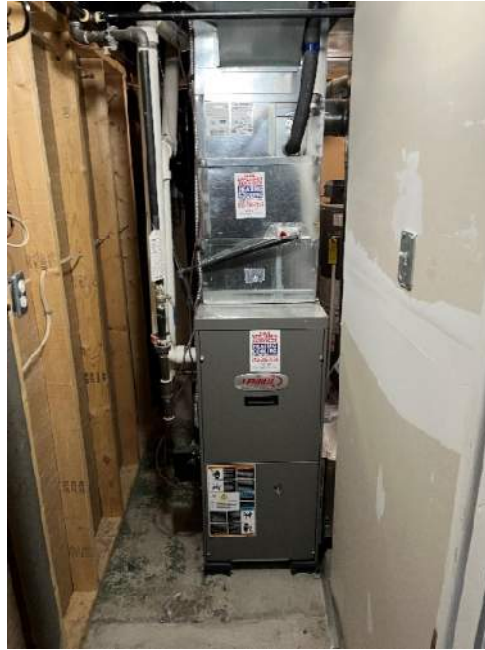
Photograph No. 3

The property at 7 Hilliard Avenue was occupied by a single storey residence with a full basement. The residence was heated via a forced air natural gas fired furnace. An air conditioning unit was present on the north side of the residence.

Natural gas fired forced air furnace in the basement of 7 Hilliard Avenue.

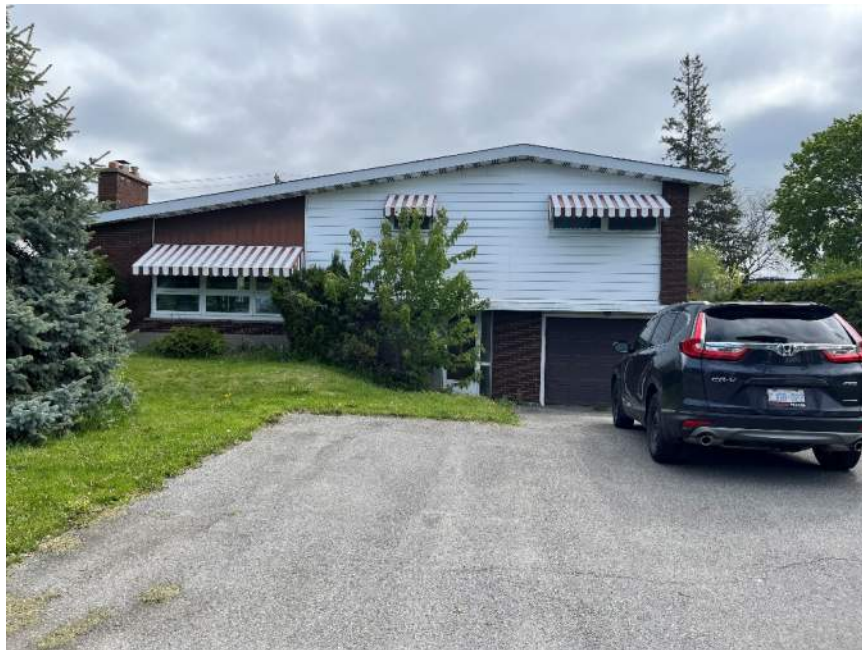
Photograph No. 4

View of the front of 9 Hilliard Avenue.

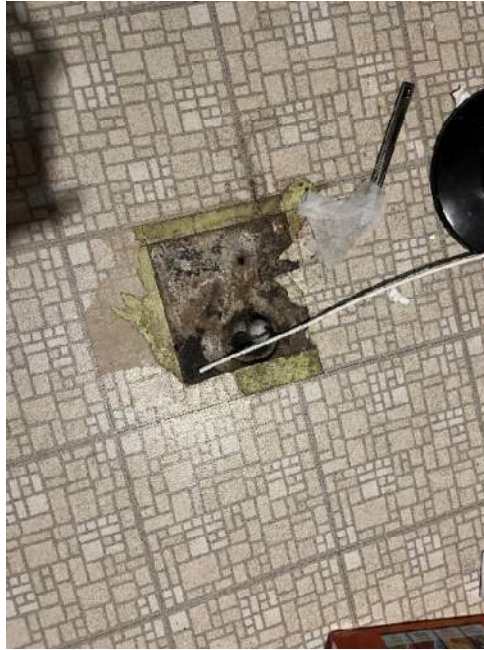
Photograph No. 5

Floor drain in the basement of 9 Hilliard Avenue.

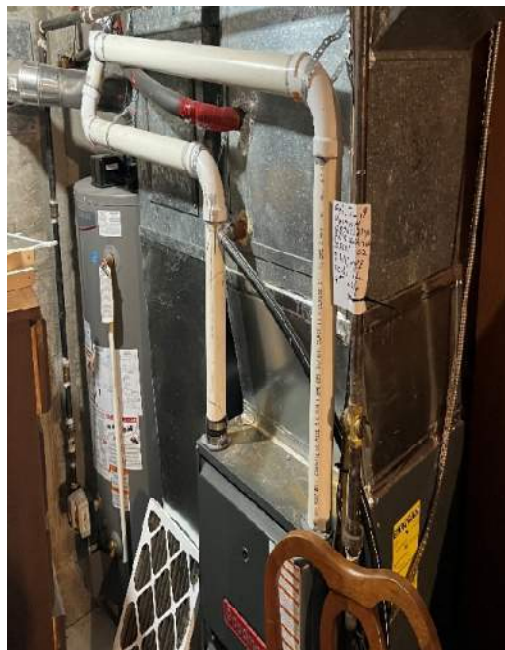
Photograph No. 6

The property at 9 Hilliard Avenue was occupied by a split-level residence with a full basement. The residence was heated via forced air natural gas furnace. An air conditioning unit was located on the north side of the residence.

Natural gas fired forced air furnace in the basement of 9 Hilliard Avenue.

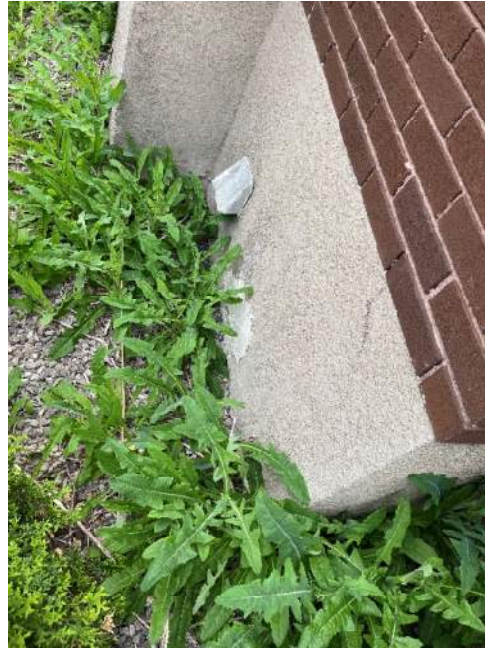
Photograph No. 7

Suspected location of former vent/fill pipes (removed and patched) at 9 Hilliard Avenue.
