Tree Conservation Report

5646/5650 Manotick Main St.  
Manotick, ON K4M 1B3

May 4, 2023

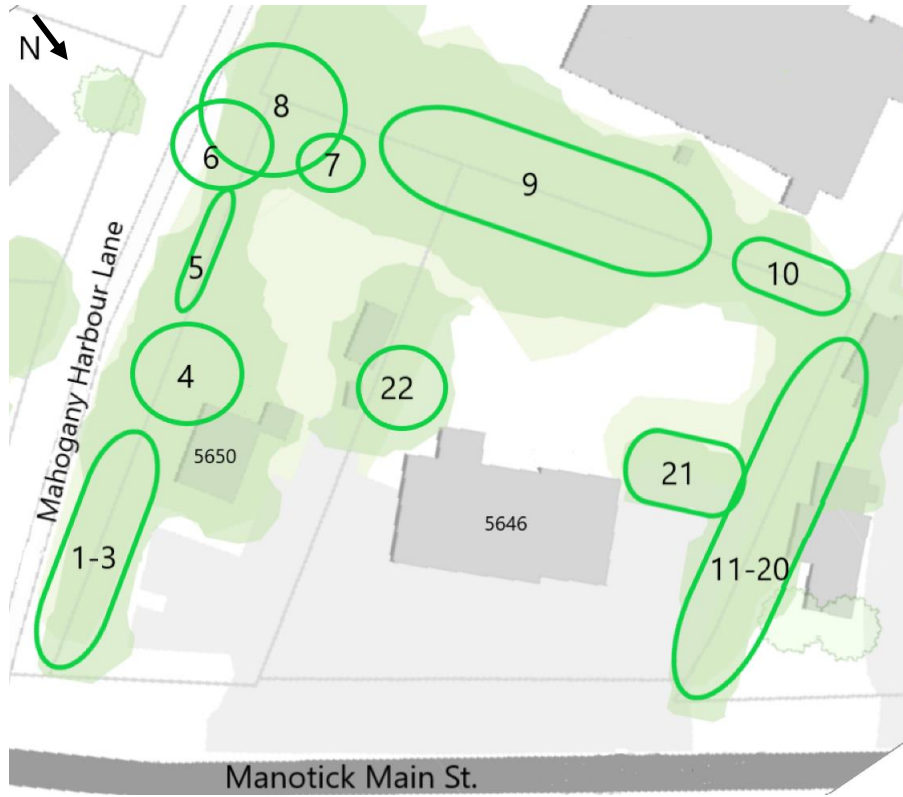
**Map #1: Existing vegetation**

All trees in the tables below are labelled on Map#1 with the allocated number.

Indicates existing trees or clusters of trees

All trees fall within the scope of the construction and require removal.

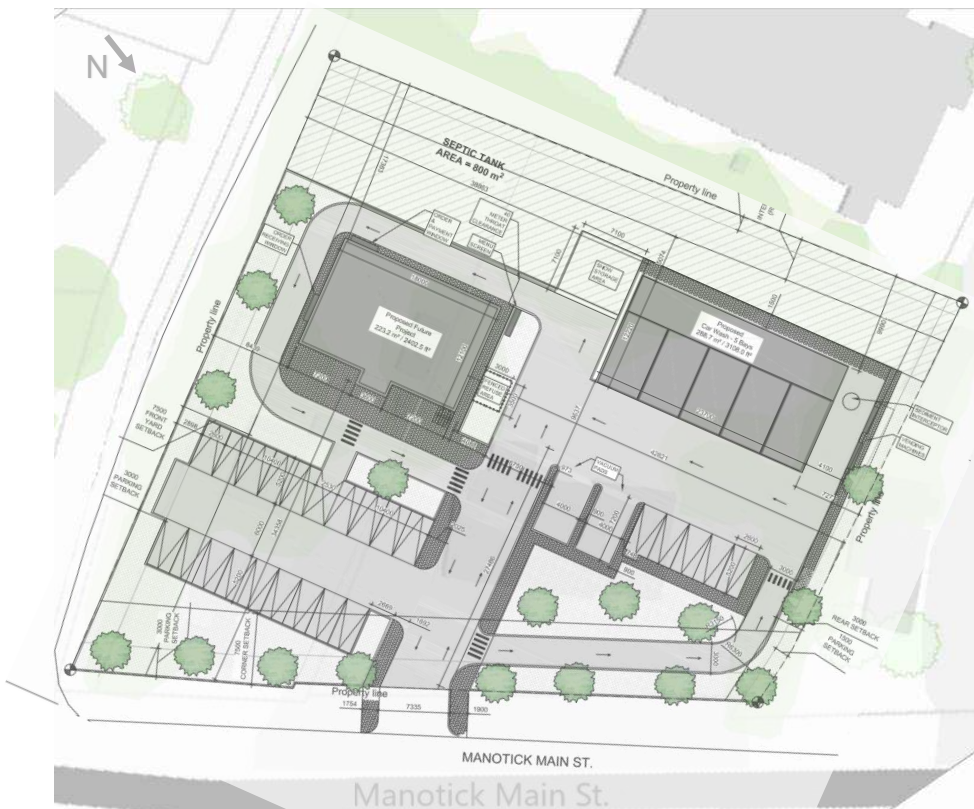
**Map #2: Overlay of development plans onto area map.**

Trees to be planted

As a significant amount of canopy and screening between the commercial property and existing residential properties is to be removed, trees should be planted as replacement in these areas particularly, as well as in front of the property.

Trees planted between the properties should be native and small-medium in size. Suggestions include: red maple (*Acer rubrum* – NOT *Acer plantenoides*) honey locust, white spruce, white birch, cedar.

Trees planted in the front of the new building will be ornamental in nature with small areas for potential growth, a mixture of smaller trees should be used. Suggestions for tree planting include: crab apple, choke cherry, dogwood, serviceberry, Japanese lilac, white or blue spruce.
