PHASE ONE ENVIRONMENTAL SITE ASSESSMENT

5646 & 5650 Manotick Main Street Ottawa, Ontario

FINAL REPORT

December 16, 2022

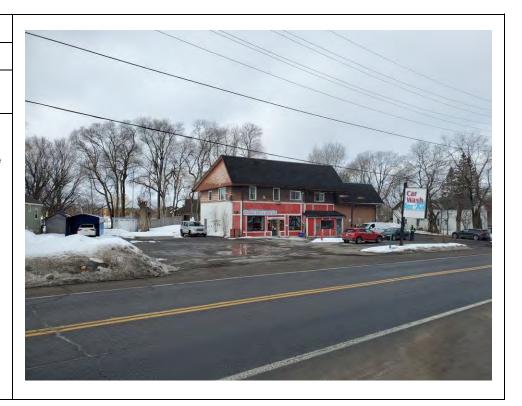
A view of the Site from the eastern side of Manotick Main Street.

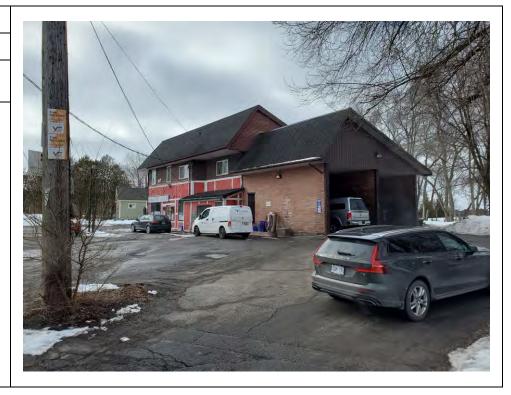
Photo No: 2

View of the Site from the northeastern portion of the Site. The two-bay car wash is visible at the north end of the building.

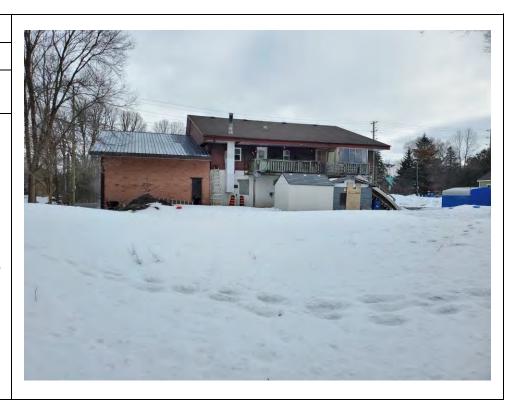
View of rear portion of the building from the southwestern portion of the Site.

The two second floor apartments are accessed from the wooden staircase at the southwest corner of the building.

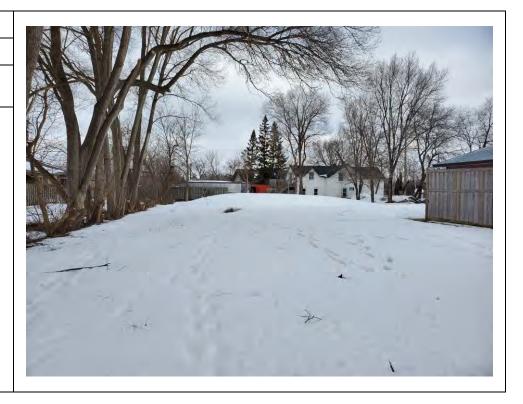
Photo No: 4

The backyard of the Site is grass covered and contains the Sites septic tanks and weeping bed. The rear of the building had a wooden staircase and deck which provided access to the two second storey apartments. A vinyl shed, which was unable to be accessed during the site inspection was located in the middle of the backyard. The backyard was not fenced except for the northern property boundary. It was noted that trees were located on the periphery of the backyard.

View of the septic bed located at the rear of the Site.

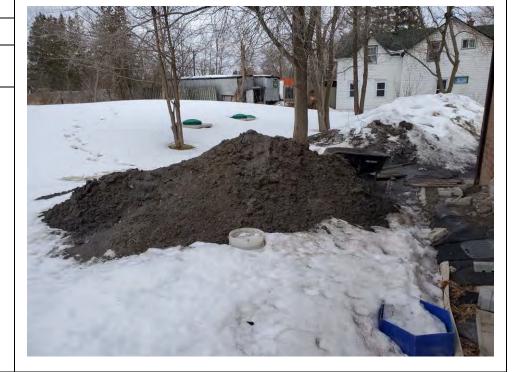
Photo No: 6

Debris and Fill Material: Debris and potential fill material were observed in the backyard of the onsite building on the 5646 Manotick Main Street property (refer to Appendix VIII, Photograph 6). Reportedly this fill was related to repairs to a foundation leak.

A view of excavated soil located at the rear of the building.

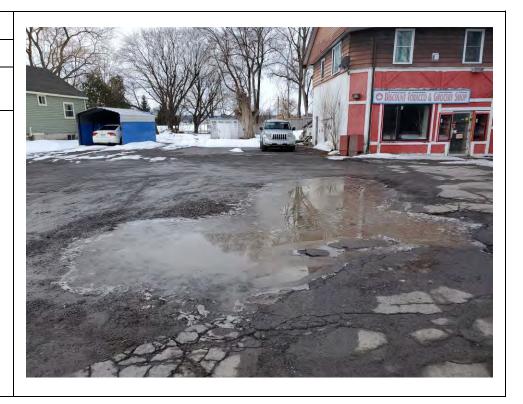
A view of the apparent location of the former underground storage tank nest.

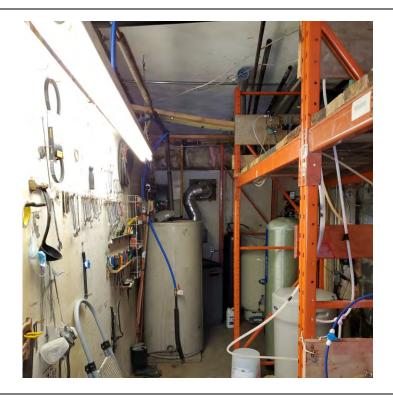
Photo No: 10

A view of car wash mechanical room located in the northern portion of the building.

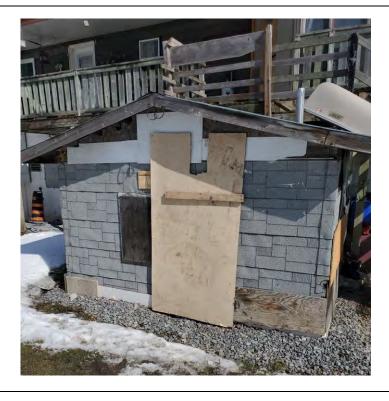
Photo No: 12

The interior of this expansion was covered in drywall and had extensive mold and water damage throughout.

A view of extension located at the rear of the building.

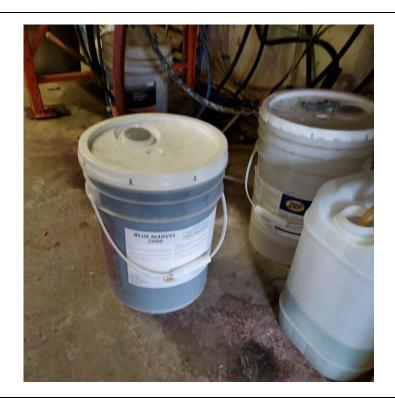
Storage Containers: Various containers of soaps and detergents were observed in the mechanical room of the car wash in the commercial building located on the 5646 Manotick Main Street property.

A view of the bulk detergents stored in the mechanical room for the car wash.

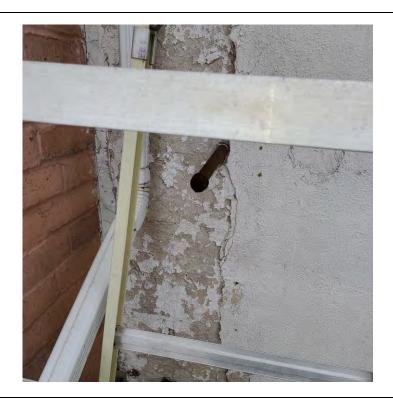
A view of a pipe leading out of the building.

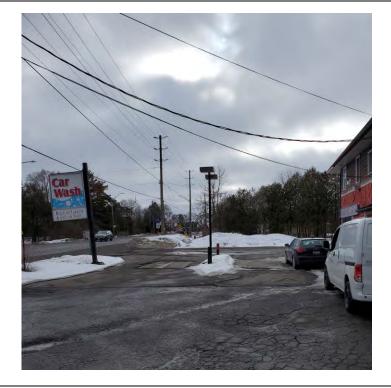
Photo No: 14

A view of the former pump island.

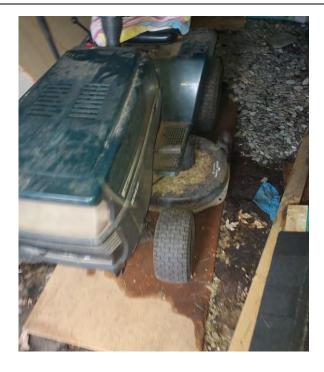
Photo No: 18

PCA 6 / APEC 4: Staining underneath the ride on lawn mower in the white shed.

Residues and Staining: Staining was observed underneath the ride-on lawn mower located in the shed on the 5650 Manotick Main Street property (refer to Appendix VIII, Photograph 18). Due to the extent of the staining this will be considered a PCA.

A view of the staining located underneath the lawn mower inside the shed located on the 5650 Manotick Main Street Property.
