Tree Conservation Report

5646/5650 Manotick Main St.  
Manotick, ON K4M 1B3

May 4, 2023

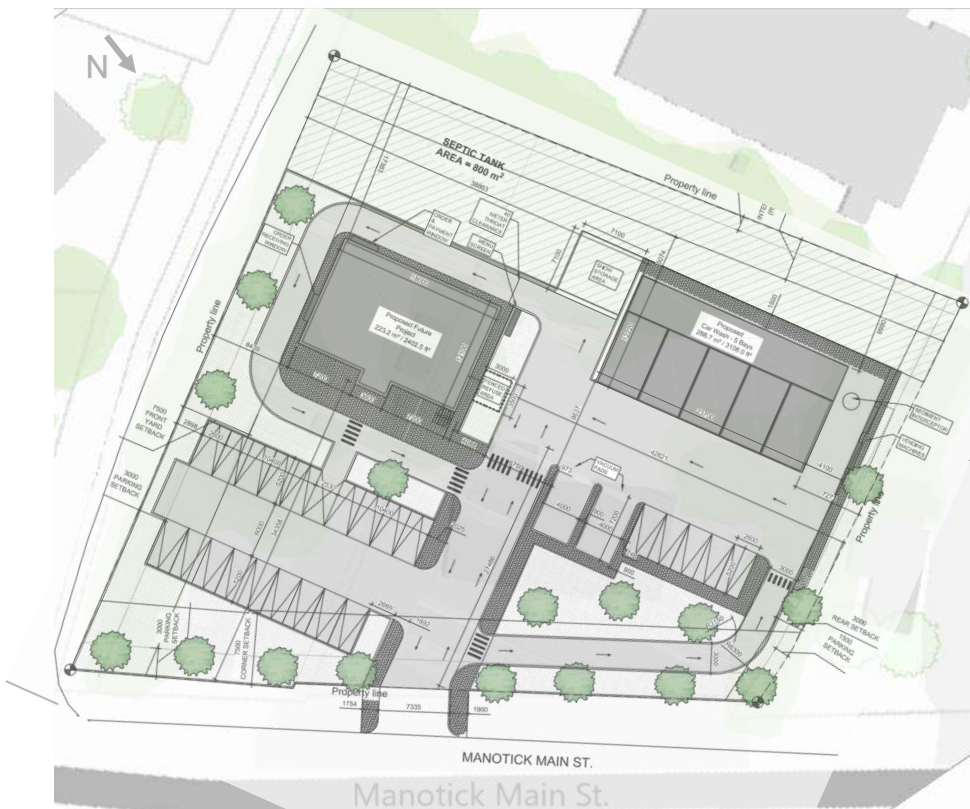
**Map #2: Overlay of development plans onto area map.**

Trees to be planted

As a significant amount of canopy and screening between the commercial property and existing residential properties is to be removed, trees should be planted as replacement in these areas particularly, as well as in front of the property.

Trees planted between the properties should be native and small-medium in size. Suggestions include: red maple (*Acer rubrum* – NOT *Acer planetoides*) honey locust, white spruce, white birch, cedar.

Trees planted in the front of the new building will be ornamental in nature with small areas for potential growth, a mixture of smaller trees should be used. Suggestions for tree planting include: crab apple, choke cherry, dogwood, serviceberry, Japanese lilac, white or blue spruce.
