Tree Conservation Report

5646/5650 Manotick Main St.
Manotick, ON K4M 1B3

May 4, 2023
Updated, Sept 21, 2023
Updated Dec 18, 2023

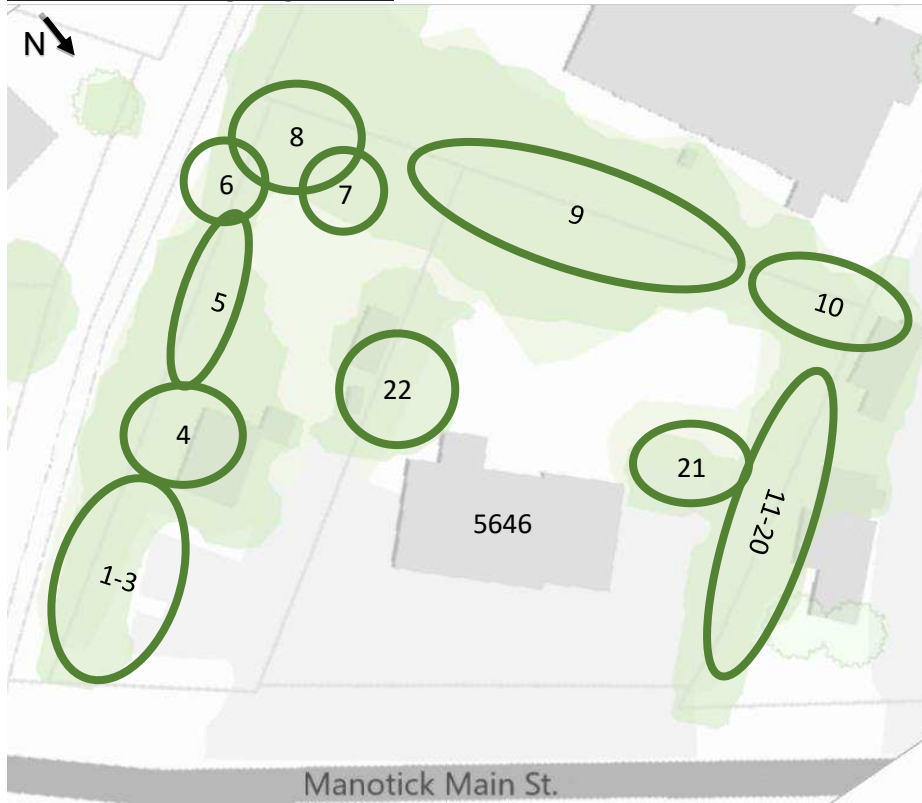
Map #1: Existing vegetation

All trees in the tables below are labelled on Map#1 with the allocated number.

Existing trees or clusters of trees

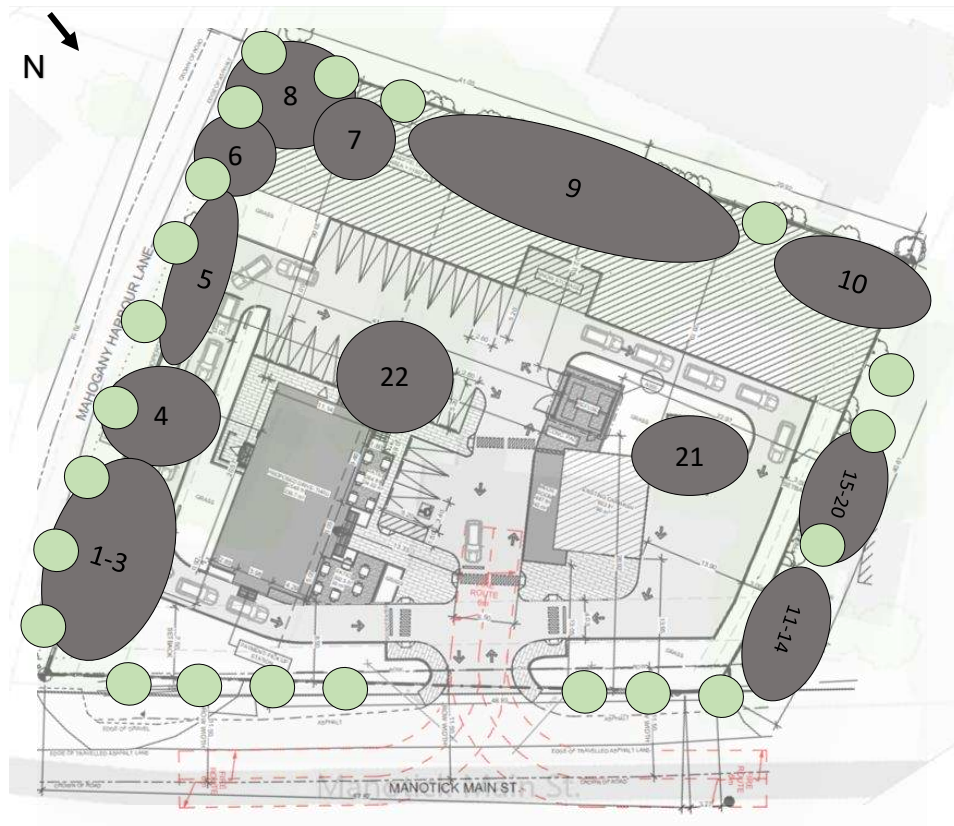
Map #2: Overlay of development plans onto area map.

Trees to be planted
Trees or clusters to trees to be removed

All trees fall within the scope of the construction and require removal for this plan to proceed. **Removals of trees should be done outside of the migratory bird season April 15-Aug 15.**

As a significant amount of canopy and screening between the commercial property and existing residential properties is to be removed, trees should be planted as replacement in these areas particularly, as well as in front of the property. It will likely not be possible to plant replacement trees in a 1:1 ratio due to area constraints, however supplementary trees can be planted in nearby locations or feeds paid in lieu as per City of Ottawa guidelines. A total of at least 40 trees should be planted as replacement.
