## Phase I Environmental Site Assessment

3-33 Selkirk Street  
and 2 Montreal Road  
Ottawa, Ontario

April 22, 2019

Report: PE4546-1

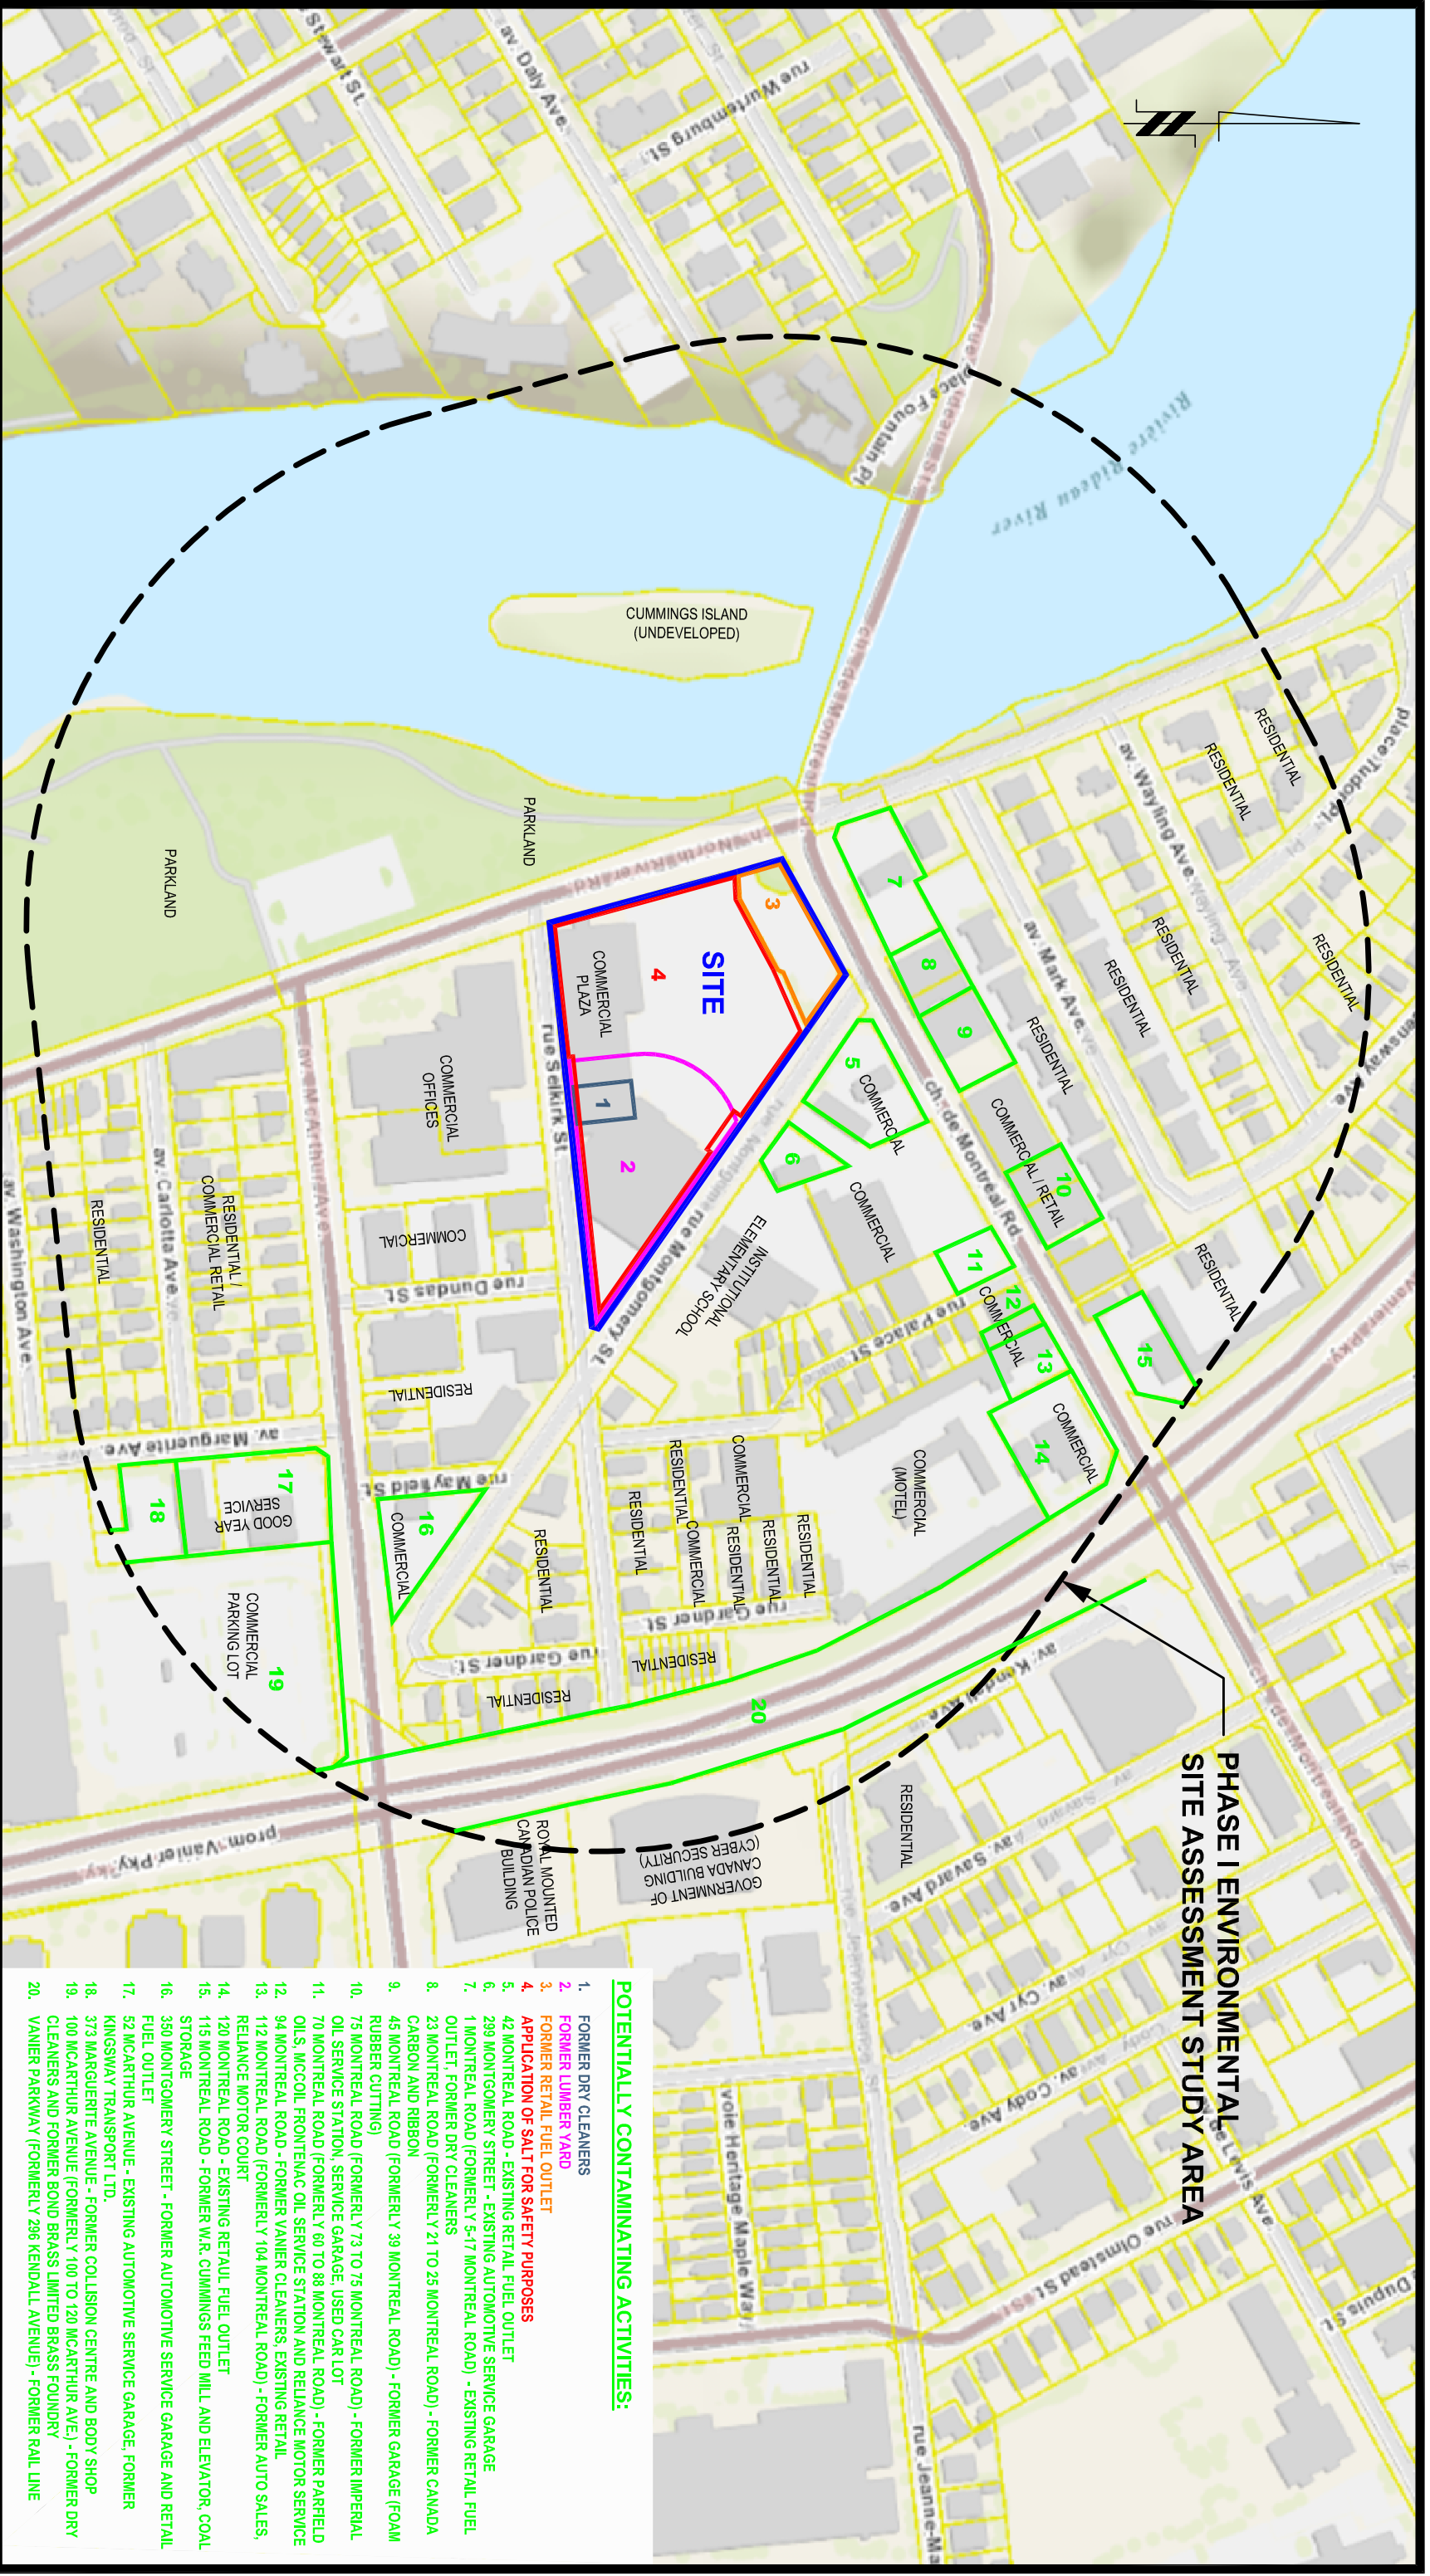
**DRAWING PE4546-2 – SURROUNDING LAND USE PLAN**

**PHASE I ENVIRONMENTAL  
SITE ASSESSMENT STUDY AREA**

**POTENTIALLY CONTAMINATING ACTIVITIES:**

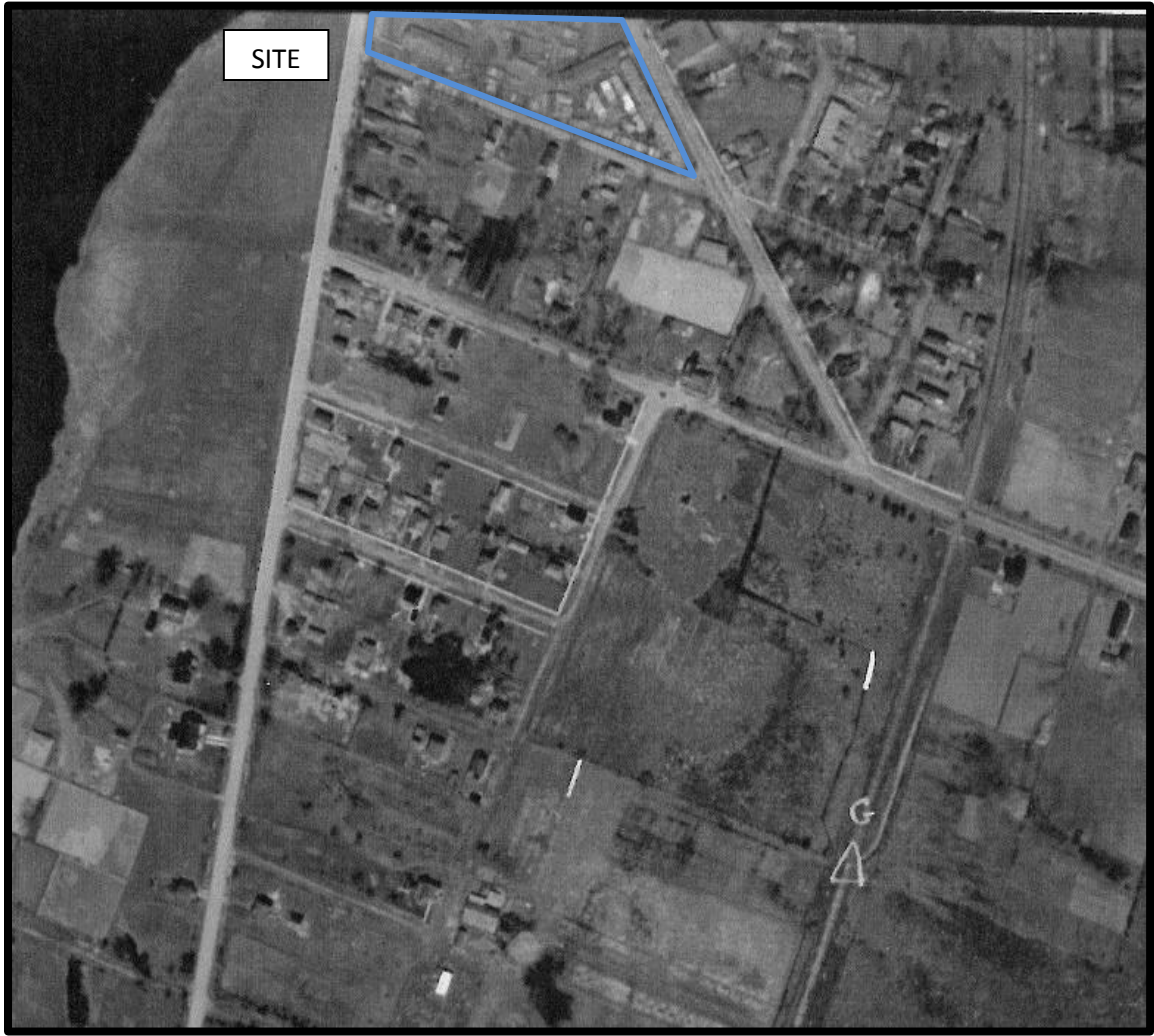
AERIAL PHOTOGRAPH  
1928

| 1928 | The lumber yard identified in the 1912 Fire Insurance Plans is visible on the southern portion of the Phase I ESA property. Surrounding properties appear to have been developed with residential dwellings. |

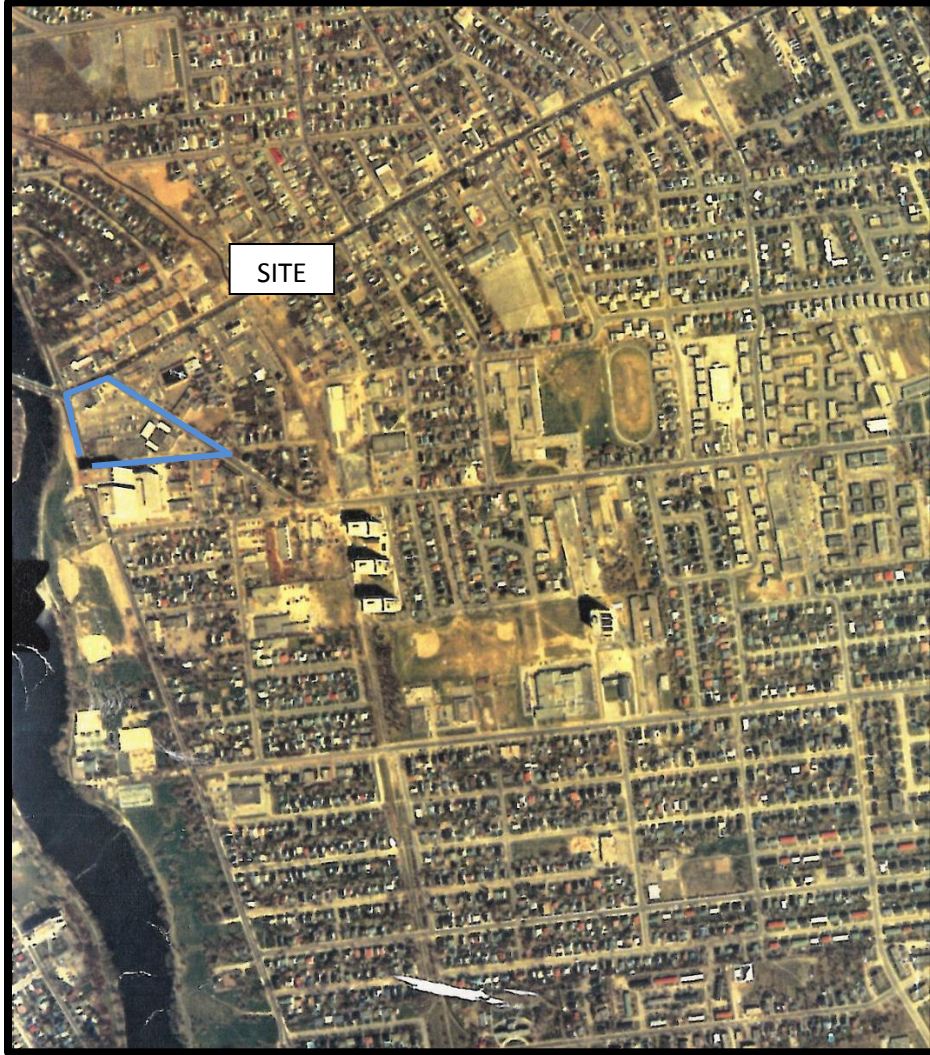
AERIAL PHOTOGRAPH  
1975

| 1975 | The retail plaza has been fully developed at this time. A retail fuel outlet is visible on the west side of the 2 Montreal Road property. To the east of the subject site redevelopment of the adjacent properties with a commercial plaza has taken place. |
