Phase I Environmental Site Assessment

1531 St. Laurent Boulevard, Ottawa, ON

KATASA Groupe + Développement
Final Report

June 7, 2023
02305731.000

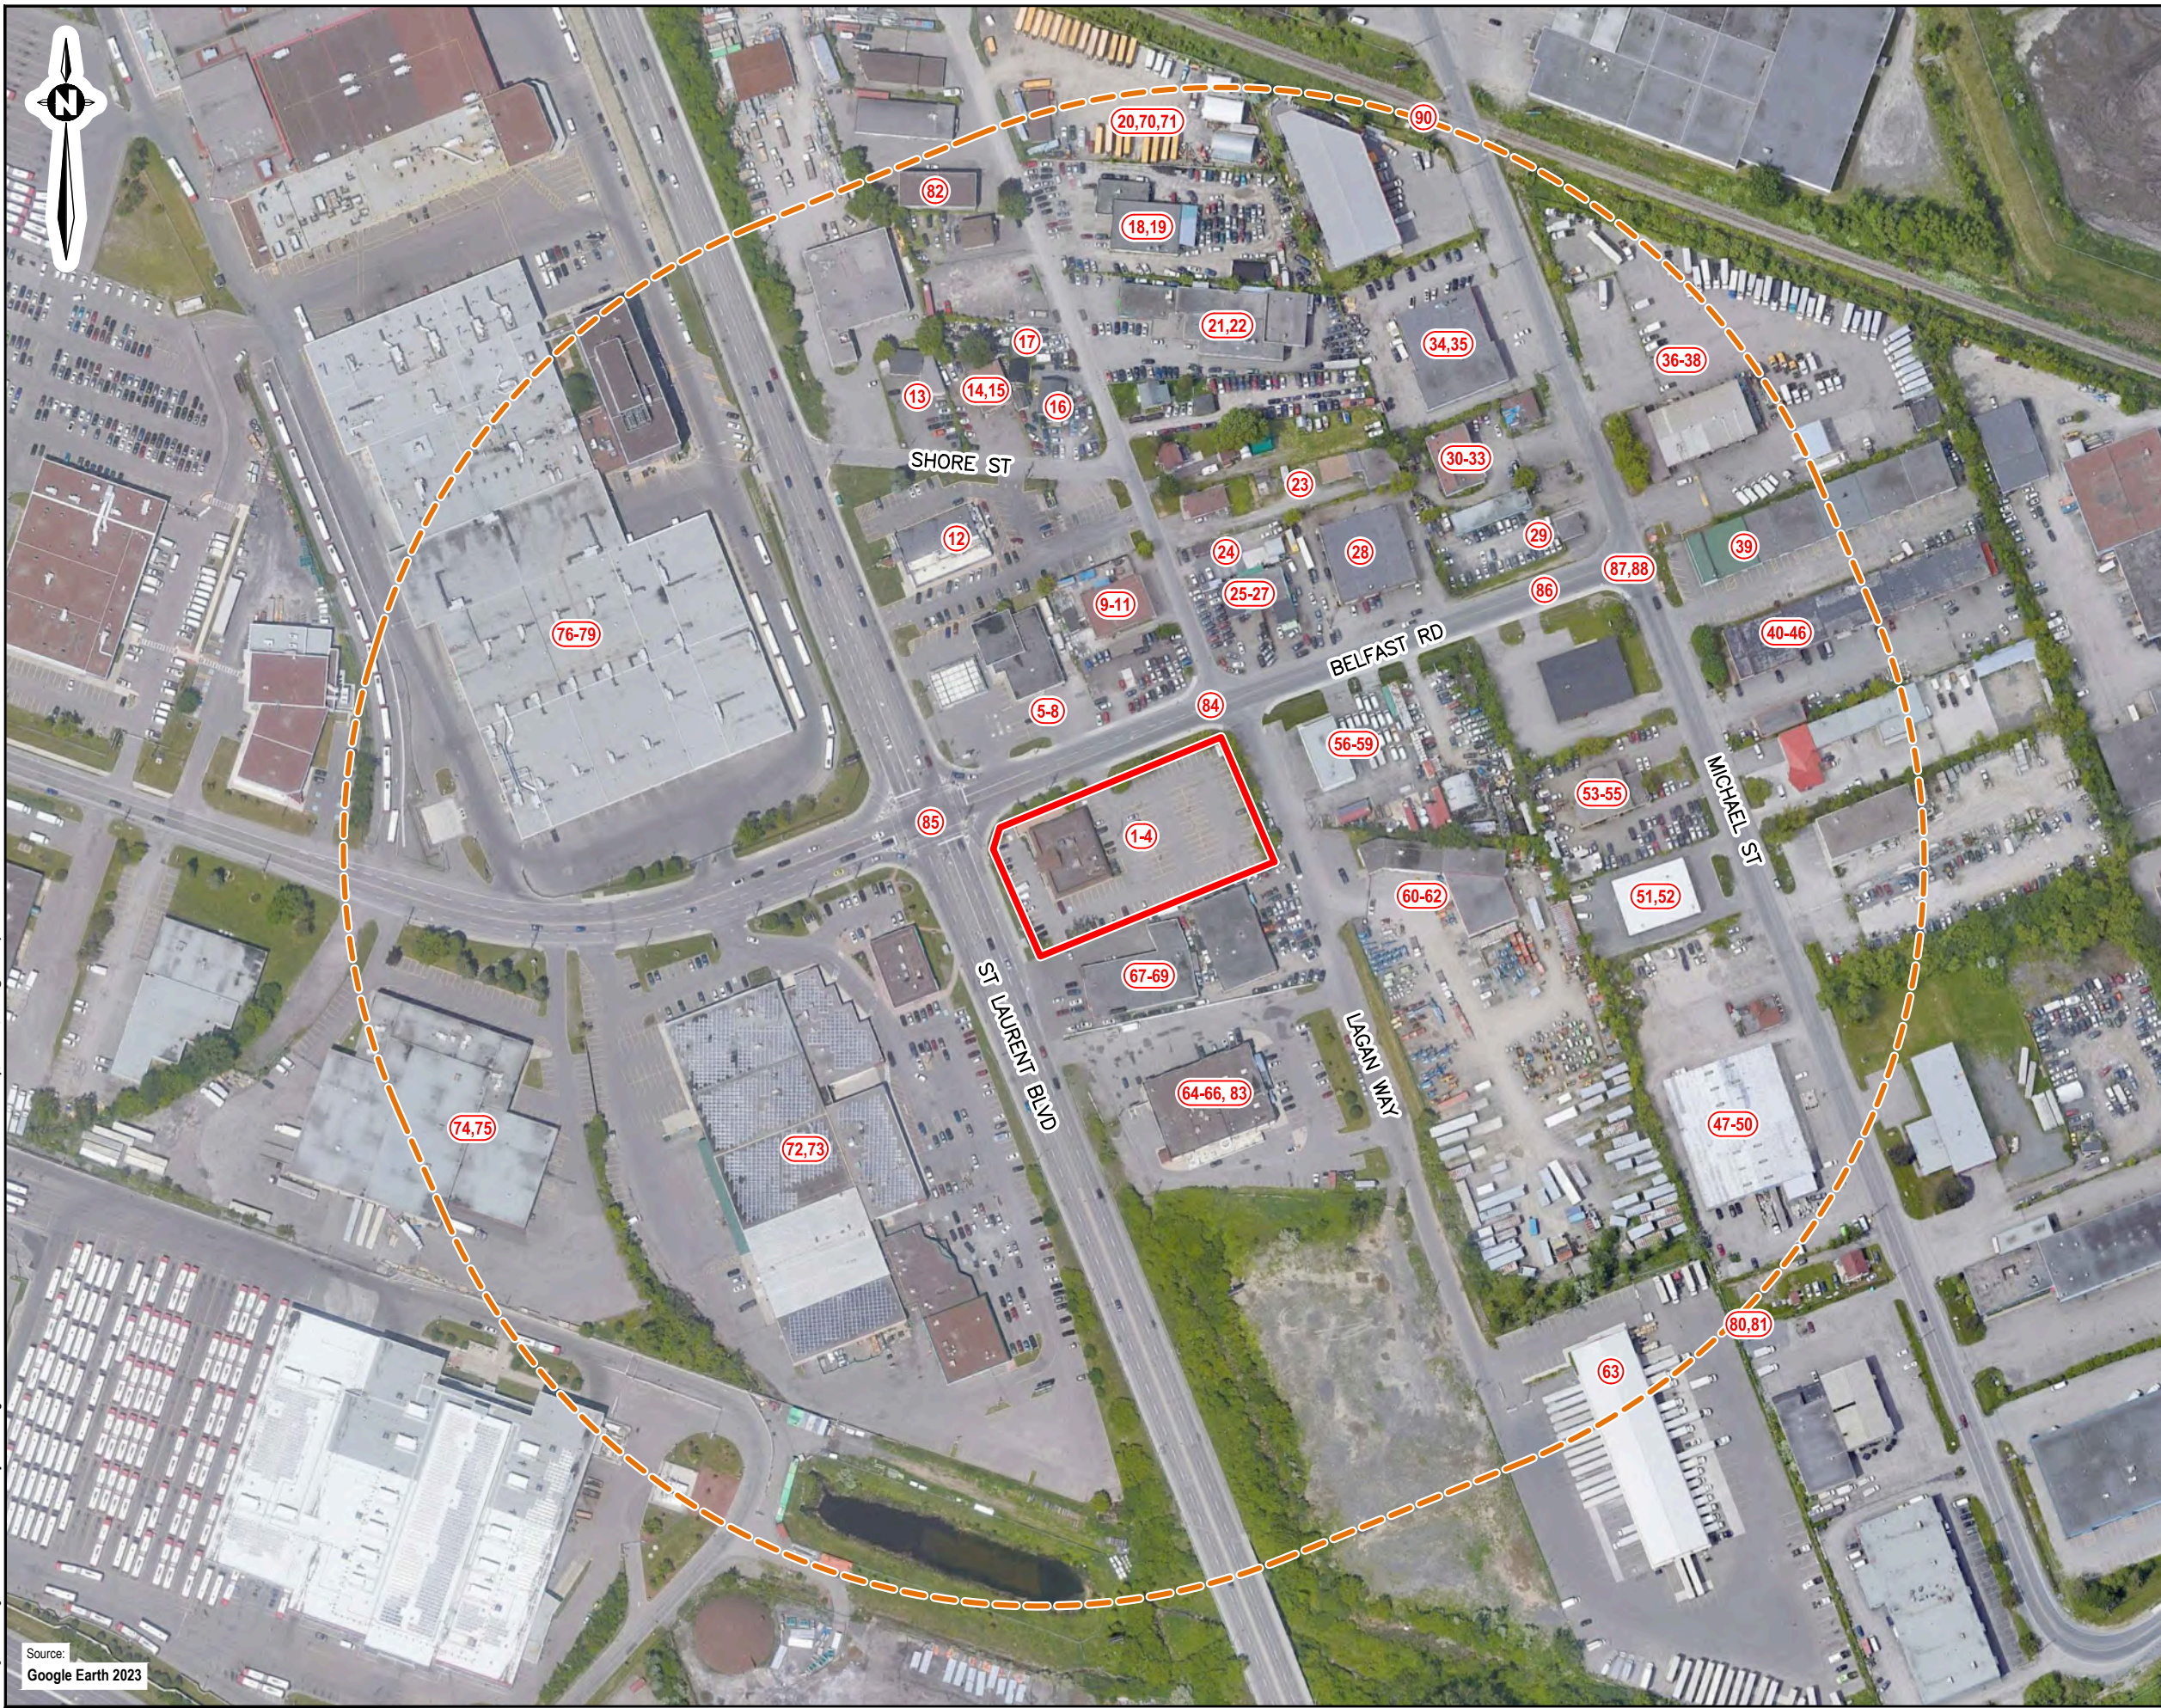
Legend
 — Phase I Property
 - - - 250 m Study Area
 ① Potentially Contaminating Activities (PCAs)

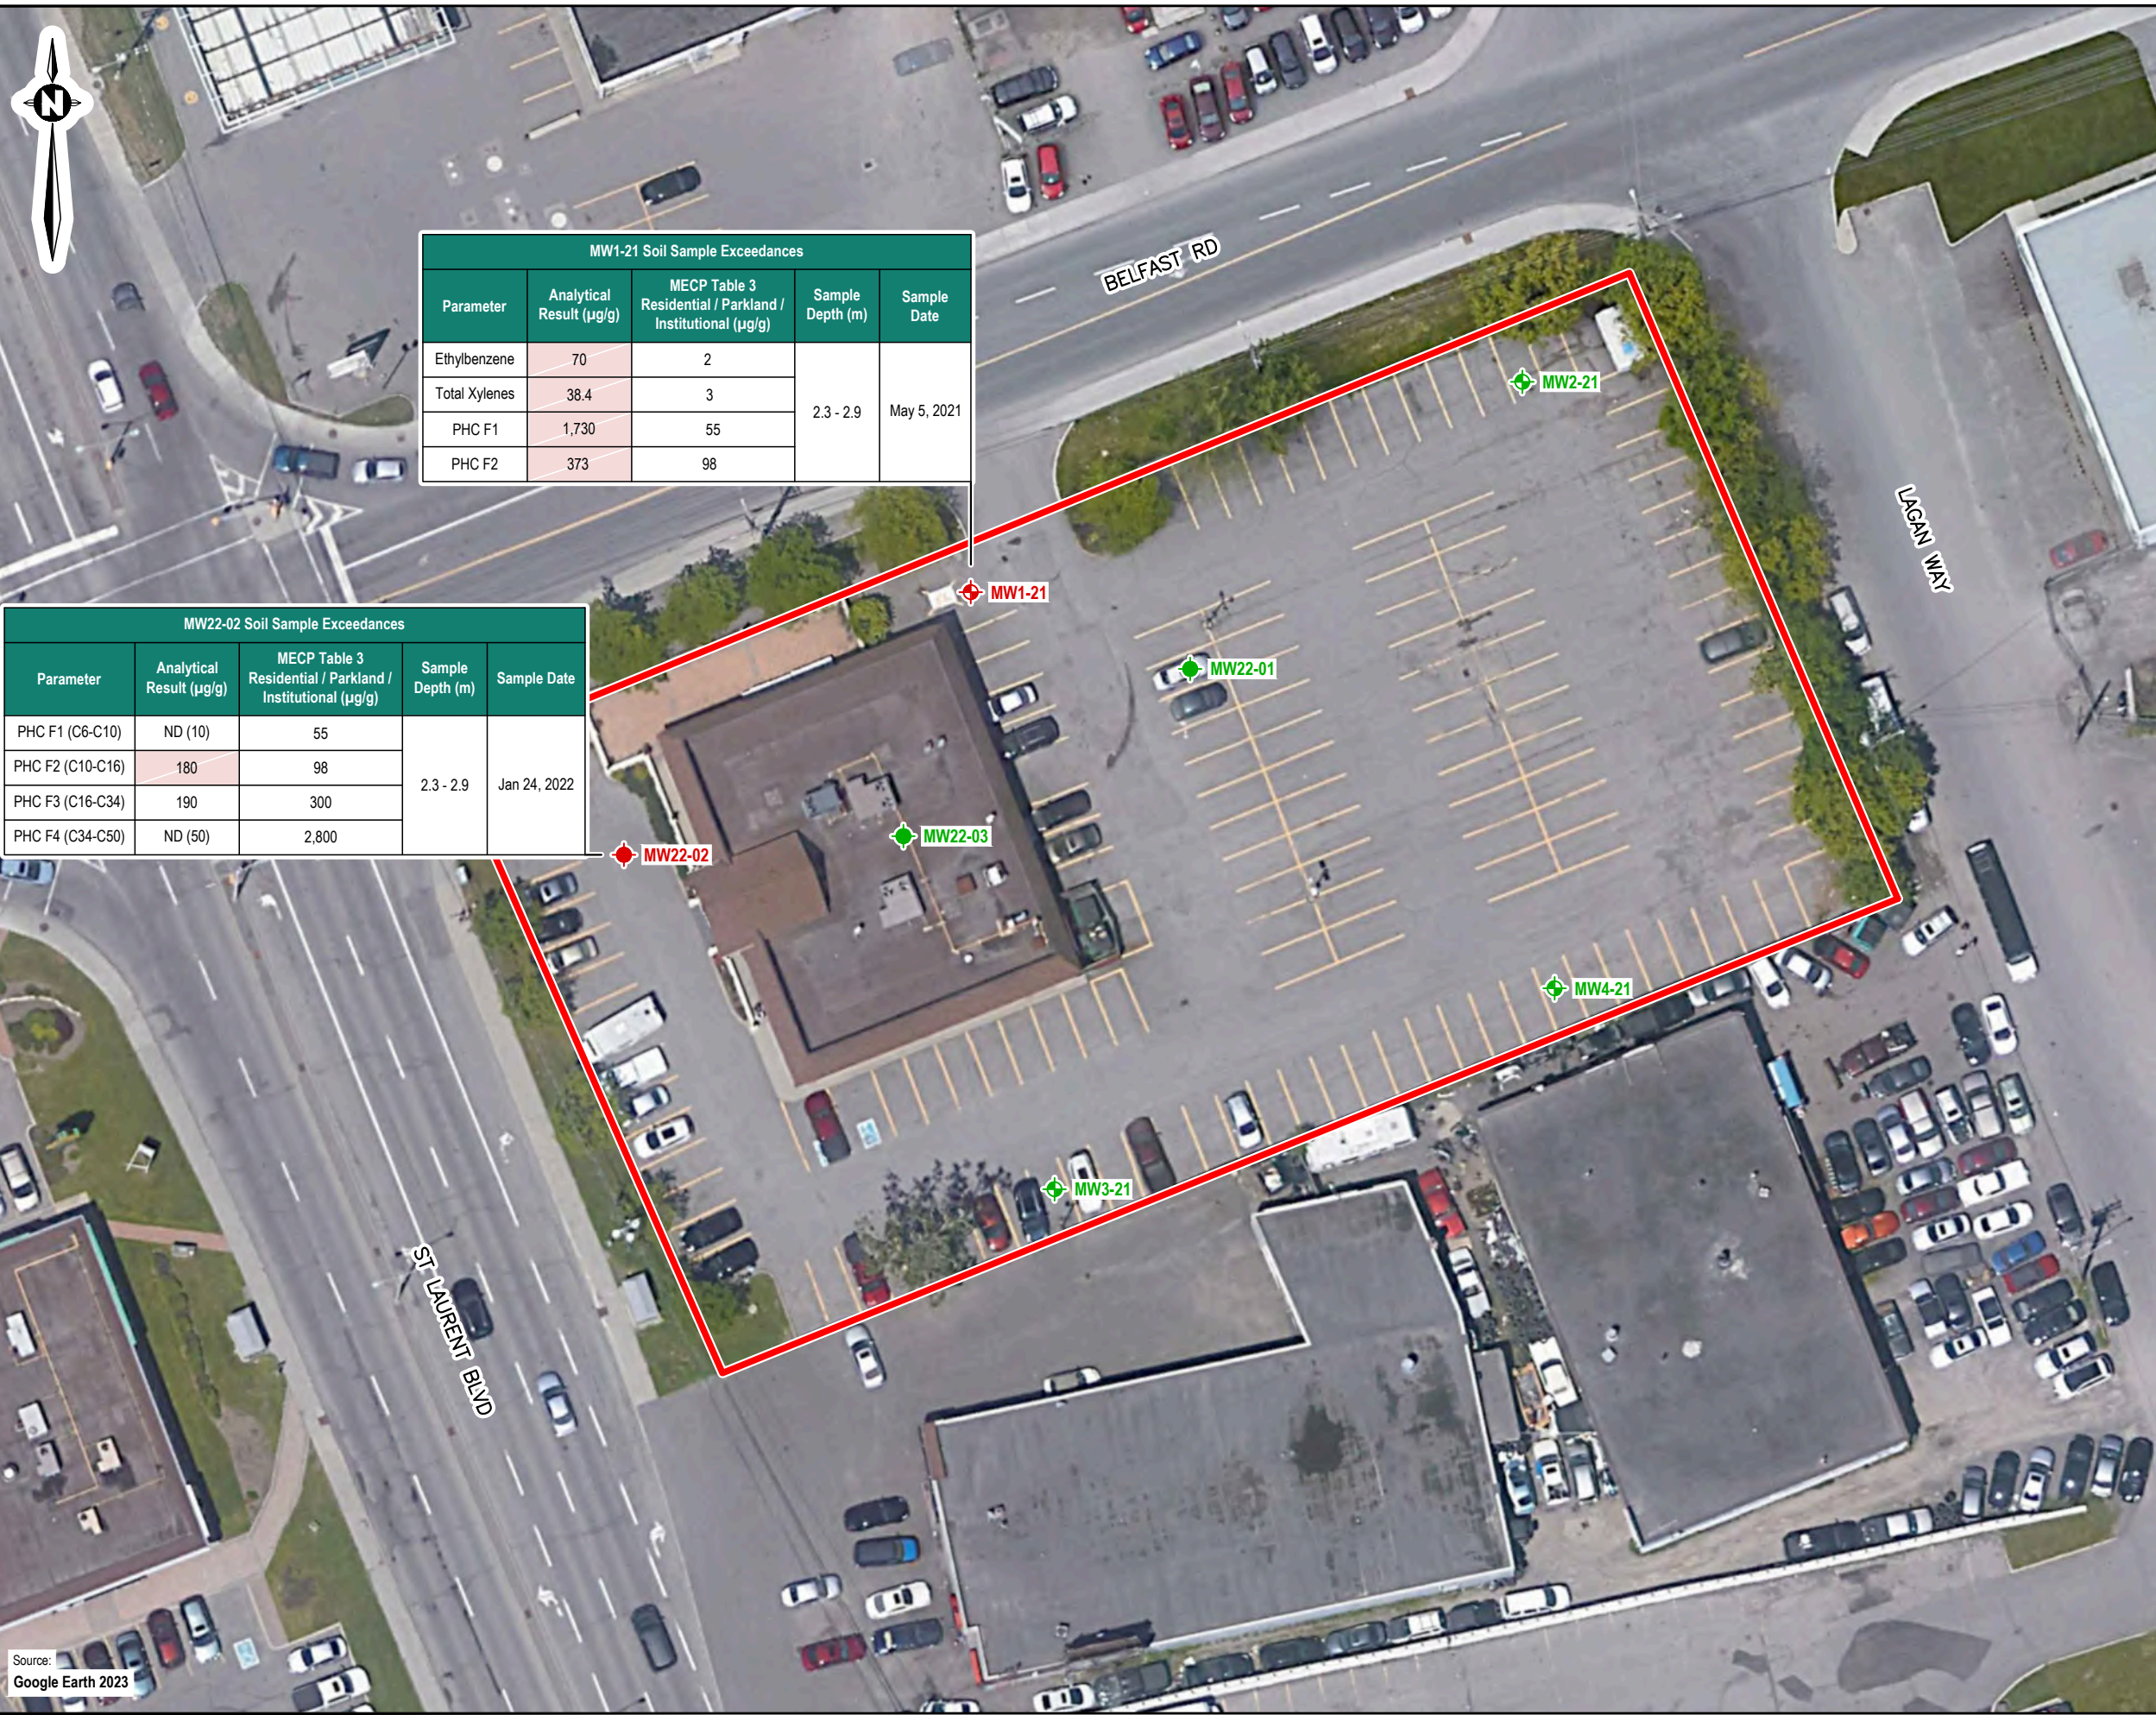
Drawing: 4 BH Locations.dwg Folder: L:\ITS\CAD\Projects\Vantage Point\02305731 - St Laurent\Phase I ESA\DWG Tuesday, June 06, 2023 @ 15:35 by Joven Mendoza

- Legend**
- ▬ Phase I Property
 - ⊕ Borehole / MW (DST, 2021) Meets Applicable MECP Table 3 Standards (Residential / Parkland / Institutional)
 - ⊕ Borehole / MW (DST, 2021) Exceeds Applicable MECP Table 3 Standards (Residential / Parkland / Institutional)
 - ⊕ Borehole / MW (Englobe, 2022) Meets Applicable MECP Table 3 Standards (Residential / Parkland / Institutional)
 - ⊕ Borehole / MW (Englobe, 2022) Exceeds Applicable MECP Table 3 Standards (Residential / Parkland / Institutional)

Further to the completion of the Phase I and II ESAs, the assessment identified impacts to the soil quality at borehole location MW1-21, which is located to the north of the building footprint. The subject impacts at this borehole location were likely attributed to off-Site sources potentially linked to one or more of the previously noted PCAs within the Phase I Study Area.

It was inferred that existing soils to the north of the Site building, up to the northern property boundary, contain impacts above the applicable MECP Table 3 standards, from a depth of approximately 1.0 metres below ground surface (m bgs) to 3.0 m bgs. Further investigation was recommended to the south and east of borehole location MW1-21 in order to confirm the horizontal and vertical extents of the soil impacts in the vicinity of the subject borehole location.

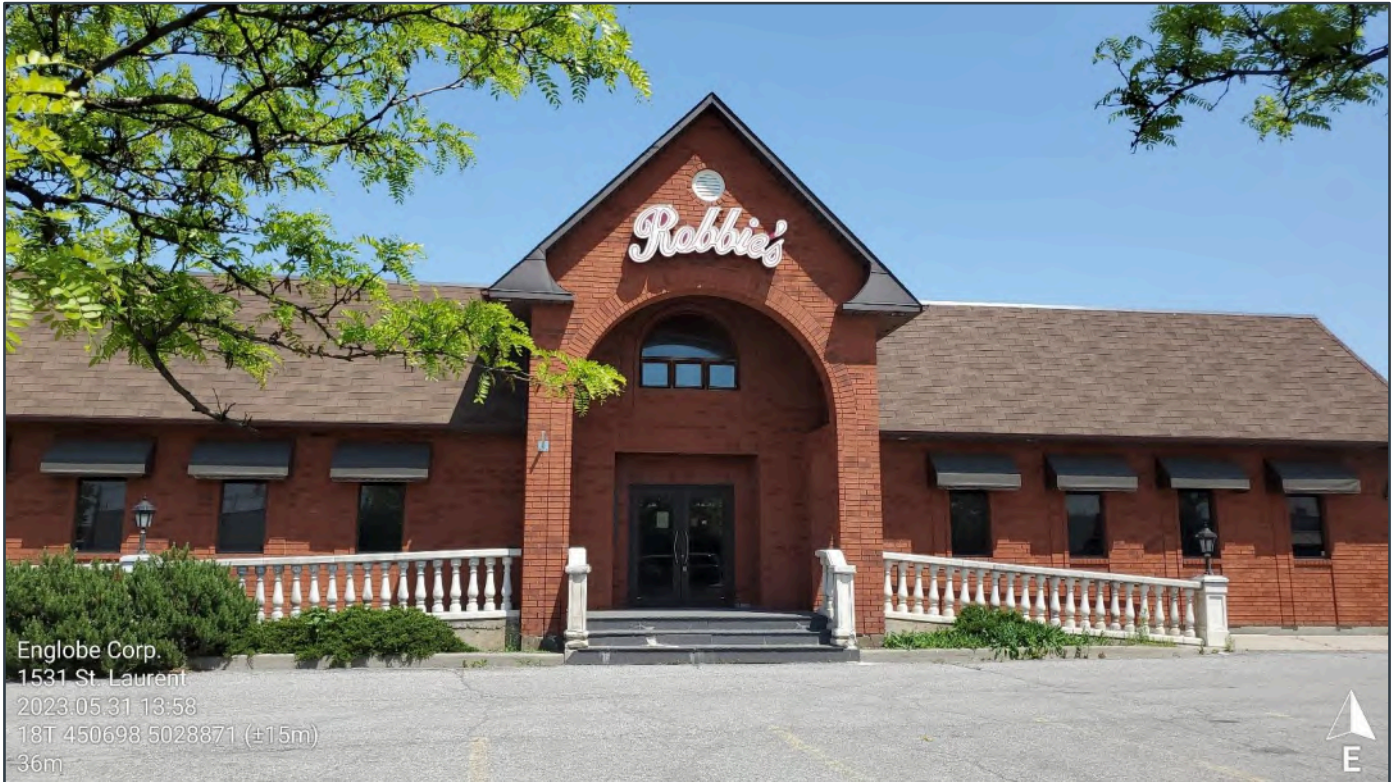
Site Photograph 1: Overview of the Site.

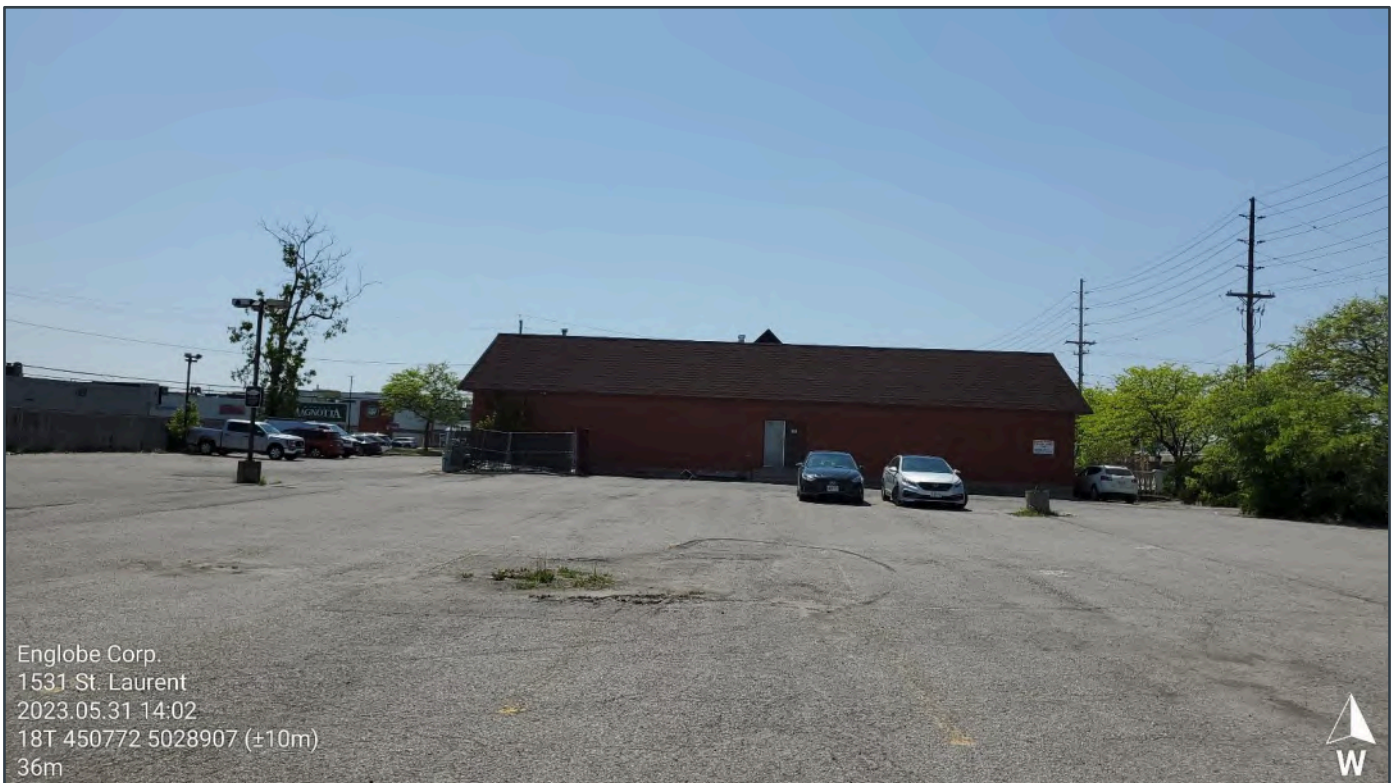
Site Photograph 2: Overview of the rear of the building.
