Muncaster
Environmental
Planning Inc.

RE: 1540 Star Top Road, Gloucester
Environmental Impact Study - Updated

ENVIRONMENTAL IMPACT STATEMENT

**1540 Star Top Road
Gloucester, City of Ottawa**

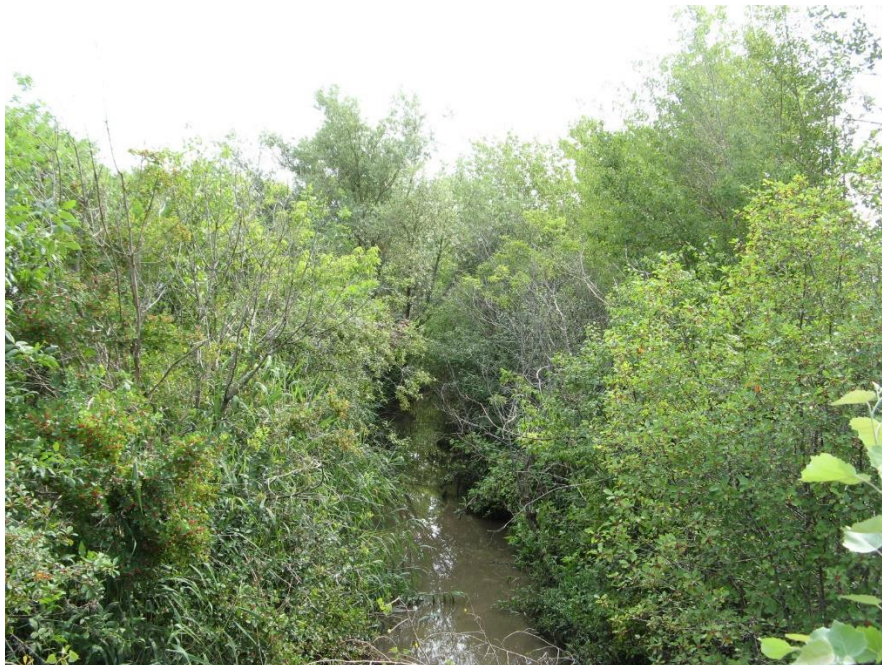
The wetted width of the South Cyrville Municipal Drain is between 2.5 and 3.5 metres. The water on July 11th was turbid (Photo 1). The canopy cover from an adjacent upland poplar deciduous forest is good in many areas. Small woody debris provides some instream habitat structure but there was no evidence of boulders, other coarse material, notable areas of aquatic vegetation, or undercut banks. The channel is straight with connecting sharp turns to the west of the site and as described above is open for approximately 750 metres.

*Photo 1 - South Cyrville Municipal Drain immediately to the north of the site.
View looking east from the northwest entrance to the site*

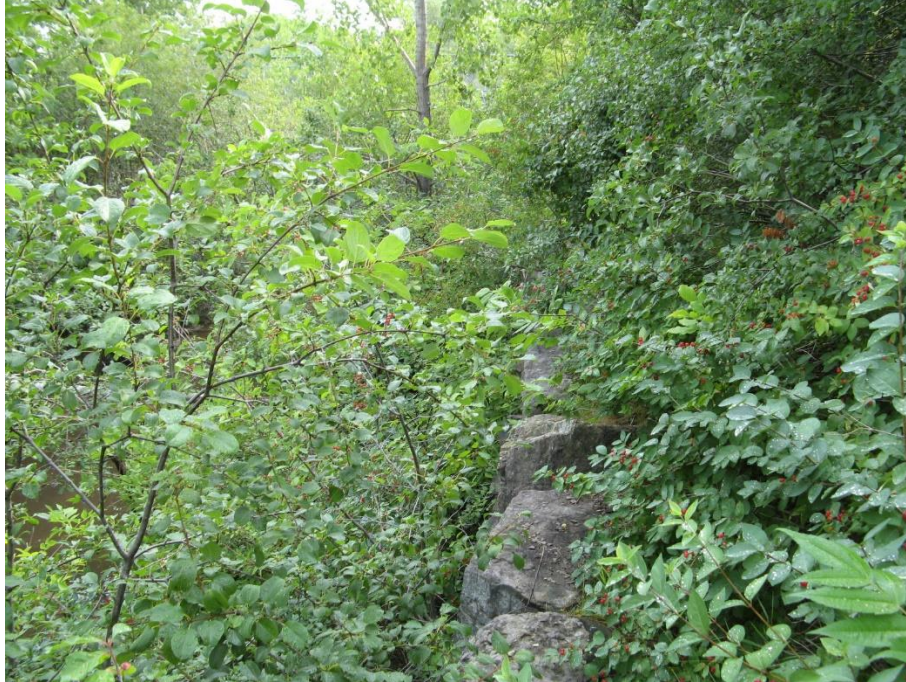
A retaining wall of large boulders is along the top of slope of both sides of the channel corridor (Photo 2). There is a setback of 7.5 metres from the retaining wall to the north edge of the site. Trembling aspens up to 30 cm diameter at breast height (dbh) are dominant in the setback, along with smaller green ash and Manitoba maple (Photos 3 and 4). The understory in the setback area is thick in most areas, with glossy buckthorn dominant in areas and staghorn sumac, red-osier dogwood, and tartarian honeysuckle common, along with regenerating stems of poplar, ash, and Manitoba maple. A chain-link fence is around the north and south edges of the channel setback and two surface connections crossing the channel between 1282 Algoma Road and the site (Photo 4). A gate in the fencing between the two crossing along the north site boundary provides access to the corridor, including for the plantings recommended below.

Photo 2 – South side of the Municipal Drain corridor to the north of the site, with large boulder retaining wall. View looking east, with site beginning 7.5 metres from wall

Although much less than a typical setback, a setback of 7.5 metres from the retaining wall top of slope to the south edge of the riparian corridor is considered suitable due to the highly disturbed nature of the channel, including limited exposed reaches, straight alignment that was excavated and associated artificial cross-section. The 7.5 metres setback is greater than that provided for other open sections of the Drain to the west of the site. The drain is enclosed to the east of Star Top Road.

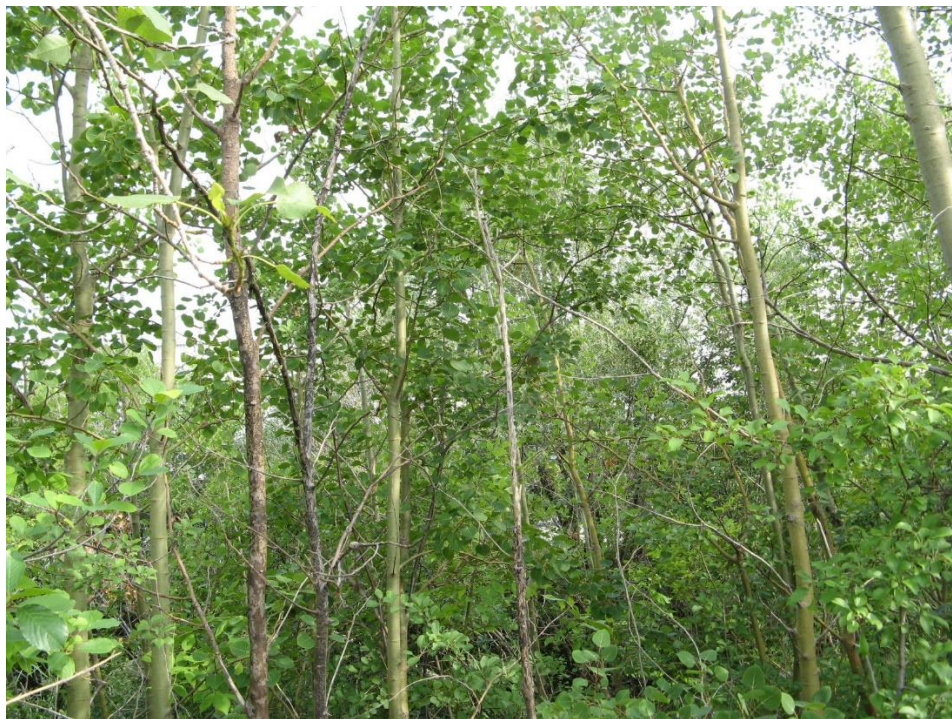
Photo 3 – The corridor between the Municipal Drain and the site is generally well treed with young poplars. View looking north from the centre of the north property line

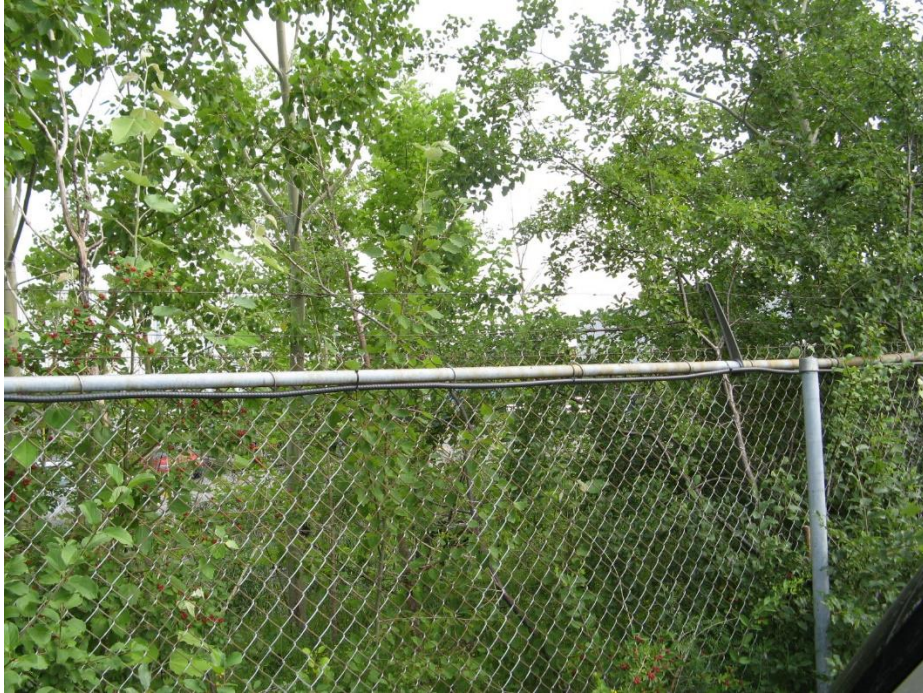
Photo 4 – The Municipal Drain corridor is protected with a chain-link fence along the north property line. This area has fewer trees and plantings are recommended to increase the diversity of the buffer function. View looking north

Natural buffers provide important functions such as filtering excess nutrients running into the channel, infiltrating rainwater, shading and food inputs for the channel, maintaining bank stability (though in this case retaining walls are present), contributing to baseflow, and providing wildlife habitat. The buffer immediately to the north of this site can be improved with plantings of native trees and shrubs where currently there are fewer poplar trees. This will provide a diversity compared to the existing woody vegetation. Recommended native species shown on the Landscape Plan completed by GJA Inc. (revised April 15th, 2024) in the buffer to the north include nannyberry, grey dogwood, and serviceberry shrubs along with sugar maple, red maple, common hackberry, bur oak, red oak, basswood, balsam fir, and white spruce trees. Twenty trees and fifteen shrubs are proposed for planting in the corridor to the north. Obtaining native species from local seed sources is strongly recommended to promote adaptability and longevity.

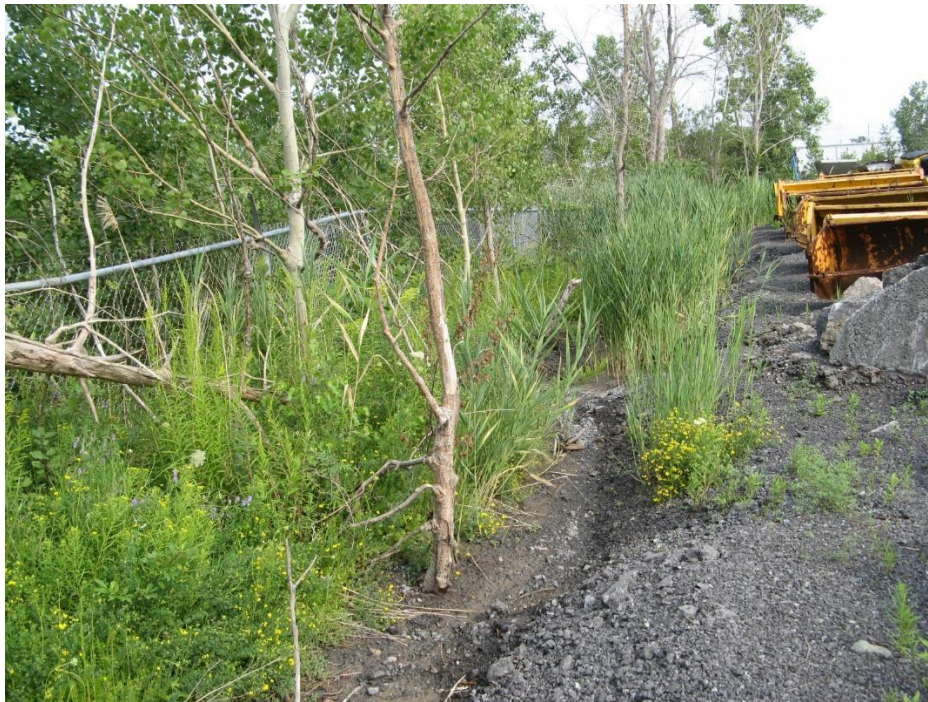
A ditch on the west side of the site was mostly dry during the field review, with small pockets of standing water (Photo 5). Significant rain had occurred within the previous 30 hours. The drain does not have an open connection to the South Cyrville Municipal Drain to the north.

Photo 5 – Dry ditch along the west boundary of the site. View looking north

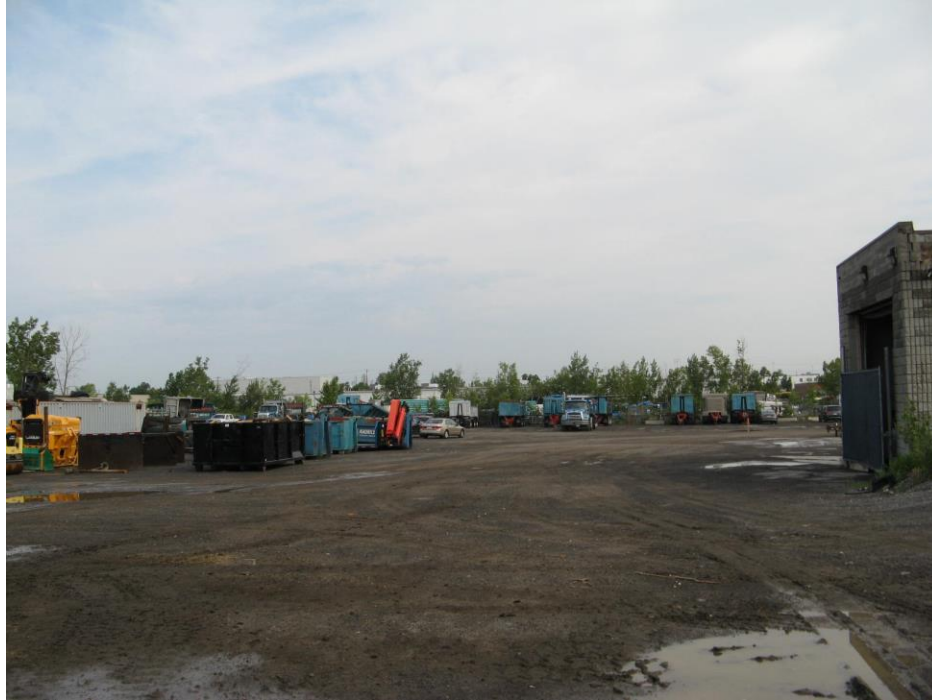
The site is dominated by fill material with a generally level topography (Photo 6). Paterson (2023) identified crushed stone, topsoil, brown silty sand, trace clay and occasional gravel in the fill. Bedrock consisting of black shale was noted by Paterson (2023) at depths ranging between approximately 1.9 to 2.9 metres below grade. Similarly, Paterson (2023) observed groundwater depths between approximately 1.9 and 2.9 metres below the existing ground surface, with groundwater flow generally in a northern direction.

Photo 6 – West portion of the site looking north from south edge

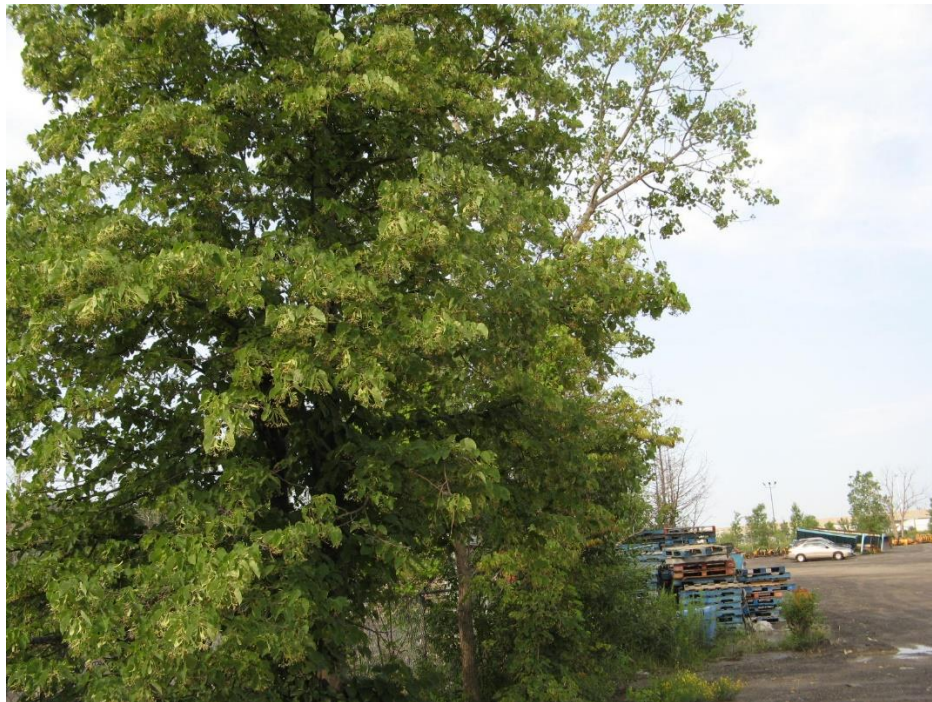
Scattered regenerating deciduous trees are along portions of the site boundaries and these areas are referred to as intermittent deciduous hedgerows on Figure 1. Trembling aspens are dominant, with eastern cottonwood well represented and green ash, white elm, and linden also present (Photo 7). Regenerating poplar, birch, ash, linden, and white poplar stems are among the intermittent hedgerow trees, along with staghorn sumac, Bebb's willow, red-osier dogwood, tartarian honeysuckle, and glossy buckthorn shrubs. The largest trees in the intermittent hedgerows are cottonwood and trembling aspen up to 32cm dbh. Many of the white elms are dead and leaf-out is greatly reduced on many of the poplars. The larger eastern cottonwoods along the west ditch appear dead as well. Wild grape coverage is common on the lower portions of some of the trees.

Photo 7 – Cottonwood along southeast boundary of the site. View looking west

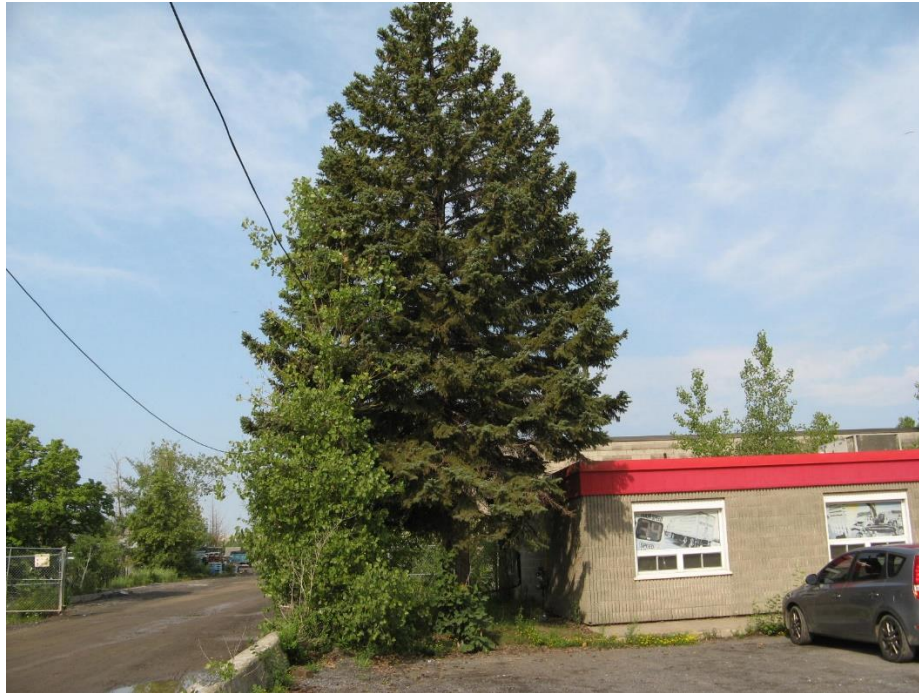
A twin-stem bur oak, with individual stems up to 30cm dbh and a 48cm dbh white spruce are adjacent to the existing office building west of Star Top Road (Photo 8).

Photo 8 – White spruce in the east portion of the site, west of Star Top Road was the largest tree observed on or adjacent to the site. View looking west

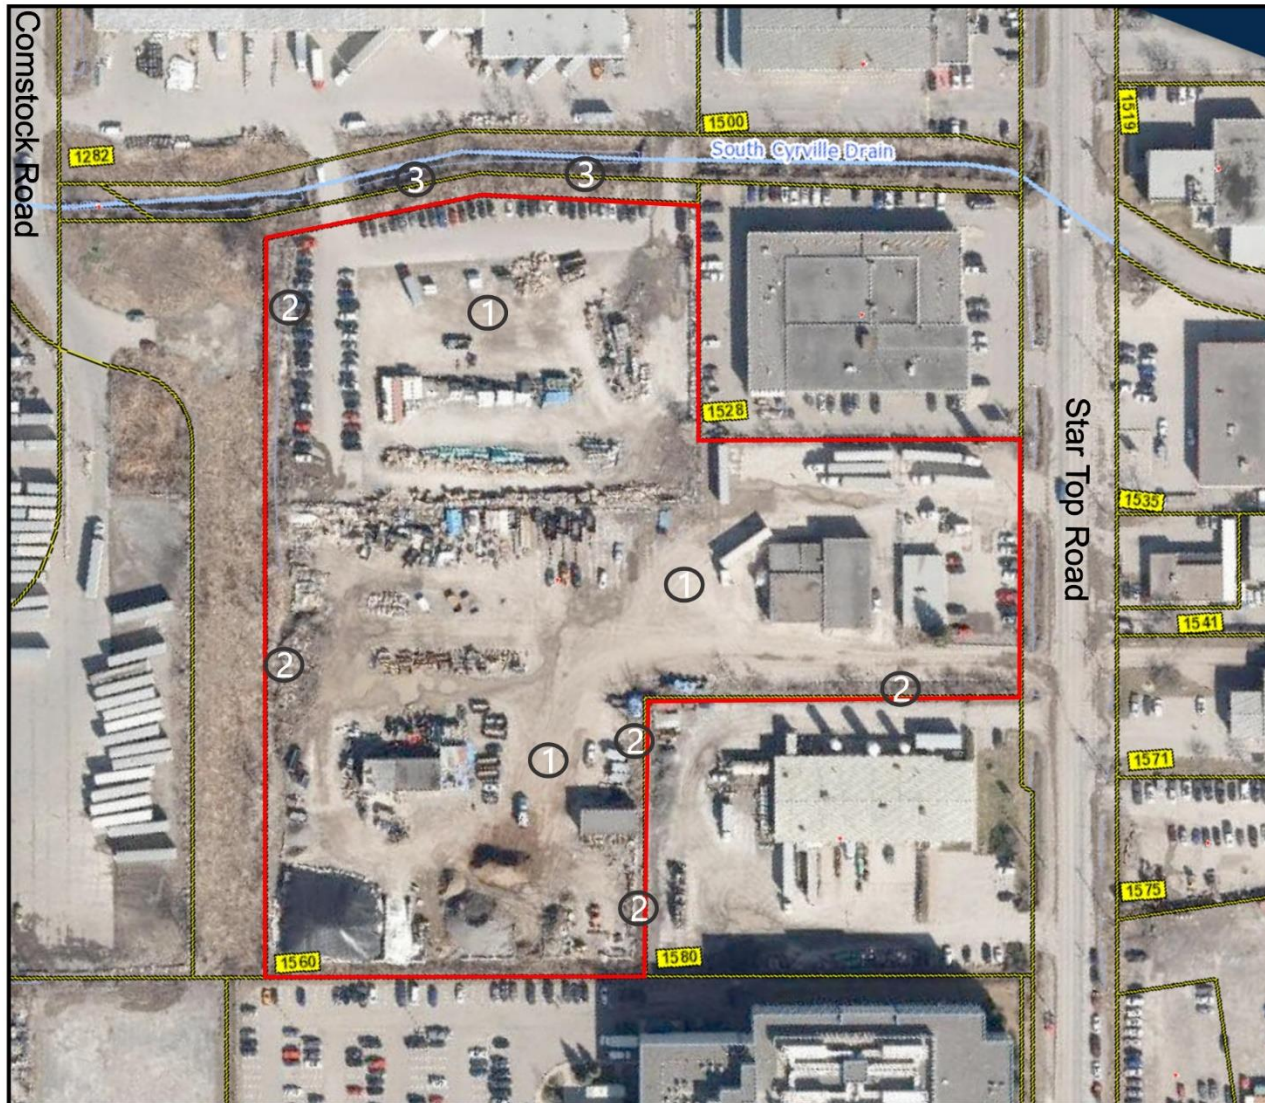
Figure 1

The site is within a light industrial area, including warehouses, commercial operations, automobile dealerships, and office buildings. The site is highly disturbed from a natural environment perspective and is dominated by gravel and asphalt areas used for surface storage and small one storey office and former maintenance buildings. The maintenance buildings were part of a former concrete plant and the offices of Transport Training Centres of Canada Inc. are currently in the east portion of the site. The South Cyrville Municipal Drain is immediately to the north of the site (Figure 1).
