Muncaster
Environmental
Planning Inc.

RE: 1540 Star Top Road, Gloucester
Environmental Impact Study - Updated

ENVIRONMENTAL IMPACT STATEMENT

**1540 Star Top Road
Gloucester, City of Ottawa**

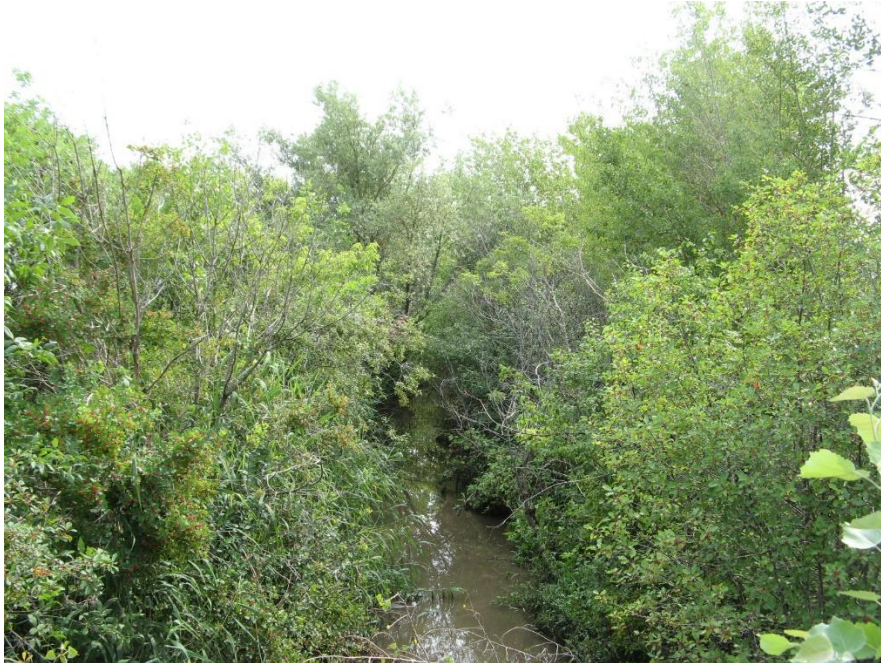
The wetted width of the South Cyrville Municipal Drain is between 2.5 and 3.5 metres. The water on July 11th was turbid (Photo 1). The canopy cover from an adjacent upland poplar deciduous forest is good in many areas. Small woody debris provides some instream habitat structure but there was no evidence of boulders, other coarse material, notable areas of aquatic vegetation, or undercut banks. The channel is straight with connecting sharp turns to the west of the site and as described above is open for approximately 750 metres.

*Photo 1 - South Cyrville Municipal Drain immediately to the north of the site.
View looking east from the northwest entrance to the site*

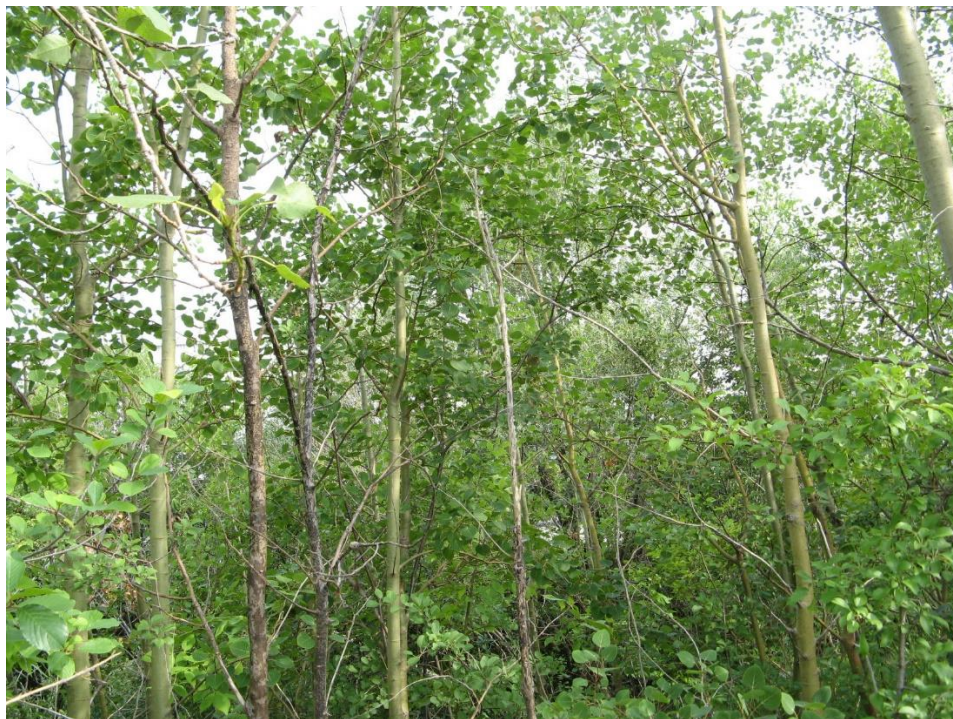
Photo 3 – The corridor between the Municipal Drain and the site is generally well treed with young poplars. View looking north from the centre of the north property line

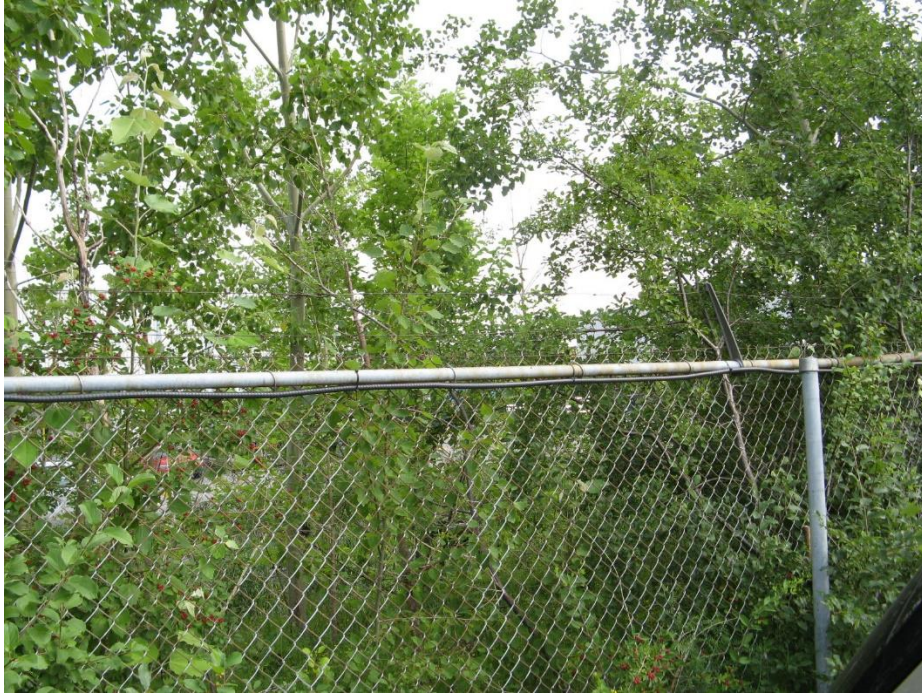
Photo 4 – The Municipal Drain corridor is protected with a chain-link fence along the north property line. This area has fewer trees and plantings are recommended to increase the diversity of the buffer function. View looking north

Natural buffers provide important functions such as filtering excess nutrients running into the channel, infiltrating rainwater, shading and food inputs for the channel, maintaining bank stability (though in this case retaining walls are present), contributing to baseflow, and providing wildlife habitat. The buffer immediately to the north of this site can be improved with plantings of native trees and shrubs where currently there are fewer poplar trees. This will provide a diversity compared to the existing woody vegetation. Recommended native species shown on the Landscape Plan completed by GJA Inc. (revised August 15th, 2024) in the buffer to the north include nannyberry, grey dogwood, and serviceberry shrubs along with sugar maple, red maple, basswood, and white spruce trees. Twenty trees and fifteen shrubs are proposed for planting in the corridor to the north. Obtaining native species from local seed sources is strongly recommended to promote adaptability and longevity.

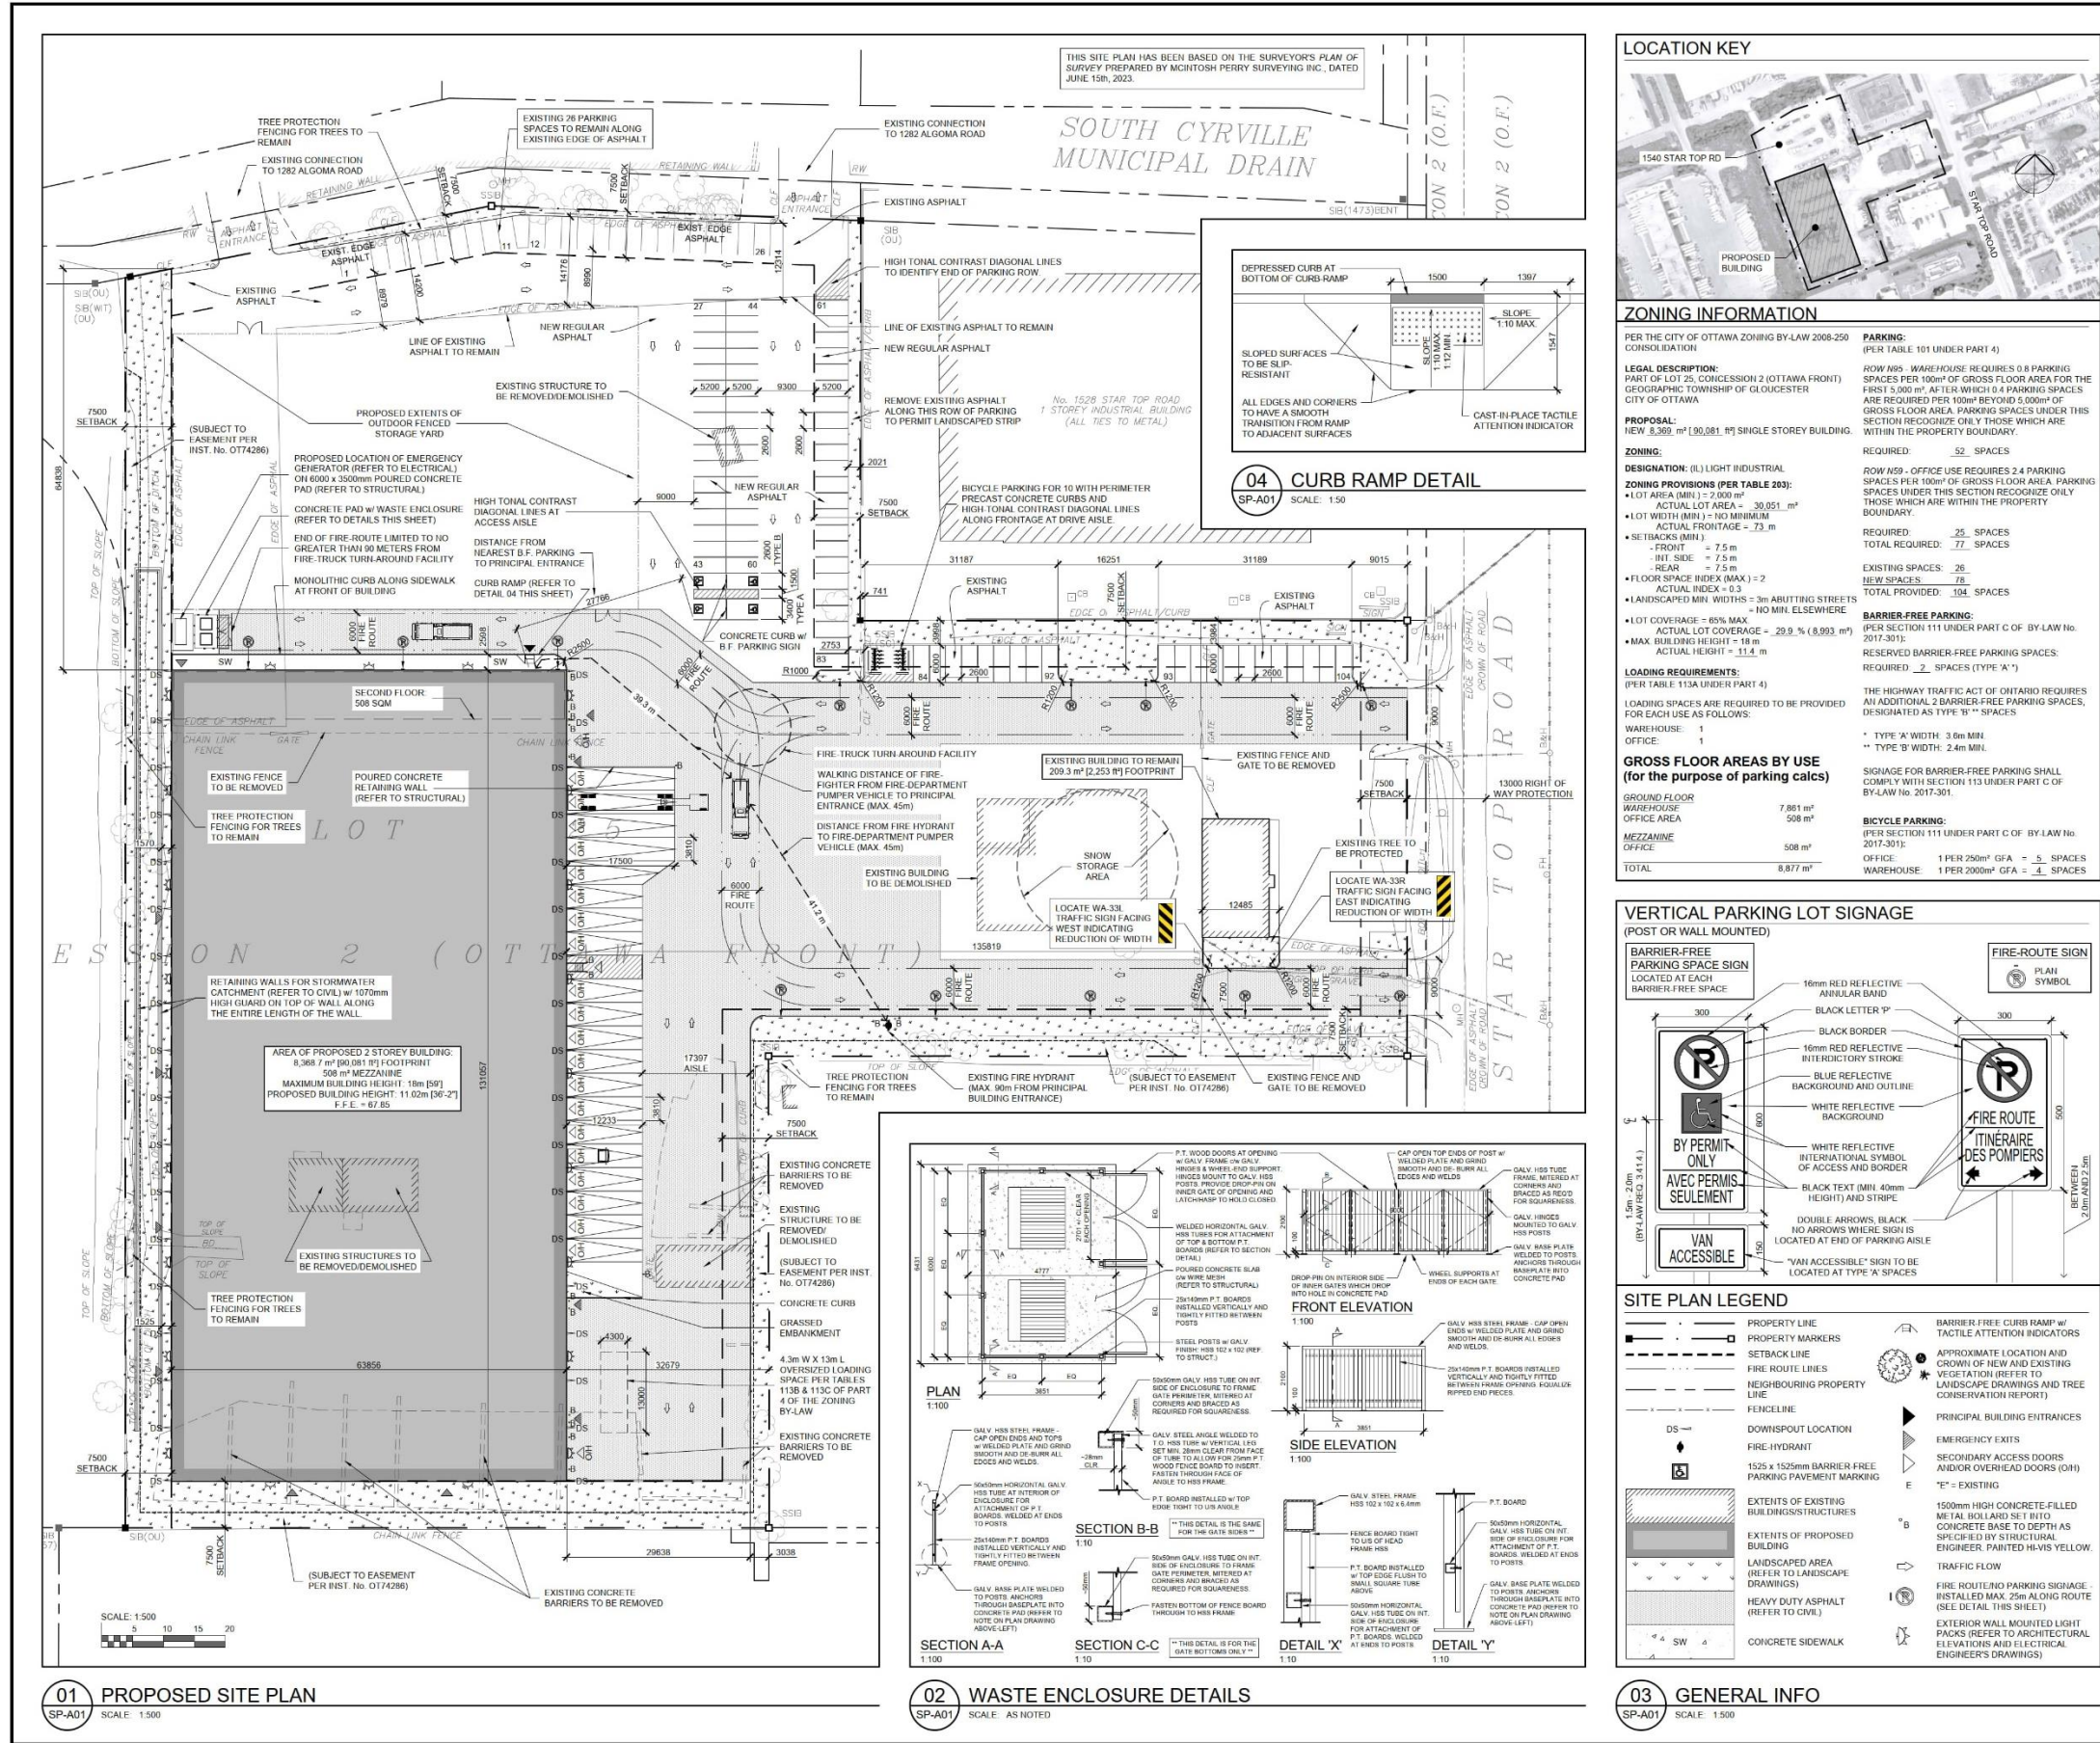
FIGURE 2 – SITE PLAN (by Deimling Architecture & Interior Design, Revised August 9, 2024)

It is proposed to construct a two storey building in the west portion of the site, with a footprint of approximately 90,000 sq ft (Figure 2). This building will be on mostly existing surface storage, with two small structures to be removed. There are two existing buildings in the east portion of the site. The smaller one closer to Star Top Road will be removed, with the one to the west, approximately 6,700 sq ft., to be retained. One-hundred and eight surface parking spaces will be provided, with the balance of the site to be used for access and an outdoor fenced storage yard.
