**RE: 1540 Star Top Road, Gloucester
Environmental Impact Study**

ENVIRONMENTAL IMPACT STATEMENT

**1540 Star Top Road
Gloucester, City of Ottawa**

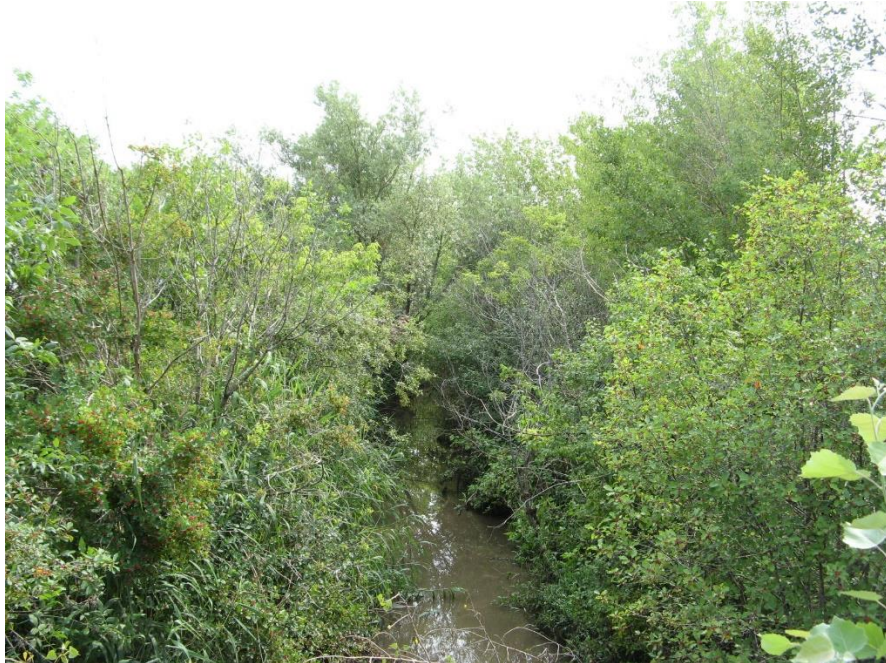
The wetted width of the South Cyrville Municipal Drain is between 2.5 and 3.5 metres. The water on July 11th was turbid (Photo 1). The canopy cover from an adjacent upland poplar deciduous forest is good in many areas. Small woody debris provides some instream habitat structure but there was no evidence of boulders, other coarse material, notable areas of aquatic vegetation, or undercut banks. The channel is straight with connecting sharp turns to the west of the site and as described above is open for approximately 750 metres.

*Photo 1 - South Cyrville Municipal Drain immediately to the north of the site.
View looking east from the northwest entrance to the site*

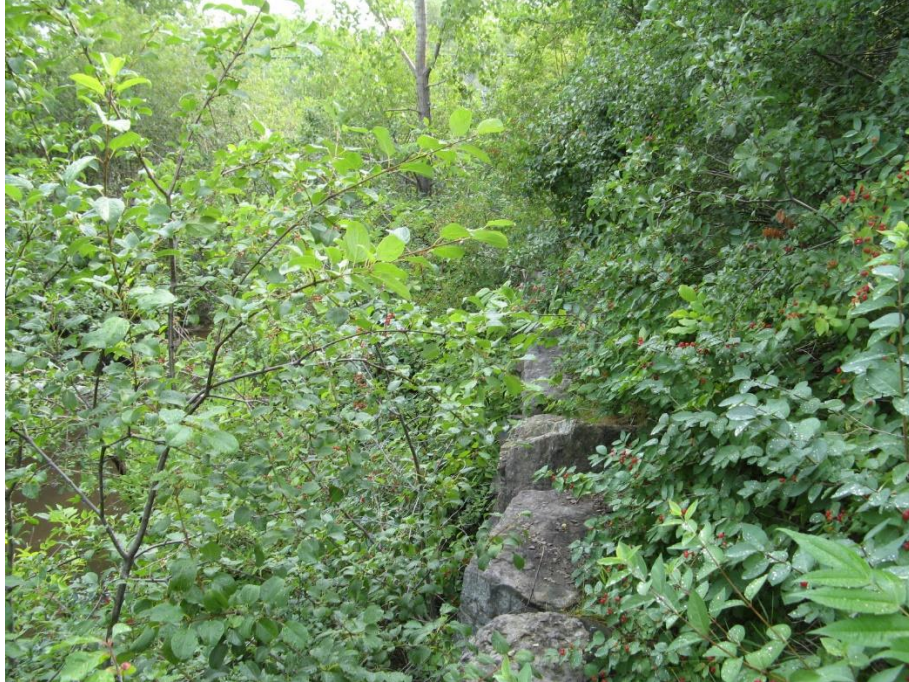
A retaining wall of large boulders is along the top of slope of both sides of the channel corridor (Photo 2). There is a setback of 7.5 metres from the retaining wall to the north edge of the site. Trembling aspens up to 30 cm diameter at breast height (dbh) are dominant in the setback, along with smaller green ash and Manitoba maple (Photos 3 and 4). The understory in the setback area is thick in most areas, with glossy buckthorn dominant in areas and staghorn sumac, red-osier dogwood, and tartarian honeysuckle common, along with regenerating stems of poplar, ash, and Manitoba maple. A chain-link fence is around the north and south edges of the channel setback and two surface connections crossing the channel between 1282 Algoma Road and the site (Photo 4). A gate in the fencing between the two crossing along the north site boundary provides access to the corridor, including for the plantings recommended below.

Photo 2 – South side of the Municipal Drain corridor to the north of the site, with large boulder retaining wall. View looking east, with site beginning 7.5 metres from wall

Although much less than a typical setback, a setback of 7.5 metres from the retaining wall top of slope to the south edge of the riparian corridor is considered suitable due to the highly disturbed nature of the channel, including limited exposed reaches, straight alignment that was excavated and associated artificial cross-section. The 7.5 metres setback is greater than that provided for other open sections of the Drain to the west of the site. The drain is enclosed to the east of Star Top Road.

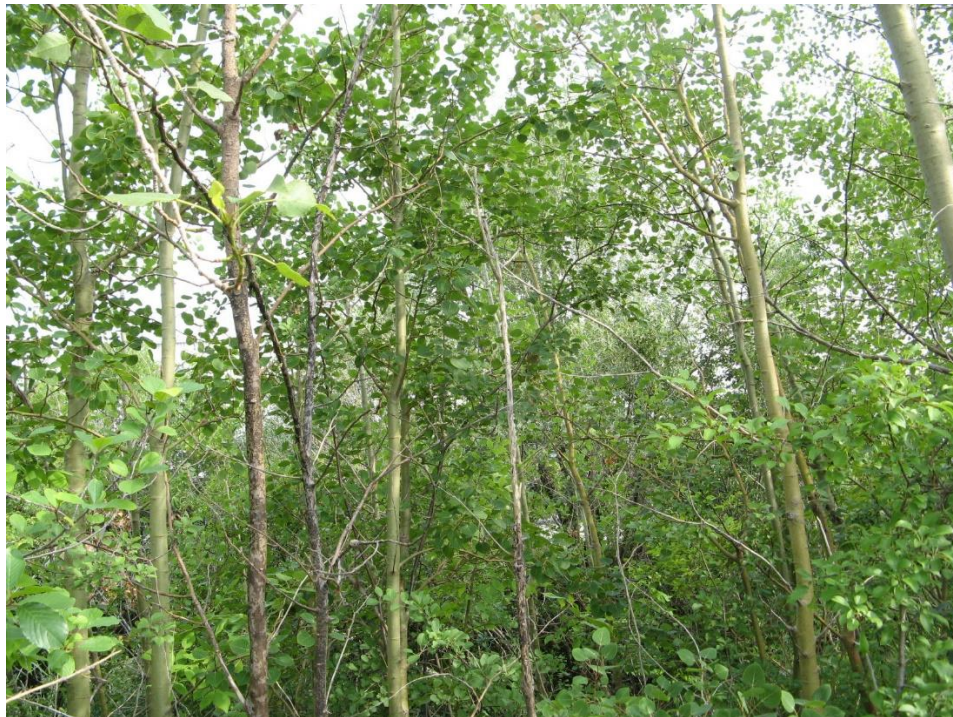
Photo 3 – The corridor between the Municipal Drain and the site is generally well treed with young poplars. View looking north from the centre of the north property line

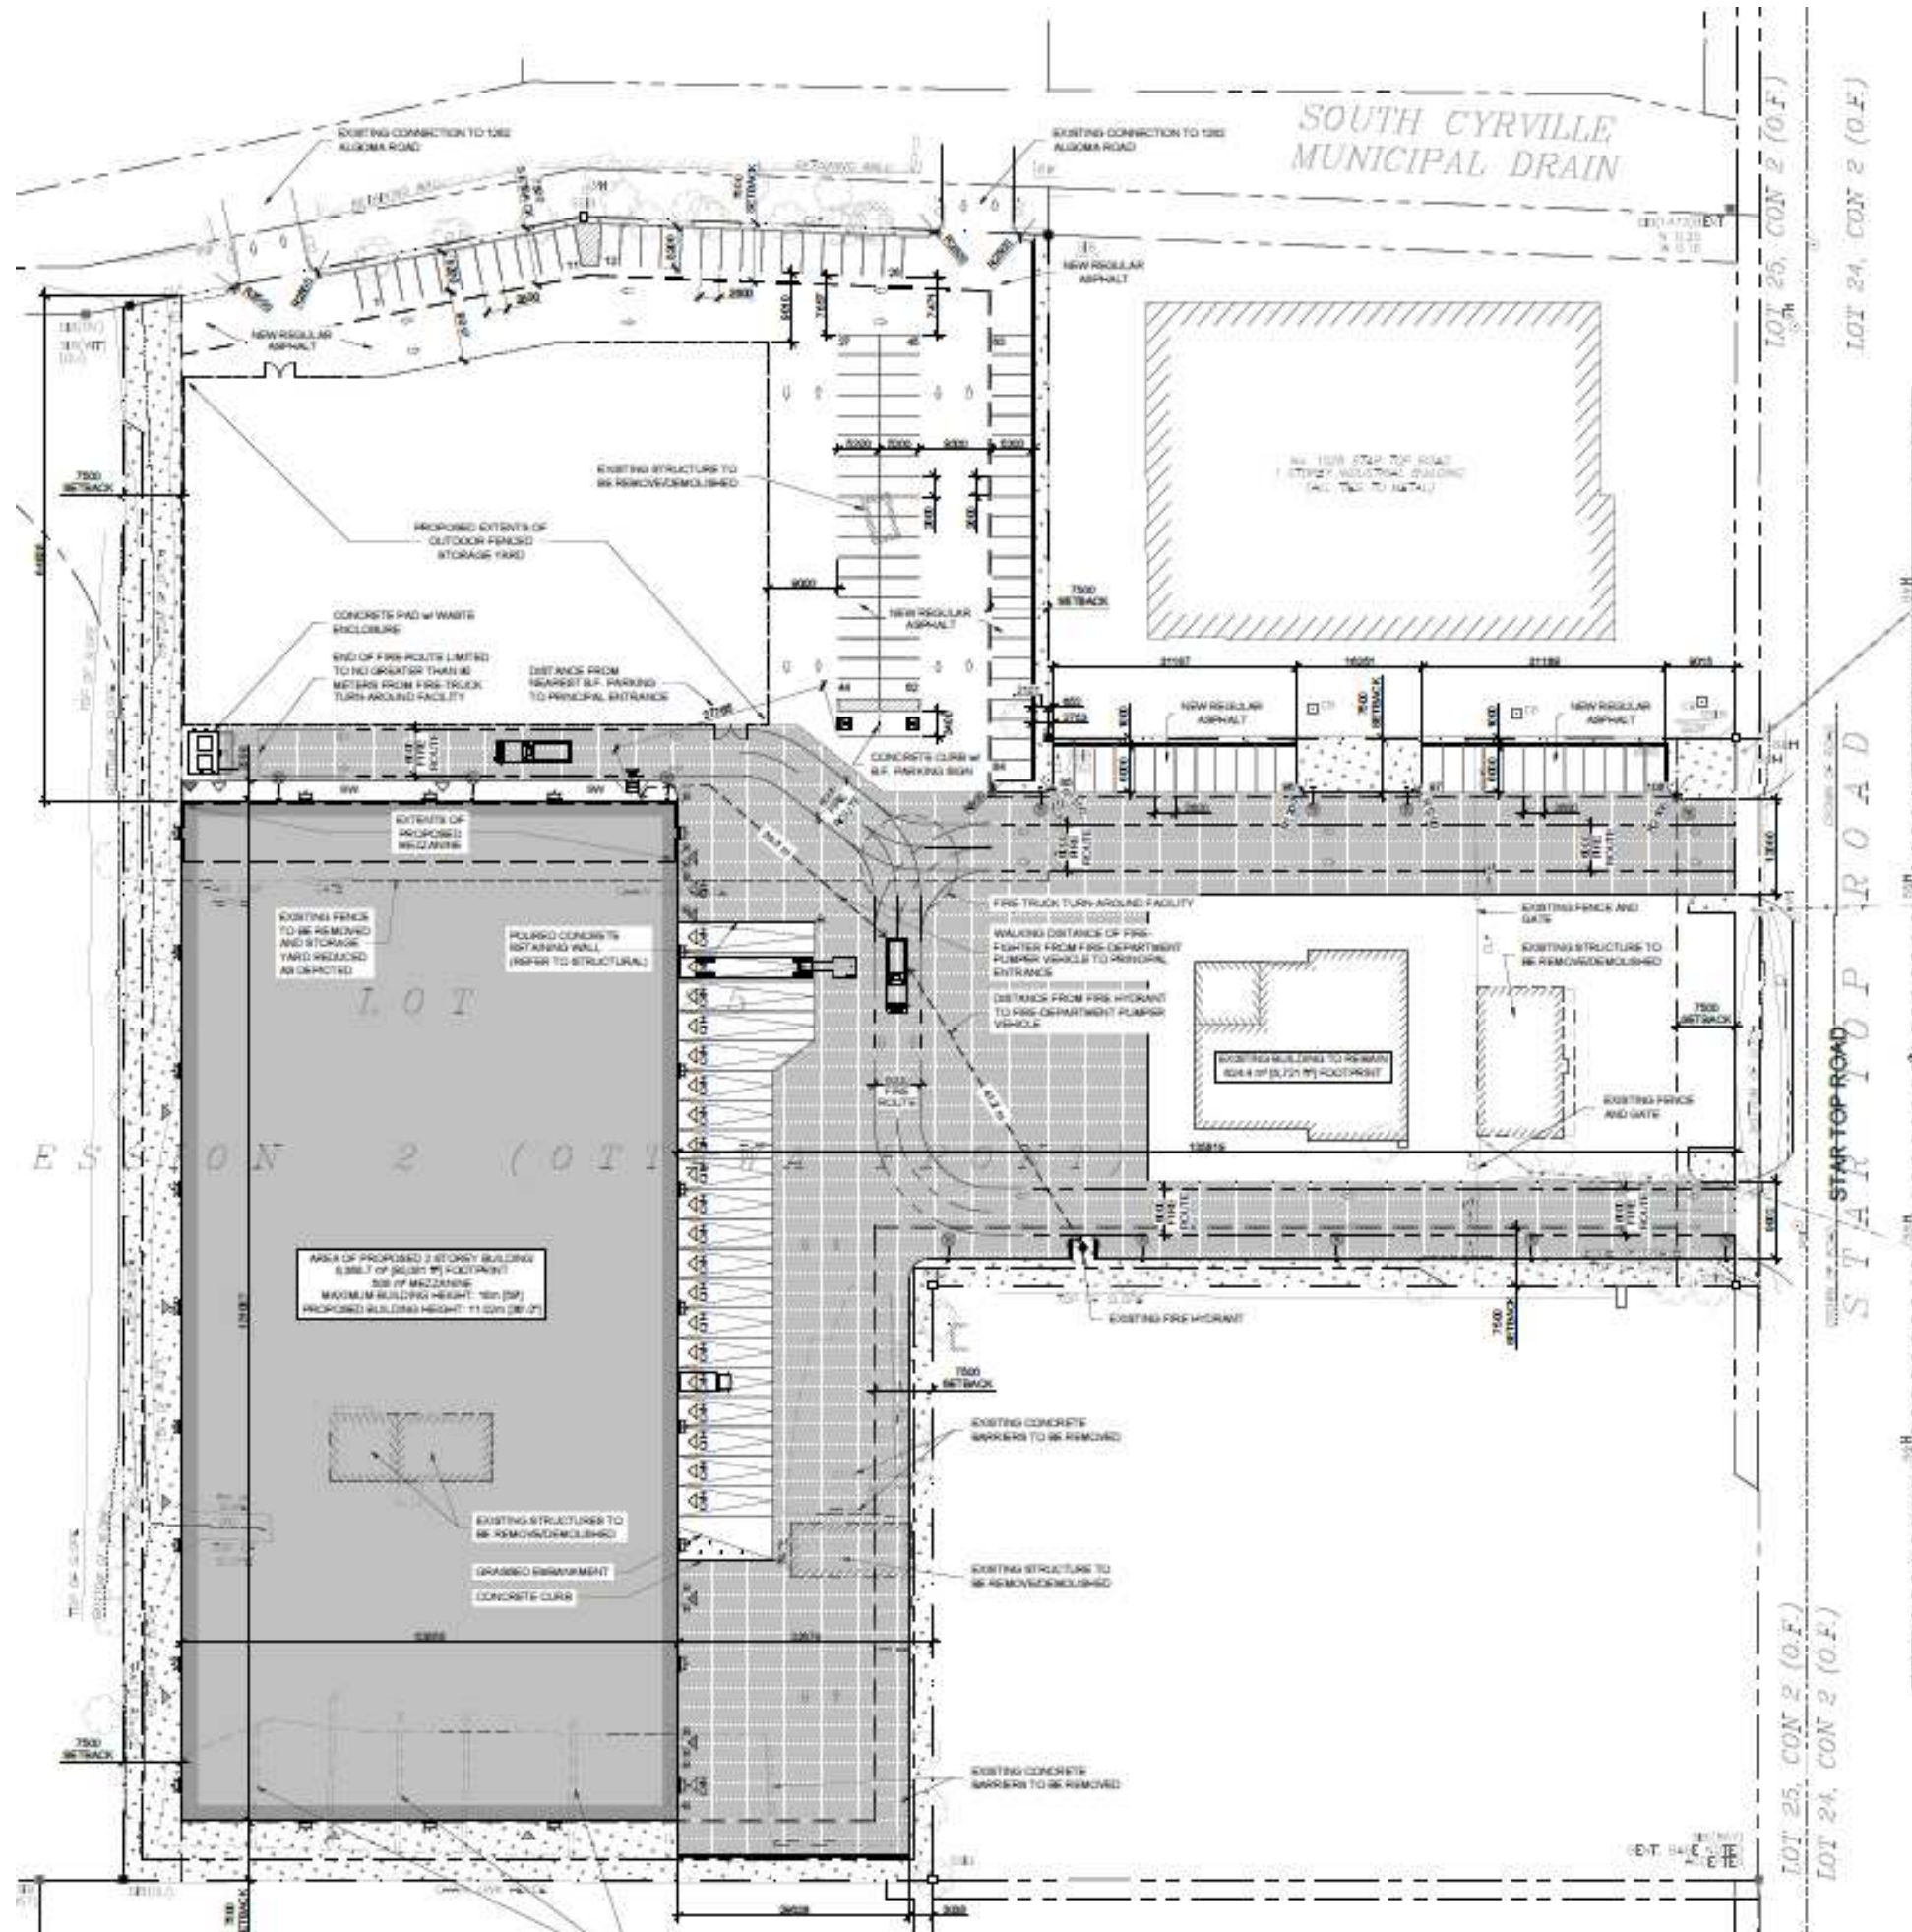
FIGURE 2 – SITE PLAN (by Deimling Architecture & Interior Design)

It is proposed to construct a two storey building in the west portion of the site, with a footprint of approximately 90,000 sq ft (Figure 2). This building will be on mostly existing surface storage, with two small structures to be removed. There are two existing buildings in the east portion of the site. The smaller one closer to Star Top Road will be removed, with the one to the west, approximately 6,700 sq ft., to be retained. One-hundred and eight surface parking spaces will be provided, with the balance of the site to be used for access and an outdoor fenced storage yard.
