98 + 100 BEARBROOK LANDRIC HOMES
98 + 100 BEARBROOK ROAD
OTTAWA, ON, K1B 3B9

PRE-DEVELOPMENT VEGETATION

DRAWING TITLE: POST-DEVELOPMENT VEGETATION

LANDSCAPE PLAN

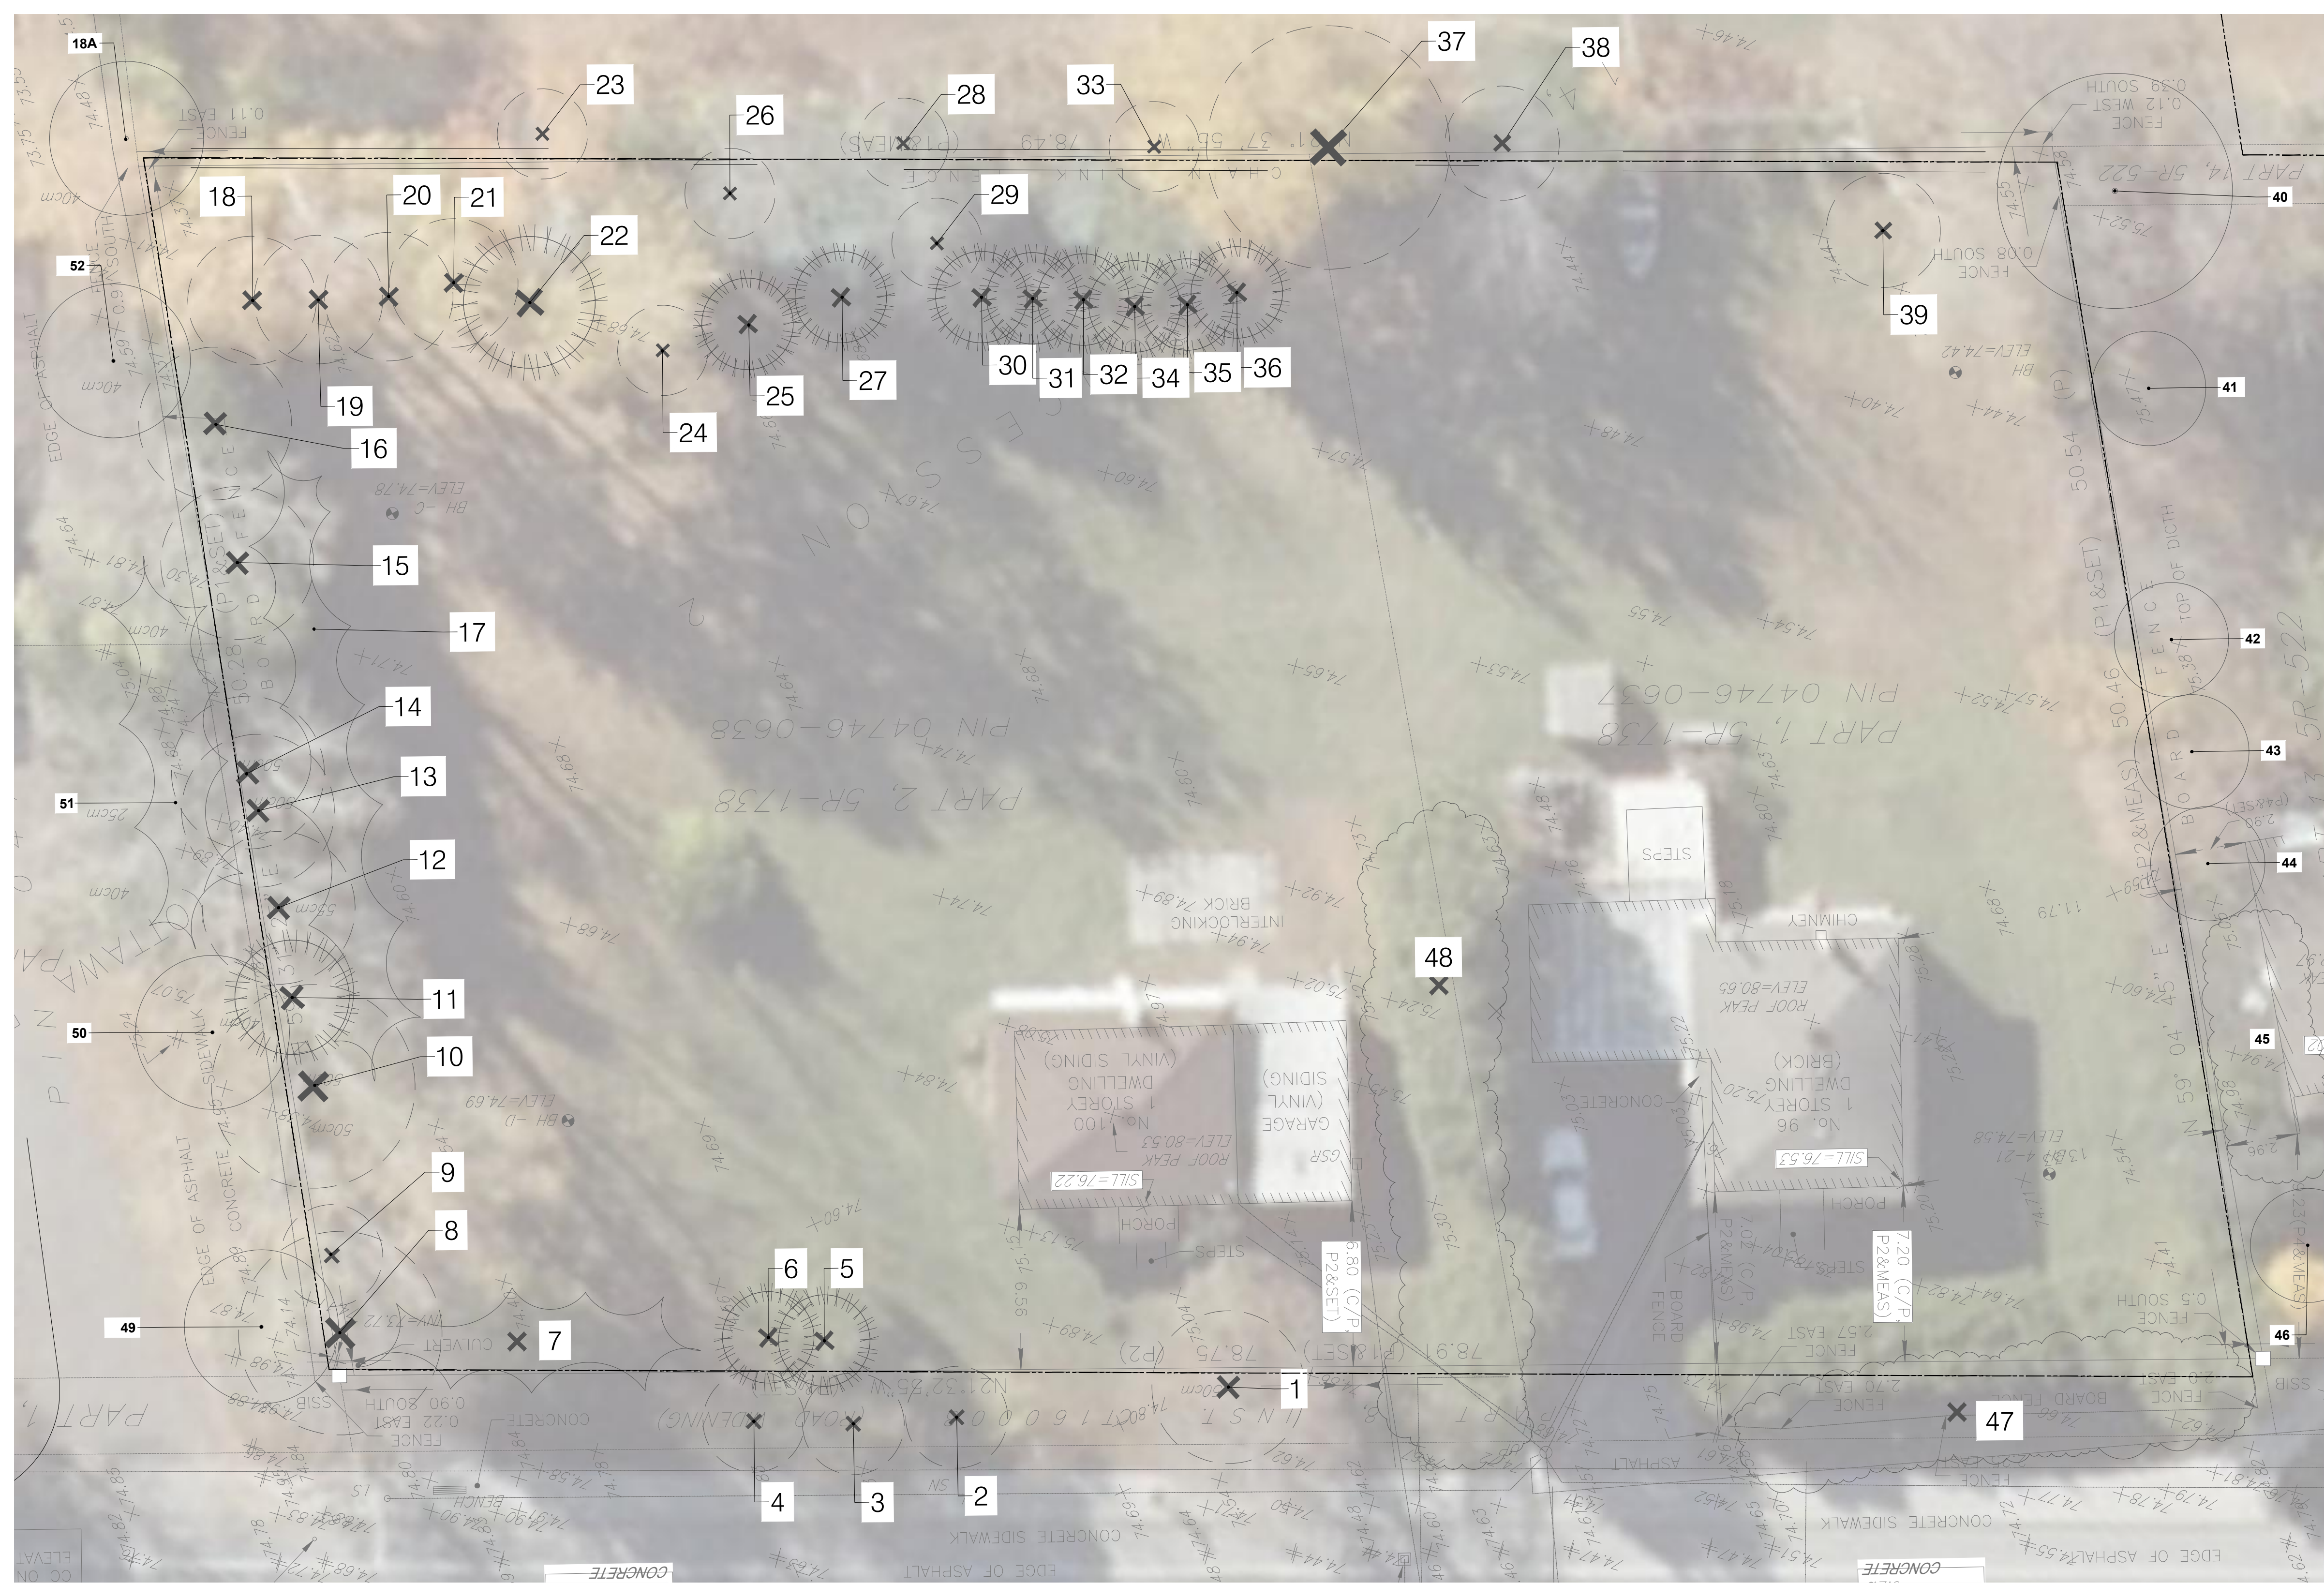
1 PRE-DEVELOPMENT PLAN

TREES TO REMAIN				
NO.	SPECIES	DBH (CM)	HEALTH	COMMENTS
18	Trembling Aspen/ <i>Populus tremuloides</i>	35	Good	Adjacent Property
40	Manitoba Maple / <i>Acer negundo</i>	52	Fair	Adjacent Property. Identified as #1 in dendron report
41	Manitoba Maple / <i>Acer negundo</i>	20	Poor	Adjacent Property
42	Red Maple / <i>Acer rubrum</i>	20	Good	Adjacent Property
43	Apple / <i>Malus sp.</i>	20, 22, 18	Poor	Adjacent Property
44	Manitoba Maple / <i>Acer negundo</i>	33	Fair	Adjacent Property
45	European Buckthorn / <i>Rhamnus cathartica</i>	10-15	Fair	Adjacent Property, Hedge
46	Red Maple / <i>Acer rubrum</i>	16	Fair	Adjacent Property
49	Norway Maple/ <i>Acer platanoides</i>	30	Poor	Adjacent Property
50	Norway Maple/ <i>Acer platanoides</i>	30	Fair	Adjacent Property
51	Austrian Pine / <i>Pinus nigra</i>	20-28	Good	Adjacent Property, 4 Stems
52	Norway Maple/ <i>Acer platanoides</i>	40	Good	Adjacent Property

TREES ON CITY PROPERTY TO BE REMOVED				
NO.	SPECIES	DBH (CM)	HEALTH	COMMENTS
1	Basswood/ <i>Tilia americana</i>	46	Good	
2	Apple sp. / <i>Malus sp.</i>	33	Poor	Poor pruning / dieback
3	Apple sp. / <i>Malus sp.</i>	22	Poor	Poor pruning / dieback
4	Apple sp. / <i>Malus sp.</i>	14 / 15	Poor	Poor pruning / dieback
47	Eastern White Cedar / <i>Thuja occidentalis</i>	8-14	Poor-Fair	Hedge

TREES ON PRIVATE PROPERTY TO BE REMOVED				
NO.	SPECIES	DBH (CM)	HEALTH	COMMENTS
5	Eastern White Cedar / <i>Thuja occidentalis</i>	19	Good	
6	Eastern White Cedar / <i>Thuja occidentalis</i>	20	Good	
7	Eastern White Cedar / <i>Thuja occidentalis</i>	8-14	Fair	Hedge
8	Silver Maple / <i>Acer saccharinum</i>	15, 15, 20, 26, 32	Fair	5 stems joined at 1.3m
9	Silver Maple / <i>Acer saccharinum</i>	10, 13, 13, 15	Fair	4 stems joined at base
10	Eastern Cottonwood / <i>Populus deltoides</i>	43, 45	Good	2 stems joined at 1.0m
11	Eastern White Cedar / <i>Thuja occidentalis</i>	35	Good	
12	Eastern Cottonwood / <i>Populus deltoides</i>	64	Good
