Phase I Environmental Site Assessment

2506 Innes Road
Ottawa, Ontario

Report: PE6214-1R
November 29, 2023

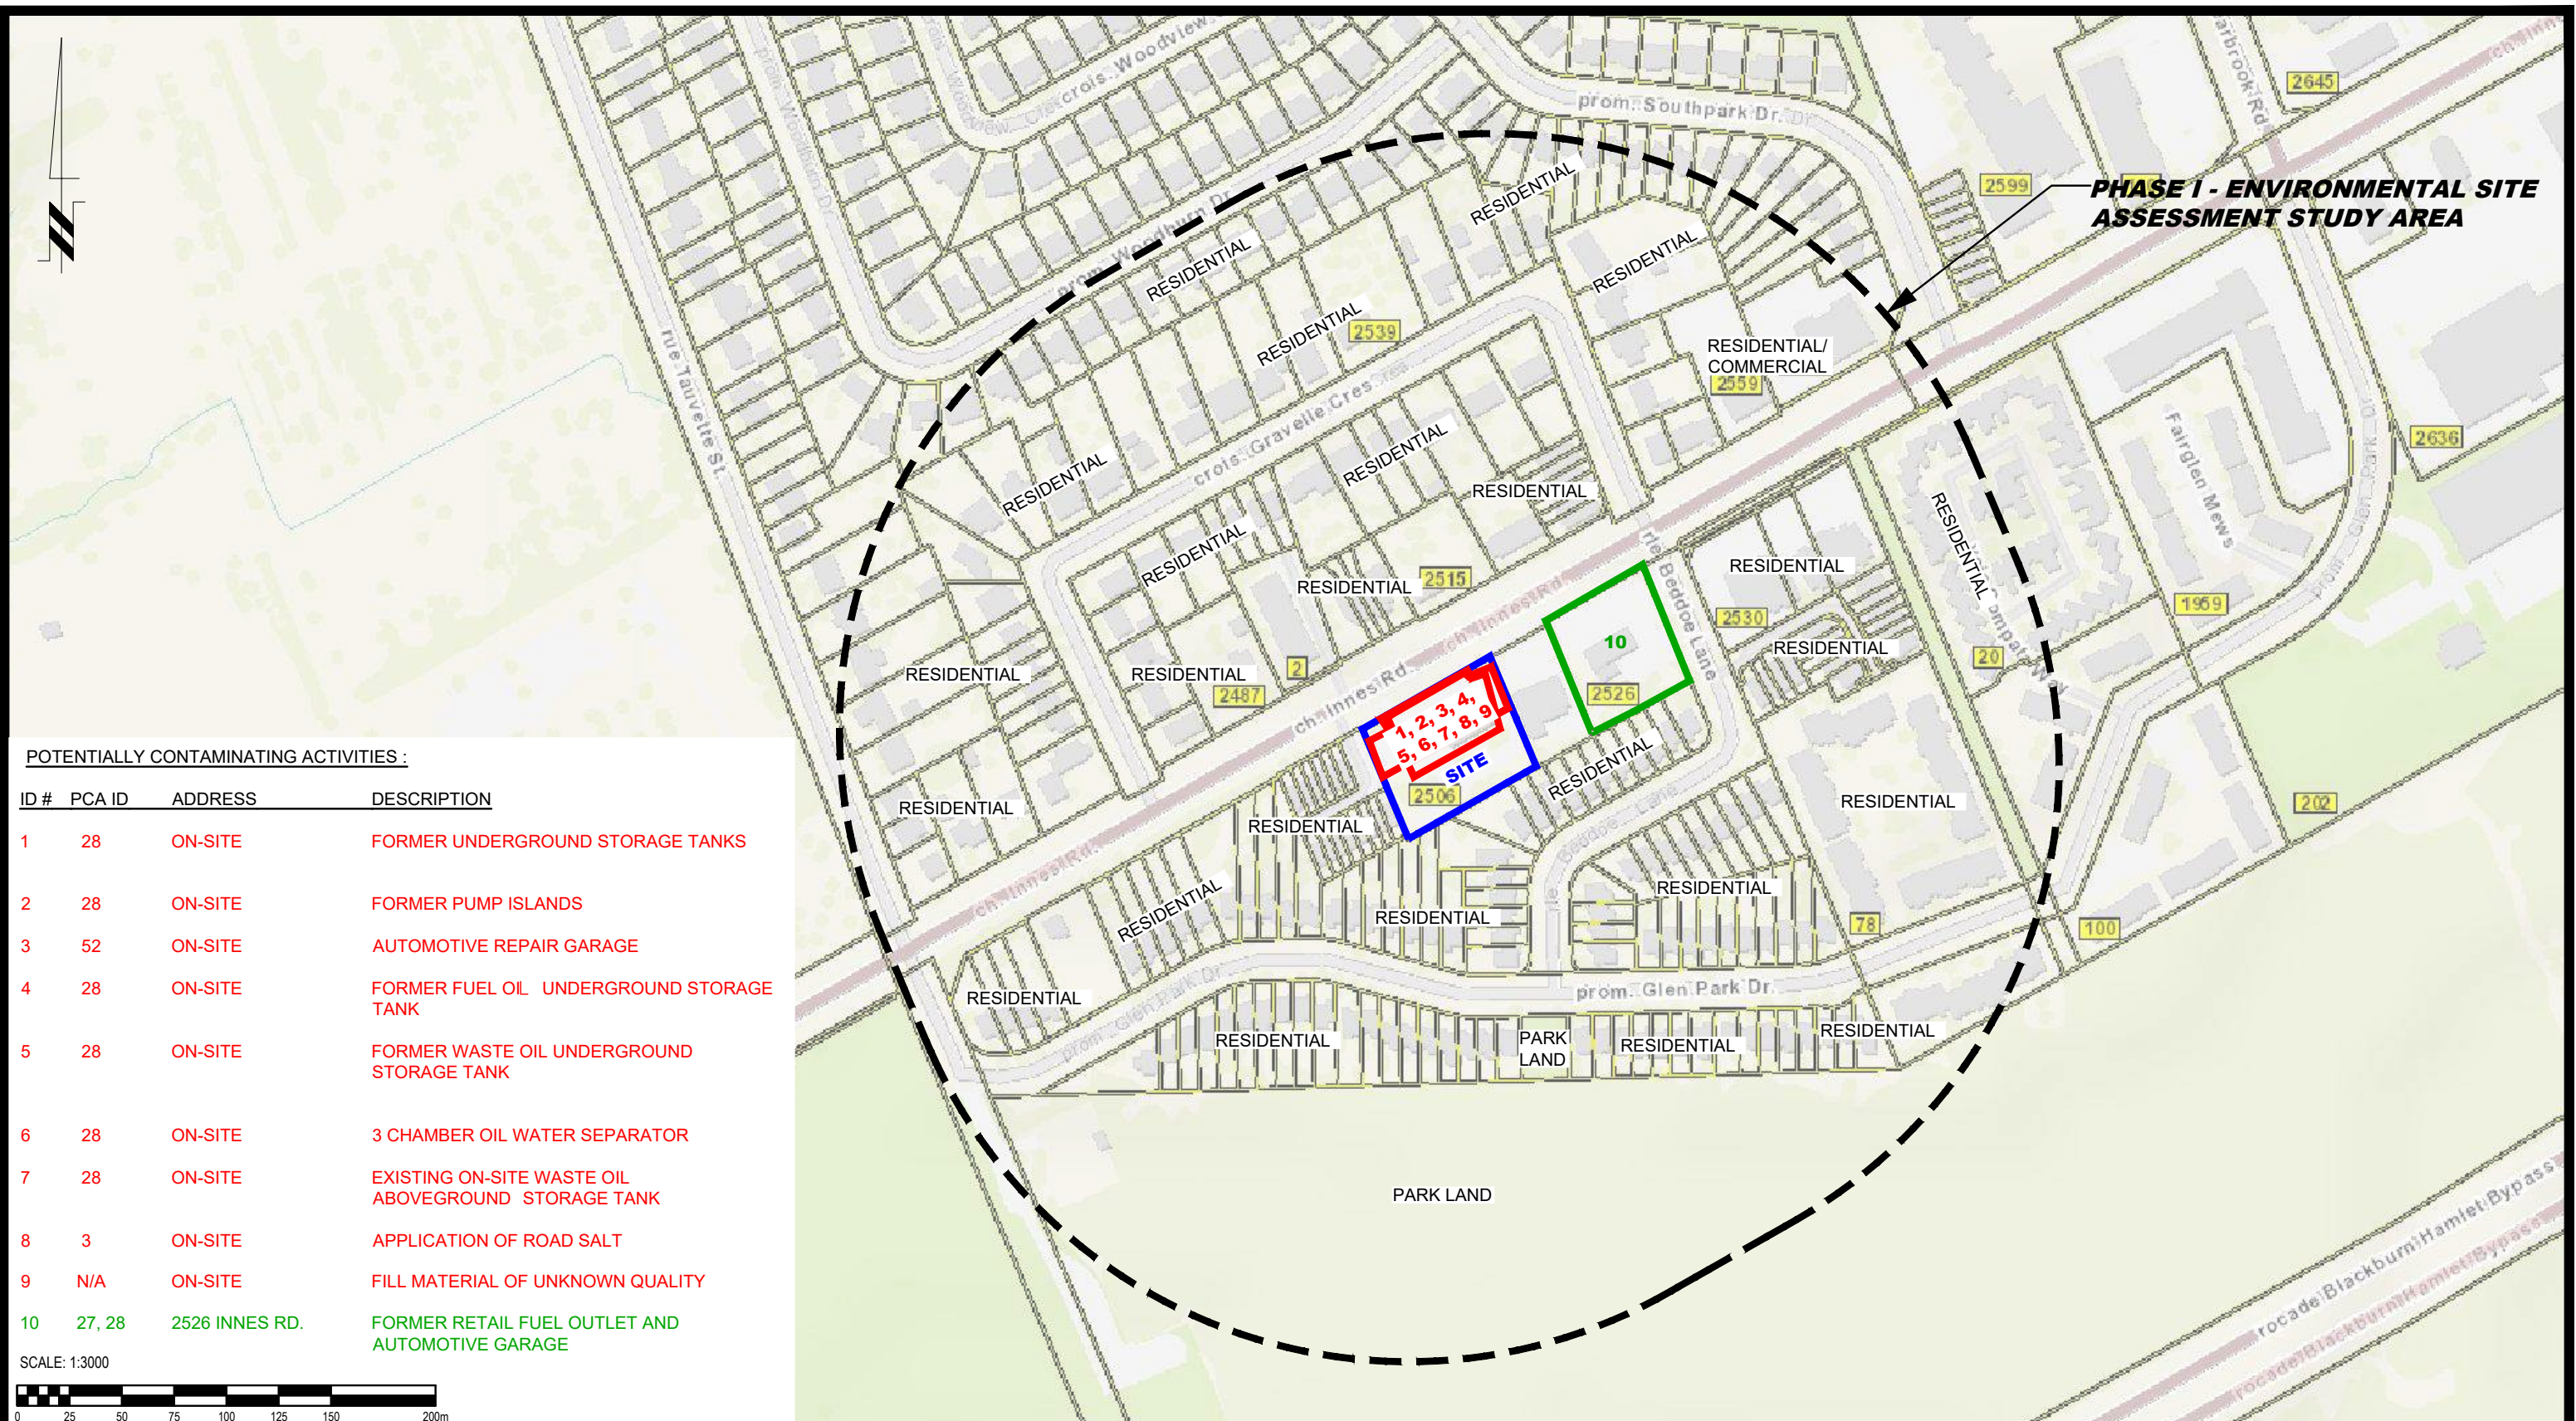
PHASE I - ENVIRONMENTAL SITE ASSESSMENT STUDY AREA

POTENTIALLY CONTAMINATING ACTIVITIES :

ID #	PCA ID	ADDRESS	DESCRIPTION
1	28	ON-SITE	FORMER UNDERGROUND STORAGE TANKS
2	28	ON-SITE	FORMER PUMP ISLANDS
3	52	ON-SITE	AUTOMOTIVE REPAIR GARAGE
4	28	ON-SITE	FORMER FUEL OIL UNDERGROUND STORAGE TANK
5	28	ON-SITE	FORMER WASTE OIL UNDERGROUND STORAGE TANK
6	28	ON-SITE	3 CHAMBER OIL WATER SEPARATOR
7	28	ON-SITE	EXISTING ON-SITE WASTE OIL ABOVEGROUND STORAGE TANK
8	3	ON-SITE	APPLICATION OF ROAD SALT
9	N/A	ON-SITE	FILL MATERIAL OF UNKNOWN QUALITY
10	27, 28	2526 INNES RD.	FORMER RETAIL FUEL OUTLET AND AUTOMOTIVE GARAGE

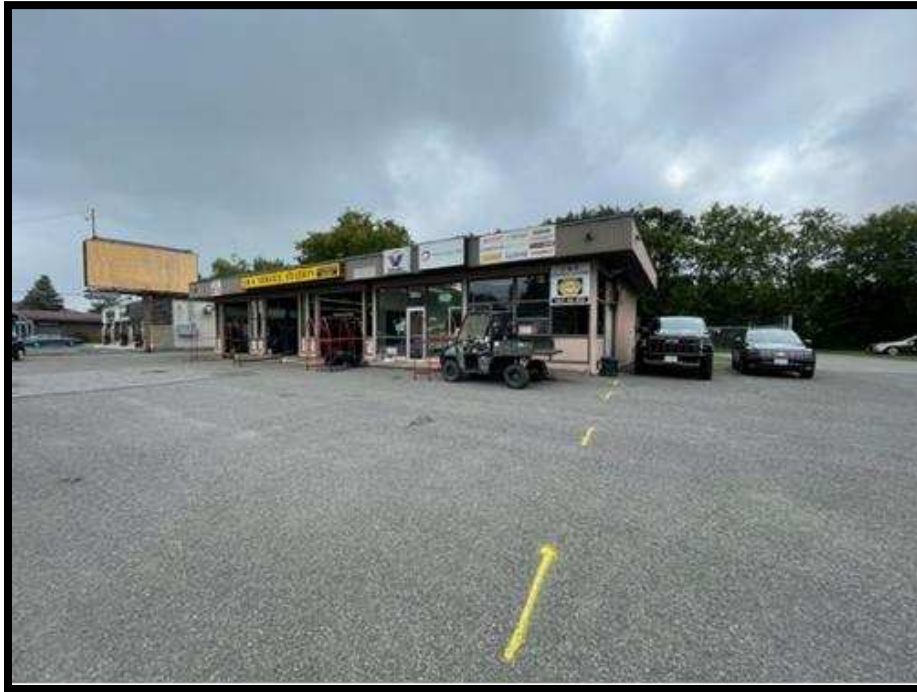
Photograph 1: View of the Phase I Property, facing south from Innes Road.

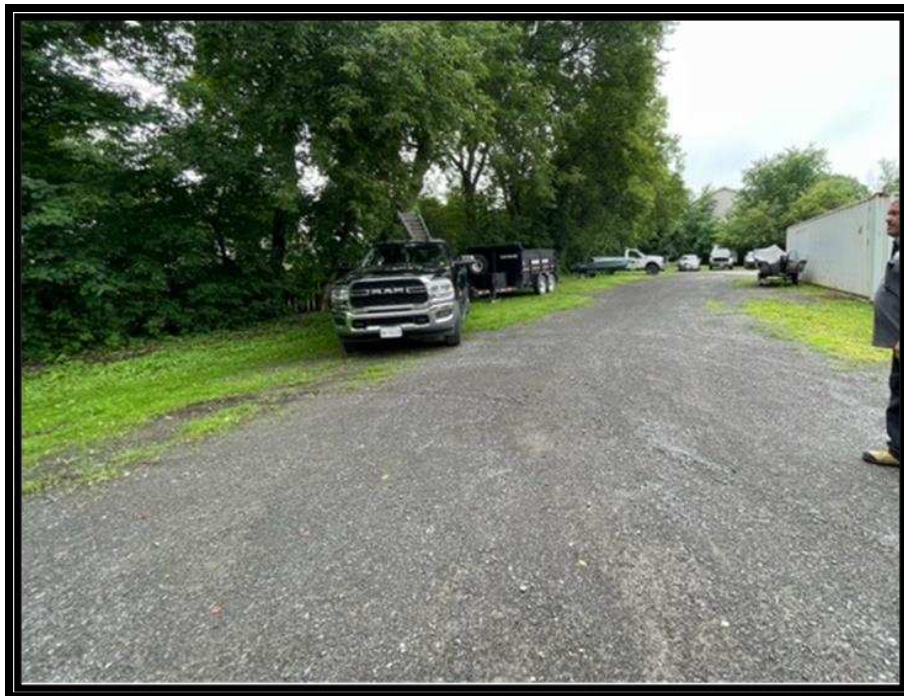
Photograph 4: View of the southern side of the Phase I Property, facing west.

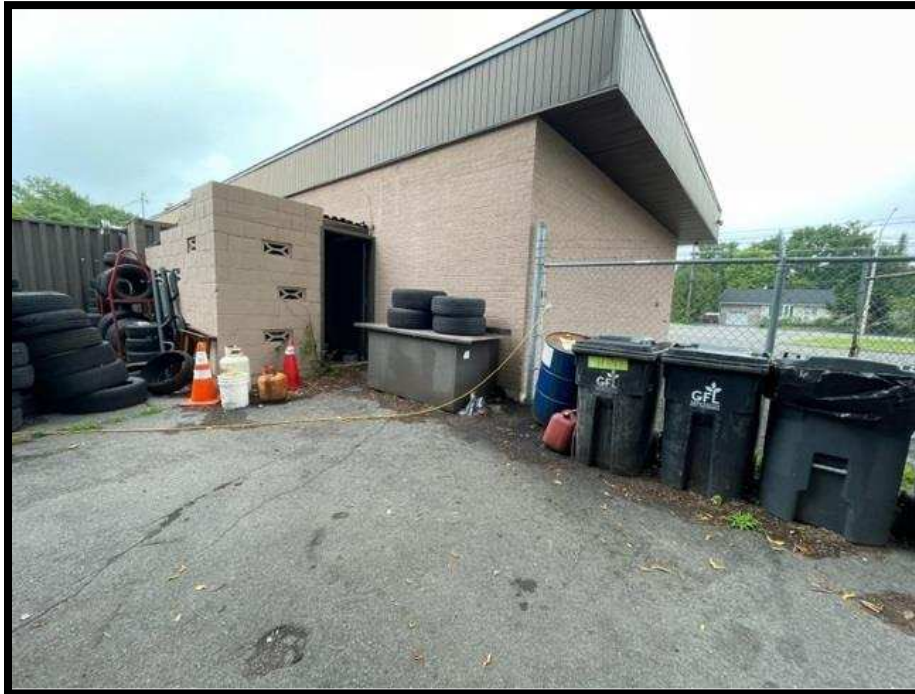
One waste oil AST was noted on the eastern side of the south exterior wall of the subject building. Some minor staining was noted on the ground surface in the immediate area of the AST.

Photograph 7: View of the exterior south wall on the eastern side of the Phase I Property showing the waste oil AST (with 4 tires stacked on top of it).

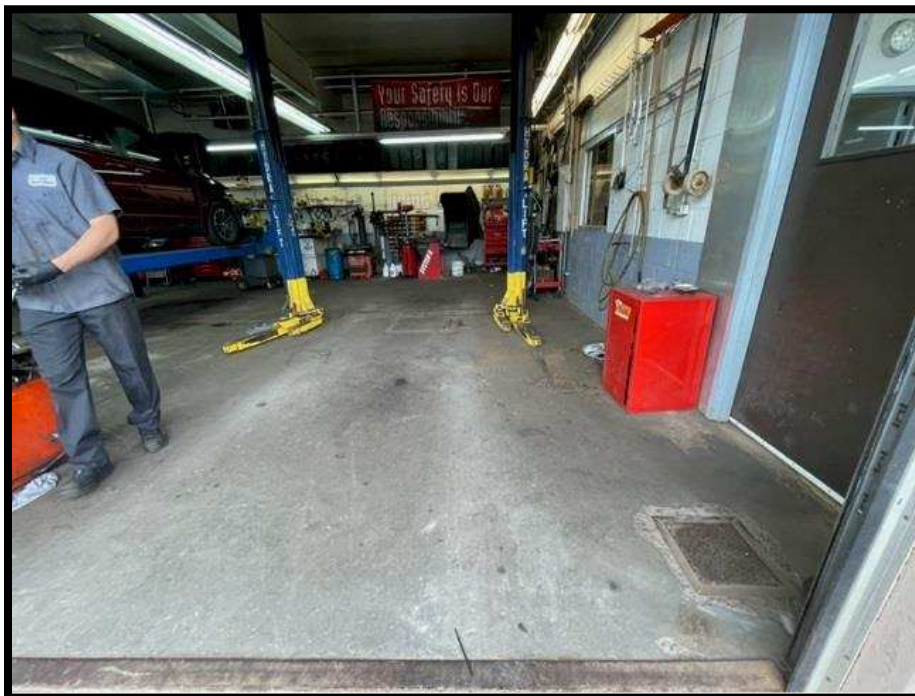
Engine oil, transmission and brake fluids, greasing and degreasing chemicals were noted along the interior south wall stored in properly labelled containers and bins. No potential environmental concerns were noted with storage and handling of chemicals.

Photograph 8: Interior view of the subject building (service garage).

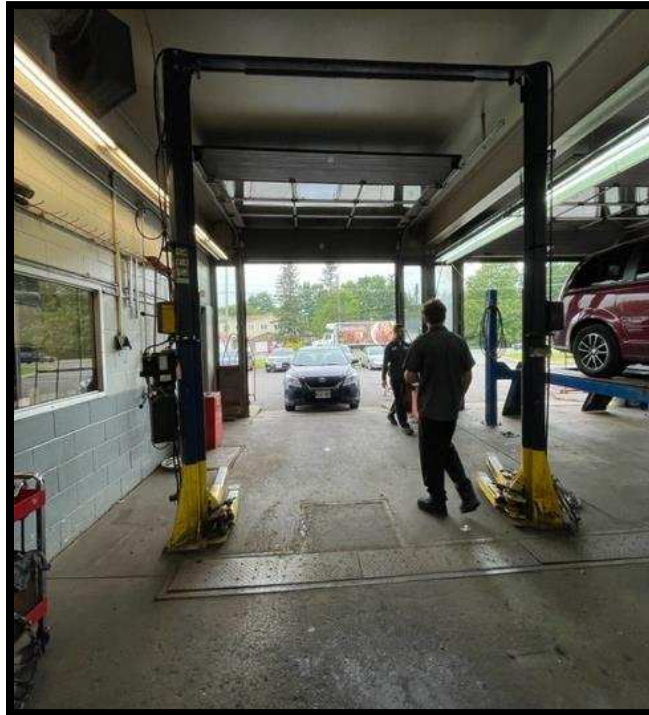
At the time of the site visit, the 3-chamber water-oil separator was noted and in-use, inside the garage. The oil-water separator is emptied on an as-needed-basis by a licenced contractor. Waste oil produced on-site as part of the automotive service garage operation is stored on-site in an (approximately) 800-L capacity AST. The waste-oil AST is situated on the eastern side of the south exterior wall of the subject building. Three service bays with above ground electric hoists were noted as well.

Photograph 9: Interior view of the garage showing the oil-water separator channel.

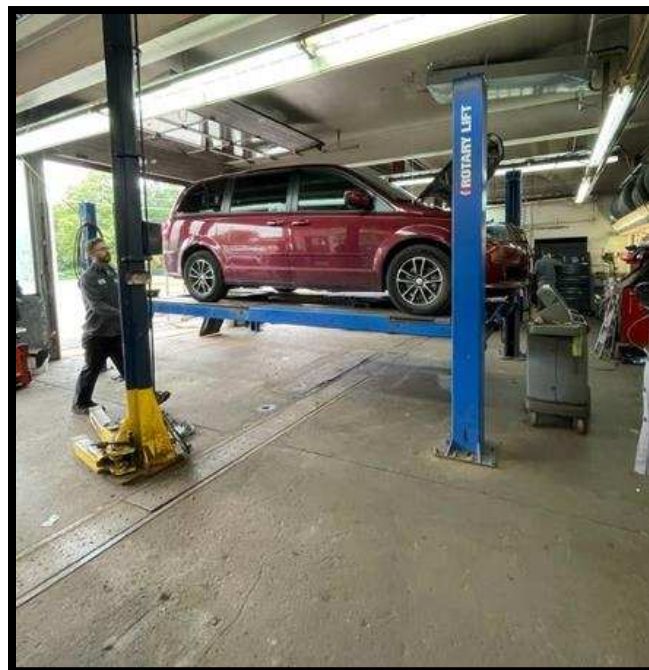
Photograph 10: Another interior view of the garage and oil-water separator channel.
