**Tree Conservation Report
Proposed Development Application
788 March Road
Ottawa, Ontario**

September 20, 2024
Project: 103027.001

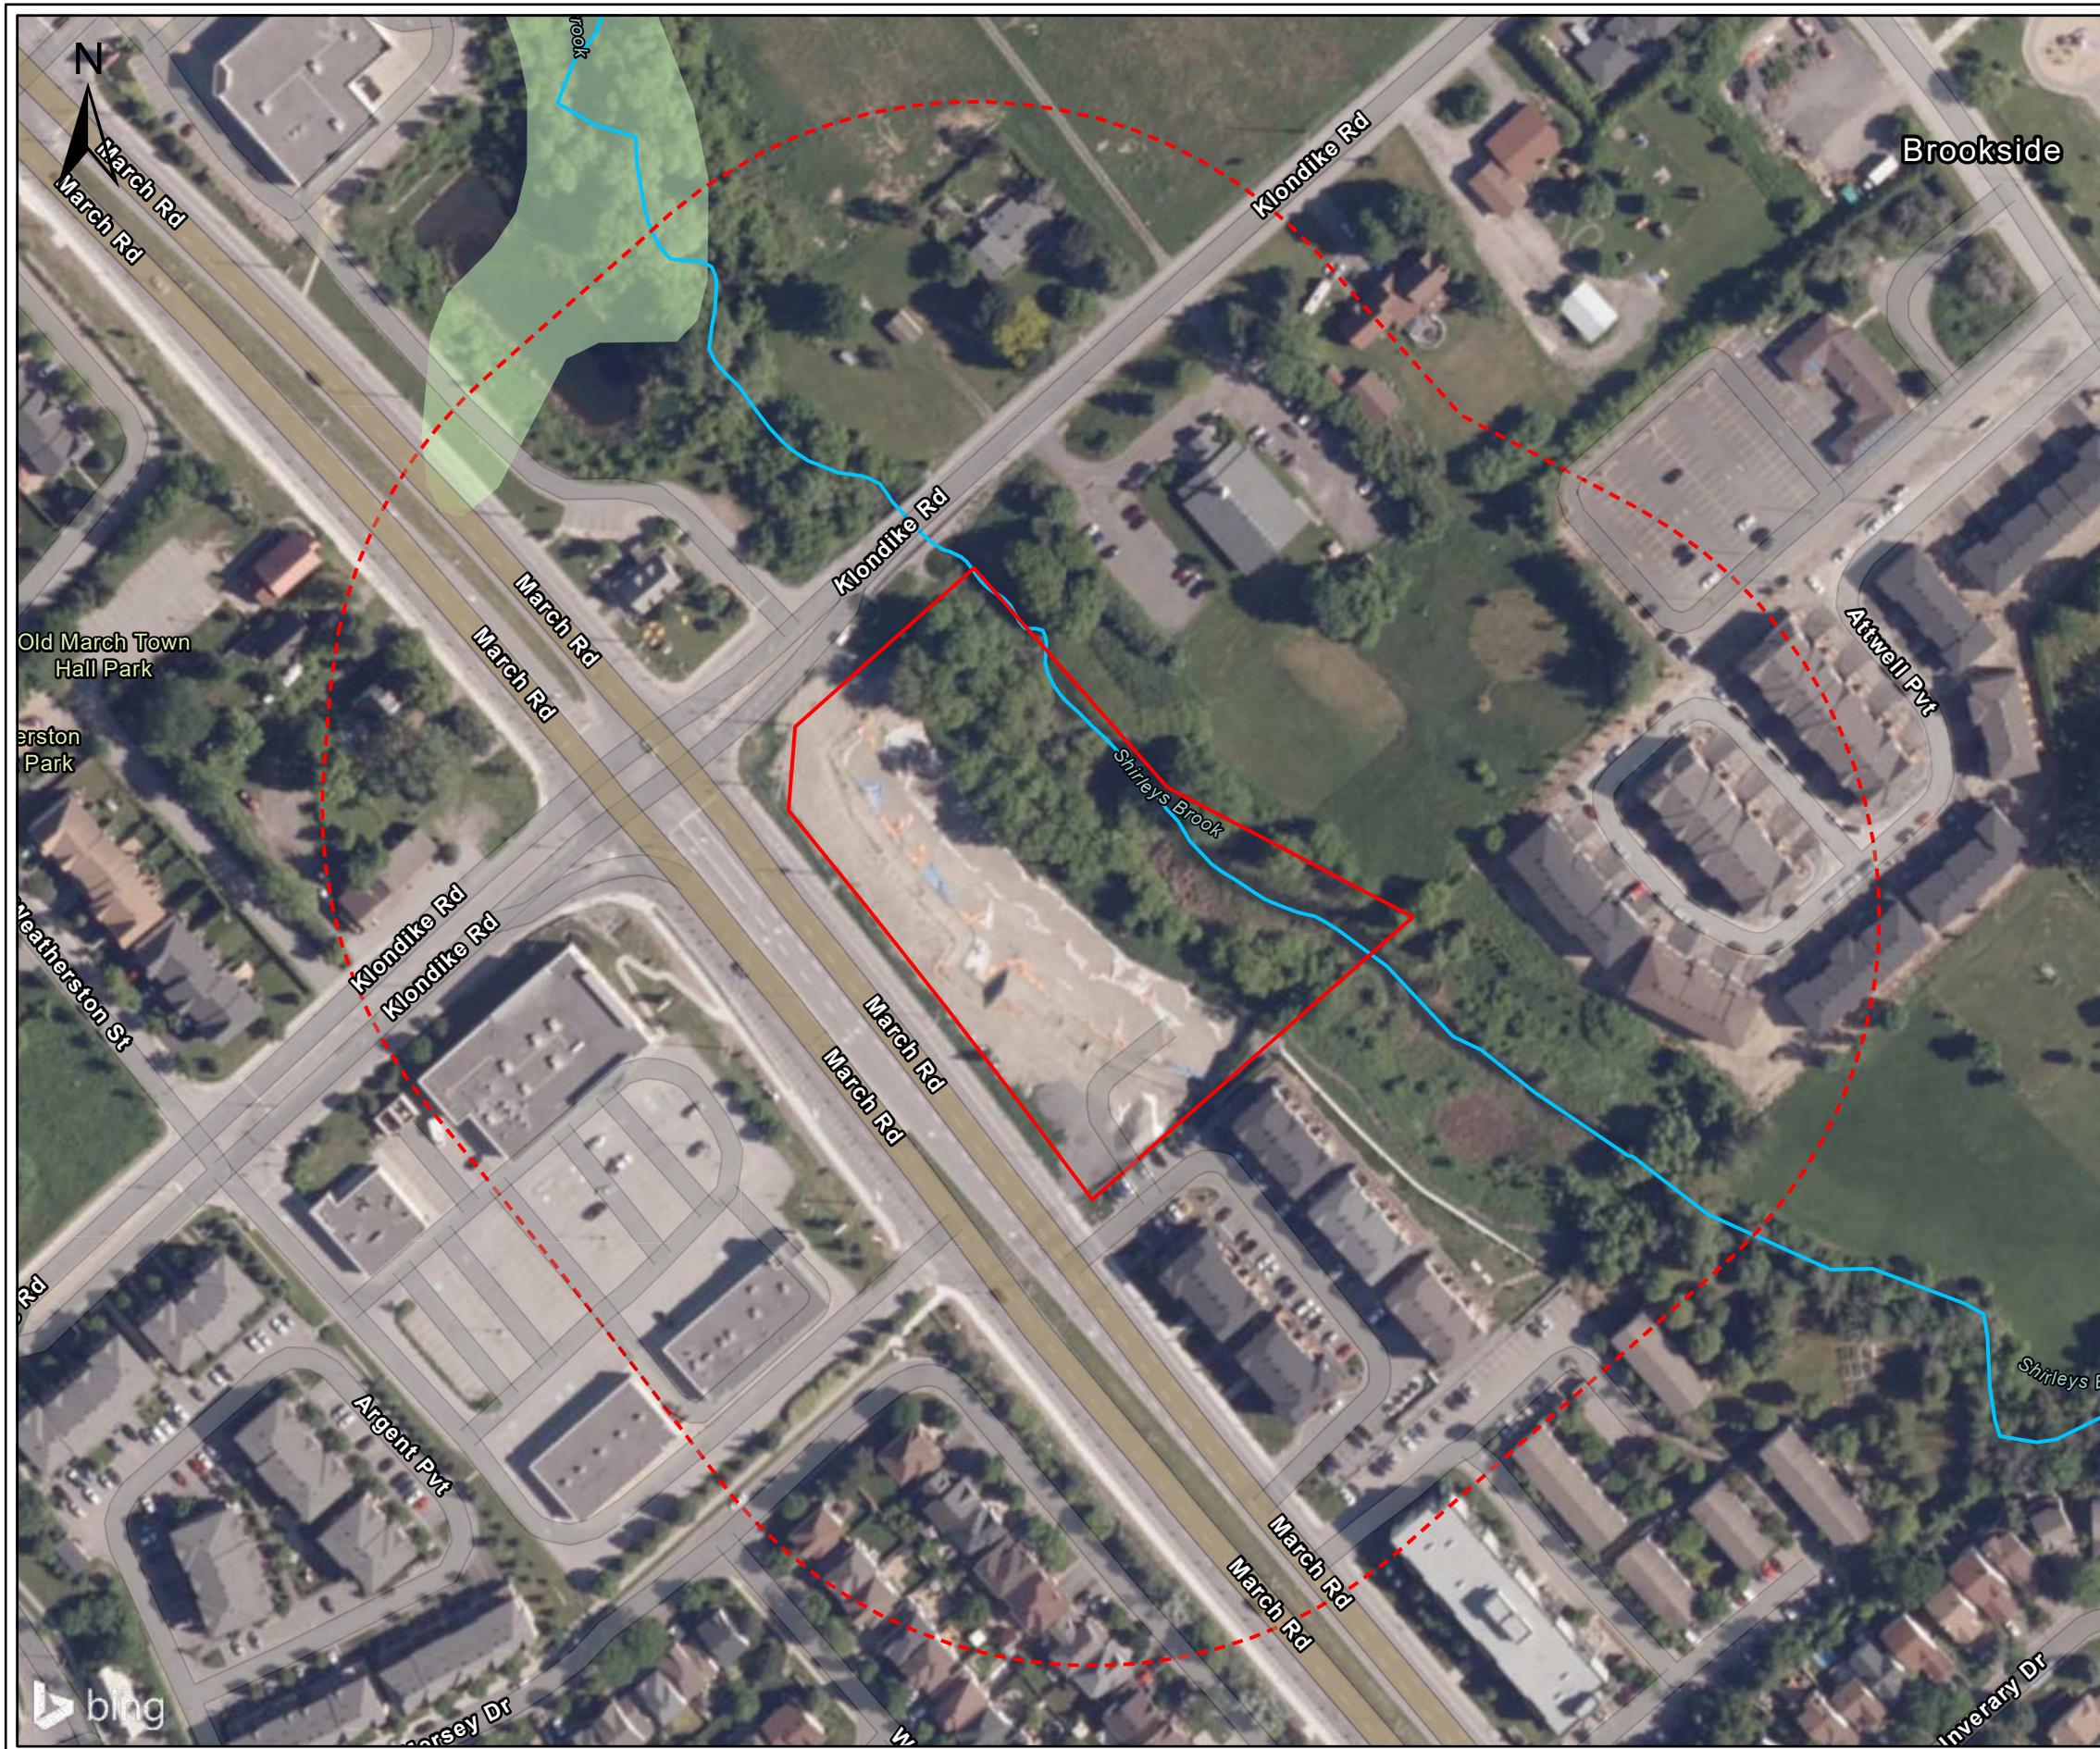
Date: June 2024	Rev. 3	Figure: A.2
© King's Printer for Ontario

Drwn By: E.P.	Chkd By: T.W.	Site Layout
------------------	------------------	--------------------

The property has an approximate size of 1.21 hectares (ha). The proposed site development includes a mixed-use apartment building with road access via March Road and Klondike Road. The existing site layout and proposed development is provided in Figure A.2 and Figure A.3, respectively, in Appendix A.

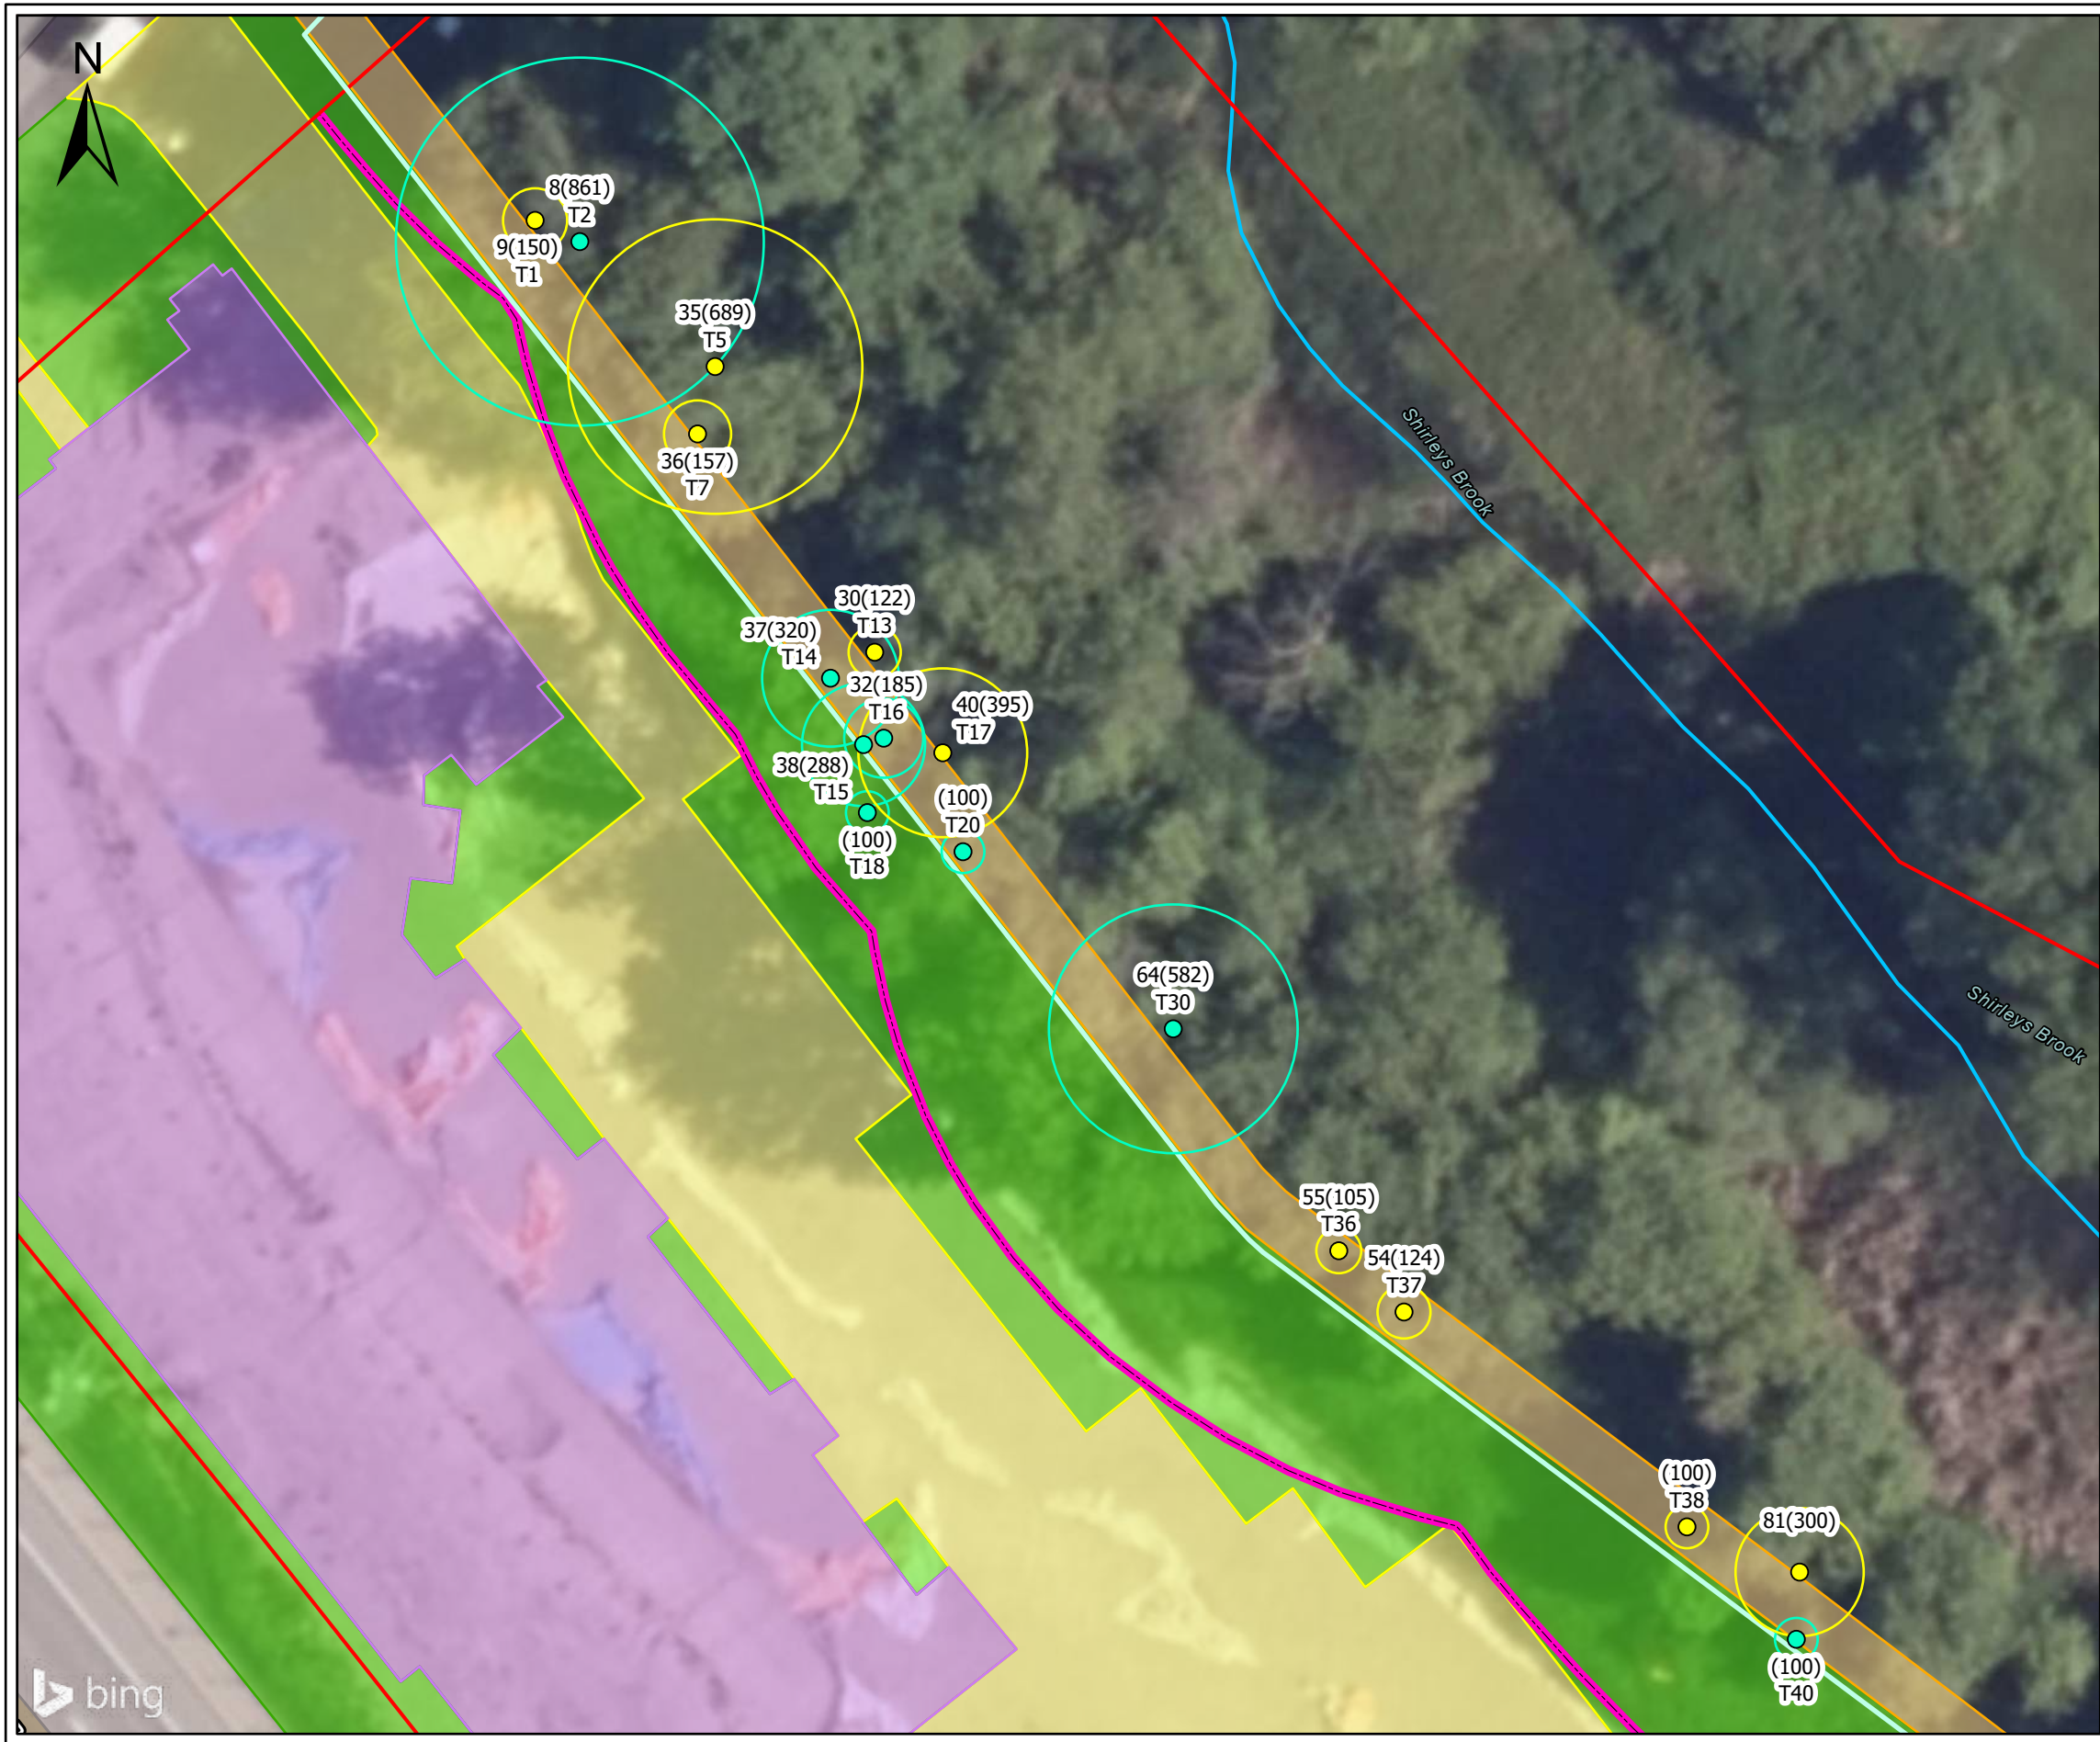
- Property Boundary
- Study Area
- Watercourse
- 30 m Setback
- Tree Protection Fencing
- Proposed Building Footprint
- Proposed Paved Area
- Conceptual Proposed Bicycle Path
- Proposed Soft Landscape Area
- Conflict - Build
- Conflict - Pathway

- Out of 113 trees identified by GEMTEC on-site with a DBH greater or equal to 10 cm, 97 were identified as retainable and 16 trees were identified as conflict. The 16 trees identified as conflict, illustrated on Figures A.4a, A.4b. and A.4c, are considered non-retainable as they are in direct conflict with the development plan or greater than 30% of the trees CRZ will be impacted by the grading from the building and/or the approximate location of the pathway;

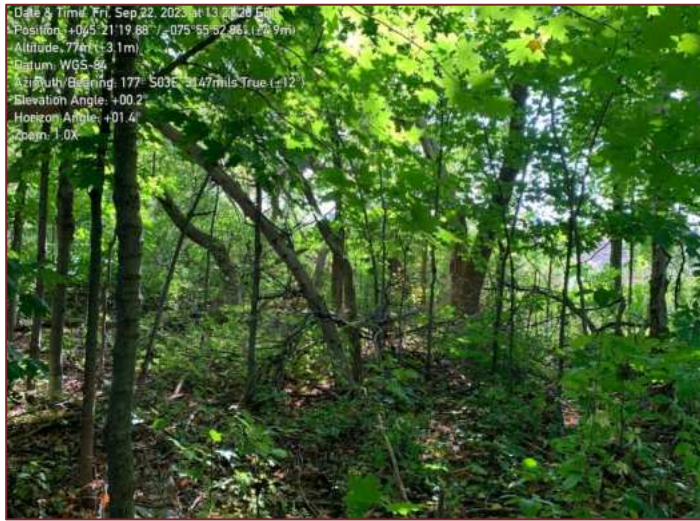
Site Photograph 1 – Wooded Area

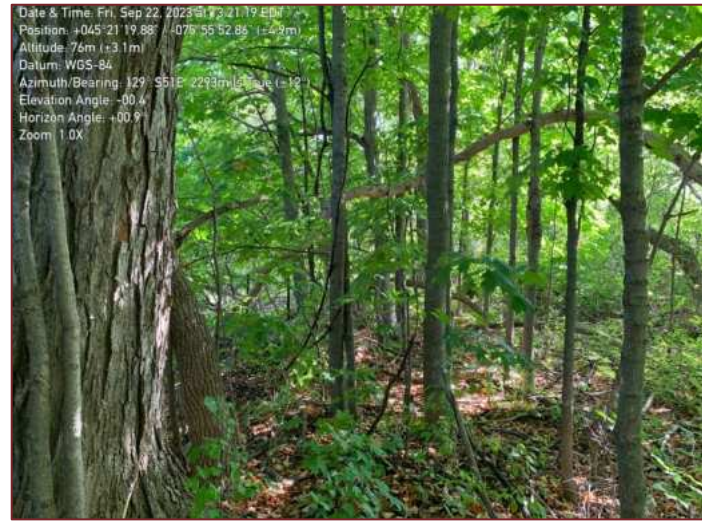
Site Photograph 2 – Wooded Area

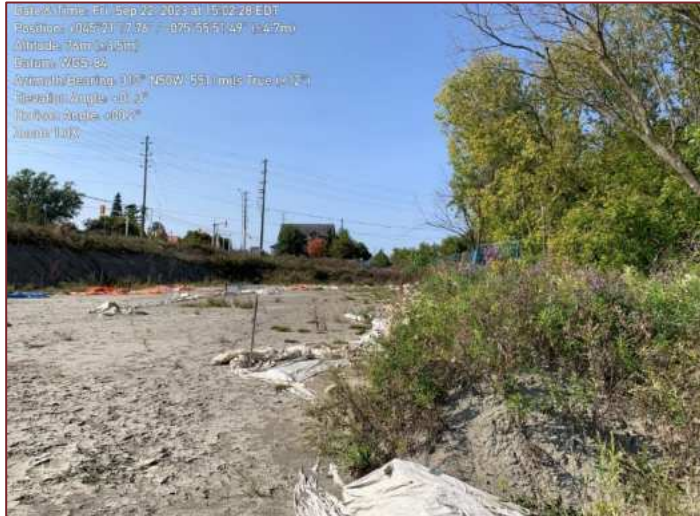
Site Photograph 3 – Disturbed Area and Wooded Area

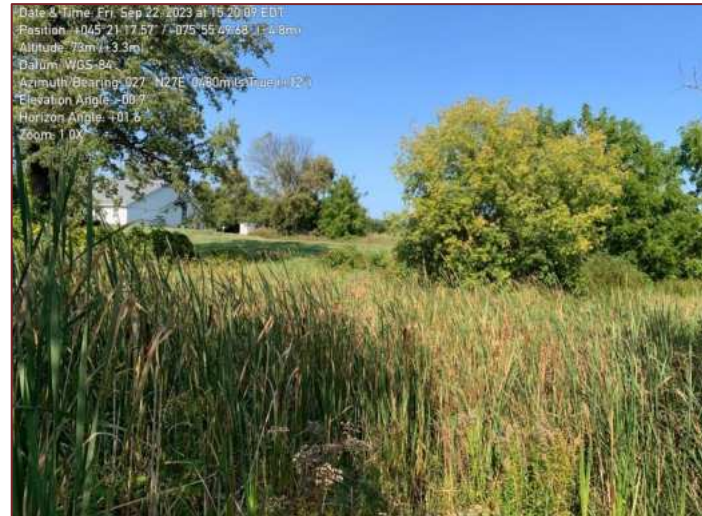
Site Photograph 4 – Shirley's Brook and Riparian Area
