REPORT

Phase One Environmental Site Assessment

283-285 McLeod Street, Ottawa, Ontario

December 2023

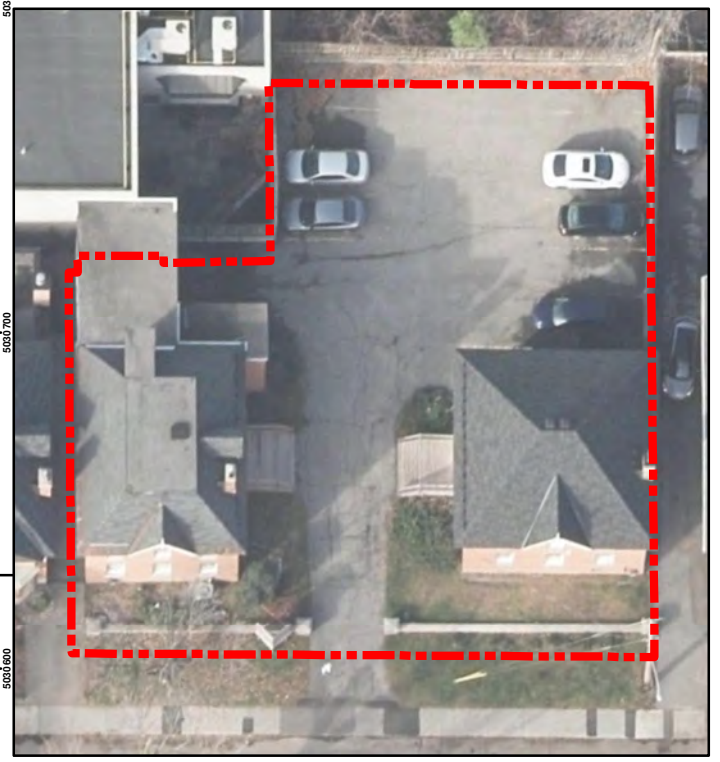
CLIENT		REZY PROPERTIES INC.	
PROJECT		PHASE ONE ENVIRONMENTAL SITE ASSESSMENT 283-285 MCLEOD STREET, OTTAWA, ONTARIO	
TITLE		SITE PLAN AND POTENTIALLY CONTAMINATING ACTIVITIES	
CONSULTANT	YYYY-MM-DD	2020-08-14	
	DESIGNED	---	
	PREPARED	JEM	
	REVIEWED	AW	
	APPROVED	KPH	
PROJECT NO.	CONTROL	REV.	FIGURE
20355191	0001	0	2

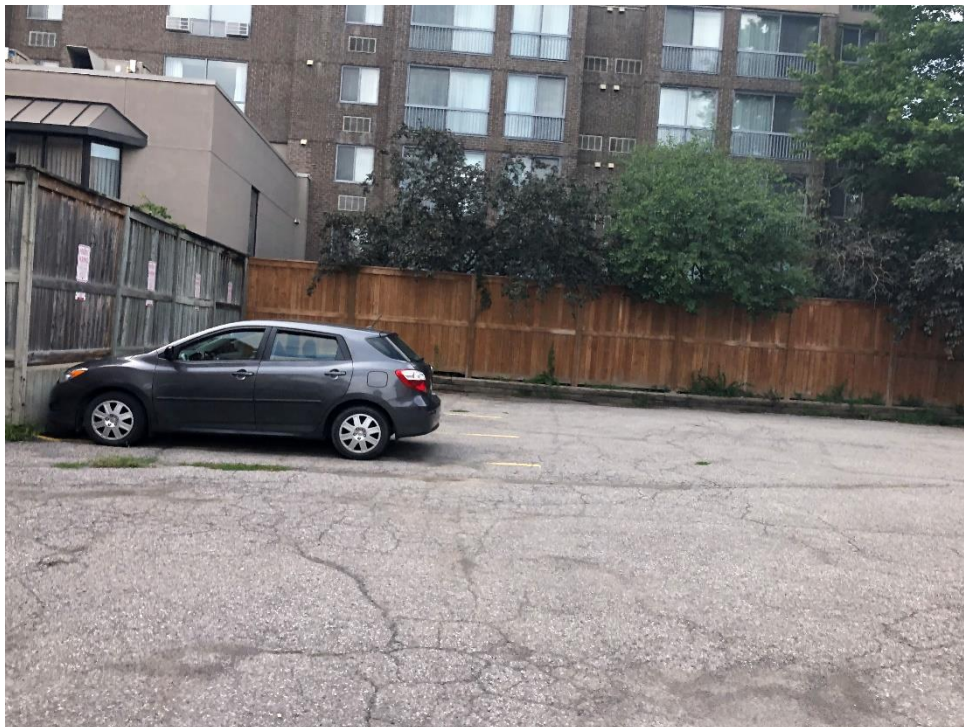
Photo 4: View of parking area at rear of property looking at the hotel to the north (2020 Site Visit).

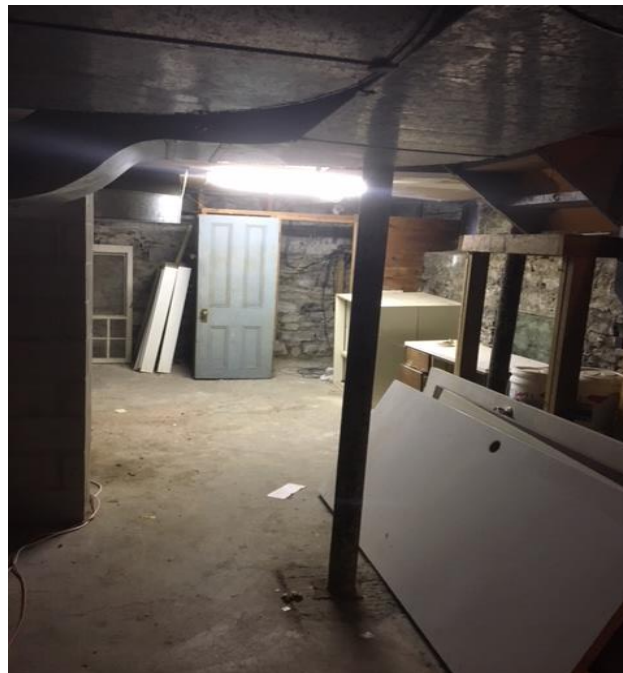
Photo 6: Typical Photo of unfinished stone foundation basement (2020 Site Visit).

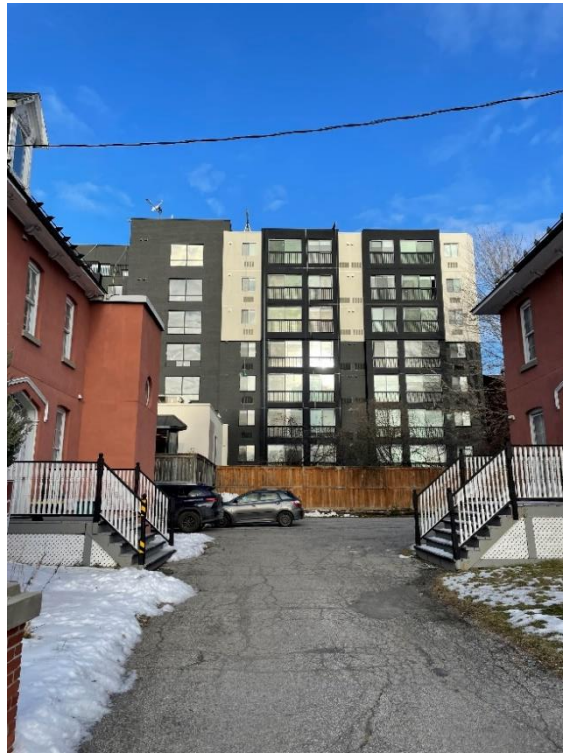
Photo 7: Parking Area and property to the north (2023 Site Visit).
