Phase I Environmental Site Assessment

917 Merivale Road
Ottawa, Ontario

Sheppard Property Development
2335 Baseline Road
Ottawa, Ontario
K2C 0E2

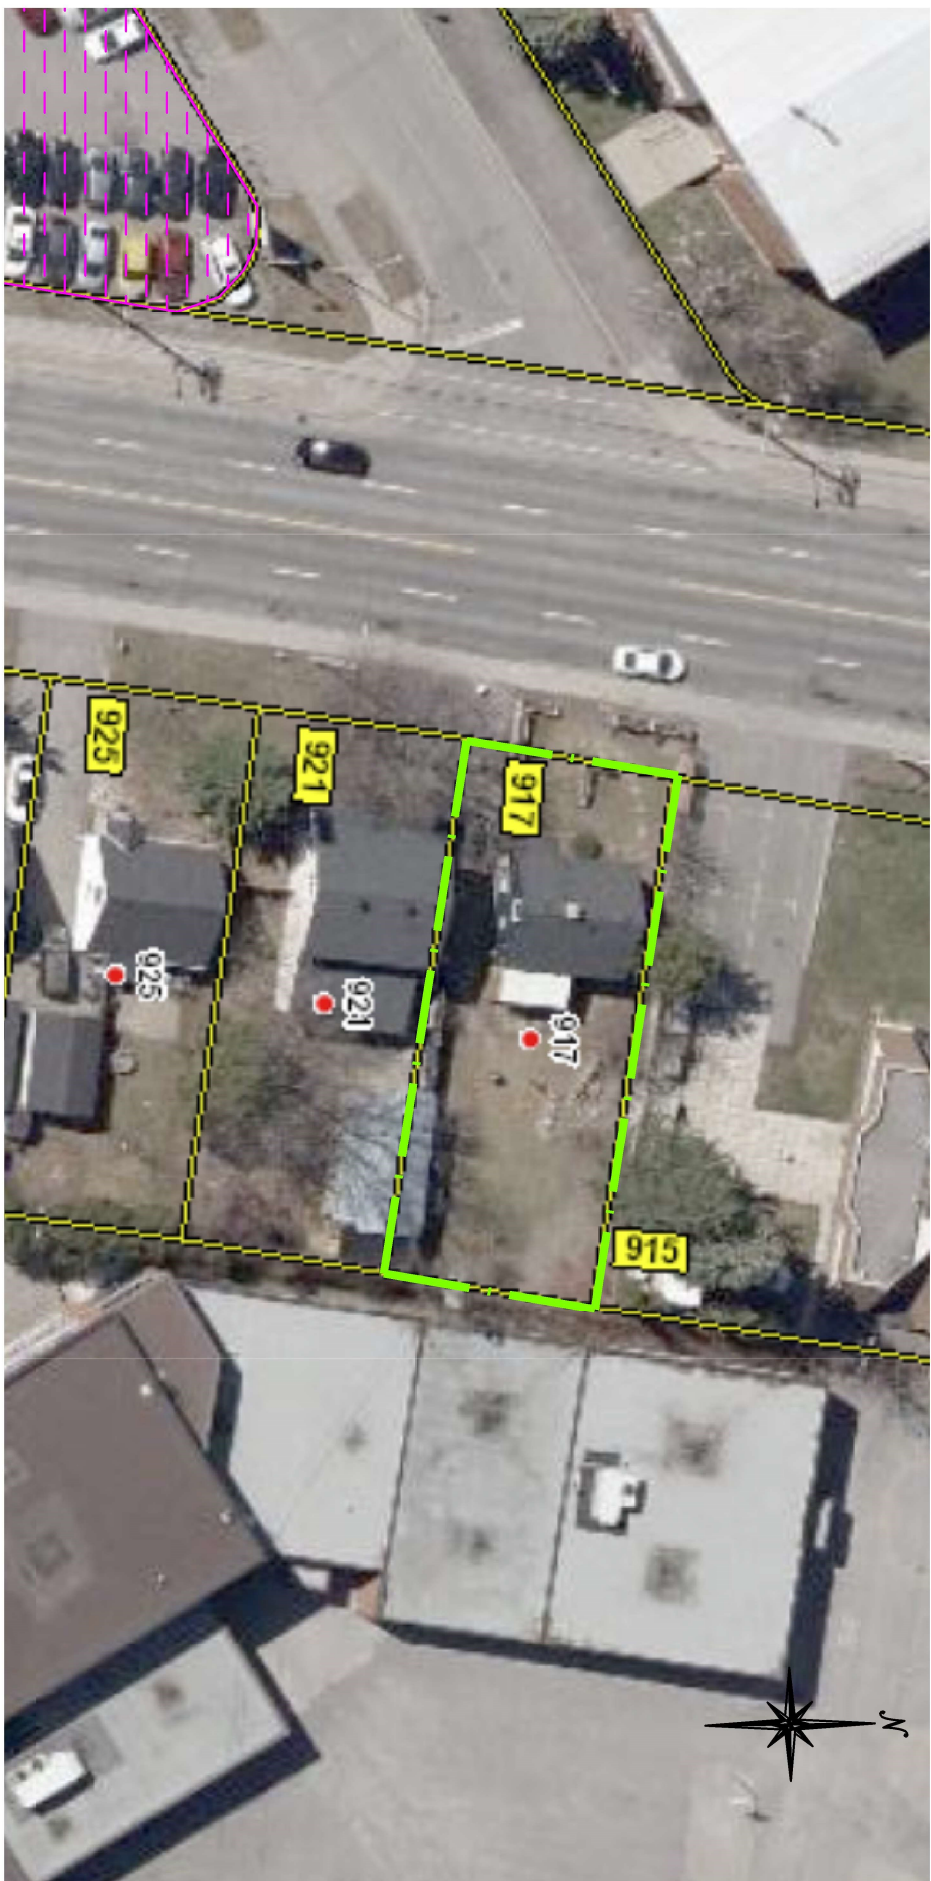
FIGURE 1

The Site’s location is shown in **Figure 1** and the general Site configuration is shown on the Site Plan in **Figure 2**. For the purposes of this report, Merivale Road will be inferred as running in an north-south direction.

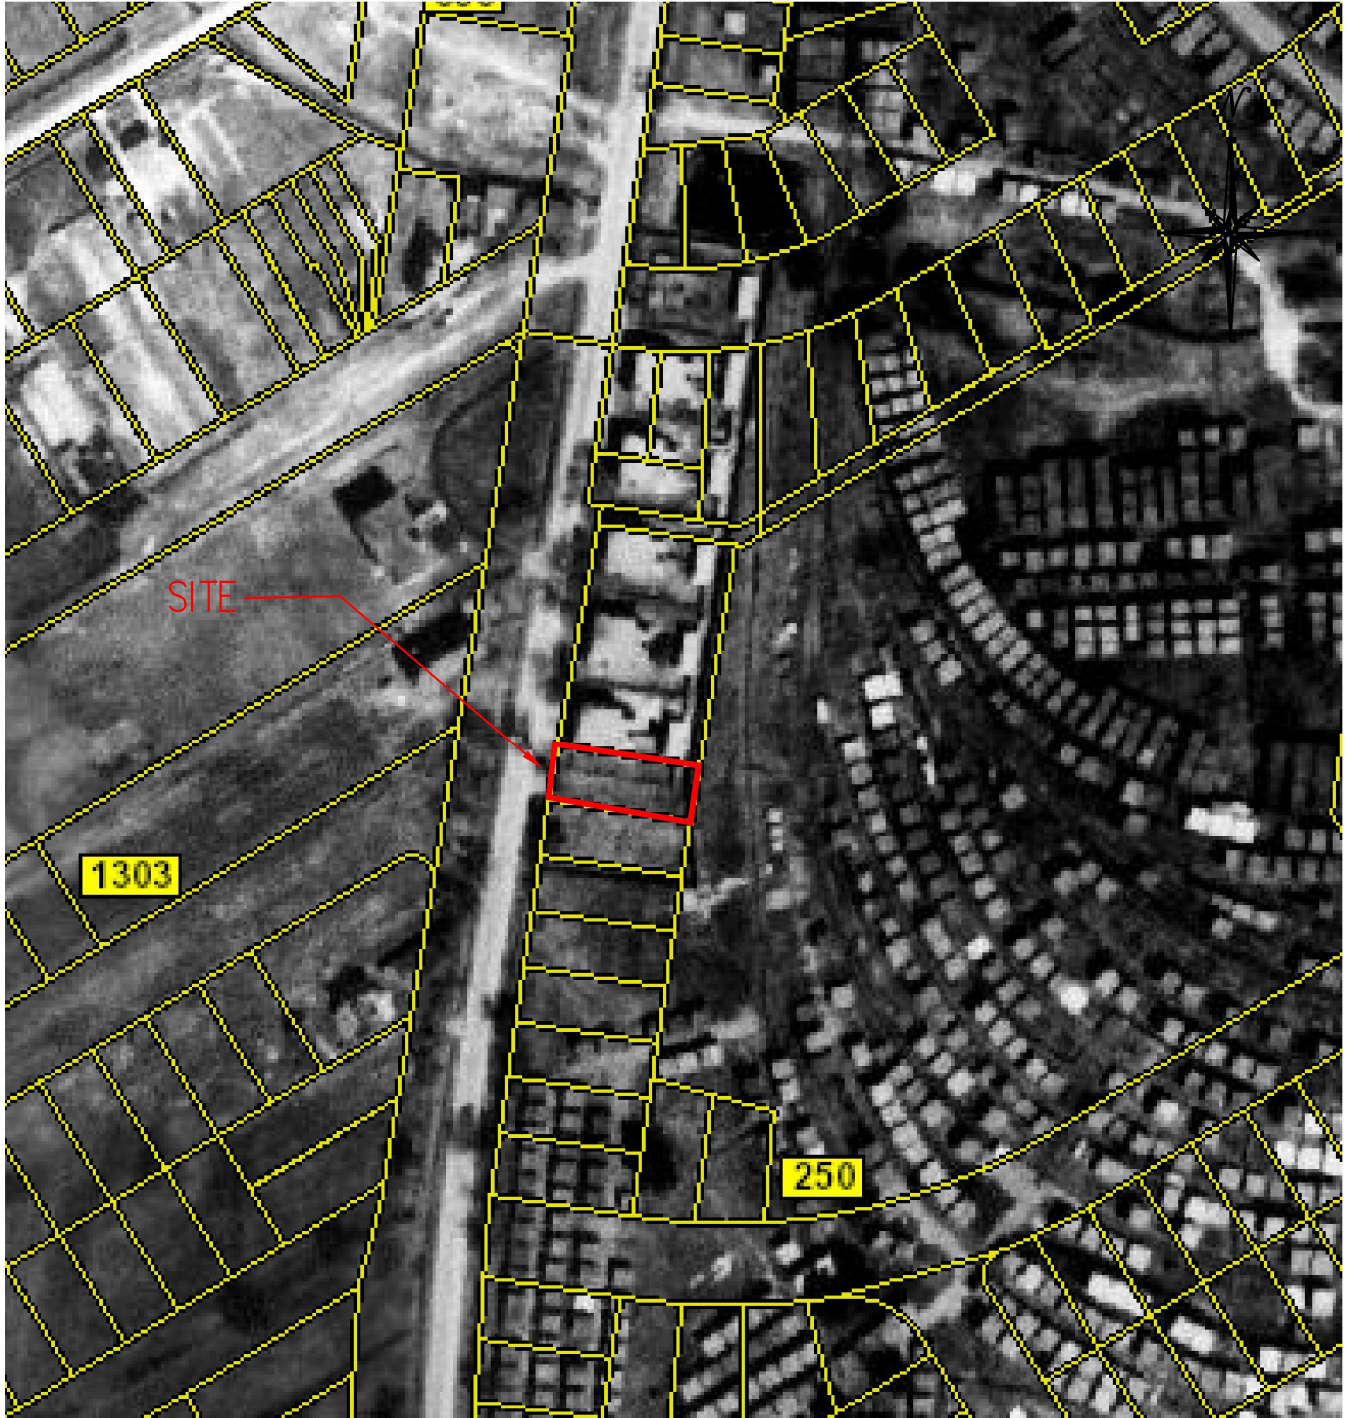
AP1

The Site appears to be un-developed in the 1928 aerial image (AP1), in addition to the adjacent lands to the south. East of the Site is developed with the lumber yard, as noted above in Section 3.1.3. Merivale Road is present along the western boundary of the Site, generally in its current configuration, and is followed by un-developed lands inferred to be agricultural fields. Northwest of the Site is developed with the existing place of worship and school, also identified in Section 3.1.3. North of the Site is developed, with what appears to be residences. The structures appear to continue in a row like configuration on the properties further north, all of which have a comparable size and configuration.

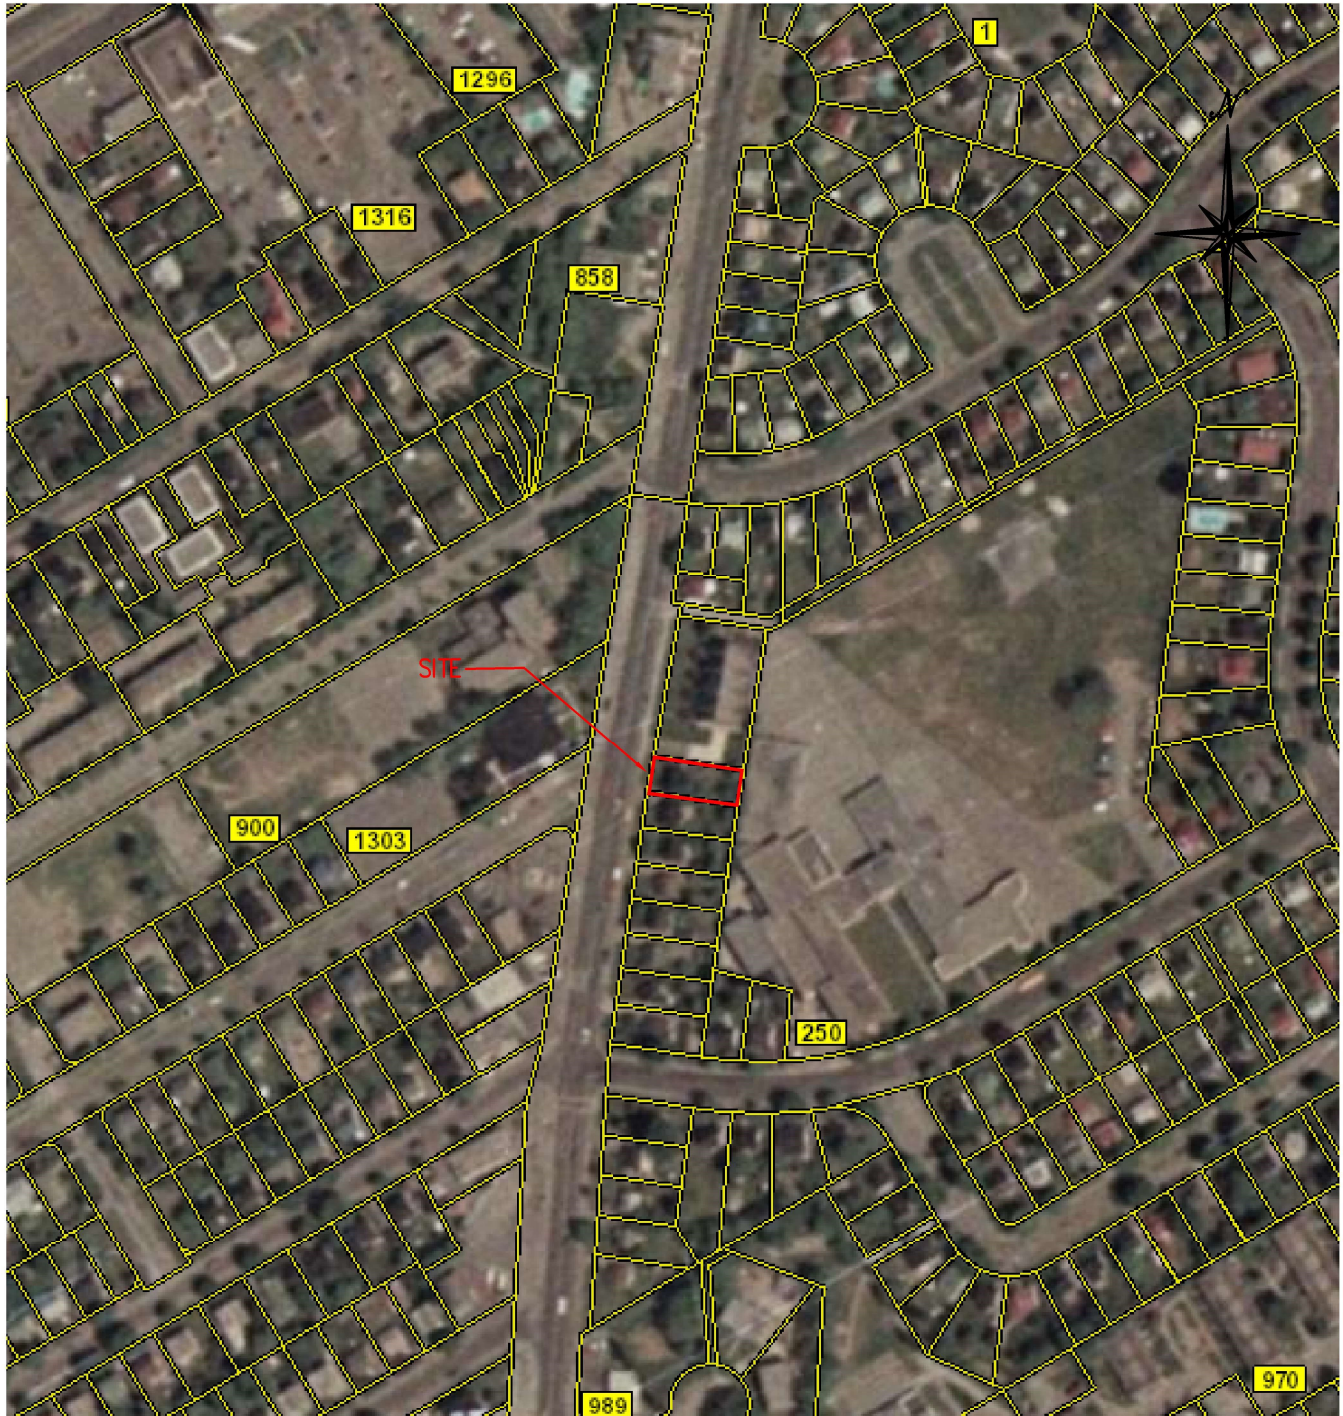
AP3

No significant changes are observed in 1965, 1976 (AP3), 1999 (AP4), 2008 (AP5), 2014 and 2021 (AP6) aerial images.

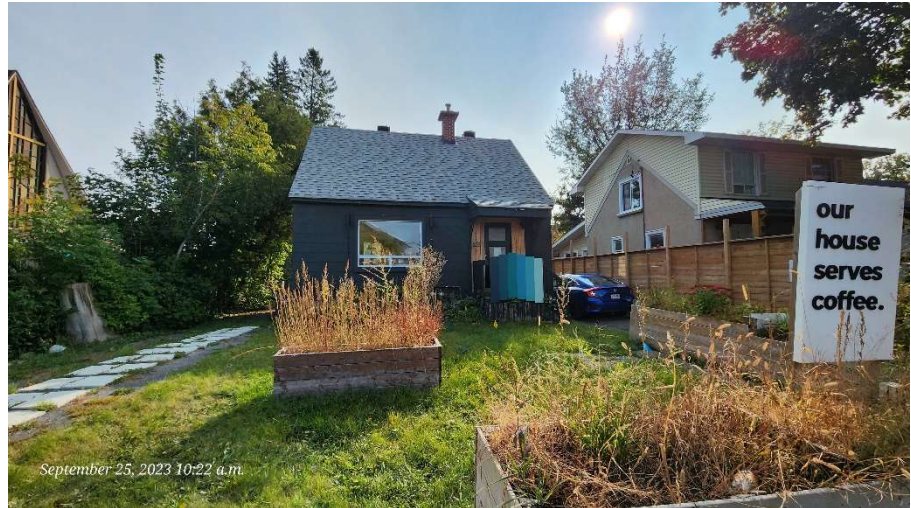
From west facing east across the western extent of the Site.

Generally referred to as the 'front yard' along Merivale Road.

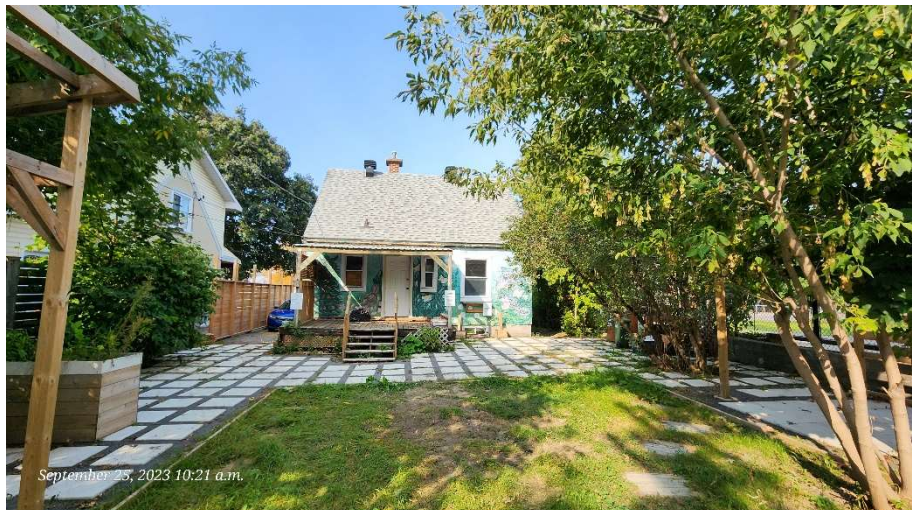
Photograph No. 2

From east facing west across the eastern extent of the Site.

Generally referred to as the 'back yard' at the rear of the building.

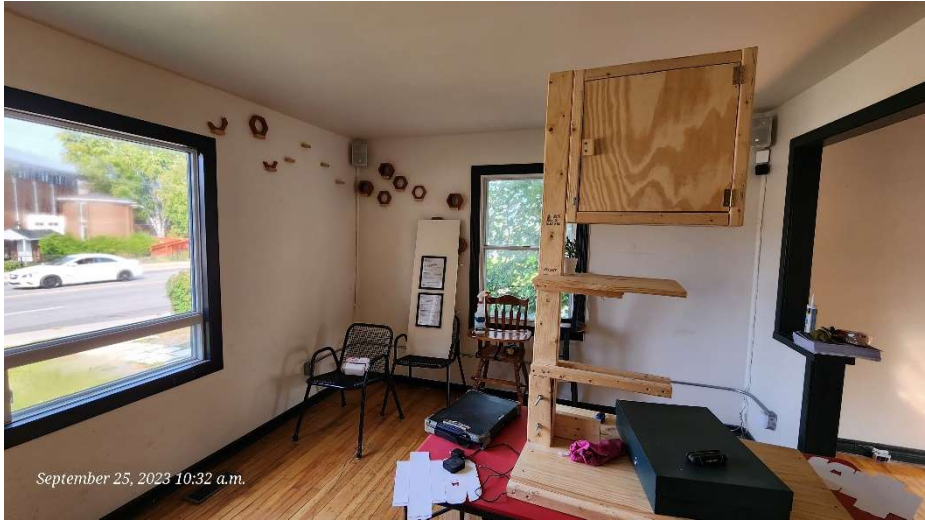
Photograph No. 3

<p>September 25, 2023 10:32 a.m.</p>
Date: 9/25/2023	
Description <p>Typical conditions of the main floor of the building, as encountered at the time of the Site visit.</p>

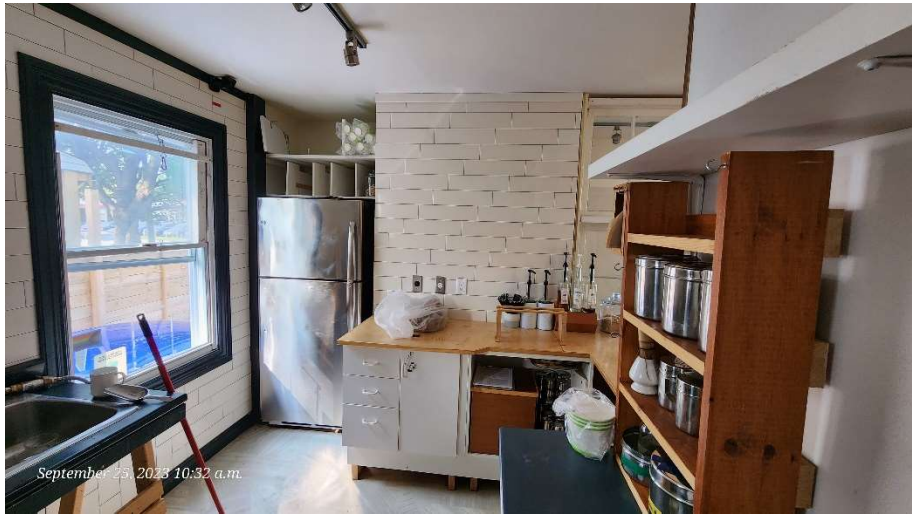
Photograph No. 4

<p>September 25, 2023 10:32 a.m.</p>
Date: 9/25/2023	
Description <p>Typical conditions of the main floor of the building, as encountered at the time of the Site visit.</p>

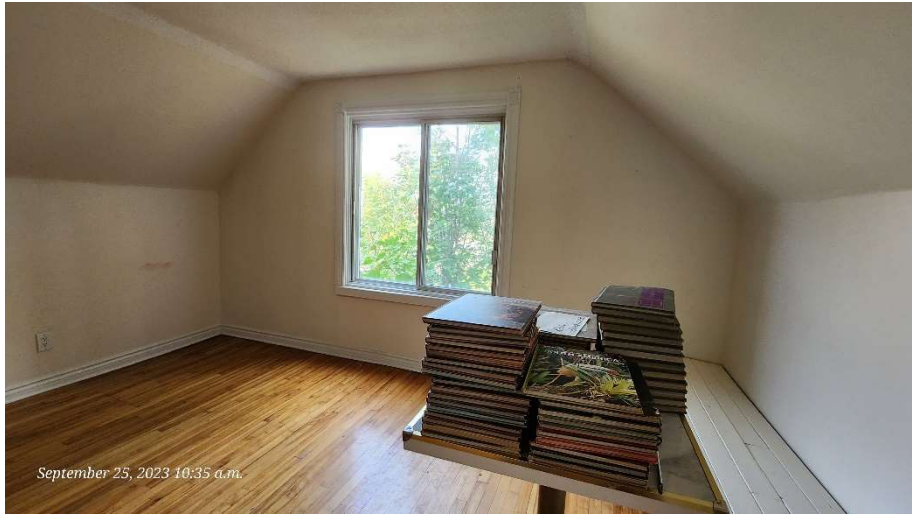
Photograph No. 5

Date: 9/25/2023	
Description Second level of building on Site – general conditions encountered.

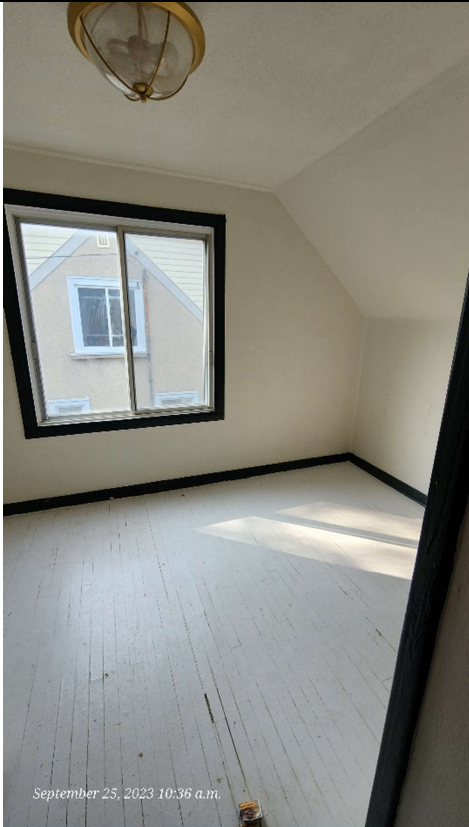
Photograph No. 6

Date: 9/25/2023	
Description Second level of building on Site – general conditions encountered.

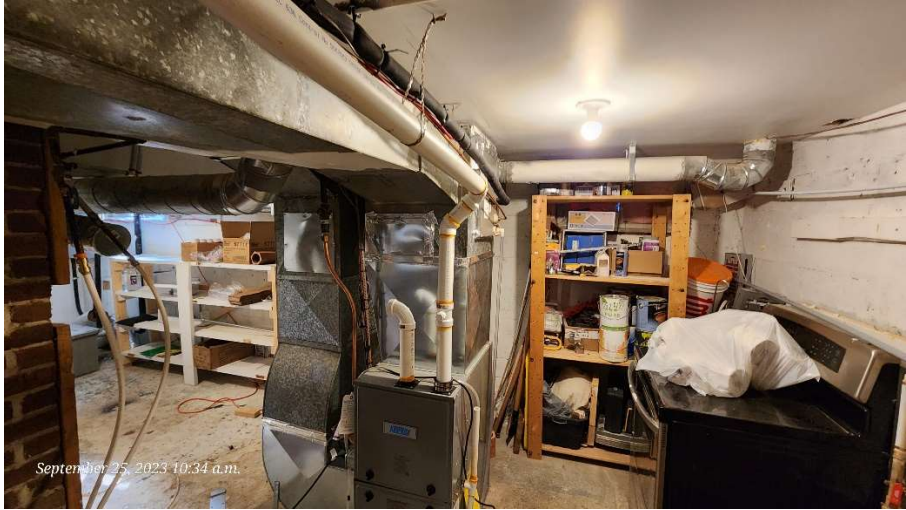
Photograph No. 7

<p>September 25, 2023 10:34 a.m.</p>
Date: 9/25/2023	
Description Typical conditions of the basement at the time of the Site visit.

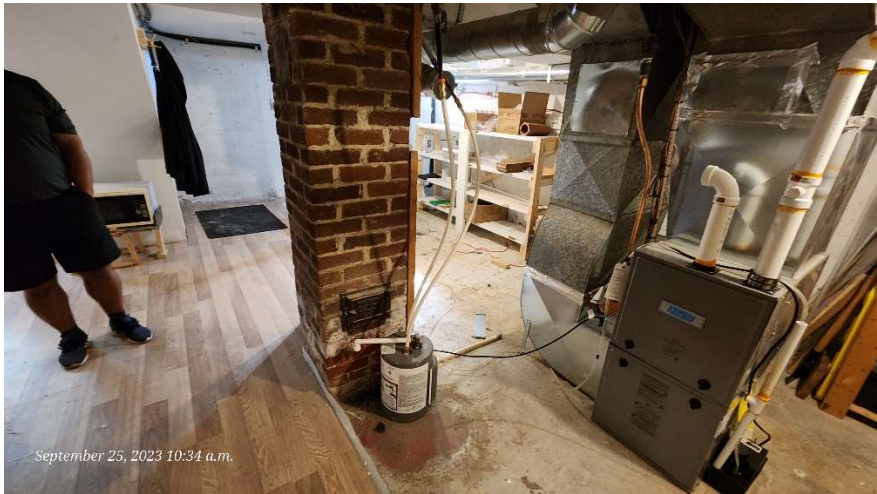
Photograph No. 8

Heating Systems:	Natural gas forced air.
Cooling Systems:	Central air cooling system.
Floor drains:	Not observed, however a sanitary clean-out port was encountered in the basement, as well as a metal plate cover concealing a cut-out of the cement slab floor. The purpose of the cover is unknown, however may be a former sump-pit location.
Sumps:	Not observed.
Paint booth:	Not observed.
Staining or corrosion (other than water):	Not observed.
Mechanical equipment:	Not observed other than a natural gas fired furnace.
Interior finishing	Hardwood flooring throughout main floor and second level, with drywall ceiling and walls. Brick and mortar as well as ceramic tile finishes were also present in limited areas of the main floor. A vinyl composite floor material covered a portion of the former kitchen area. The basement level had similar finishes encountered, include drywall ceiling and walls, with a vinyl composite floor. Poured cement falls, and flooring was encountered in the unfinished portion of the basement.

<p>September 25, 2023 10:34 a.m.</p>
Date: 9/25/2023	
Description Typical conditions of the basement encountered at the time of the Site visit. Natural gas furnace visible in the background.
