Phase I-Environmental Site Assessment

1950 Scott Street, 312 and 314 Clifton Road
Ottawa, Ontario

Prepared For
2506100 Ontario Inc.
c/o Colonnade Bridgeport

September 17, 2020
Report: PE4995-1

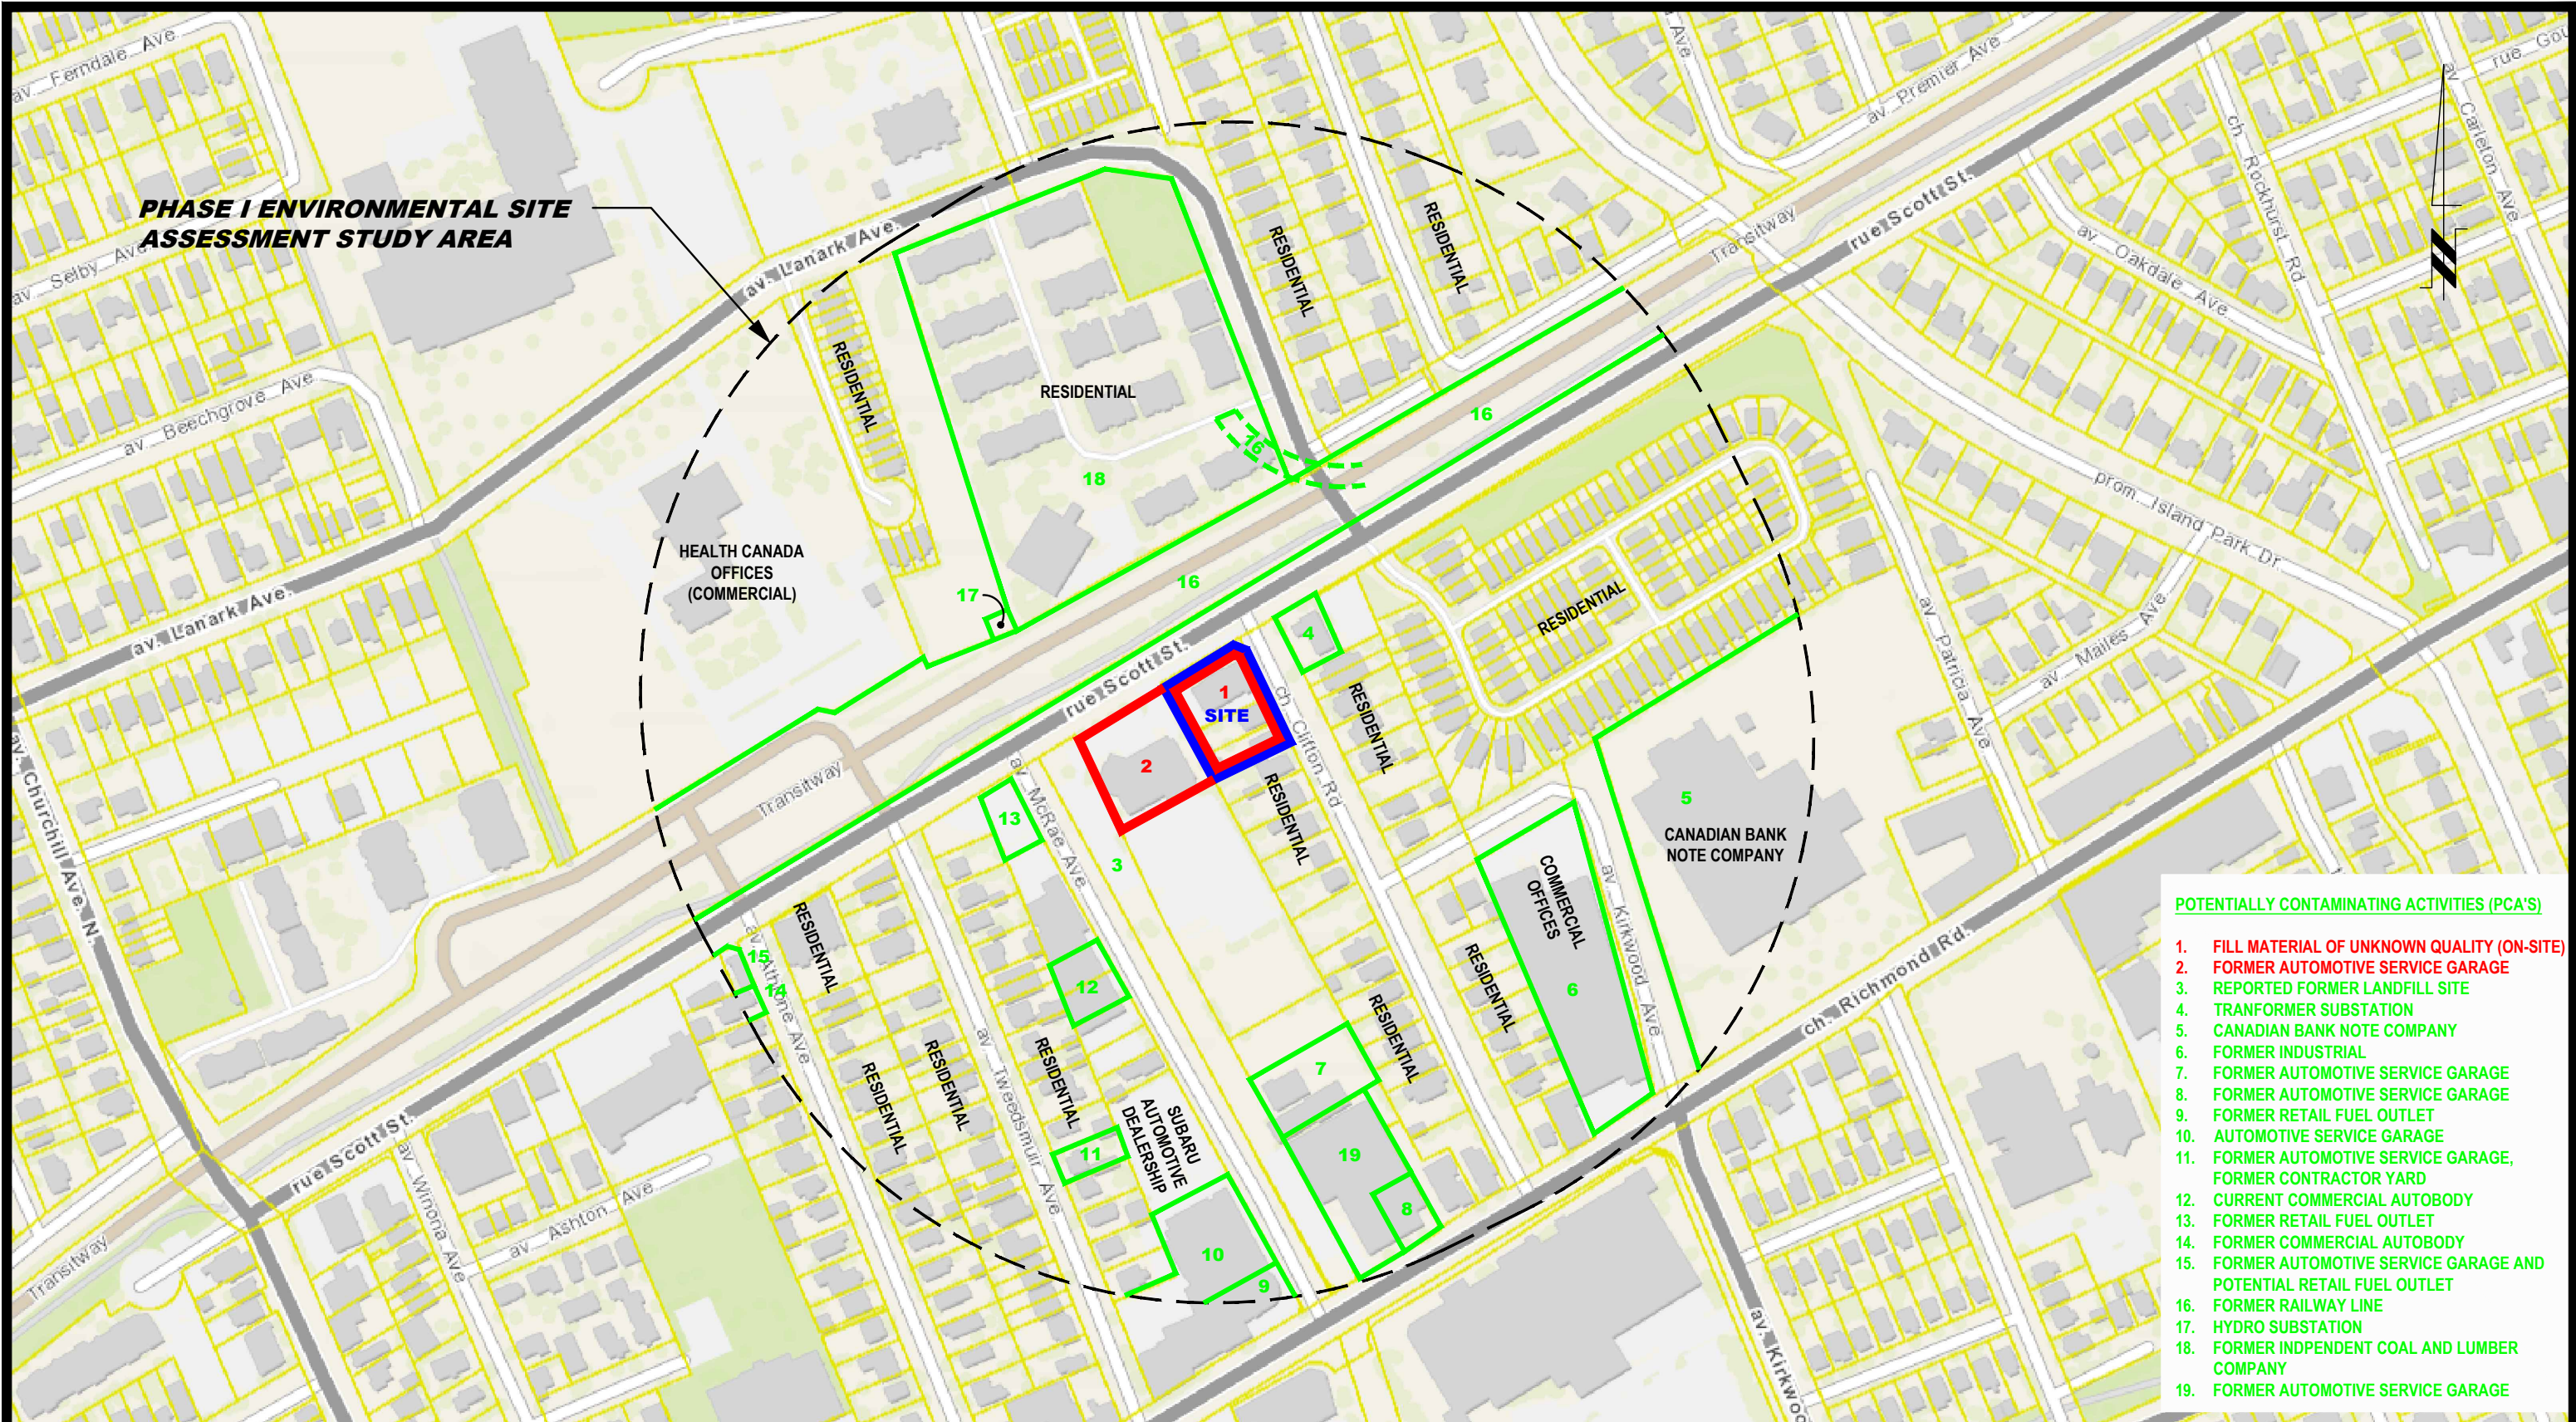
DRAWING PE4995-2 – SURROUNDING LAND USE PLAN

POTENTIALLY CONTAMINATING ACTIVITIES (PCA'S)

- 1. **FILL MATERIAL OF UNKNOWN QUALITY (ON-SITE)**
- 2. **FORMER AUTOMOTIVE SERVICE GARAGE**
- 3. **REPORTED FORMER LANDFILL SITE**
- 4. **TRANSFORMER SUBSTATION**
- 5. **CANADIAN BANK NOTE COMPANY**
- 6. **FORMER INDUSTRIAL**
- 7. **FORMER AUTOMOTIVE SERVICE GARAGE**
- 8. **FORMER AUTOMOTIVE SERVICE GARAGE**
- 9. **FORMER RETAIL FUEL OUTLET**
- 10. **AUTOMOTIVE SERVICE GARAGE**
- 11. **FORMER AUTOMOTIVE SERVICE GARAGE, FORMER CONTRACTOR YARD**
- 12. **CURRENT COMMERCIAL AUTOBODY**
- 13. **FORMER RETAIL FUEL OUTLET**
- 14. **FORMER COMMERCIAL AUTOBODY**
- 15. **FORMER AUTOMOTIVE SERVICE GARAGE AND POTENTIAL RETAIL FUEL OUTLET**
- 16. **FORMER RAILWAY LINE**
- 17. **HYDRO SUBSTATION**
- 18. **FORMER INDEPENDENT COAL AND LUMBER COMPANY**
- 19. **FORMER AUTOMOTIVE SERVICE GARAGE**

The remaining off-site PCAs noted above are not considered to represent areas of potential environmental concern (APECs) on the Phase I Property based on their separation distances and/or cross or down gradient orientations with respect to the subject site. The locations of the aforementioned PCAs, are depicted on Drawing PE4995-2 - Surrounding Land Use Plan.

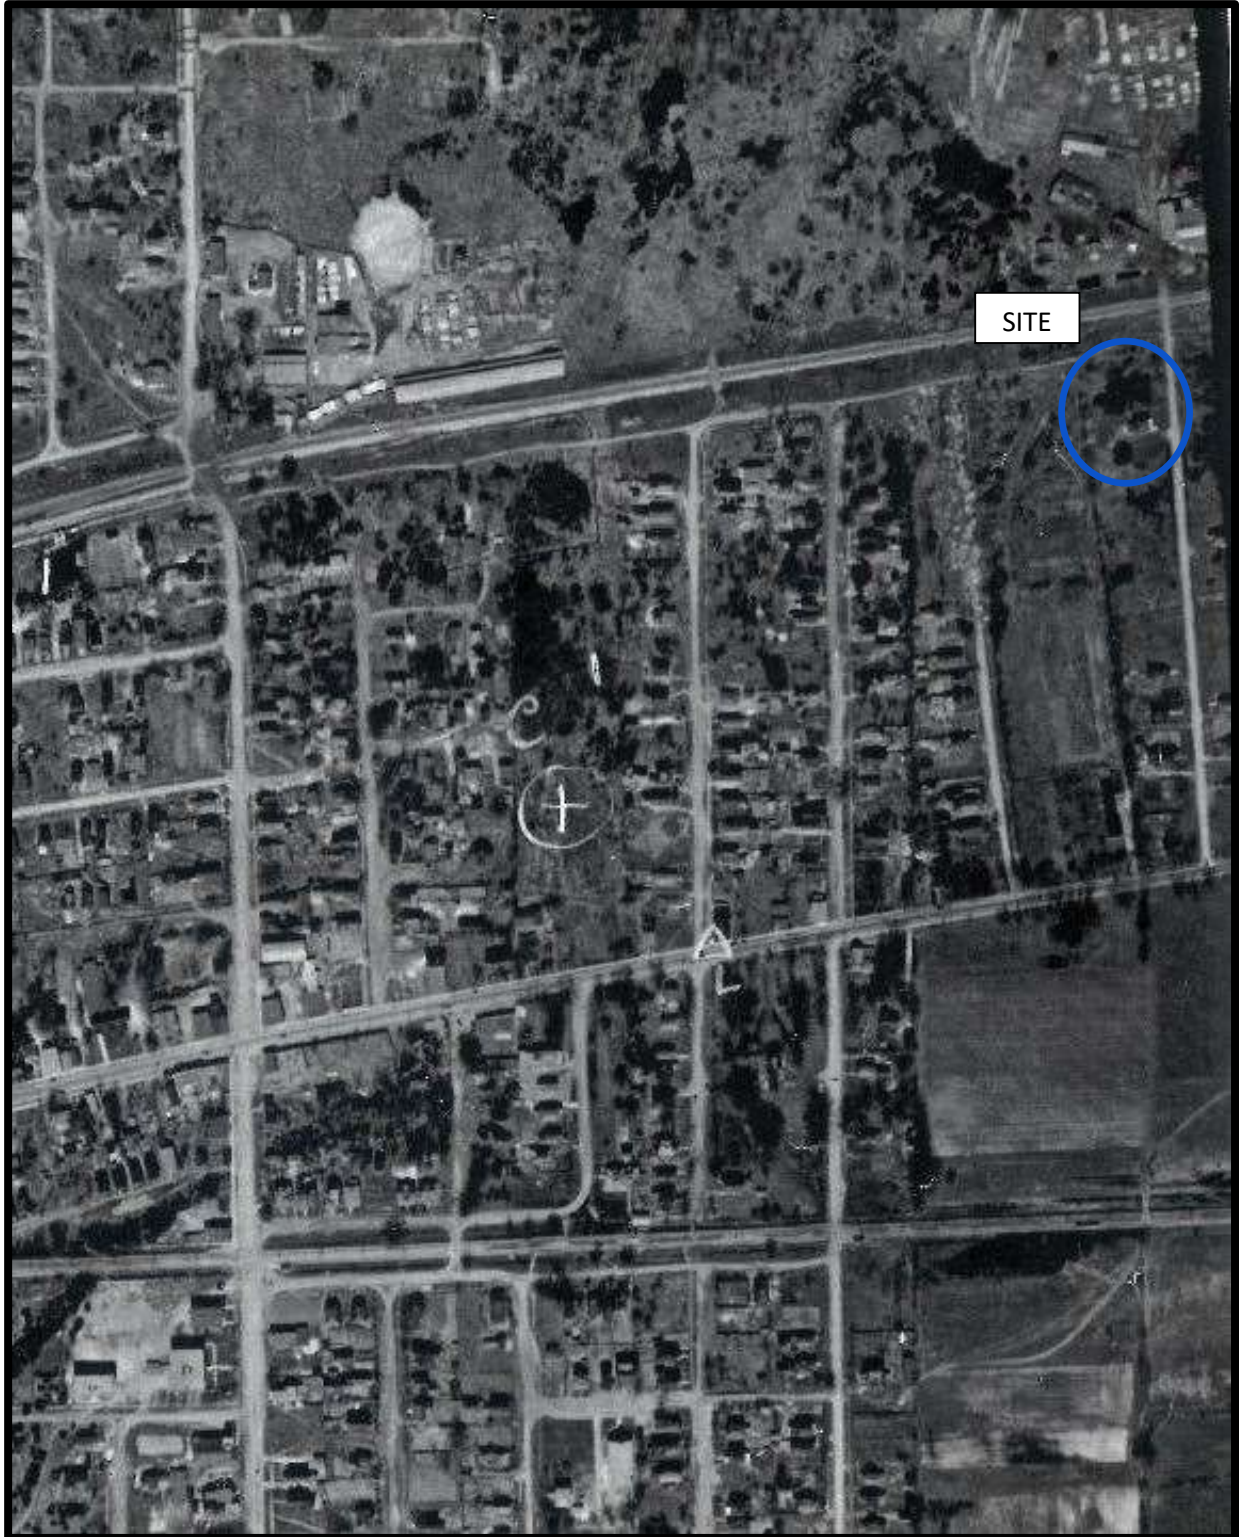
AERIAL PHOTOGRAPH
1928

The earliest aerial photograph from 1928 shows the Phase I Property was occupied by the residential dwelling addressed 312 Clifton Road. The existing structures at 1950 Scott Street (Buddhist Progress Society of Ottawa) and 312 Clifton Road (residential dwelling) are noted on a 1957 Fire Insurance Plan (FIP). The office building at 1950 Scott Street is first visible on the Phase I Property in a 1958 aerial photo. The parcel of land addressed 314 Clifton Road was undeveloped according to the 1957 FIP and the existing dwelling was first observed in a 1965 aerial photograph. The Phase I Property is considered to have been first developed in the 1920's for residential purposes, followed by commercial development circa 1957.

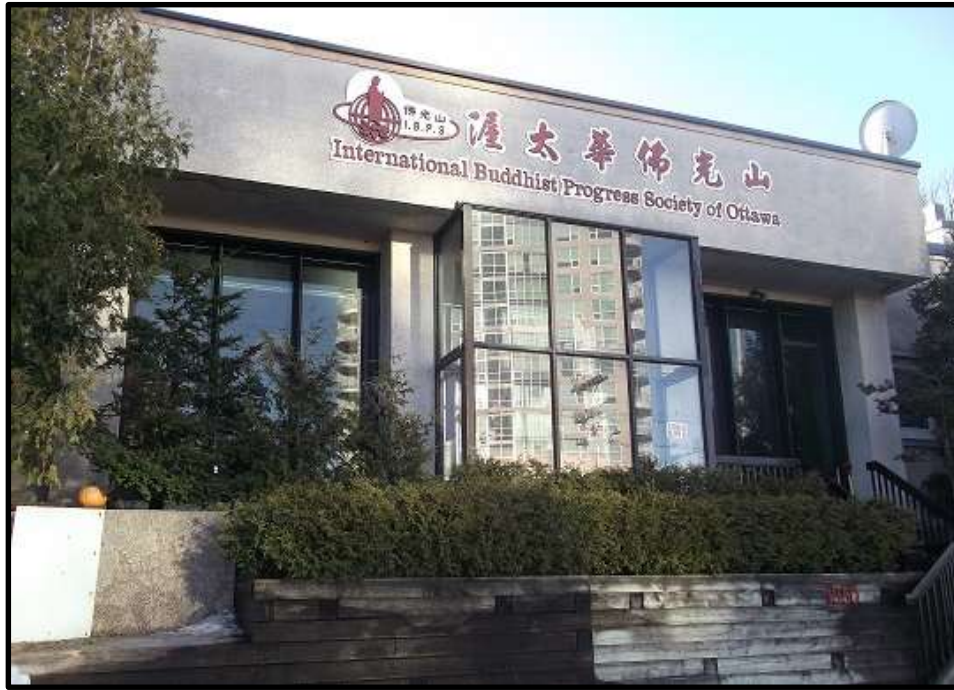
Photograph 1: North face of subject building at 1950 Scott Street, facing southeast.

The parcel of the Phase I Property addressed 1950 Scott Street, is occupied by the International Buddhist Progress Society of Ottawa. The building structure has one storey with a basement level and is constructed with a poured concrete foundation and concrete walls. The exterior is finished with parging and a flat, tar and gravel style roof. The building, constructed as early as 1953, is currently heated with electricity.

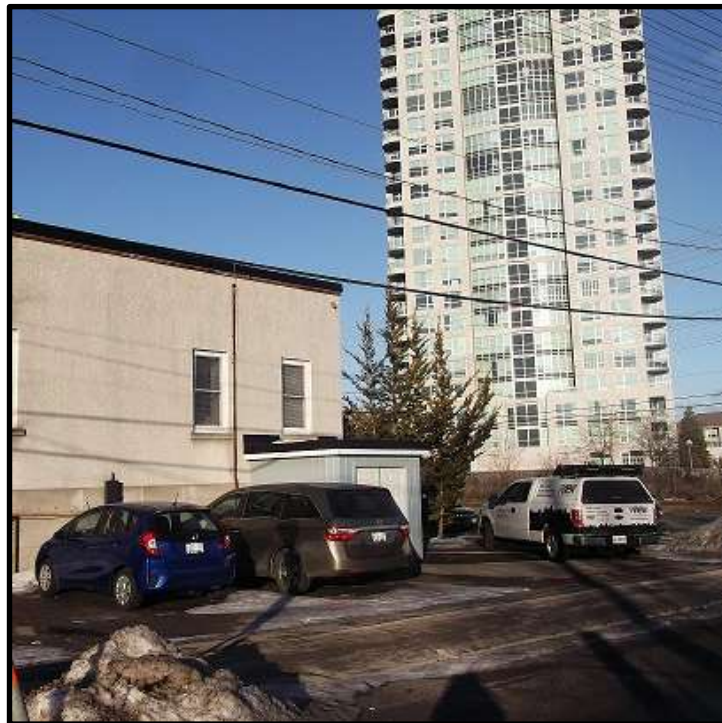
Photograph 2: East face of subject building addressed 1950 Scott Street, facing northwest. Photograph also depicts residential property to the north, across Scott Street.

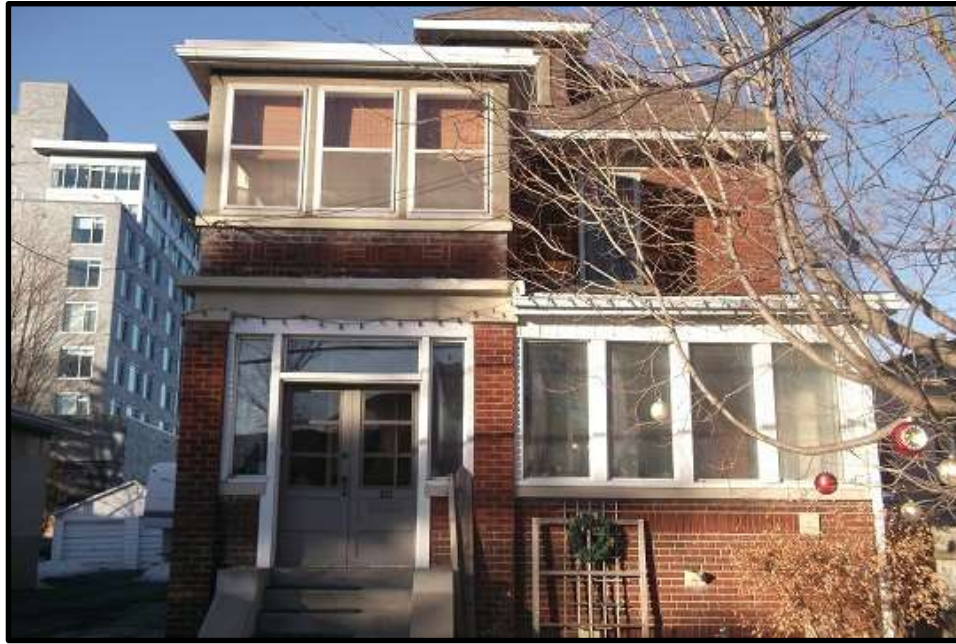
Photograph 3: East face of subject building at 312 Clifton Road, facing west.

A residential dwelling, private garage and two (2) storage sheds occupy the property addressed 312 Clifton Road. The dwelling is constructed with a stone and mortar foundation and is finished on the exterior with brick and a peaked roof covered with asphaltic shingles. The dwelling is currently heated with natural gas-fired equipment. The private garage is a wood frame structure with a poured slab-on-grade foundation, finished on the exterior with vinyl siding and parging with a peaked roof covered with asphaltic shingles. The storage sheds are temporary metal frame structures. The dwelling and private garage are considered to have been constructed as early as 1928.

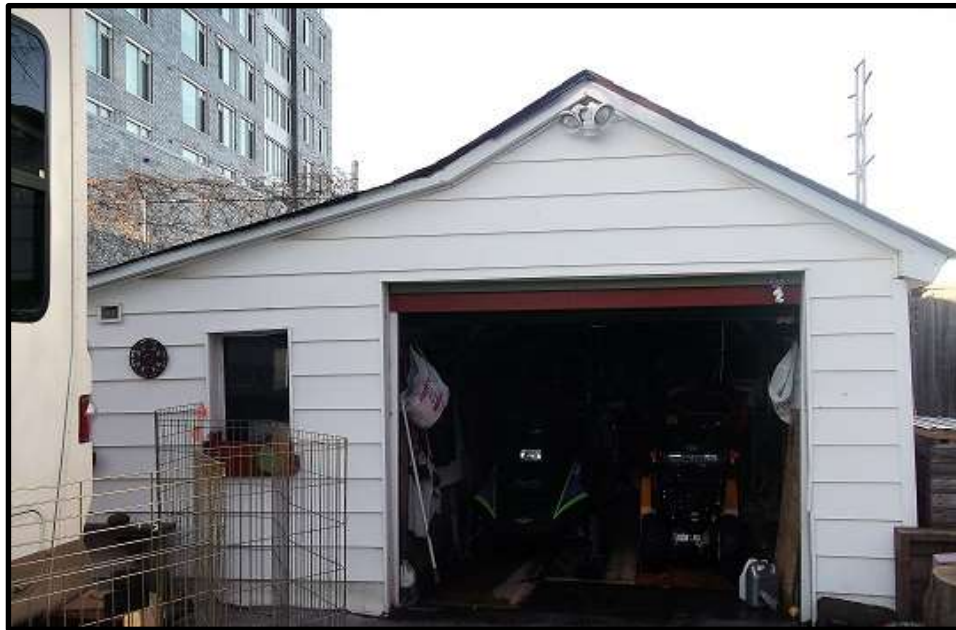
Photograph 4: View of private garage at 312 Clifton Road, facing west. Photograph also illustrates newly constructed residential building (2015) immediately southwest of the Phase I Property.
