Re: **Phase One Environmental Site Assessment Update**
25 Pickering Place and 1330 Avenue K, Ottawa, Ontario
Pinchin File: 267991.010

Pinchin Ltd. (Pinchin) is pleased to provide the findings of our Phase One Environmental Site Assessment (ESA) Update to 25 Pickering Holdings Inc. (Client) for the property described as 25 Pickering Place and 1330 Avenue K, Ottawa, Ontario (Phase One Property or Site).

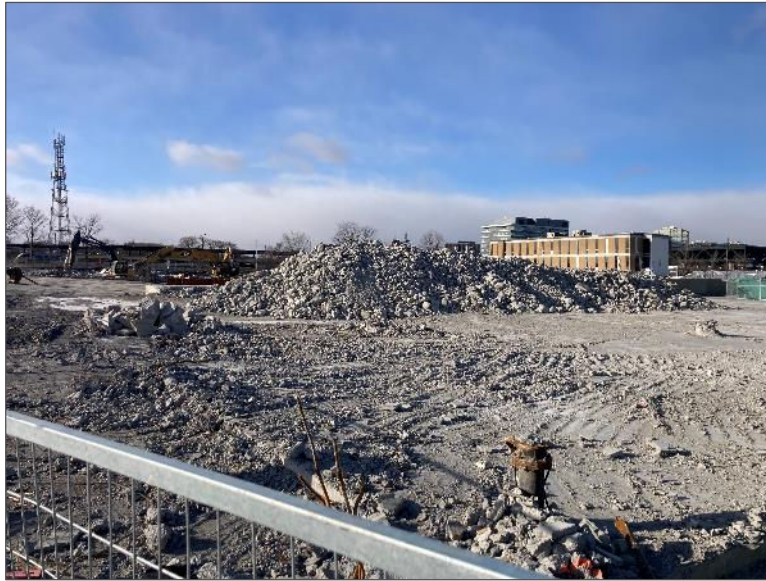
The results of the subsequent Site reconnaissance indicated that the Site Buildings are currently being demolished, with the exception of Site Building C which was still standing. No other substantial changes have been observed to have occurred on the Phase One Property or on the surrounding properties located within the Phase One Study Area from the time of the initial Site reconnaissance that would result in potential subsurface impacts at the Phase One Property. As such, no additional PCAs or APECs, beyond those identified in the initial Phase One ESA, have been identified.

Photo 1 – Building debris/rubble from former Site Buildings (currently being demolished).

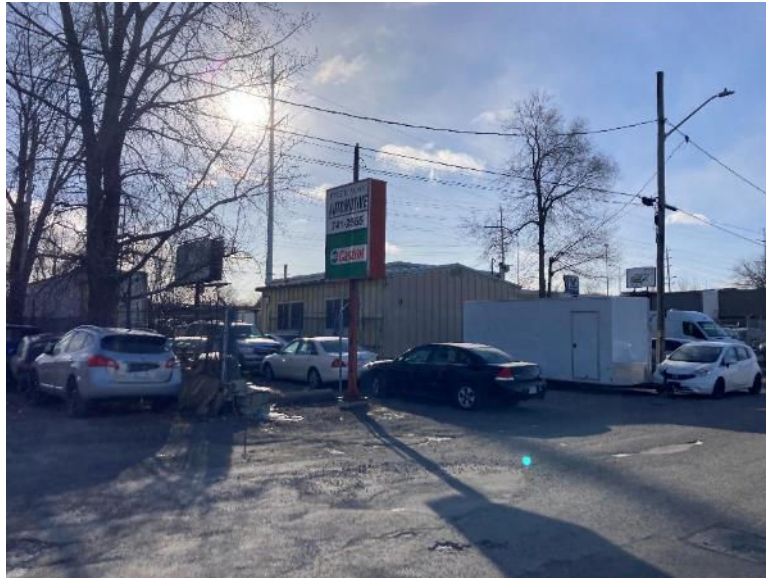
- PCA-14: Item 27 - Garages and Maintenance and Repair of Railcars, Marine Vehicles and Aviation Vehicles (Automotive repair/servicing operation located at 1333 Avenue L, approximately 20 metres (m) east of the Phase One Property); and
- PCA-15: Item 28 – Gasoline and Associated Products Storage in Fixed Tanks (a retail fuel outlet with associated USTs is located at 1333 Avenue L, approximately 20 m east of the Phase One Property).

Photo 3 – Automotive repair facility located east of the Phase One Property at 1333 Avenue K (PCA-14).

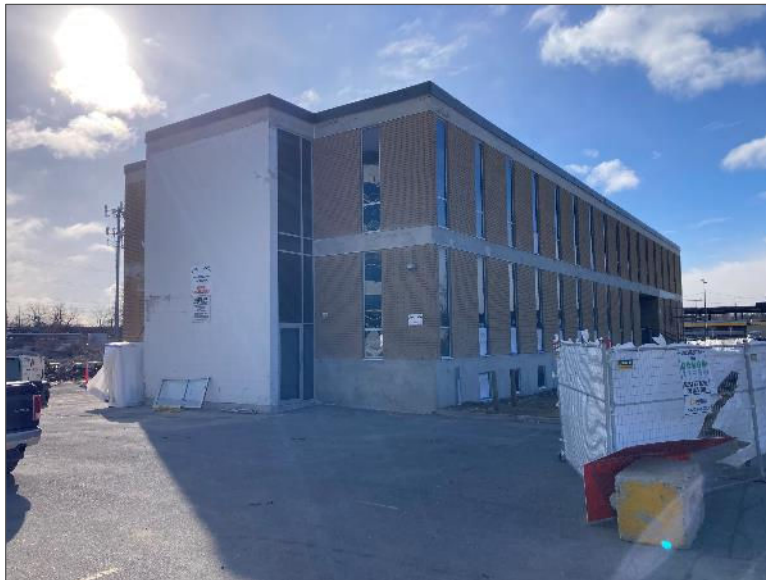
Photo 4 – Site Building C, the only Site Building that currently remains on-Site.
