Phase One Environmental Site Assessment

1132 St. Pierre Street, Ottawa, Ontario

OTT-23014181-F0

July 30, 2024

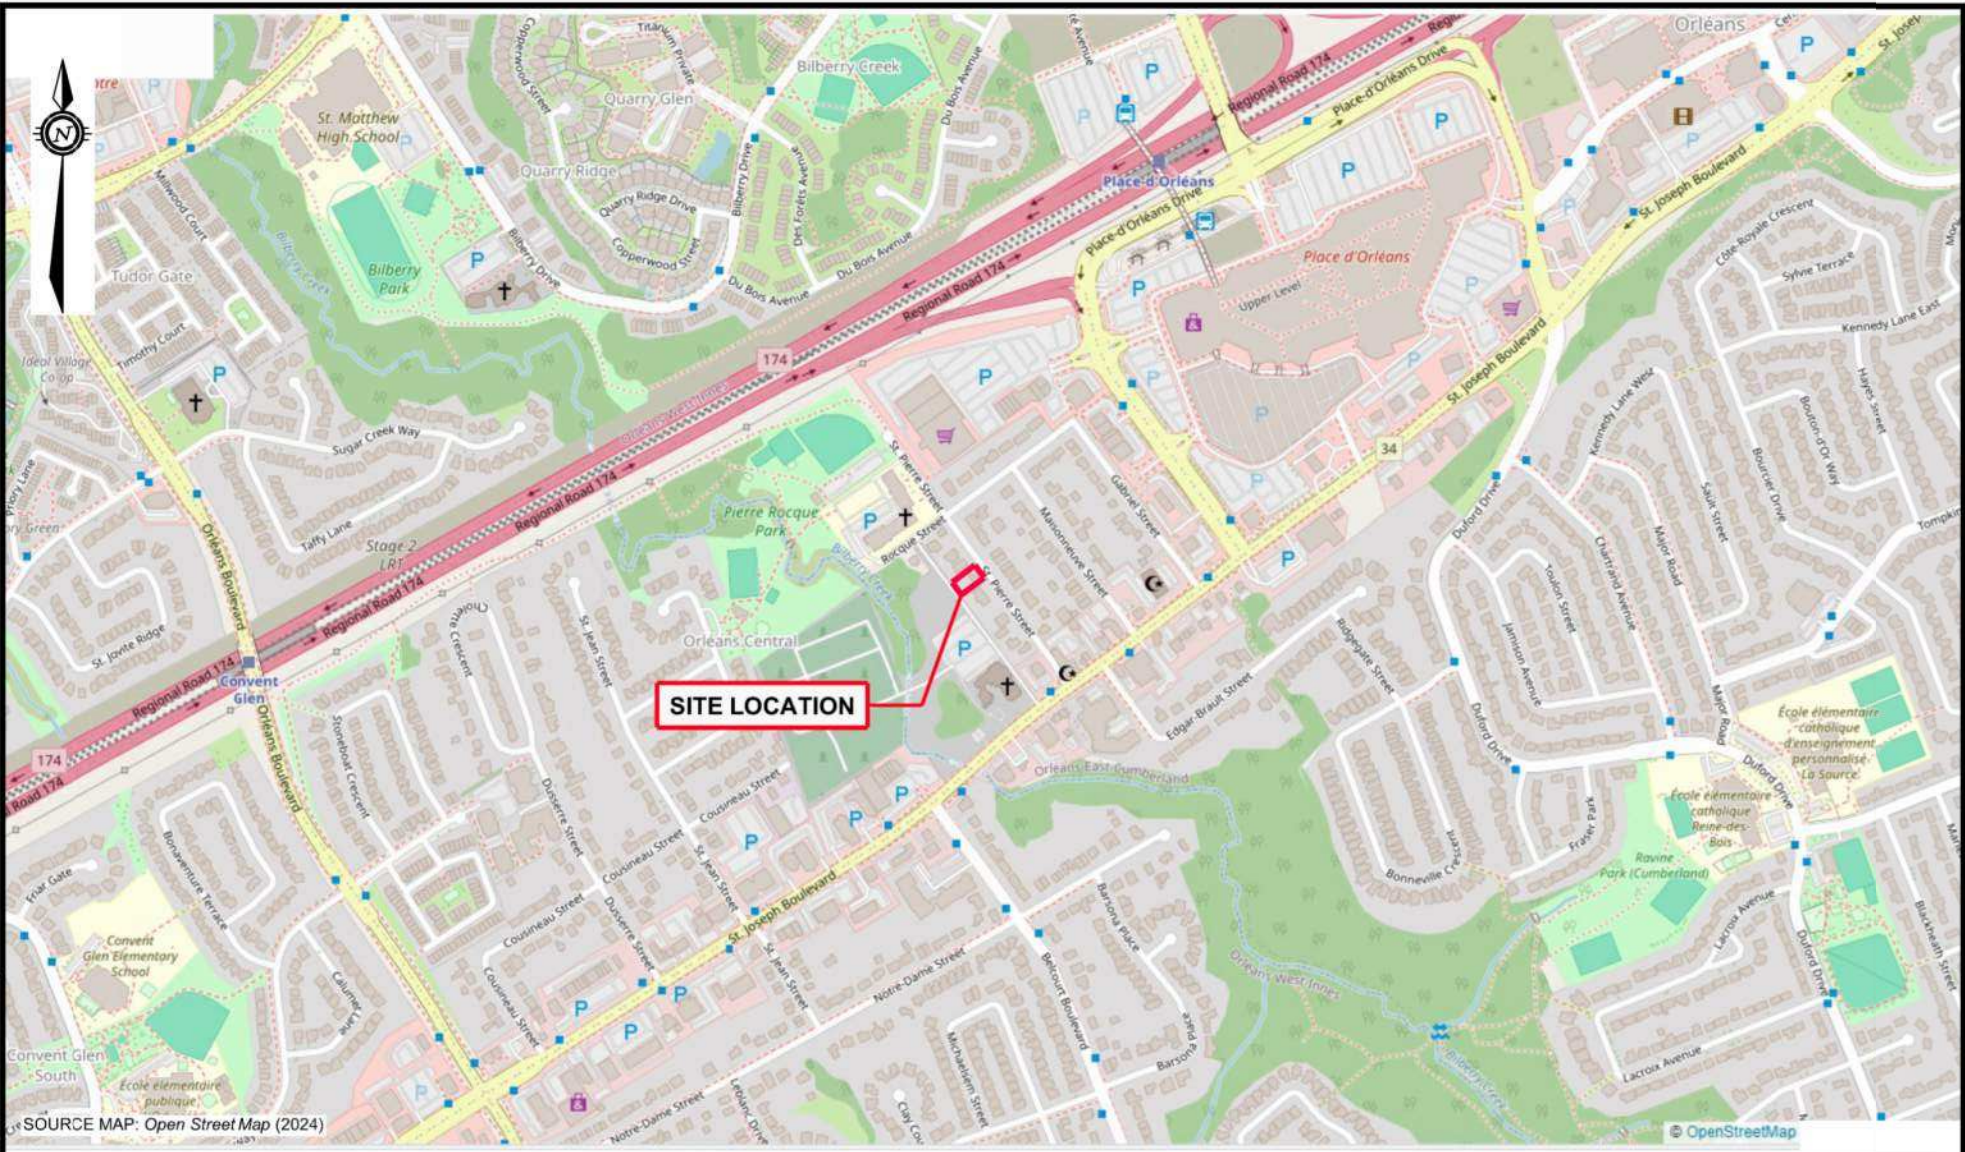
DATE JULY 2024		CLIENT: PULSE SOCIETIES LTD.	project no. OTT-23014181-F0
DESIGN SL		PROPERTY ADDRESS: 1132 ST. PIERRE STREET, OTTAWA, ONTARIO	scale 1:10,000
CHECKED SL		PROJECT: PHASE ONE ENVIRONMENTAL SITE ASSESSMENT	
DRAWN BY AS		TITLE: SITE LOCATION PLAN	FIG 1

The property is located on the west side of St. Pierre Street, between St. Joseph Boulevard and Rocque Street (see Figure 1 and 2). At the time of the investigation, the Site was improved with a two-storey, multi-tenant (duplex) building with associated asphalted parking areas (see Figure 3). The subject site is found in an urban residential neighbourhood which is serviced by municipal water and sanitary systems, as well as connected to overhead electrical supply and buried natural gas networks.

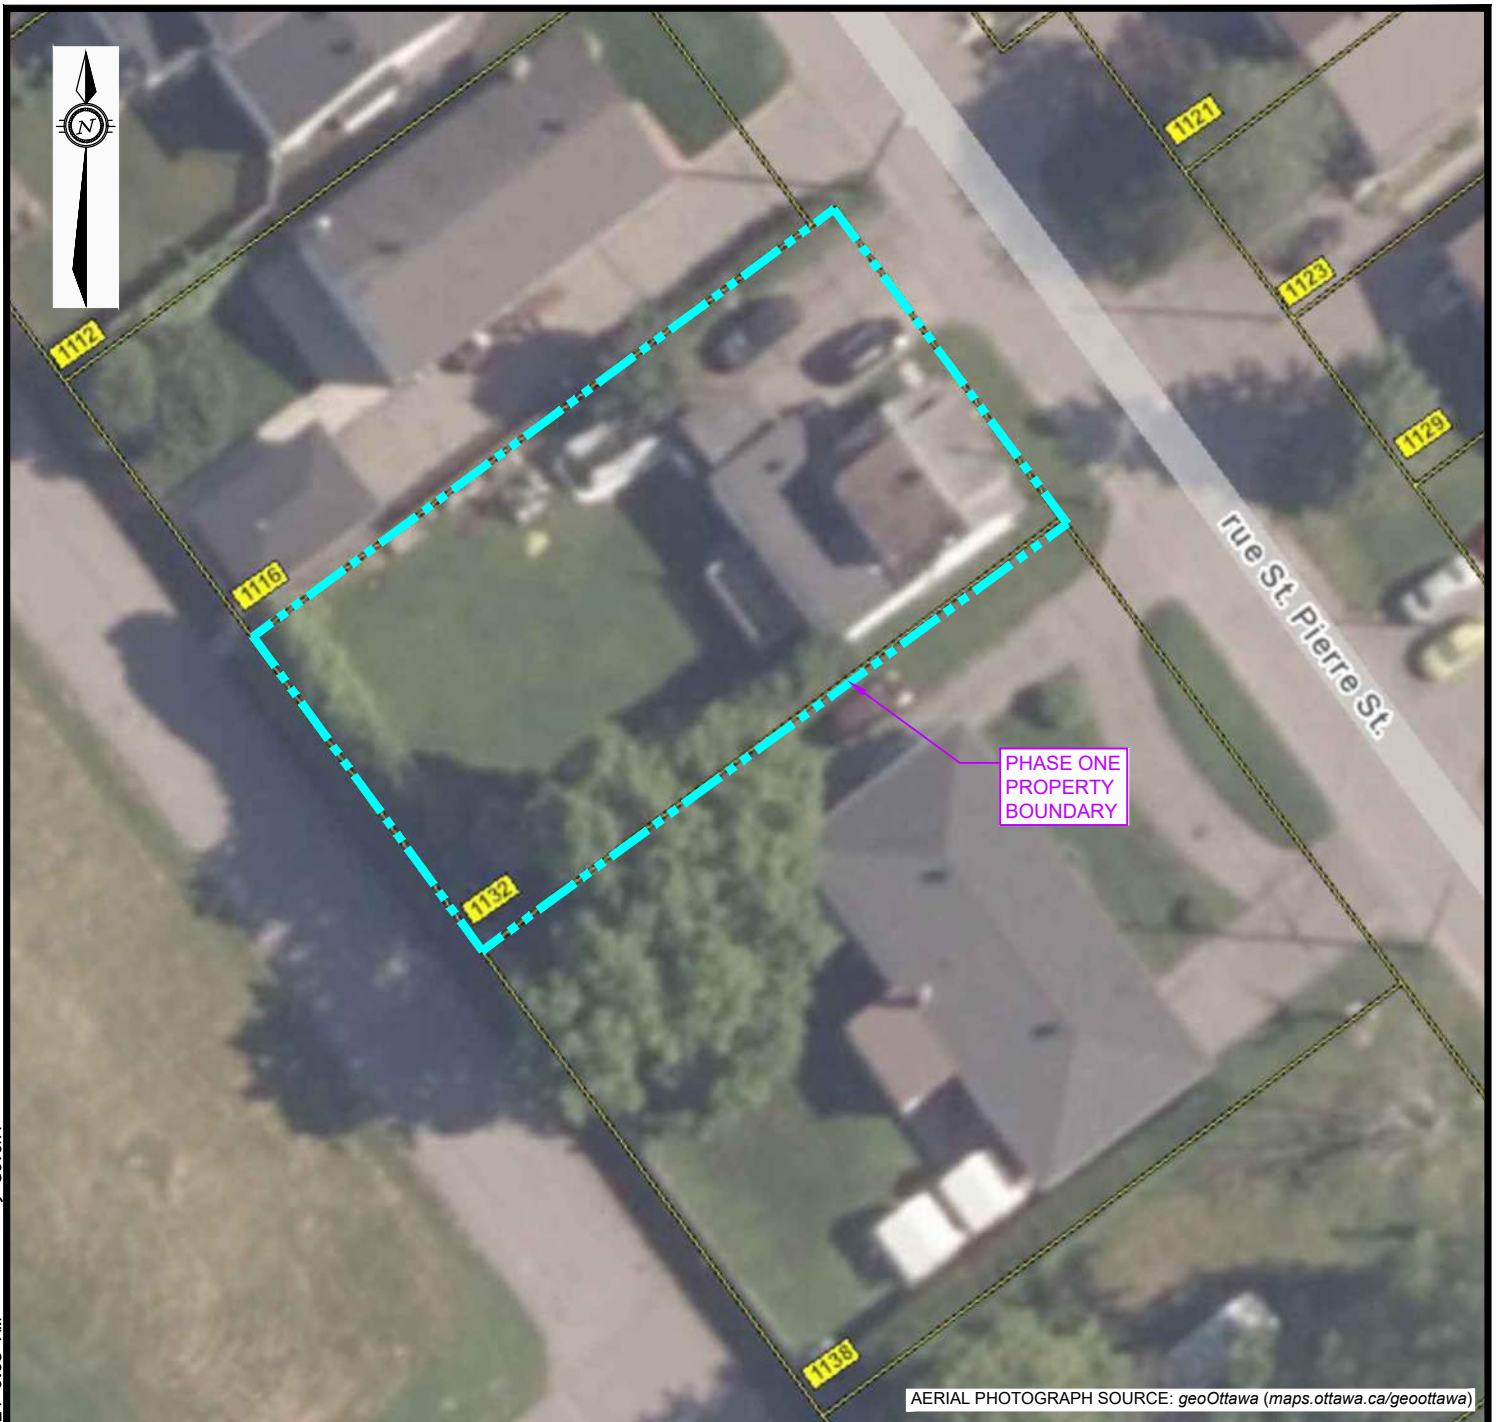
DATE JULY 2024		CLIENT: PULSE SOCIETIES LTD.	project no. OTT-23014181-F0
DESIGN SL	CHECKED SL	PROPERTY ADDRESS: 1132 ST. PIERRE STREET, OTTAWA, ONTARIO	scale 1:400
DRAWN BY AS		PROJECT: PHASE ONE ENVIRONMENTAL SITE ASSESSMENT	
		TITLE: PHASE ONE PROPERTY - SITE LAYOUT	FIG 2

A two-storey, multi tenant residential building is located on the eastern side of the Phase One property. There appears to be an addition to the original building structure to the rear (west). The building has a concrete block foundation and a partially finished basement. A small, detached storage shed is located on the southwestern portion of the Phase One property.

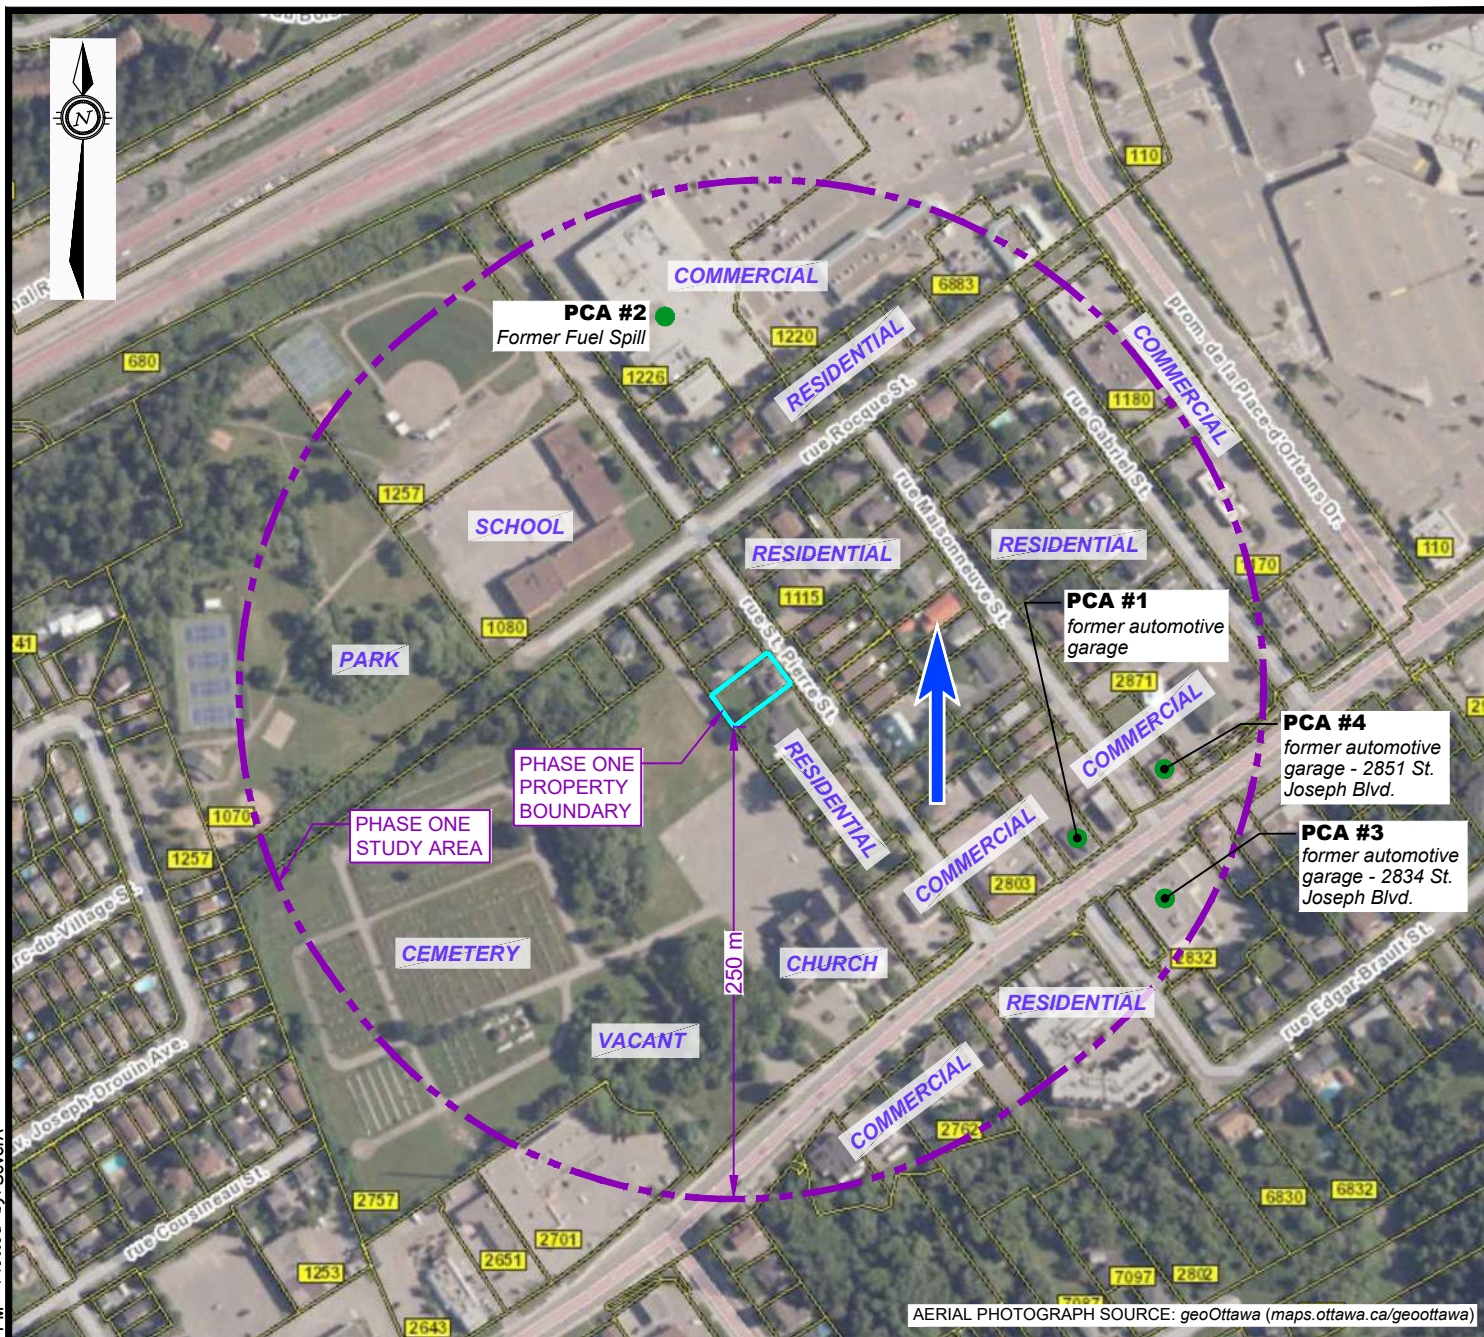
DATE	JULY 2024	CLIENT:	PULSE SOCIETIES LTD.	project no.	OTT-23014181-F0
DESIGN	SL	PROPERTY ADDRESS:	1132 ST. PIERRE STREET, OTTAWA, ONTARIO	scale	1:4,000
CHECKED	SL	PROJECT:	PHASE ONE ENVIRONMENTAL SITE ASSESSMENT		
DRAWN BY	AS	TITLE:	PHASE ONE CONCEPTUAL SITE MODEL		FIG 3

AERIAL PHOTOGRAPH SOURCE: geoOttawa (maps.ottawa.ca/geoottawa)

To develop a conceptual model for the Phase One property, the following physical characteristics and pathways were considered. A conceptual site model (CSM) showing the topography of the site, inferred groundwater flow, general site features, and PCAs is shown in Figure 3.

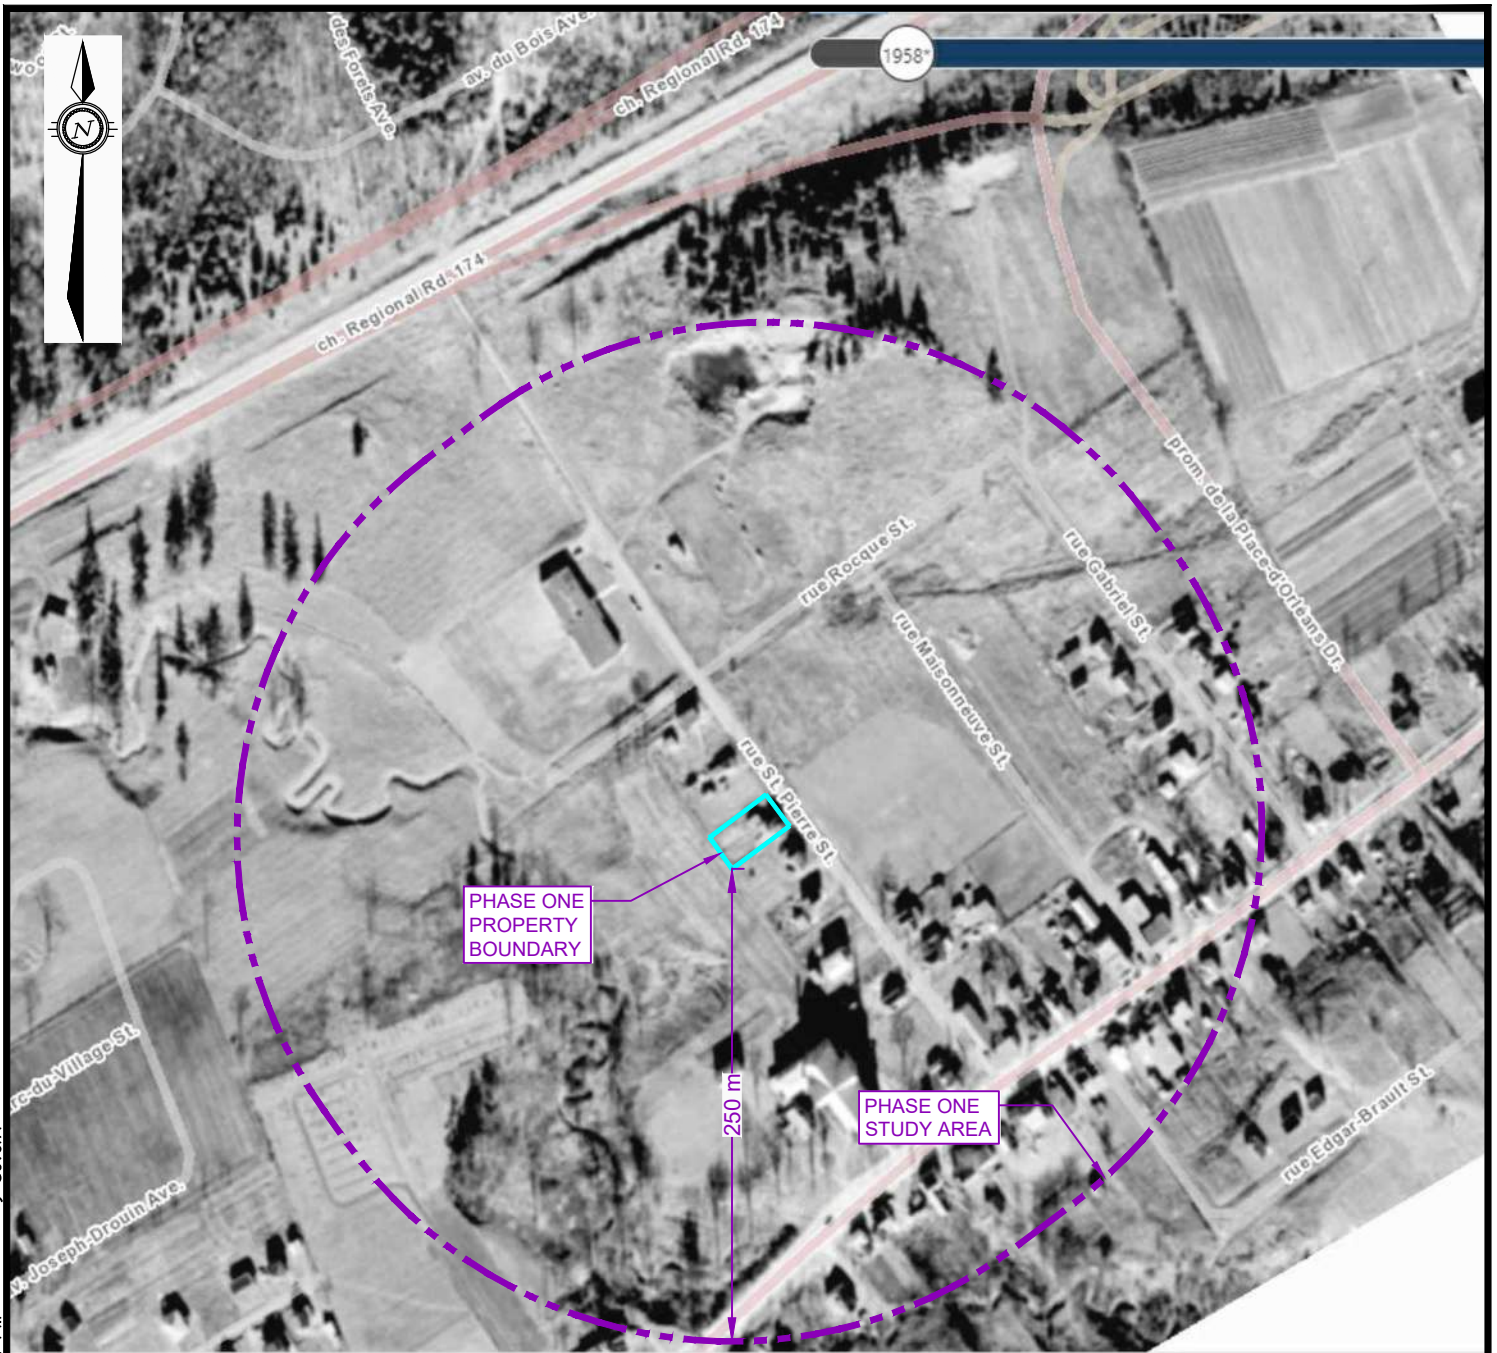
DATE JULY 2024		CLIENT: NEMORIN GROUP LIMITED	project no. OTT-23014181-F0
DESIGN SL	CHECKED SL	PROPERTY ADDRESS: 1132 ST. PIERRE STREET, OTTAWA, ONTARIO	scale 1:4,000
DRAWN BY AS		PROJECT: PHASE ONE ENVIRONMENTAL SITE ASSESSMENT	
		TITLE: 1958 AERIAL PHOTOGRAPH	FIG F-1

AERIAL PHOTOGRAPH SOURCE: geoOttawa (maps.ottawa.ca/geoottawa)

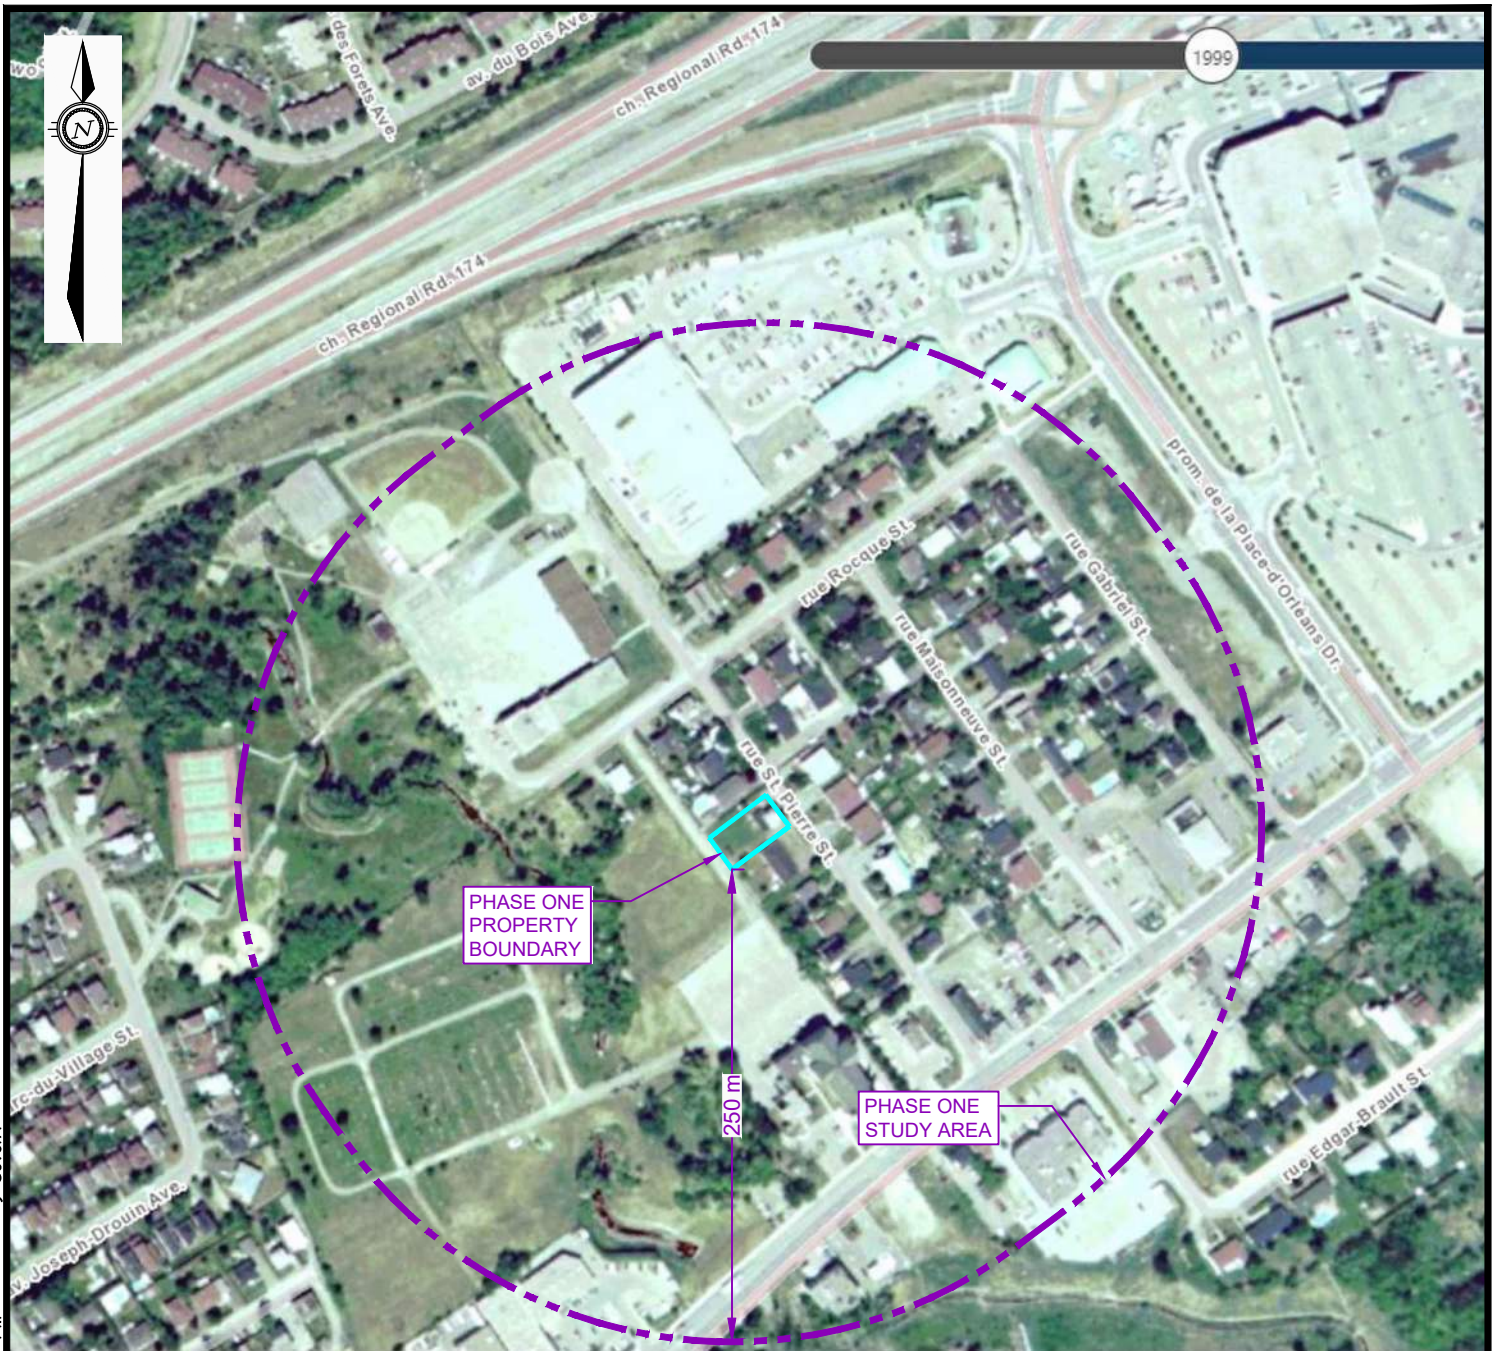
DATE JULY 2024		CLIENT: NEMORIN GROUP LIMITED	project no. OTT-23014181-F0
DESIGN SL	CHECKED SL	PROPERTY ADDRESS: 1132 ST. PIERRE STREET, OTTAWA, ONTARIO	scale 1:4,000
DRAWN BY AS		PROJECT: PHASE ONE ENVIRONMENTAL SITE ASSESSMENT	
		TITLE: 1999 AERIAL PHOTOGRAPH	FIG F-4

AERIAL PHOTOGRAPH SOURCE: geoOttawa (maps.ottawa.ca/geoottawa)

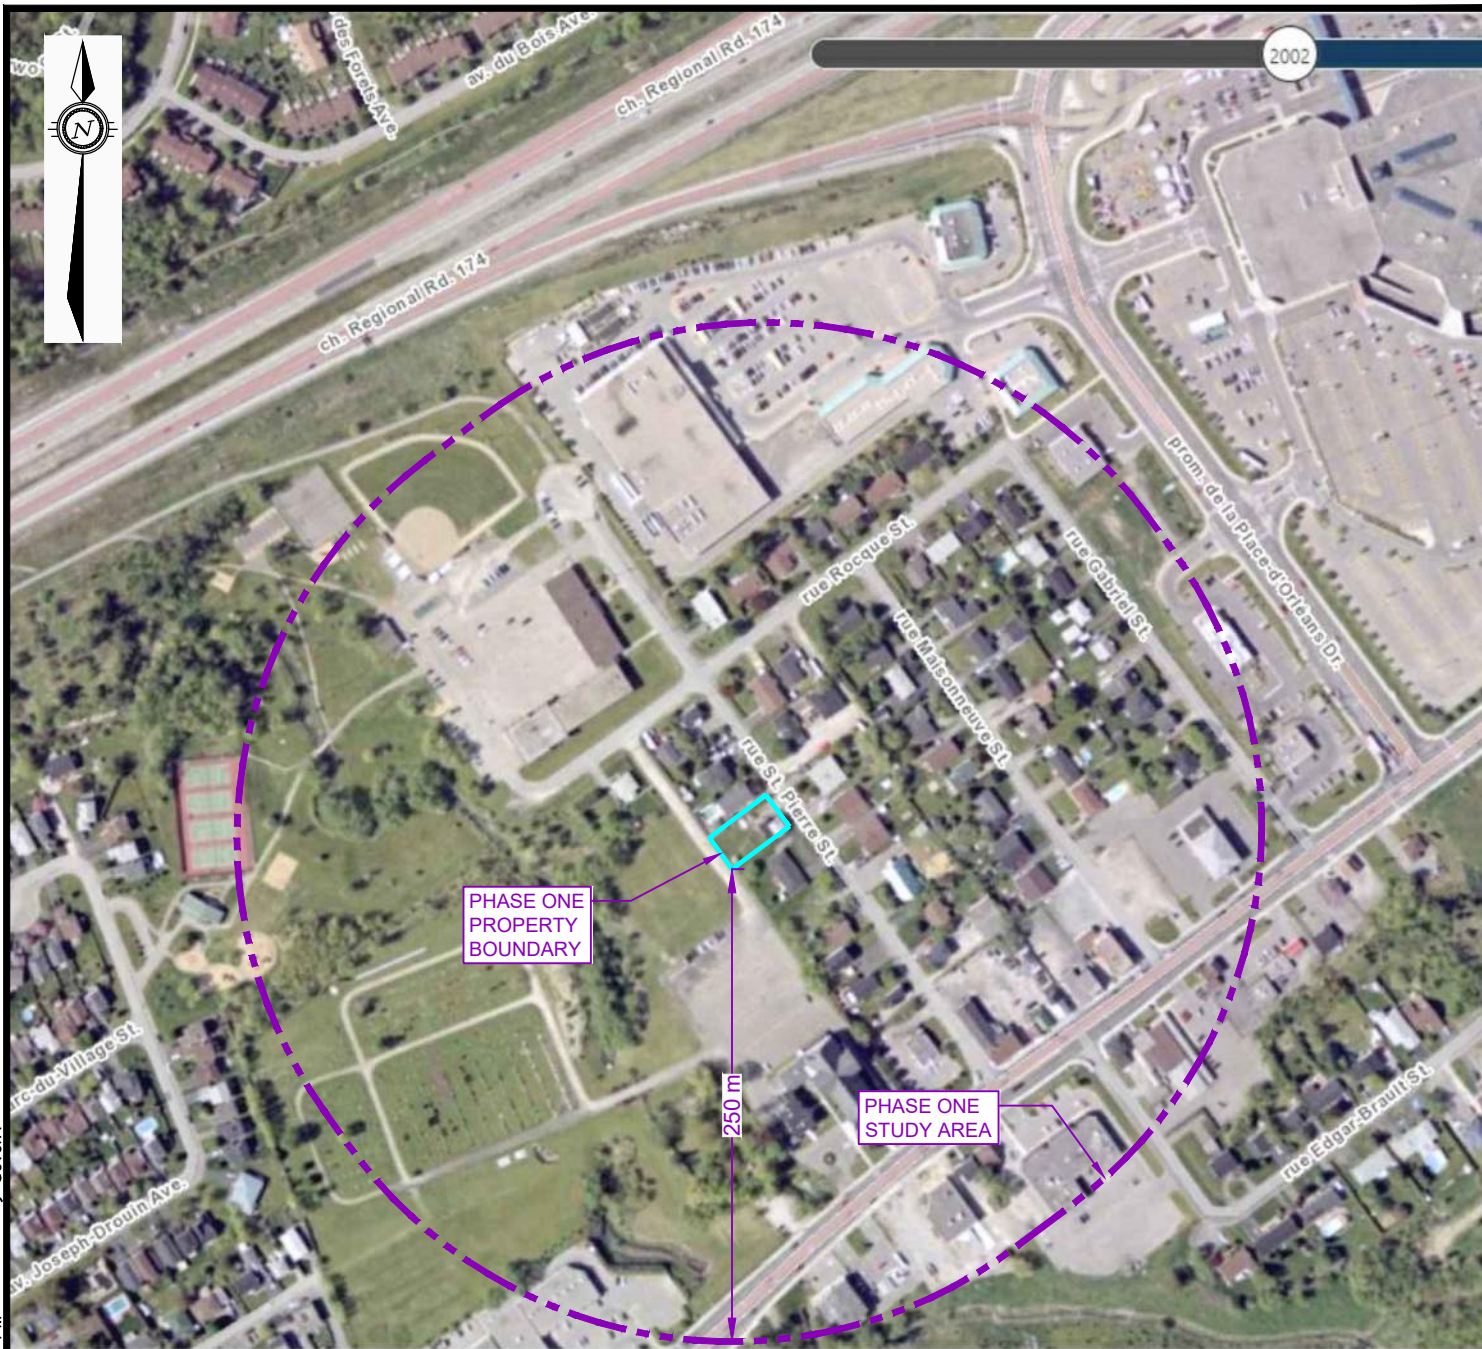
DATE JULY 2024		CLIENT: NEMORIN GROUP LIMITED	project no. OTT-23014181-F0
DESIGN SL	CHECKED SL	PROPERTY ADDRESS: 1132 ST. PIERRE STREET, OTTAWA, ONTARIO	scale 1:4,000
DRAWN BY AS		PROJECT: PHASE ONE ENVIRONMENTAL SITE ASSESSMENT	
		TITLE: 2002 AERIAL PHOTOGRAPH	FIG F-5

AERIAL PHOTOGRAPH SOURCE: *geoOttawa* (maps.ottawa.ca/geoottawa)

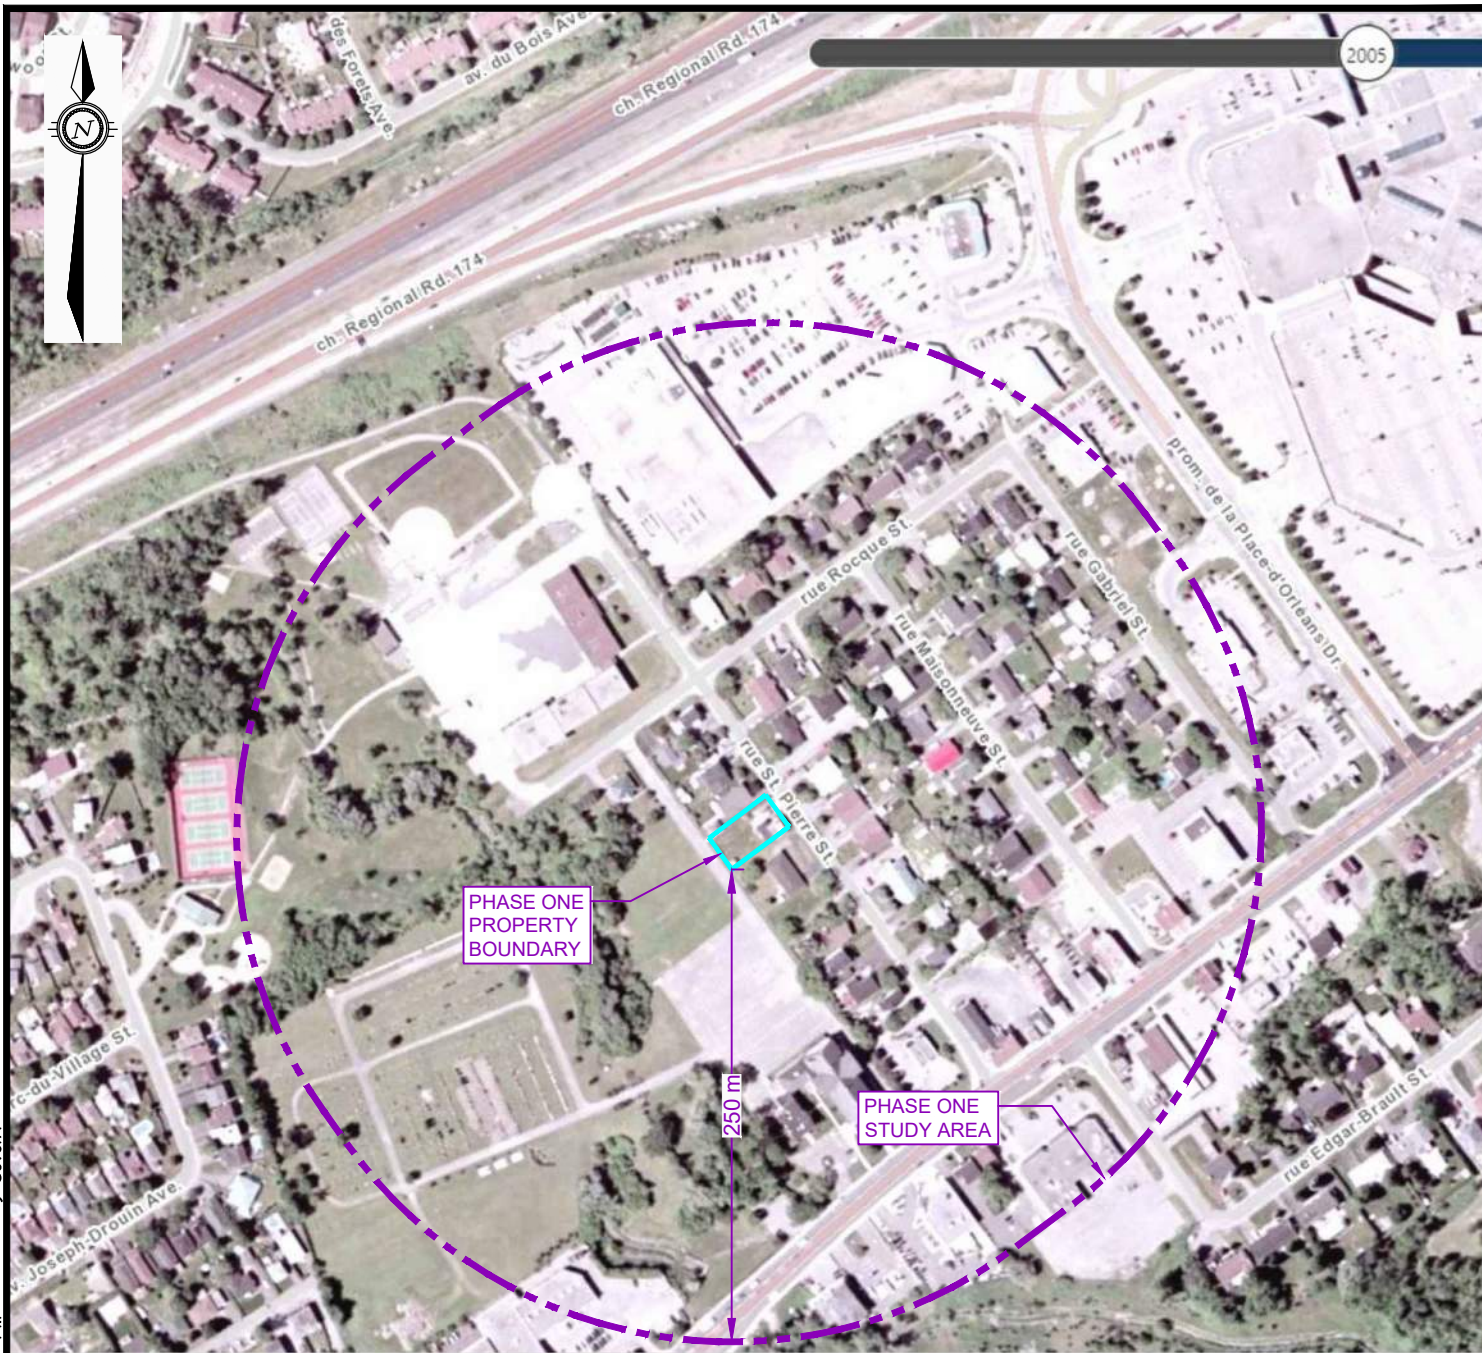
DATE JULY 2024		CLIENT: NEMORIN GROUP LIMITED	project no. OTT-23014181-F0
DESIGN SL	CHECKED SL	PROPERTY ADDRESS: 1132 ST. PIERRE STREET, OTTAWA, ONTARIO	scale 1:4,000
DRAWN BY AS		PROJECT: PHASE ONE ENVIRONMENTAL SITE ASSESSMENT	
		TITLE: 2005 AERIAL PHOTOGRAPH	FIG F-6

AERIAL PHOTOGRAPH SOURCE: geoOttawa (maps.ottawa.ca/geoottawa)

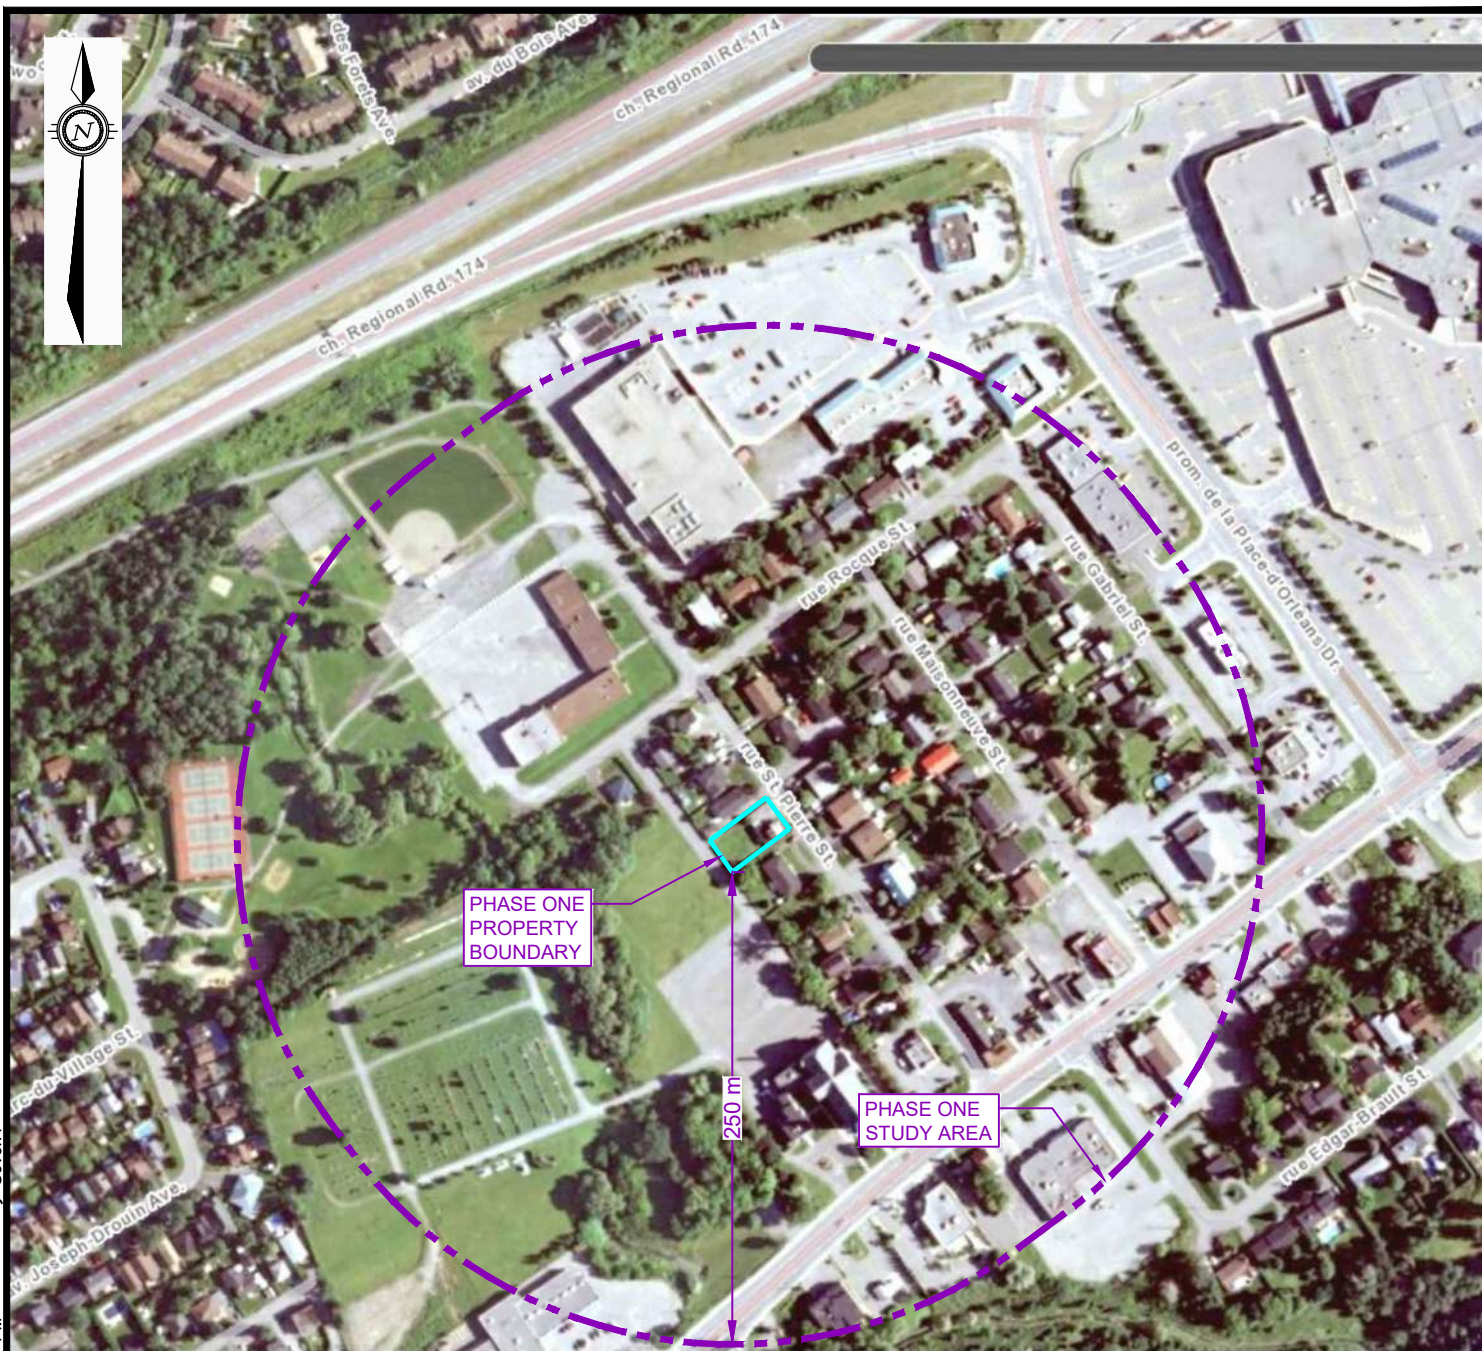
DATE JULY 2024		CLIENT: NEMORIN GROUP LIMITED	project no. OTT-23014181-F0
DESIGN SL	CHECKED SL	PROPERTY ADDRESS: 1132 ST. PIERRE STREET, OTTAWA, ONTARIO	scale 1:4,000
PROJECT: PHASE ONE ENVIRONMENTAL SITE ASSESSMENT		TITLE: 2008 AERIAL PHOTOGRAPH	FIG F-7
DRAWN BY AS

AERIAL PHOTOGRAPH SOURCE: *geoOttawa* (maps.ottawa.ca/geoottawa)

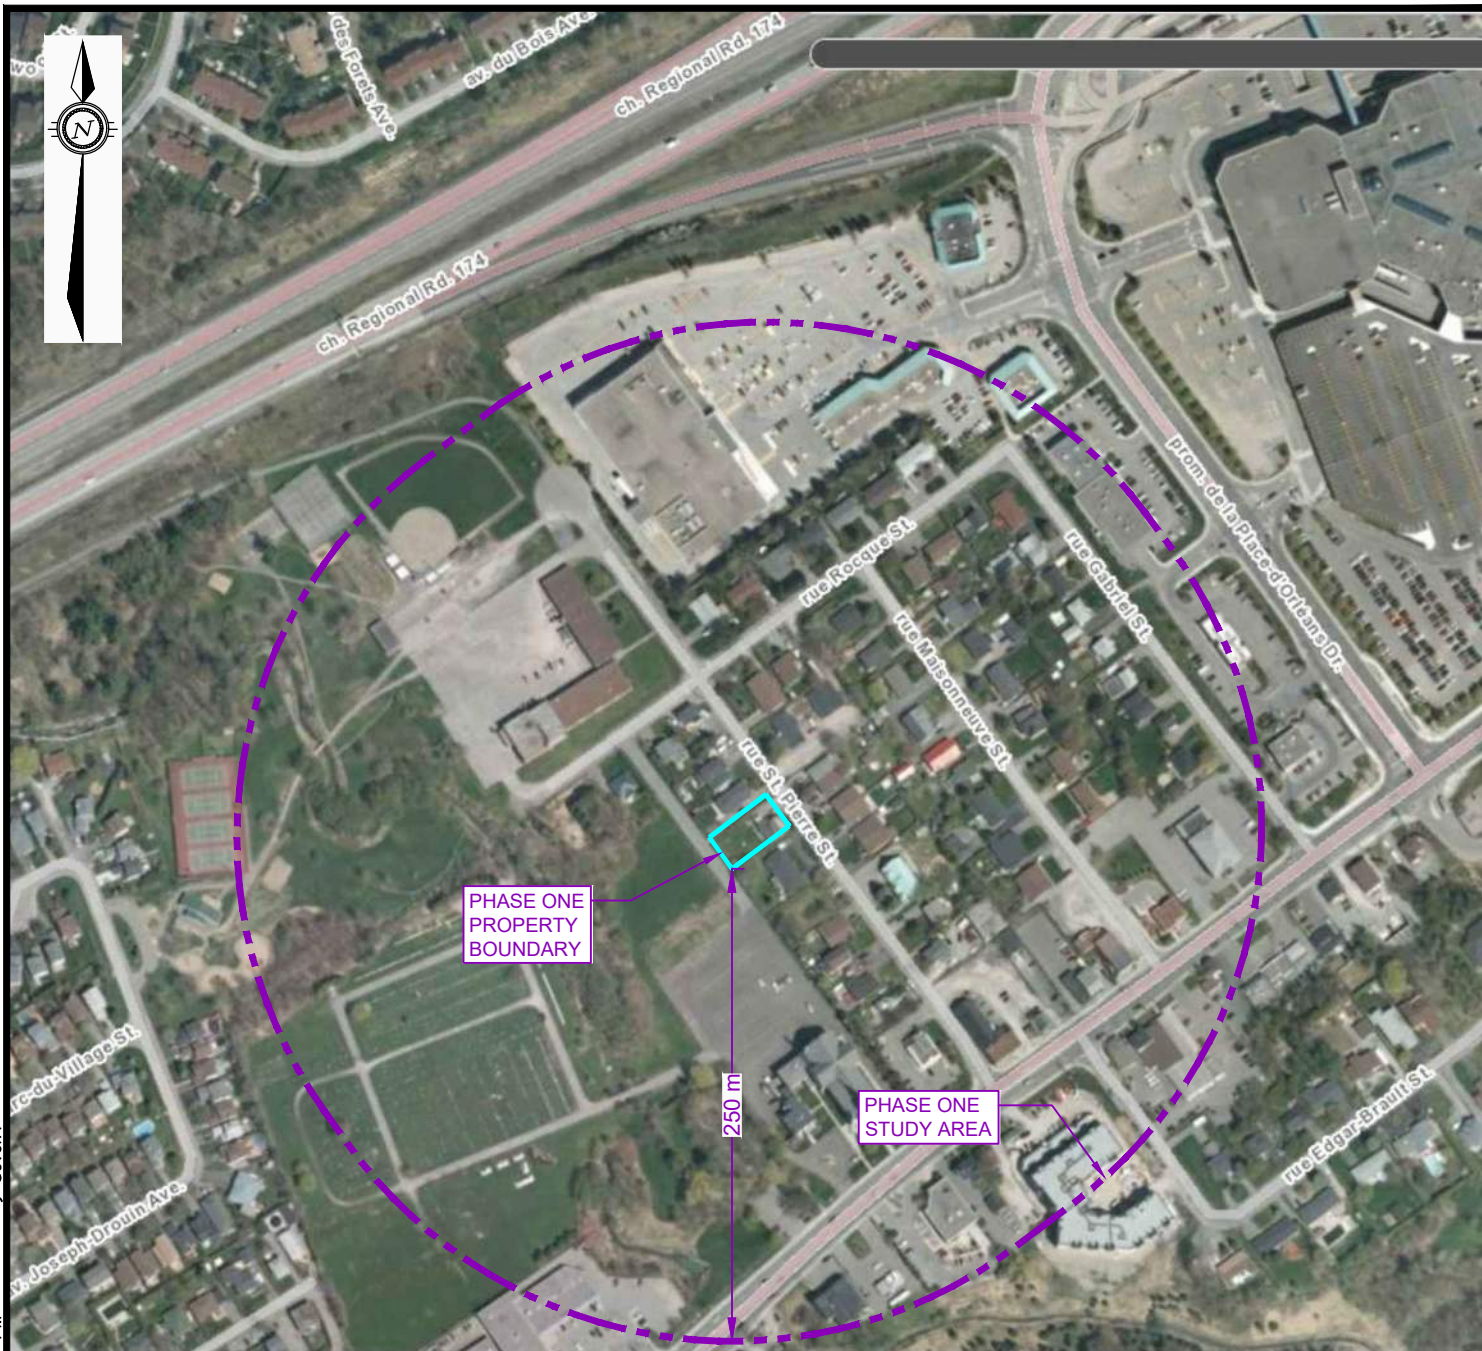
DATE JULY 2024		CLIENT: NEMORIN GROUP LIMITED	project no. OTT-23014181-F0
DESIGN SL	CHECKED SL	PROPERTY ADDRESS: 1132 ST. PIERRE STREET, OTTAWA, ONTARIO	scale 1:4,000
PROJECT: PHASE ONE ENVIRONMENTAL SITE ASSESSMENT		TITLE: 2011 AERIAL PHOTOGRAPH	FIG F-8
DRAWN BY AS

AERIAL PHOTOGRAPH SOURCE: geoOttawa (maps.ottawa.ca/geoottawa)

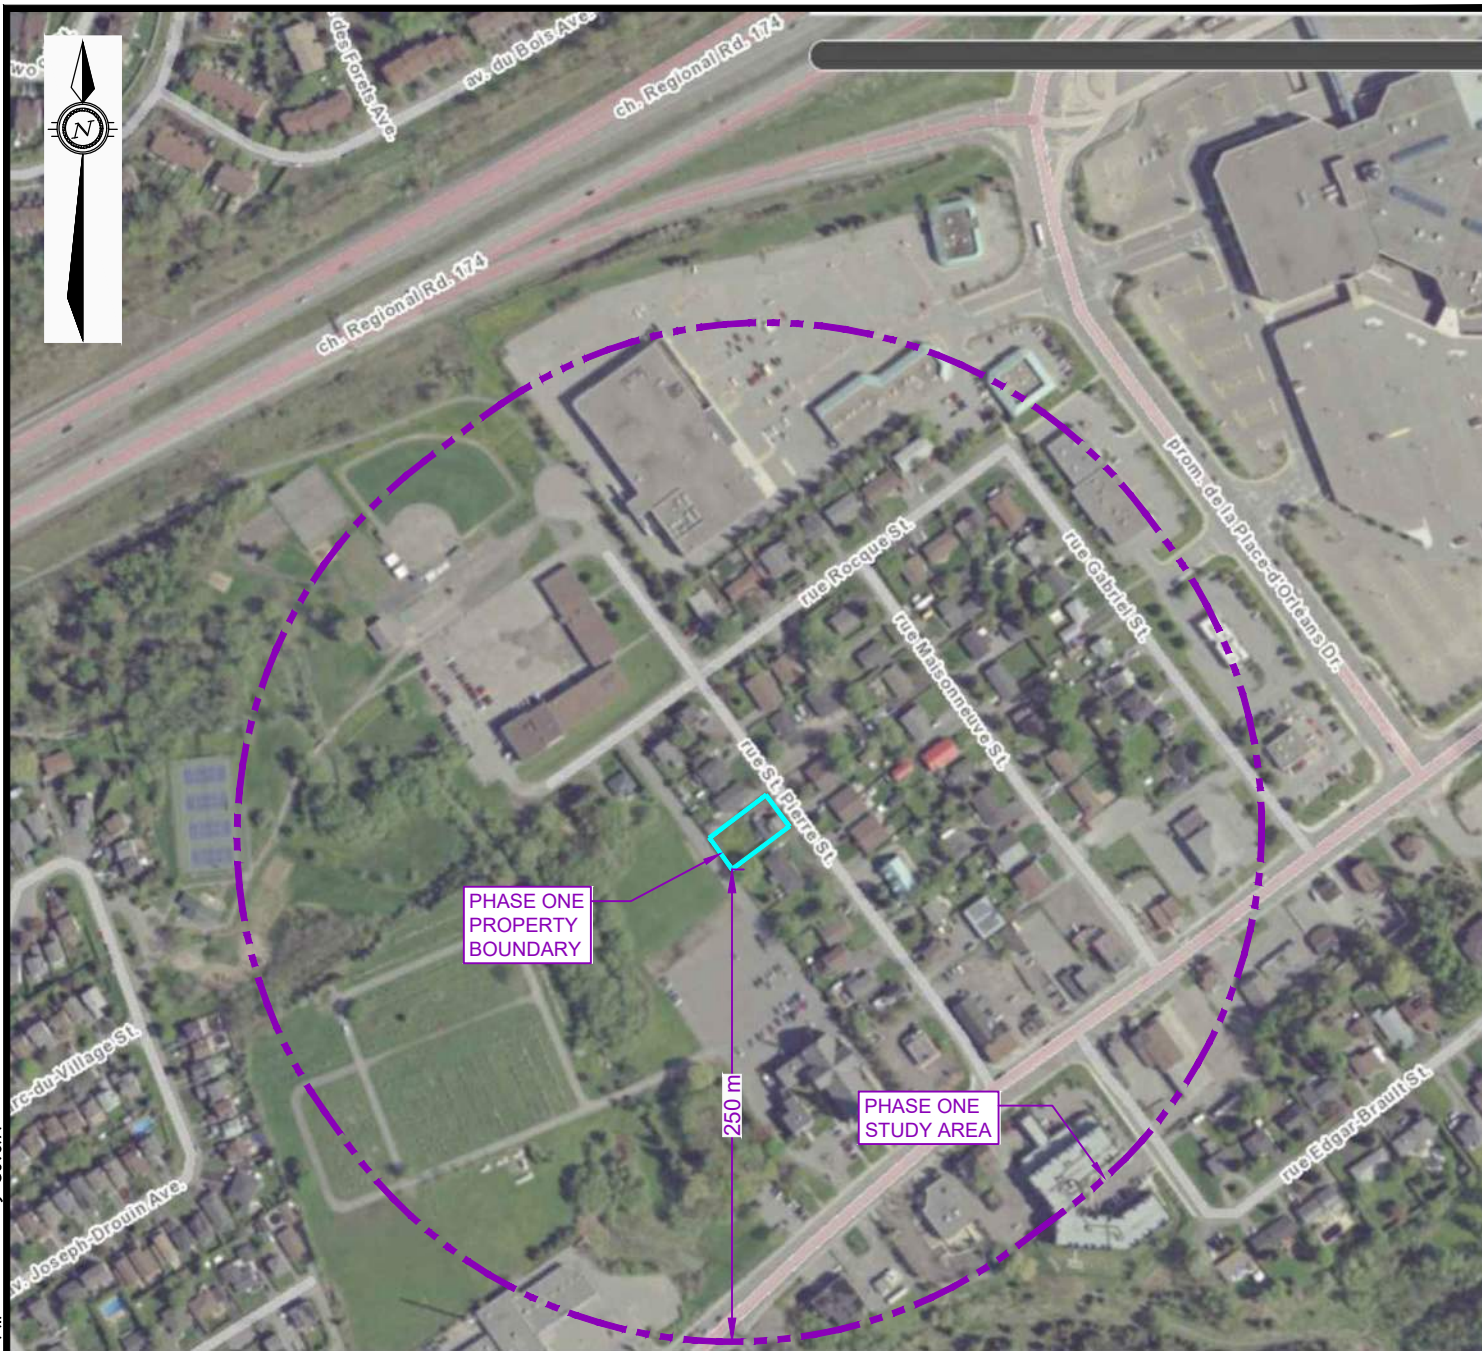
DATE JULY 2024		CLIENT: NEMORIN GROUP LIMITED	project no. OTT-23014181-F0
DESIGN SL	CHECKED SL	PROPERTY ADDRESS: 1132 ST. PIERRE STREET, OTTAWA, ONTARIO	scale 1:4,000
PROJECT: PHASE ONE ENVIRONMENTAL SITE ASSESSMENT		TITLE: 2014 AERIAL PHOTOGRAPH	FIG F-9
DRAWN BY AS

AERIAL PHOTOGRAPH SOURCE: *geoOttawa* (maps.ottawa.ca/geoottawa)

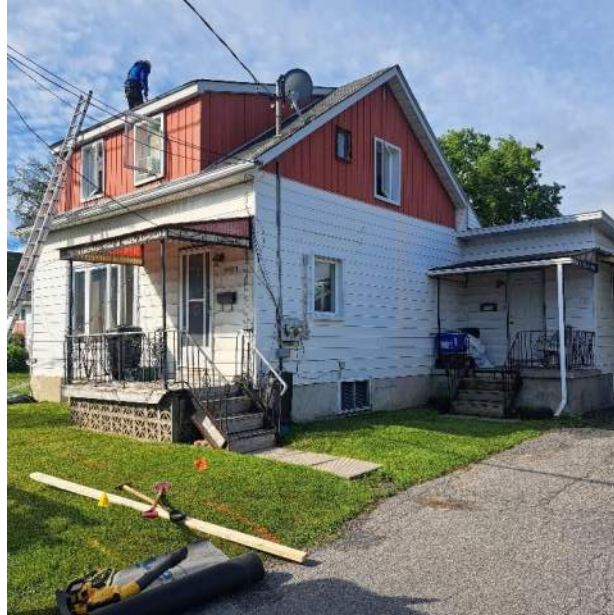
Photograph No. 1

View of the residential building located on the Phase One property from St. Pierre Street, facing south.

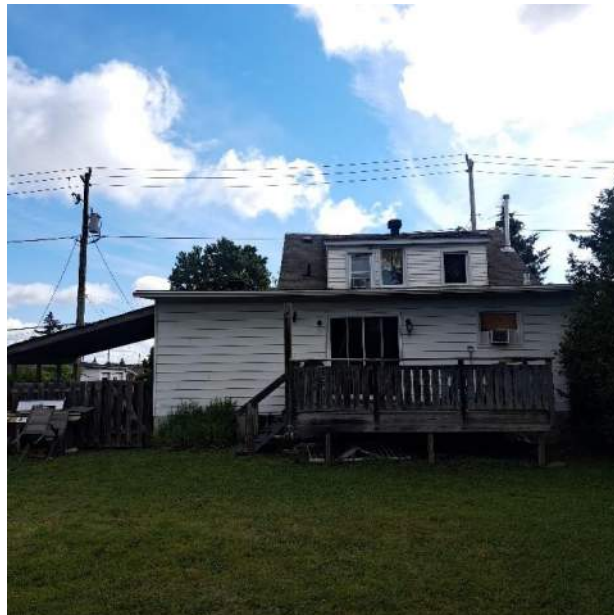
Photograph No. 2

View of the Phase One property from the backyard facing east

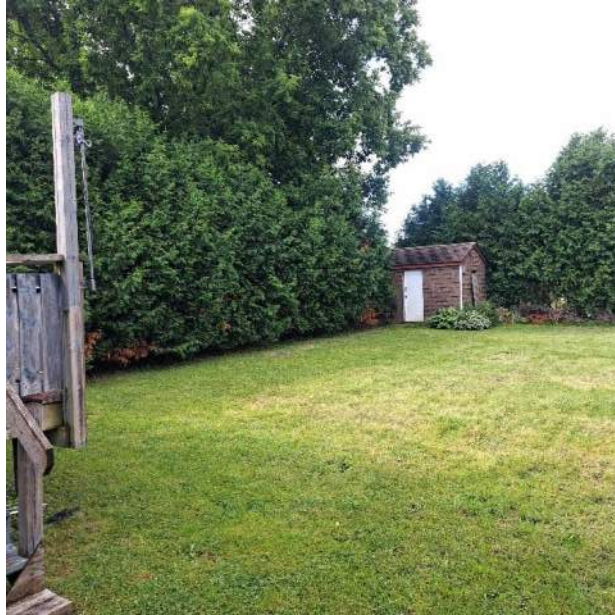
Photograph No. 3

View of the small shed and landscaped area on the western portion of the Phase One property facing west.

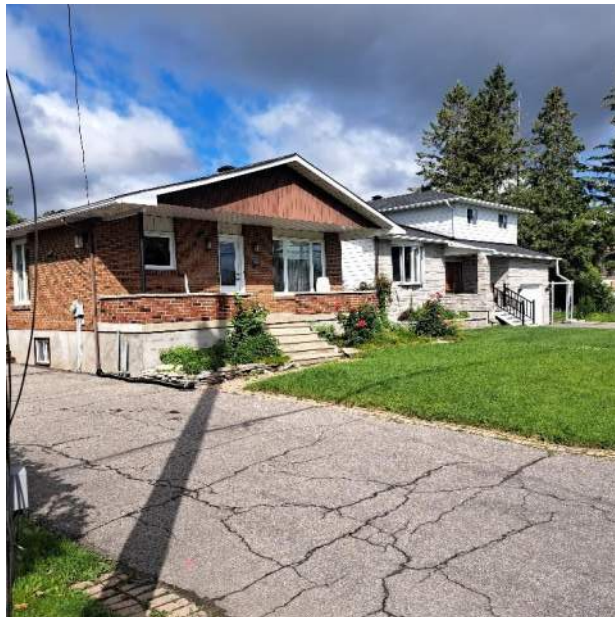
Photograph No. 4

View of the neighboring residential properties along St. Pierre Street, facing northwest.
