Phase One Environmental Site Assessment

1132 St. Pierre Street, Ottawa, Ontario

OTT-23014181-F0

July 30, 2024

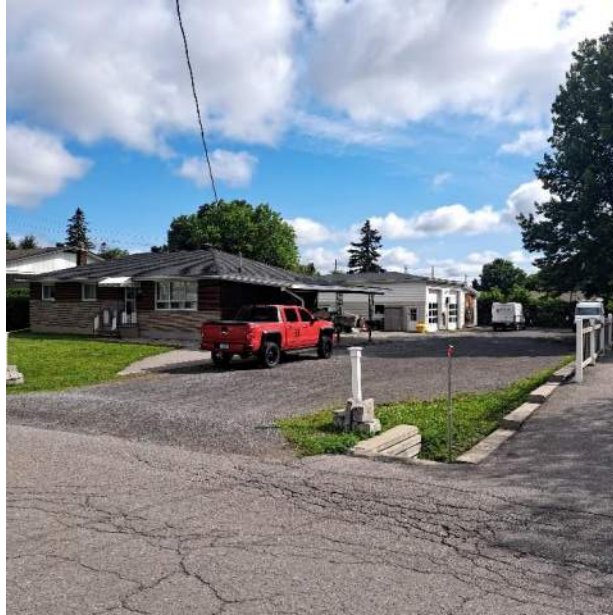
Photograph No. 5

View of the property with garage across St. Pierre to the east, facing east

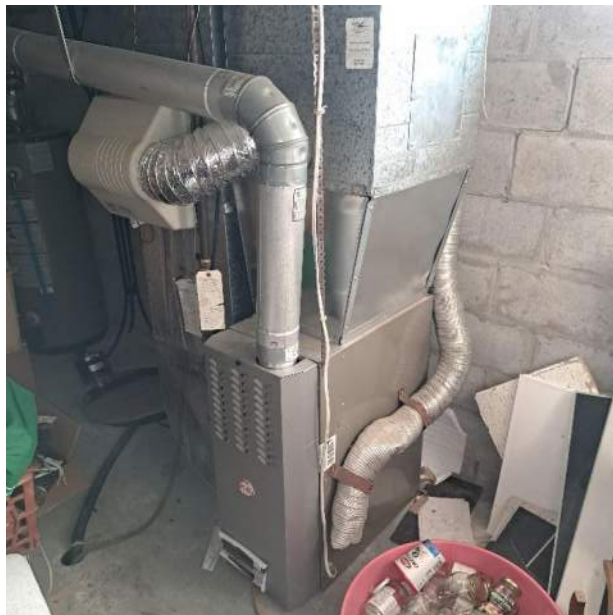
Photograph No. 6

View of the natural gas forced air furnace located in the basement.

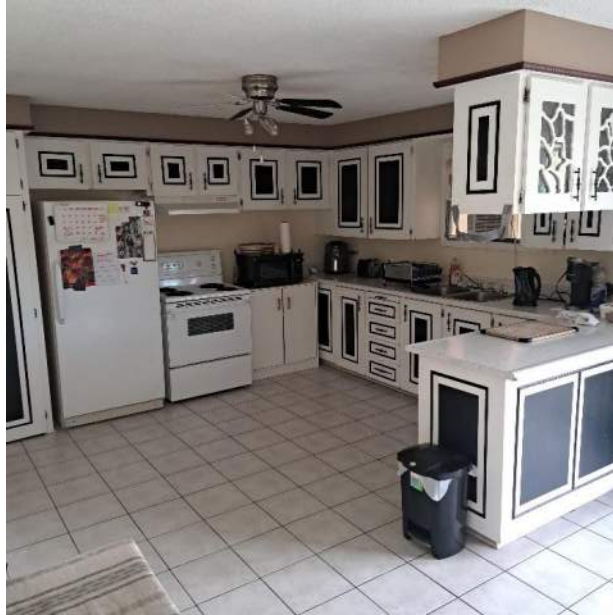
Photograph No. 7

View of the typical interior construction materials of the Phase One property.

Based on the age of the building (constructed pre-1958), ACM may be present in the building. A Designated Substance Survey (DSS) is recommended according to Ontario Regulation 490/09 prior to any renovation or demolition of the building.

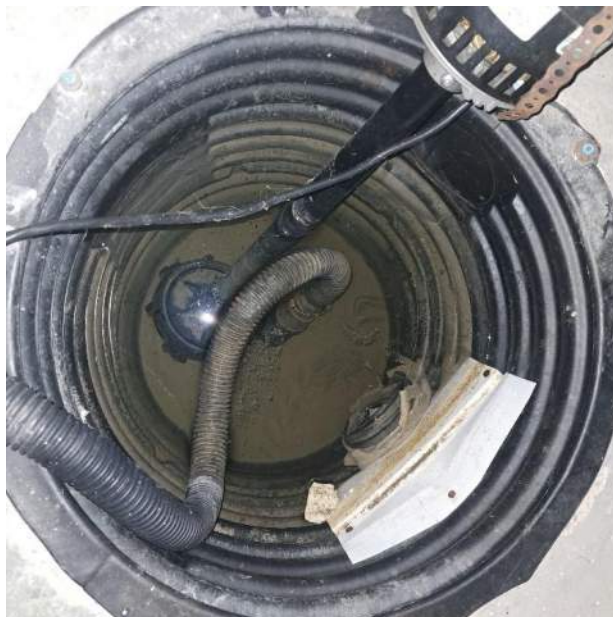
Photograph No. 8

View of the sump pit located in the basement of the Phase One property building.

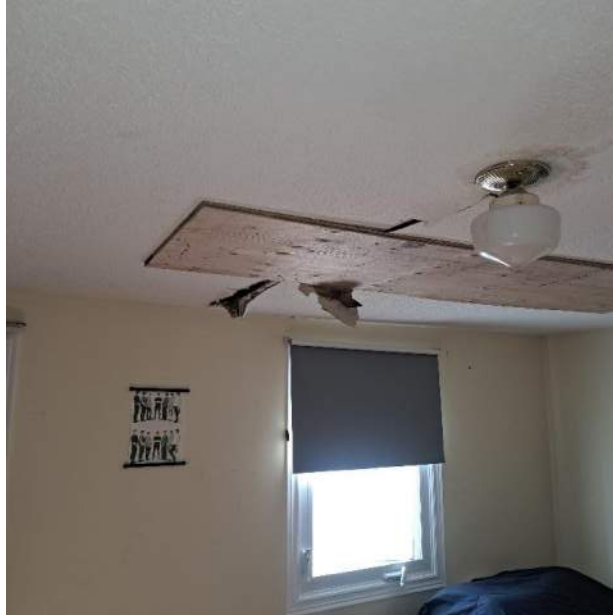
Photograph No. 9

View of the damaged ceiling and suspected mould in a second-floor bedroom.

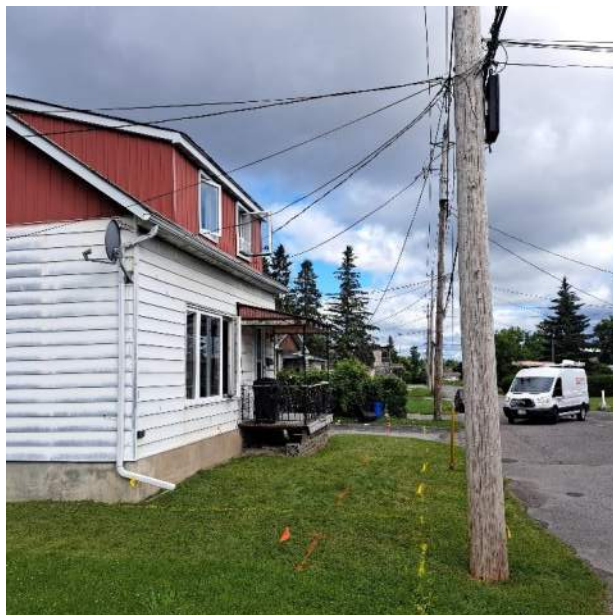
Photograph No. 10

View along the eastern Phase One property boundary, facing north.
