RE: TREE CONSERVATION REPORT – 1620 LAPERRIERE AVENUE, OTTAWA

This Tree Conservation Report (TCR) was prepared by IFS Associates Inc. (IFS) on behalf of EAU Structural & Environnemental Services in support of the proposed redevelopment of 1620 Laperriere Avenue in Ottawa. The need for this report is related to trees protected under the City of Ottawa’s Tree Protection By-law (By-law No. 2020-340). The proposed redevelopment includes the addition of a storage building to the rear of an existing commercial building.

DRAWING: Tree Conservation Plan

PROJECT: 1620 LAPERRIERE AVENUE
CITY OF OTTAWA

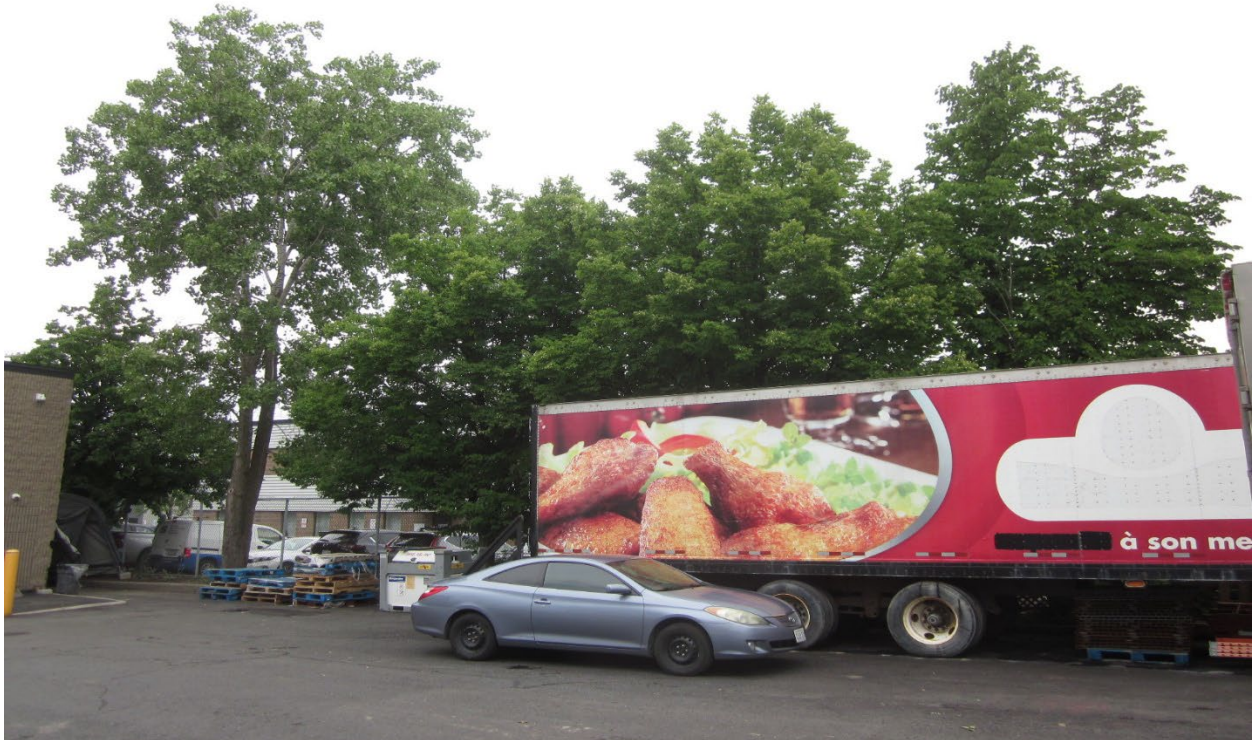
4	Cottonwood (<i>Populus deltoids</i>)	Private	59.8	Good; mature; double-stemmed at 1.5m; generally upright form - stems mildly divergent; very restricted rooting zone; native species; to be preserved and protected
5	Little-leaf linden (<i>Tilia cordata</i>)	Private	27.5	Fair; mature; central main stem with competing and suppressed laterals starting at 1.5m; broad, dense crown; very restricted rooting zone; introduced species; to be preserved and protected
6	Little-leaf linden (<i>Tilia cordata</i>)	Private	26.7	Poor; mature; central main stem with competing and suppressed laterals starting at 1m; very restricted rooting zone; broad, dense crown; very restricted rooting zone; introduced species; to be preserved and protected
7	Little-leaf linden (<i>Tilia cordata</i>)	Private	19.4 & 21.1	Fair; mature; double-stemmed from grade – mildly divergent; very restricted rooting zone; introduced species; to be preserved and protected

Picture 2. Trees #3 to 7 (left to right), linden trees and a single cottonwood at 1620 Laperriere Avenue.

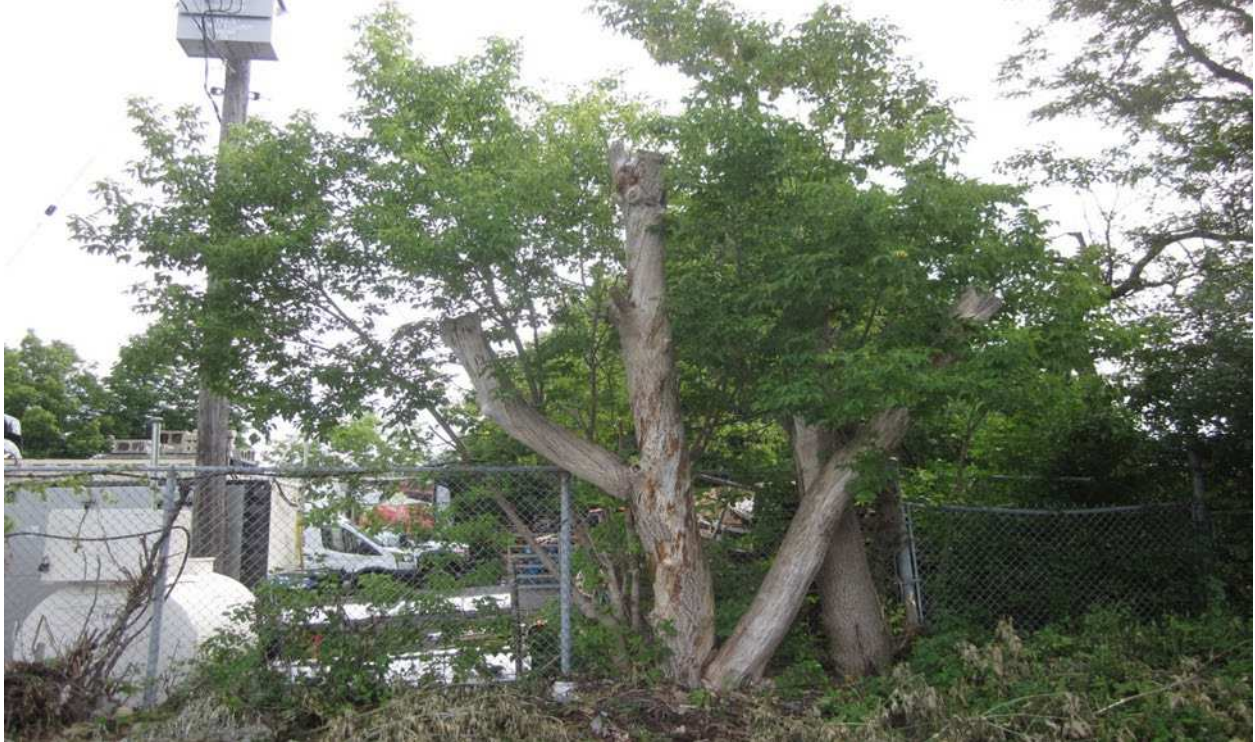
Tree No.	Tree Species	Ownership ¹	DBH ² (cm)	Tree Condition, Age class & Preservation Status (to be removed or preserved and protected)
9	Manitoba maple (<i>Acer negundo</i>)	Neighbour	35.1	Very poor; mature; topped at 4-5m; basal sprouting; naturalized species; to be preserved and protected
10	Manitoba maple (<i>Acer negundo</i>)	Neighbour	40.3	Very poor; mature; topped at 4-5m; basal sprouting; naturalized species; to be preserved and protected
11	Little-leaf linden (<i>Tilia cordata</i>)	Private	59.4	Fair; mature; co-dominant leaders at 5m; seam running from primary union to grade (weak union); introduced species; to be removed (will not survive root loss)
12	Little-leaf linden (<i>Tilia cordata</i>)	Private	32.3	Good; mature; single dominant stem for most of height; introduced species; to be removed (will not survive root loss)
13	Little-leaf linden (<i>Tilia cordata</i>)	Private	29.8	Fair; mature; single dominant stem for most of height; heavy vine growth into lower crown; introduced species; to be removed (will not survive root loss)

Picture 4. Trees #9 and 10, neighbouring Manitoba maples adjacent to 1620 Laperriere Avenue.
