ENVIRONMENTAL IMPACT STUDY UPDATE

100 STEACIE DRIVE, OTTAWA, ONTARIO

CIMA+ file number: A001489
July 11, 2025 – Review 002

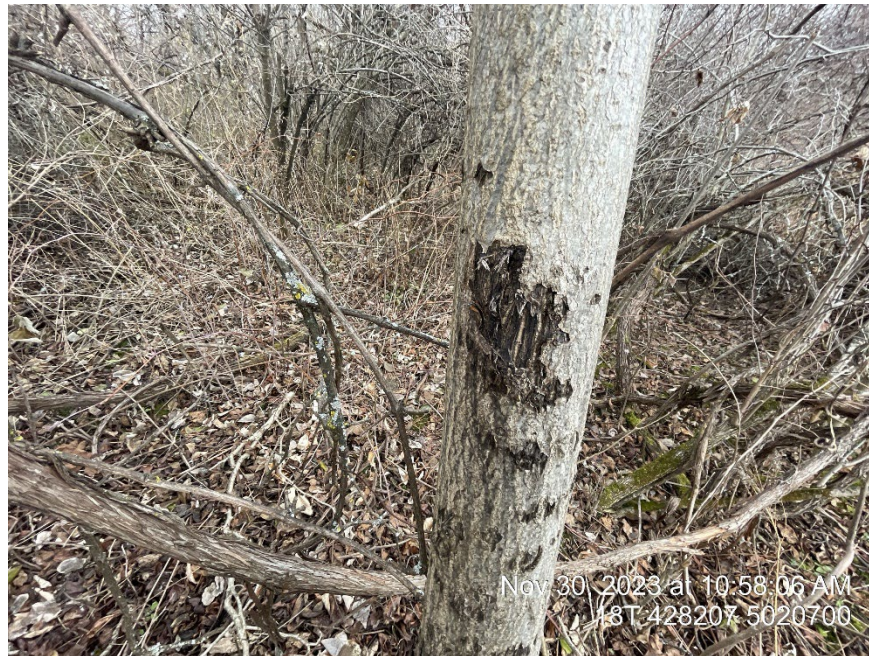
A site visit was conducted on November 1, 2023, by Al Quinsey (B.Sc. Environmental Biology, BHE). The visit was completed outside of the green-leaf period. A single butternut was observed on site (UTM coordinates 18T 428208 m E, 5020701 m N), just north of the walking trail (Figure 4). This individual had a dbh of 7 cm. Incidental observations of black ash were noted at the base of the hill on the northern side of the site.

Photo 1: Butternut Observed On Site (November 30, 2023)

- + Overall, the new design has reduced impacts to SAR flora. No further surveys for SAR flora are required if the clearing of vegetation is completed prior to June 3, 2026. Butternut Health Assessment of the single individual will be submitted to MECP. The new design allows for this species to be protected as per the provincial regulations.
- + SAR Bats: Based on the available literature, the Site does not provide high quality bat habitat (MNR, 2019). However, as policies are undergoing changes, it is recommended that MECP be contacted if bat maternity trees are identified.
- + Ensure that advice for SAR is reflective of the most recent MECP policies at the time of clearing of vegetation.

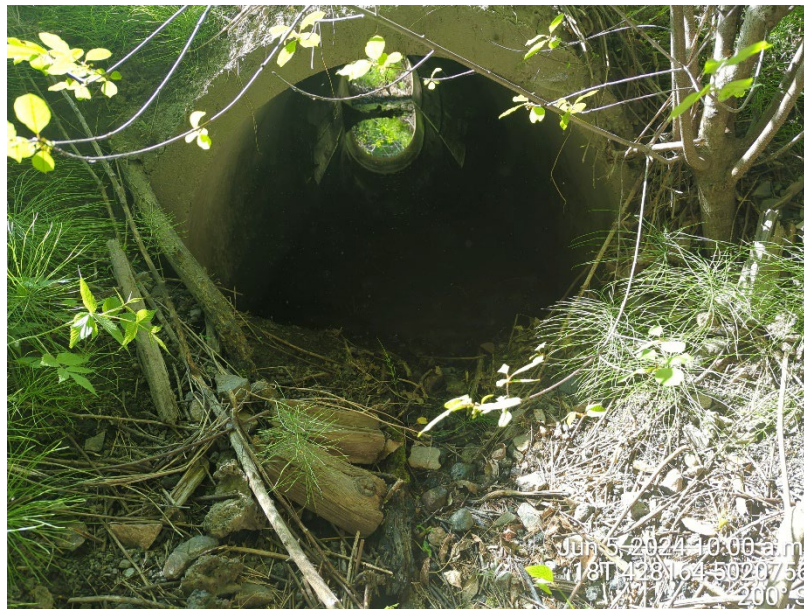
The origin of the channel was about 10 m upstream of the concrete culvert under the railroad and the entire channel was poorly defined, with an uneven gradient. The areas was also fully vegetated. There was some pooling of water in the concrete culvert and further downstream. Outside of the pools, there was no water. Just downstream of the concrete culvert, trees growing in the channel resulted in soil accumulation and created a step in the gradient (step height of 22 cm) which would represent a barrier to fish movement if fish were able to enter the ditch. However, the presence of rip rap at the connection with Kizell Drain is also a barrier to fish. There was no indication (i.e., water lines, vegetation etc.) to suggest that this barrier is overtopped in the spring.

Photo 2: Culvert under the Railroad (June 5, 2024)

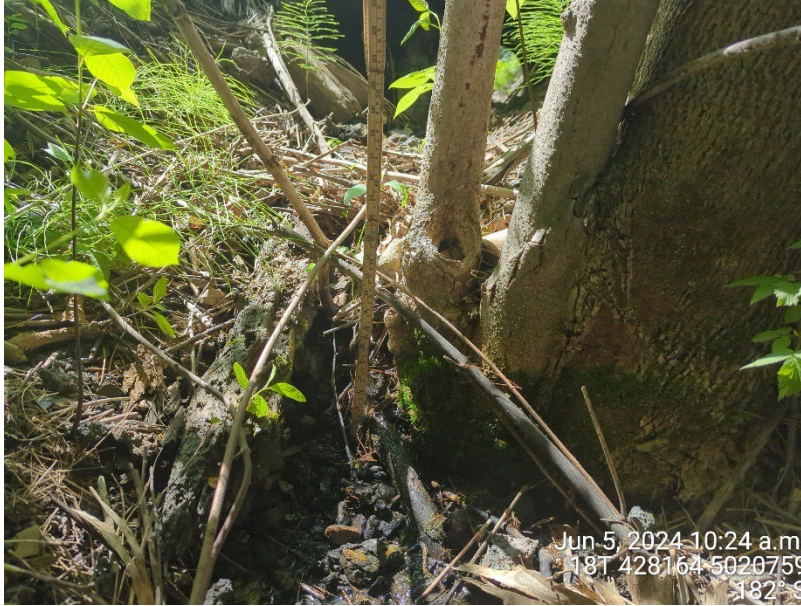
Photo 3: Tree in the channel resulting in steep of 22cm, downstream end of the culvert (June 5, 2024)

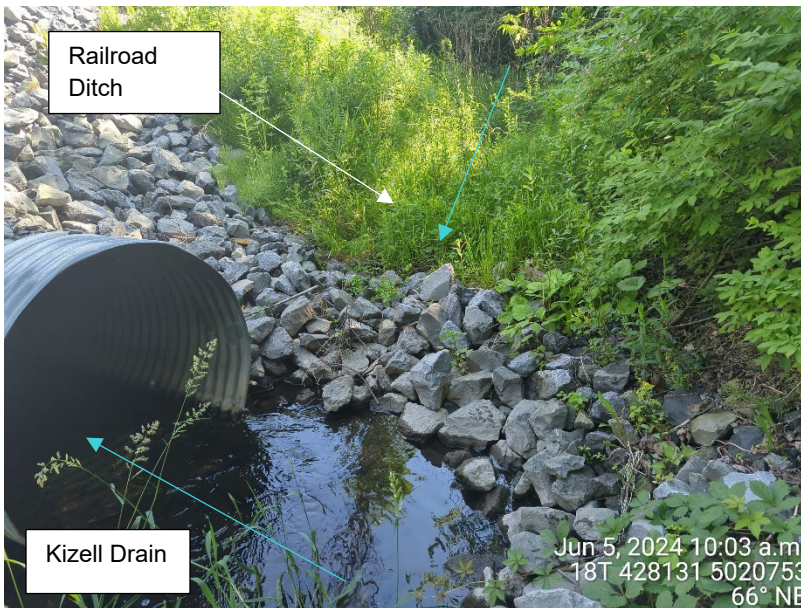
Photo 4: Rip rap at Kizell Drain creating a barrier at the downstream end of the ditch (June 5, 2024)

The railroad ditch has been assessed as indirect fish habitat due to the presence of a fish barrier at its confluence (rip rap), and poorly defined channel. It is understood that the flow being contributed to this ditch from the development is small (83.4 L/s in a 100 year event). This ditch is considered to be indirect fish habitat.

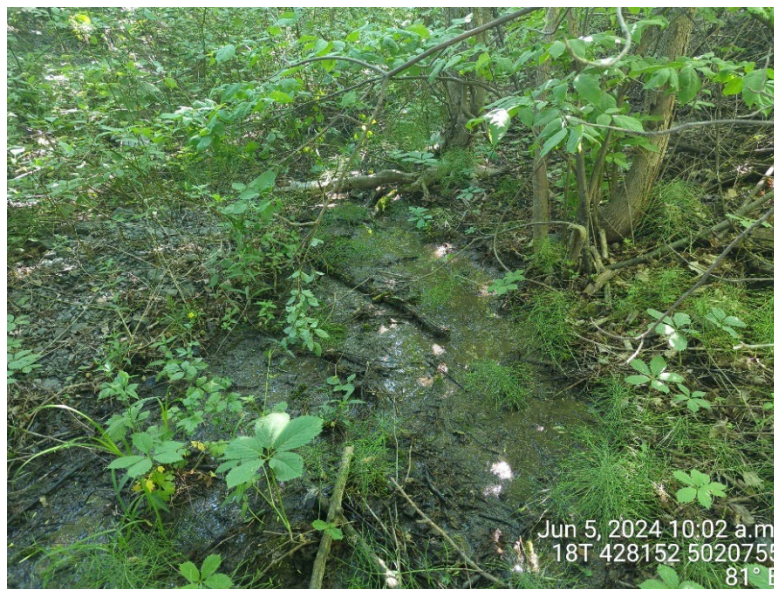
Station A began just downstream of the culvert and was 30 m in length (Figure 3). The average channel width and bankfull height were 1.0 m and 6 cm (range: 2-10 cm). The average wetted width and depths in the spring were 0.08 m and 1 cm (range: 0-2 cm), respectively. As mentioned above, the uneven grade caused pooling water near the bottom of the station. The remainder of the site was dry with pockets of water.

The substrate consisted of mostly fines with some gravel. The low to moderate in-water cover was provided by vegetation (grasses). No signs of erosion were noted.

Photo 5: Looking upstream from the downstream end of Station A (June 5, 2024)

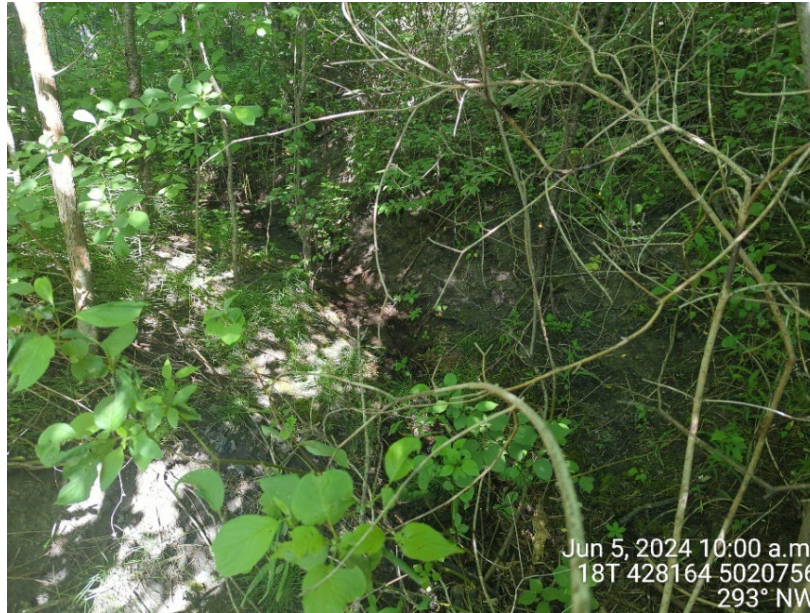
The top of the banks were fully vegetated with herbaceous vegetation and woody species. The most common herbaceous species were horsetail, grasses, yellowcress, purple loosestrife, buttercup, water parsnip, rose, goldenrod, and white meadowsweet. The most common woody species were buckthorn and ashes. The area was moderately to well shaded by the woody vegetation with some shading from the herbaceous layer.

Photo 6: Looking downstream from the upstream end of Station A (June 5, 2024)

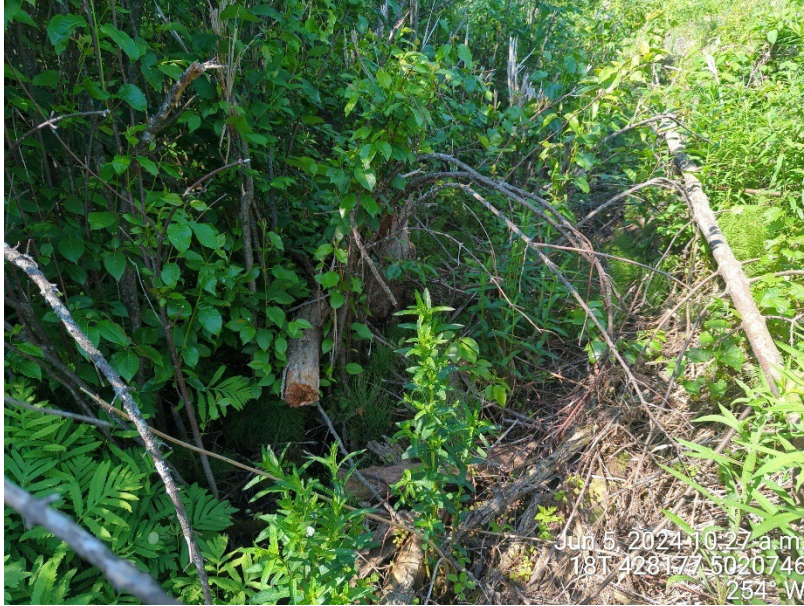
As noted above, there poorly defined channel started roughly 10 m upstream of the concrete culvert. This area was described with Station B (**Figure 3**). The average channel width and bankfull height were 1.8 m and 6 cm (range: 4-9 cm). The average wetted width and depths in the spring were 0.7 m and 1 cm (range: 0-2 cm), respectively. This portion of the channel also had an uneven grade and was poorly defined. The habitat within the station was a shallow pool.

Photo 7: Looking at the downstream end of Station B (June 5, 2024)

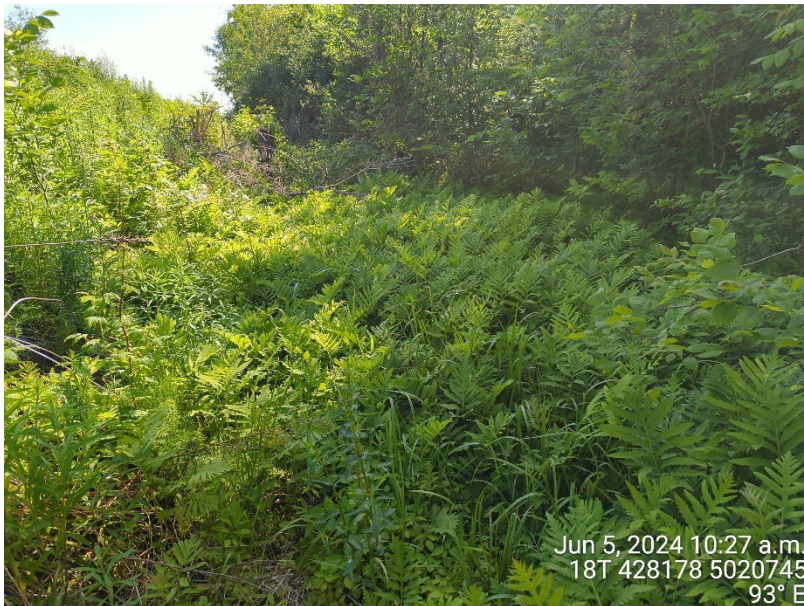
The substrate consisted of fines. The in-water cover was provided by vegetation (sensitive fern and horsetails), and small woody debris. No signs of erosion were noted. The top of the left bank was fully vegetated with herbaceous vegetation and woody species; the right bank was the railroad. The most common herbaceous species were sensitive fern, horsetails, grasses, and spotted jewelweed. The most common woody species were nannyberry and dogwoods. Both the woody and herbaceous vegetation provided little shading.

Photo 8: Looking at the upstream end of Station B (June 5, 2024)
