Environmental Impact Study Update

100 Steacie Drive, Ottawa, Ontario

CIMA+ file number: A001489
July 12, 2024 – Review 001

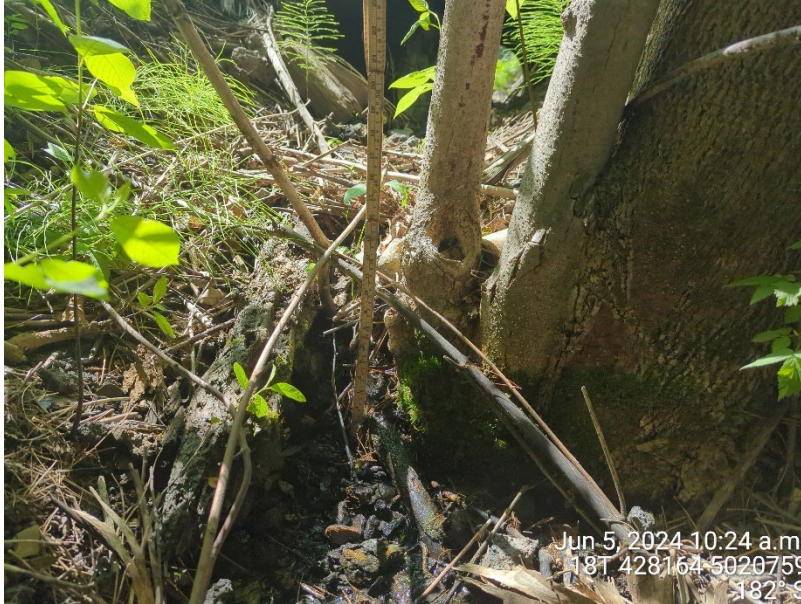
Photo 3: Tree in the channel resulting in steep of 22cm, downstream end of the culvert (June 5, 2024)

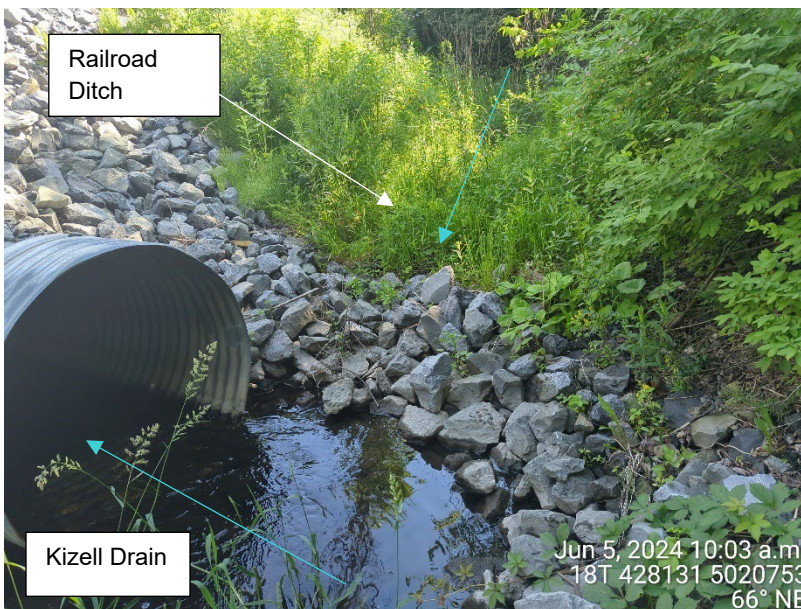
Photo 4: Rip rap at Kizell Drain creating a barrier at the downstream end of the ditch (June 5, 2024)

The railroad ditch has been assessed as indirect fish habitat due to the presence of a fish barrier at its confluence (rip rap), and poorly defined channel. It is understood that the flow being contributed to this ditch from the development is small (83.4 L/s in a 100 year event). This ditch is considered to be indirect fish habitat.
