## **Phase Two Environmental Site Assessment Update**

1280 Trim Road  
Ottawa, Ontario

LRL File No.: 230202

January 12, 2024

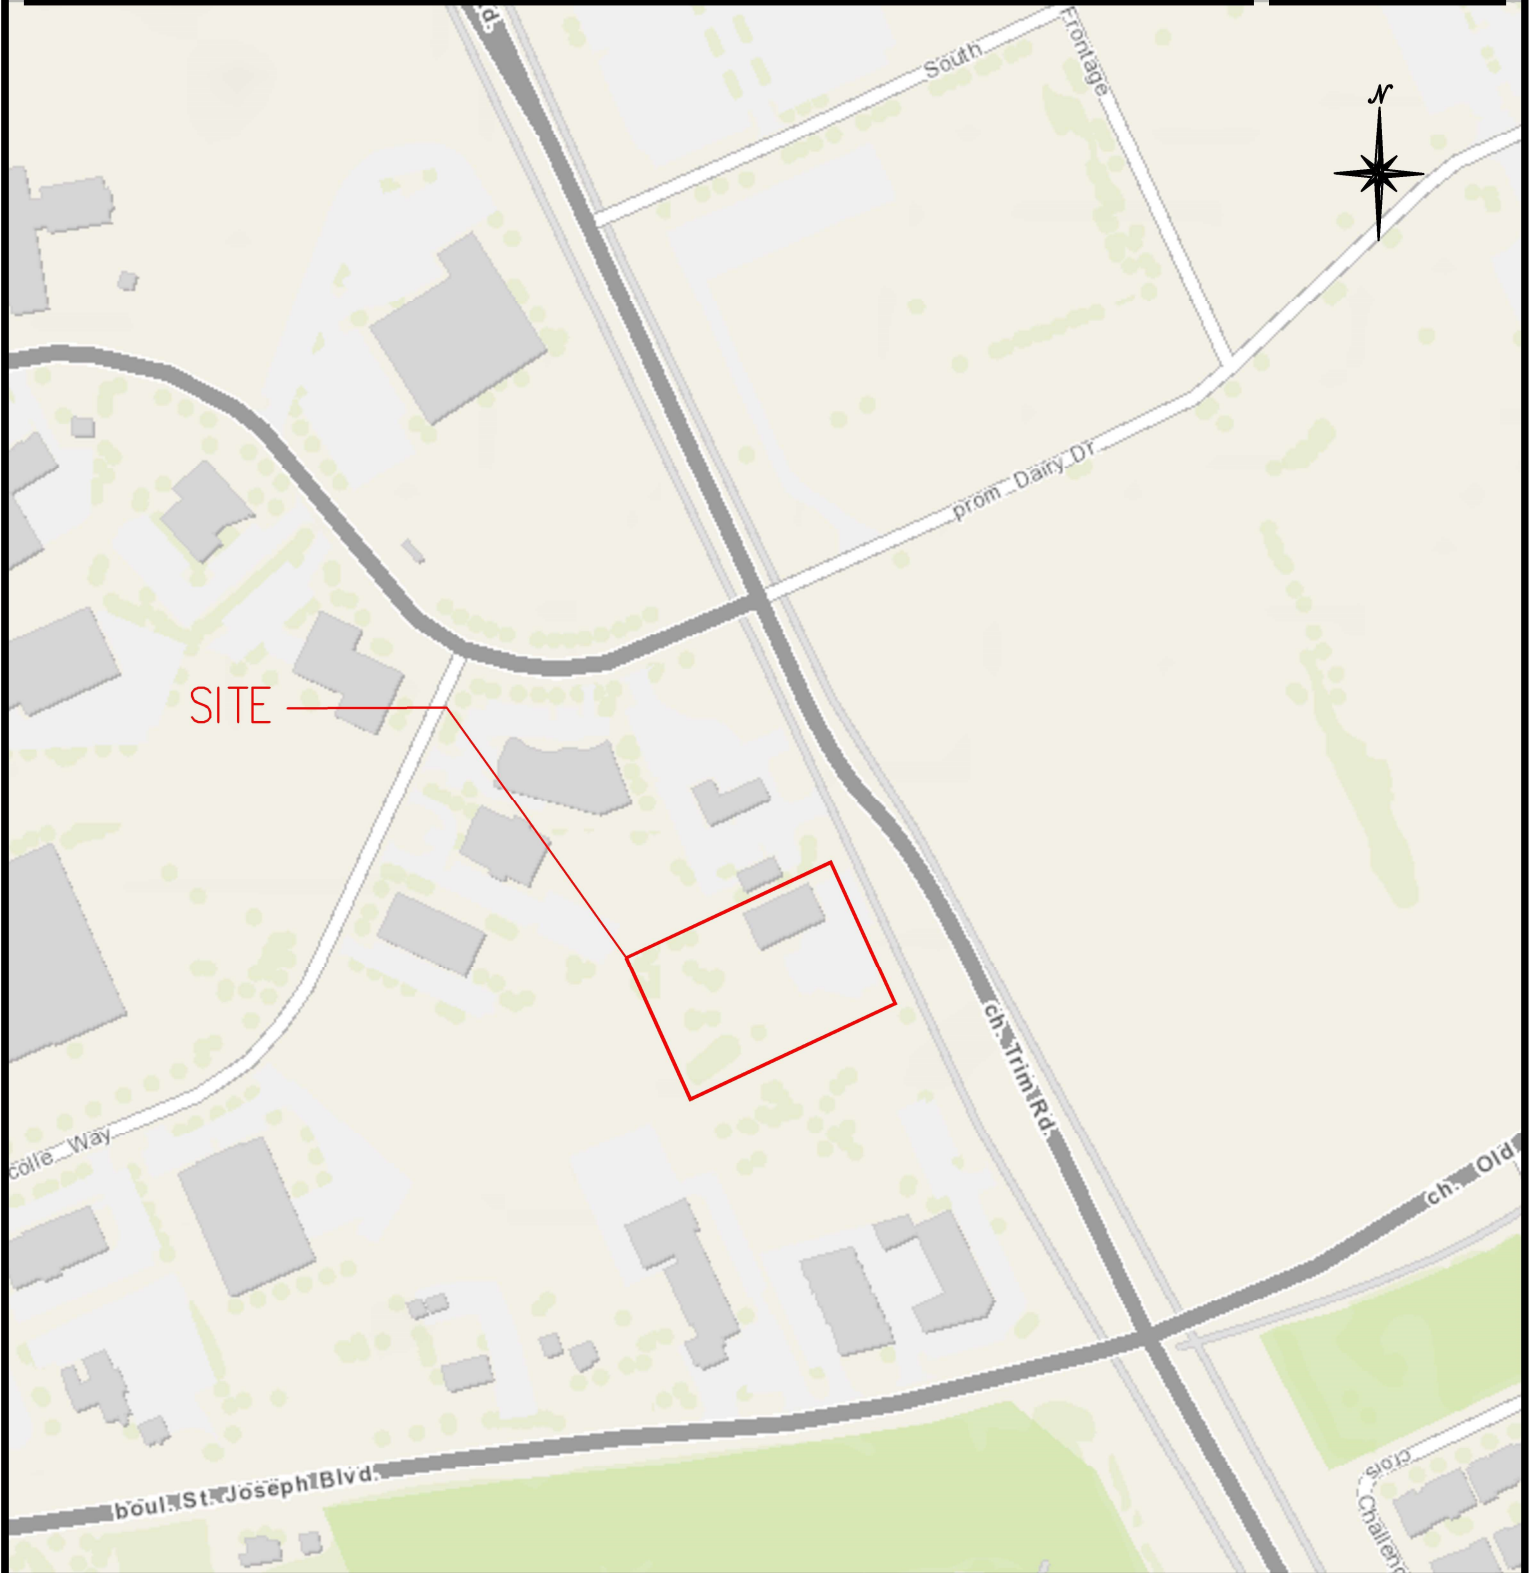
**FIGURE 1**

**Figure 1 Site Location**

Trim Works Developments Ltd. retained LRL Engineering (LRL) to complete a Phase Two Environmental Site Assessment (ESA) for the property located 1280 Trim Road, Ottawa, Ontario (herein referred to as the Site). The Site location is presented in **Figure 1**. The legal description of the Site is Part 30, Concession 10S, Part 3 to 6, Cumberland, Ottawa, and the property PIN is 50R6444.
