May 2, 2024
Ref. No. CO947.01

**Slope Stability Assessment Report
Wateridge Village, Blocks 5 and 6, Ottawa, Ontario**

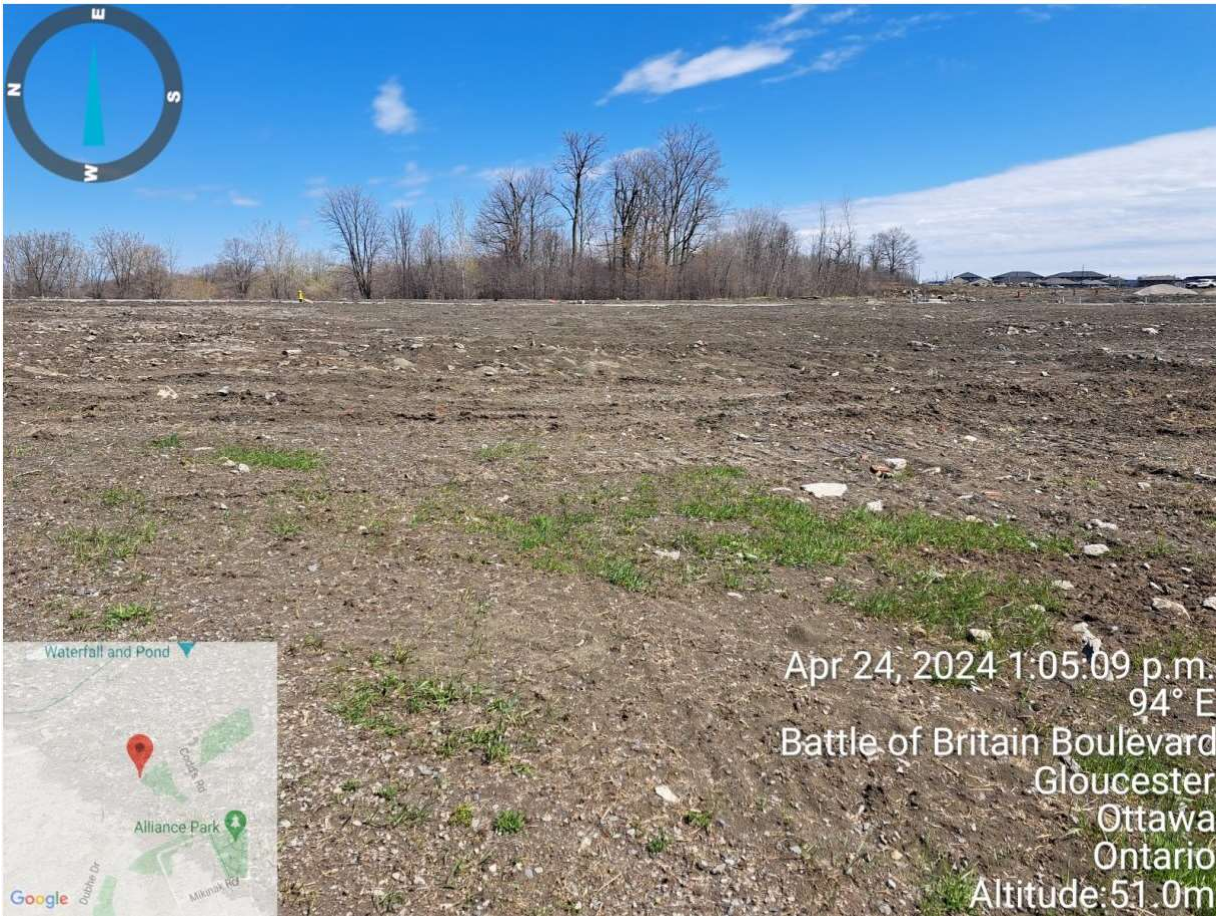
Standing at west side of Block 6 and looking towards East: No indications of existing slope greater or equal to 2 m in height or any settlement.

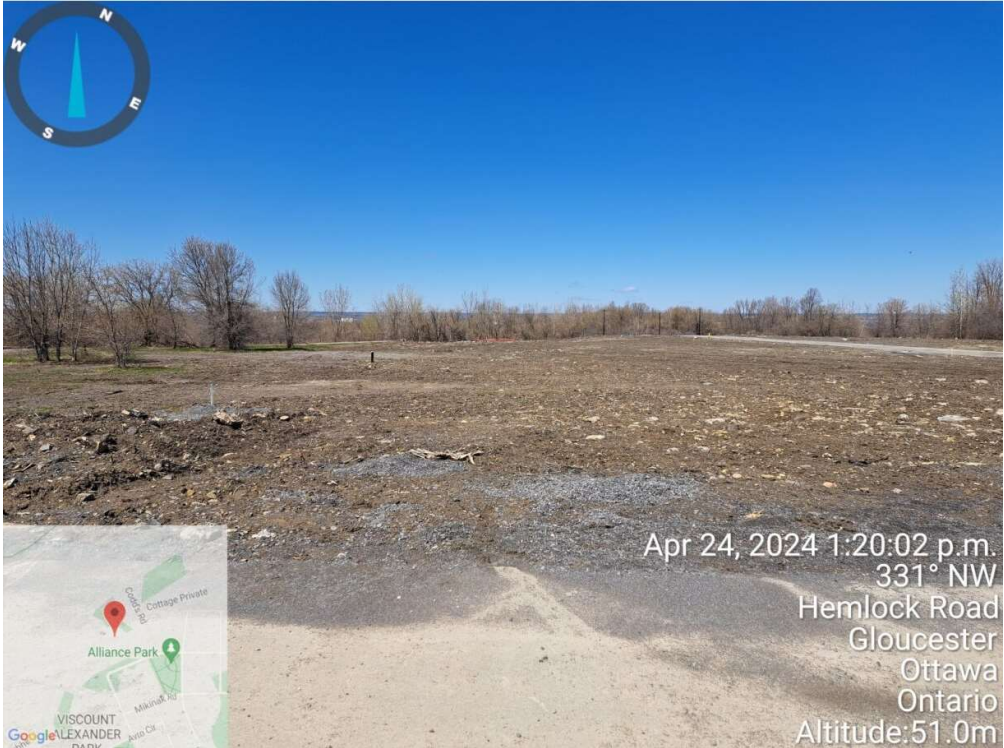
Standing at southeast side of **Street No.1** and Looking towards northwest of **Block 6**: No indications of existing slope greater or equal to 2 m in height or any settlement.

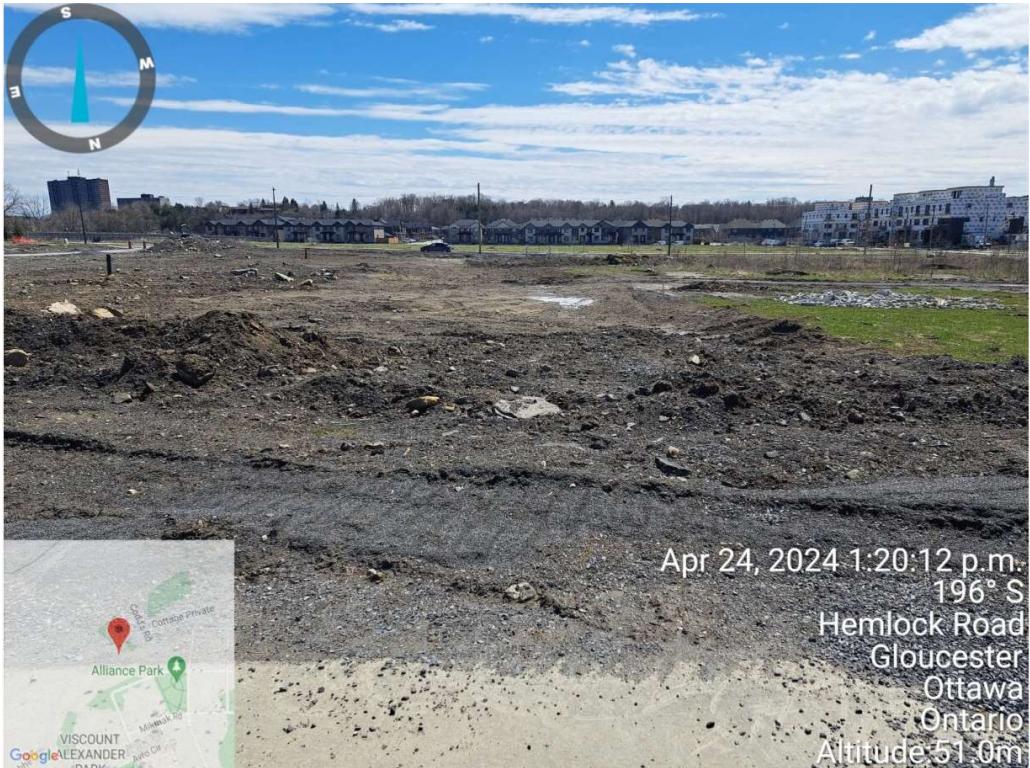
Standing at northside of **Street No.1** and looking towards south of **Block 5**: No indications of existing slope greater or equal to 2 m in height or any settlement.

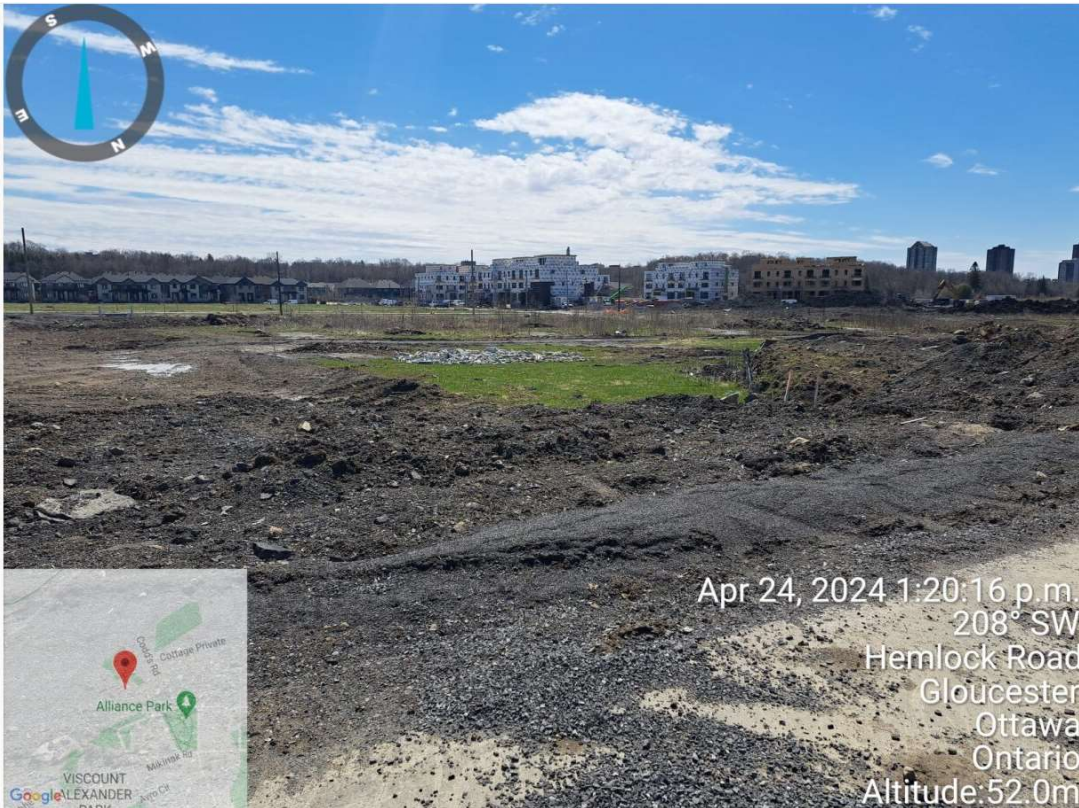
Standing at northeast side of **Street No.1** and looking towards southwest of **Block 5**: No indications of existing slope greater or equal to 2 m in height or any settlement. Presence of vegetation such as grasses and small trees.

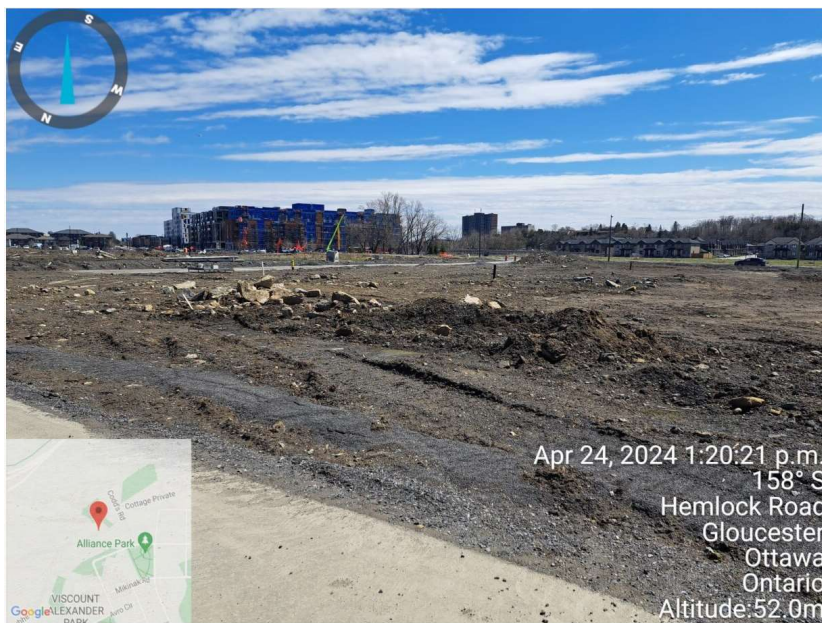
Standing at northwest side of **Street No.1** and looking towards southeast of **Block 5**: No indications of existing slope greater or equal to 2 m in height or any settlement. Presence of a pile of concrete block pieces.

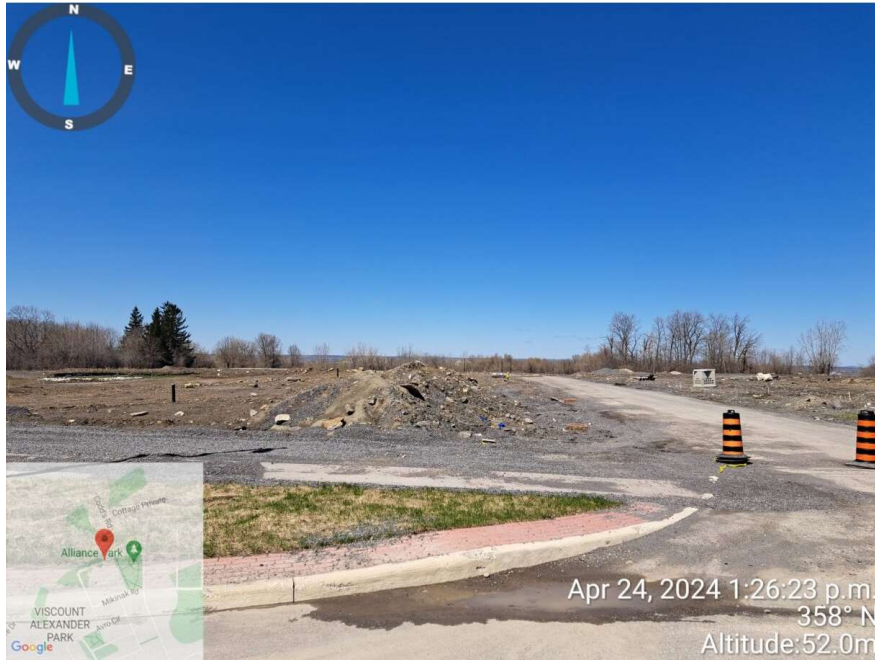
Standing at southside of **Hemlock Rd.** and looking towards North of **Block 5**: No indications of existing slope greater or equal to 2 m in height or any settlement. Presence of a pile of mixed topsoil, organics, debris, monitoring wells and service lines.

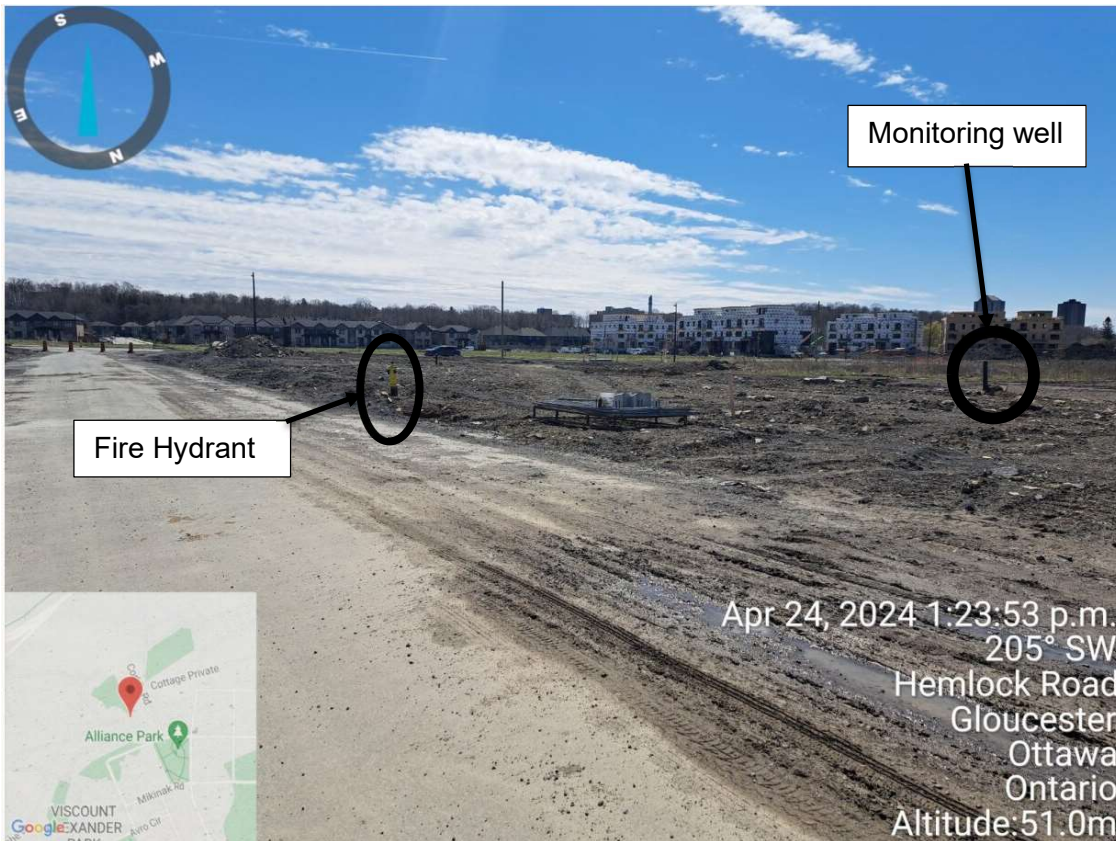
Standing at northeast side of **Oshedinaa St.** and looking towards southwest of **Block 6 and Block 5**: No indications of existing slope greater or equal to 2 m in height or any settlement. Presence of service lines, monitoring wells, etc.
