**RE: 100 Bill Leathem Drive – Proposed Office / Warehouse Development
Environmental Impact Study and Tree Conservation Report - Updated**

**100 BILL LEATHAM DRIVE – OFFICE / WAREHOUSE DEVELOPMENT
ENVIRONMENTAL IMPACT STUDY and TREE CONSERVATION REPORT - UPDATED**

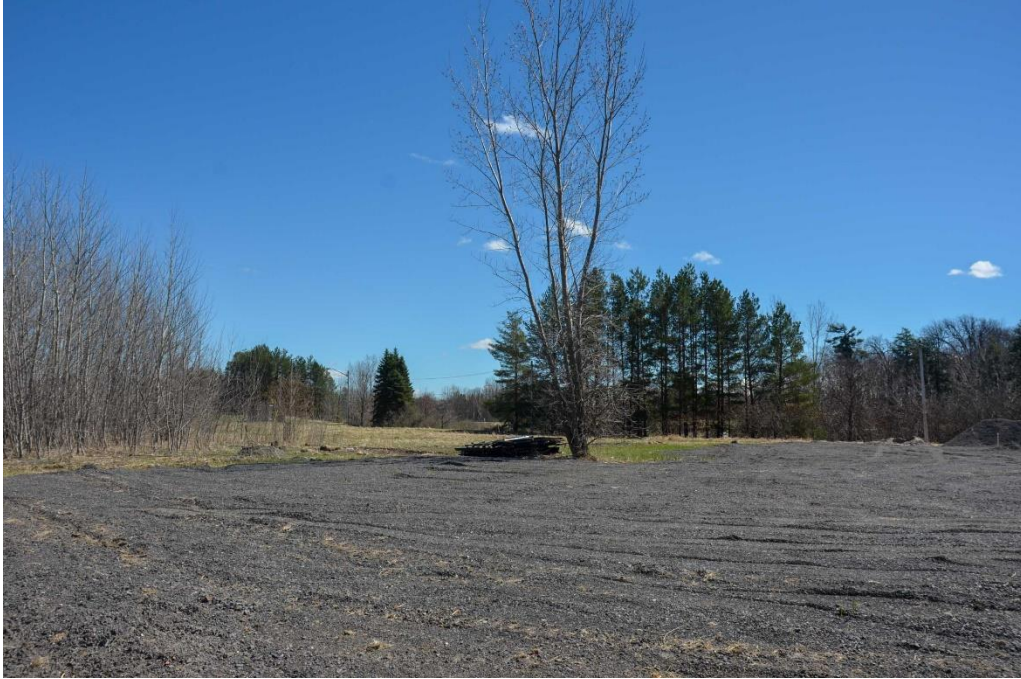
A hard packed gravel surface is on the west portion of the site (Photo 1). A small area of gravel stockpiling extends from the west onto the southwest portion of the site. The gravel is too thin and too hardpacked to be utilized by turtles for nesting. This material is also too coarse to be used by nesting swallows and other burrowing animals.

Cultural meadow habitat is present on former agricultural lands (Photo 1). Where regenerating woody vegetation is the dominant vegetation, the community is shown as a cultural thicket on Map 1. The thicket habitat is about ten years old, with a few trees up to 20 years, and is less than 0.1 hectares. Common ground flora on the site includes orchard grass, June meadow grass, reed canary grass, awnless brome grass, wild carrot, common burdock, Canada thistle, common dandelion, goldenrod, white bedstraw, white clover, red clover, and silvery cinquefoil, along with staghorn sumac and slender willows shrubs. The cultural thicket is dominated by regenerating poplar stems, with multi-stem crack willow also present. The largest trees on the site are 22cm diameter at breast height (dbh), as described in Table 1 below. Table 1 includes planted street trees, sugar maple and white ash, along north edge of the site, but south of the Bill Leatham Drive allowance.

Photo 1 – Site looking southeast from just south of Bill Leathem Drive. Tree ‘C’ is in the centre of photo, with cultural thicket to the left (northeast) and off-site conifers north of the Clarke Bellinger Environmental Facility in the background

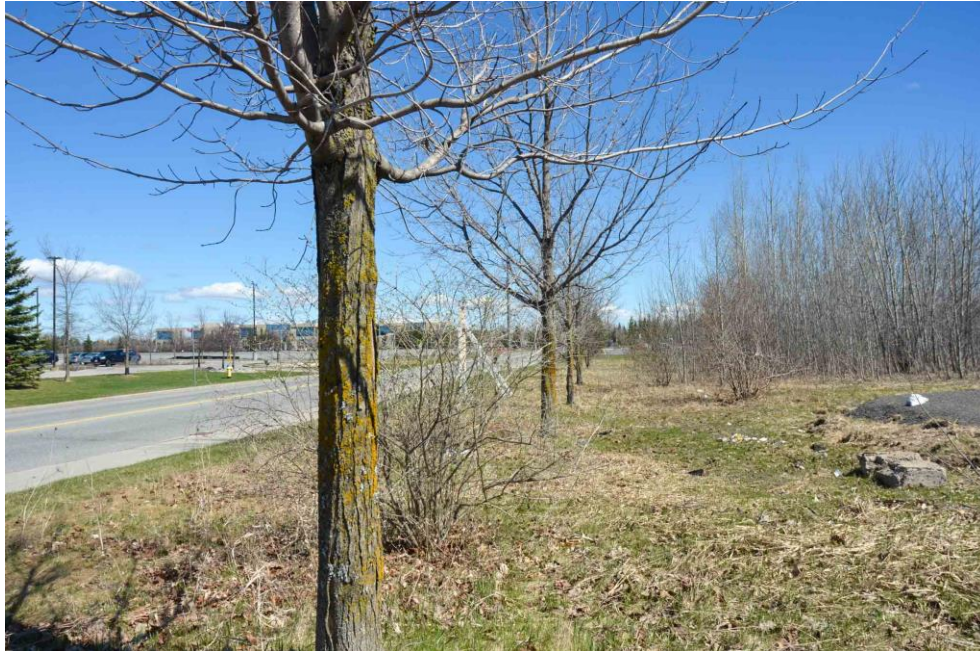
*Photo 2 – Planted maple trees along north edge of the site.
View looking east from the northwest site corner, with Bill Leathem Drive on the left*

No City-owned plantings have critical root zones extending onto the site or may otherwise be impacted. The street these plantings along the north edge of the site can be retained except for Trees ‘E’ and ‘J’ though the ash and one maple should be replaced. No critical root zones of co-owned or adjacent trees extend onto the site.

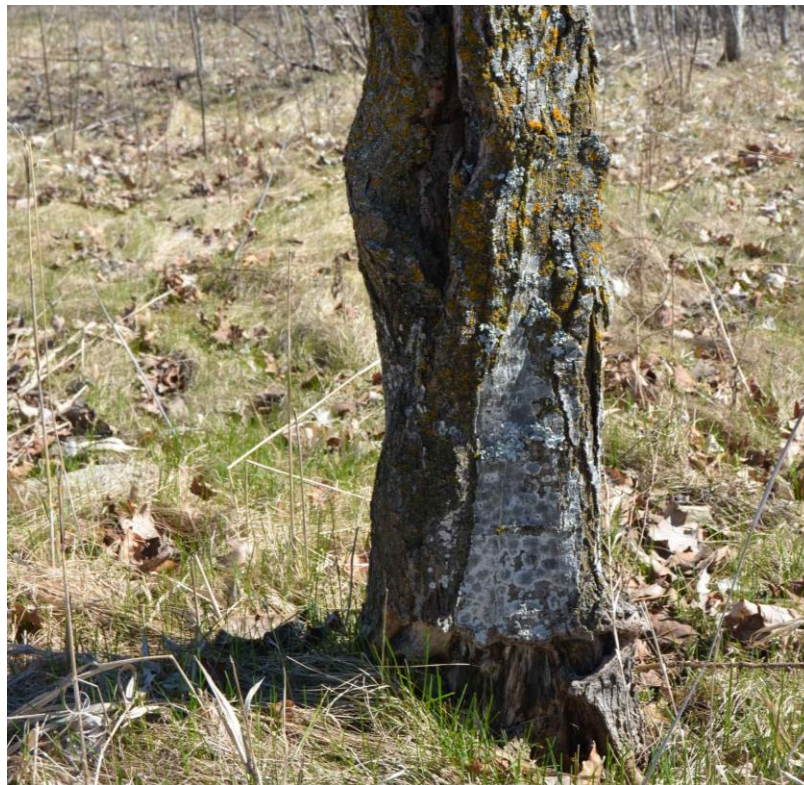
As described in Table 1, the planted street trees to the south of Bill Leatham are street plantings but on-site, as seen on the aerial photography such as the 2007 geoOttawa photo showing the planting locations (Photo 7). There are no City-owned trees that may be affected. The ash trees that will not be removed are recommended for replacement due to poor condition (Photo 4). The sugar maples can be retained except Tree ‘E’ (Map 1) which is in the entrance alignment south off Bill Leatham Drive, though Tree ‘F’ (Photo 3) is in poor condition and could be replaced.

*Photo 3 – Damage at base of maple Tree ‘F’.
View looking southeast with cultural thicket in background*

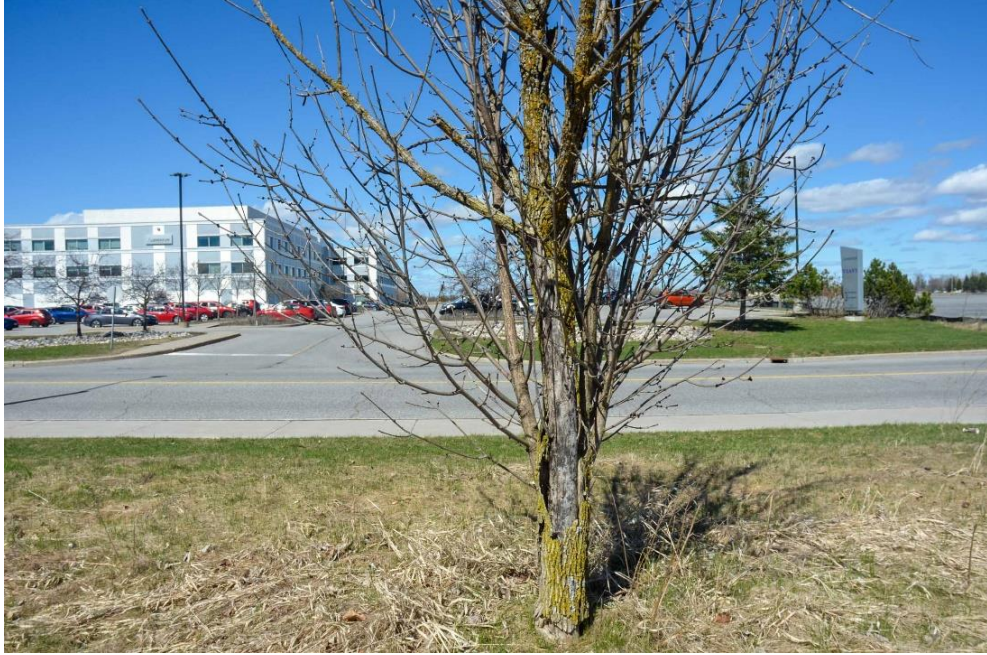
I	White ash	11 and 16	Street planting but on-site. Twin-stem, with smaller stem dead and extensive root flare damage. EAB damage. Good bud development. Dead standing 10cm dbh ash to the east. All bark is sloughed and remaining trunk two metres high. EAB damage	Replace per City comment
J	White ash	up to 13	Street planting but on-site. Poor condition with EAB damage (Photo 4). Lower trunk bark sloughed off. Good bud development	Remove

*Photo 4 – Typical condition of the planted ash trees south of Bill Leatham Drive.
This example is Tree ‘J’. View looking north*

Due to their location the regenerating poplar and crack willow stems within and adjacent to the central cultural thicket cannot be retained. The larger, up to 22cm dbh, of these trees are coppice with poor form and the poplars have notable fungal growth. Two of the street plantings (Trees 'E' and 'J') are in conflict with the access south off Bill Leathem Drive. The ash street plantings are in poor condition and will be replaced.

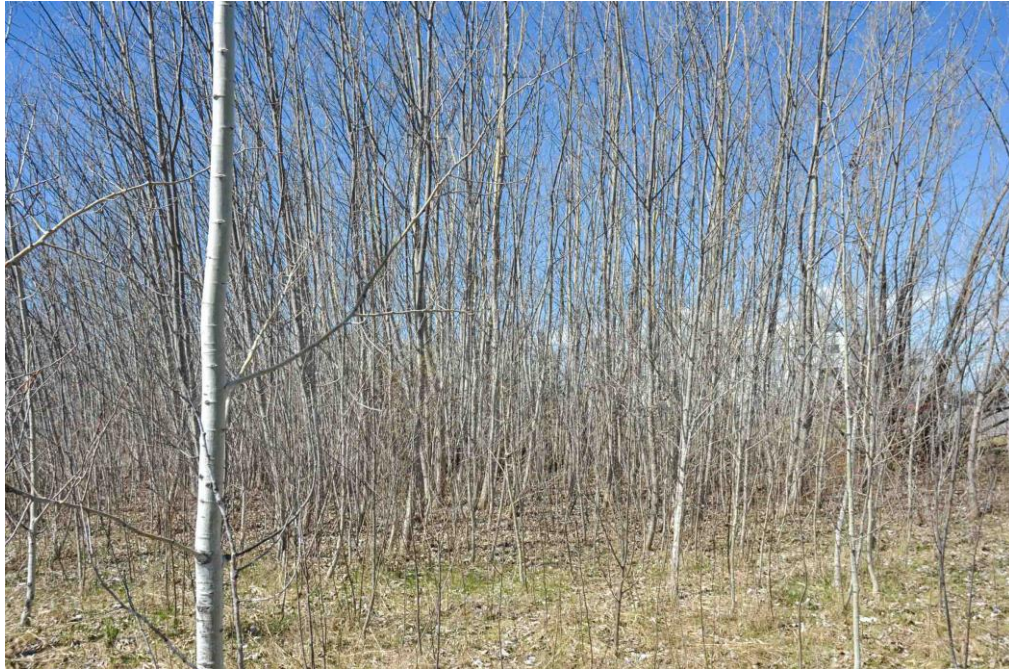
Tree Letter	Species	dbh (cm)	Condition and Comments	Fate
A	Large-tooth aspen	up to 12	Cultural thicket (< 0.1 ha) of regenerating large-tooth aspen and eastern cottonwood stems (Photo 5), the larger trees coppice. Extensive fungal growth on most stems. No dominant leader on multi-stems. Good bud development	To be removed
	Eastern cottonwood	up to 12		
	Crack willow	up to 12		
B	Large-tooth aspen	up to 22	Coppice with five stems. Poor form with no dominant leader. Trunks appear to be in good condition. Adjacent crack willow up to 10cm dbh	To be removed

*Photo 5 – Cultural thicket in the north-central portion of the site.
View looking northwest*

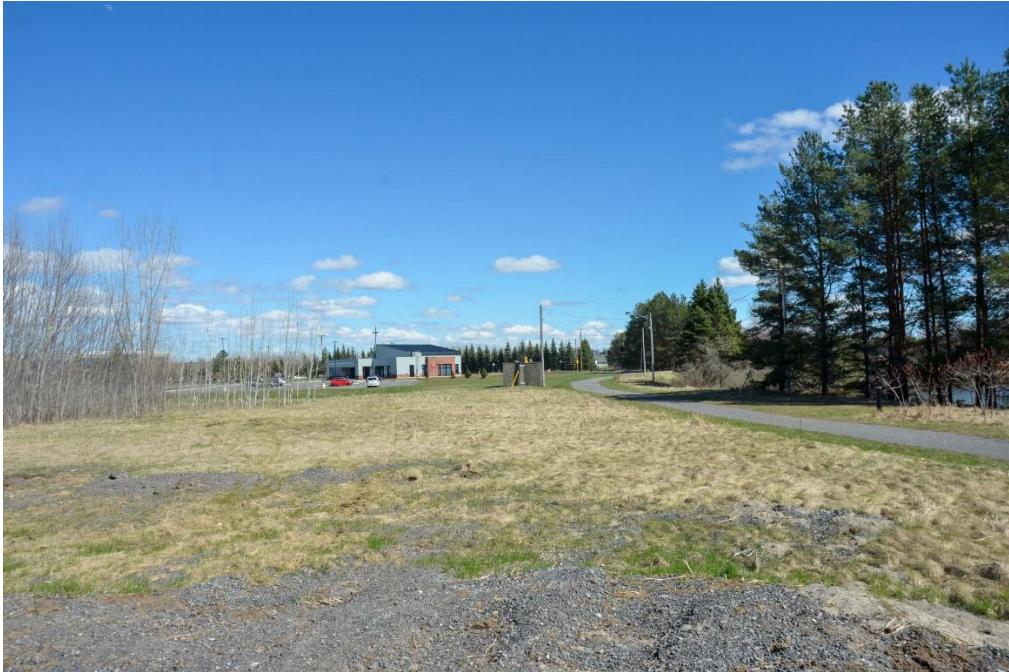
Photo 6 – South portion of the site, with cultural thicket to the right and off-site stonedust access road/pathway and conifers and sumac plantings to the left. View looking east

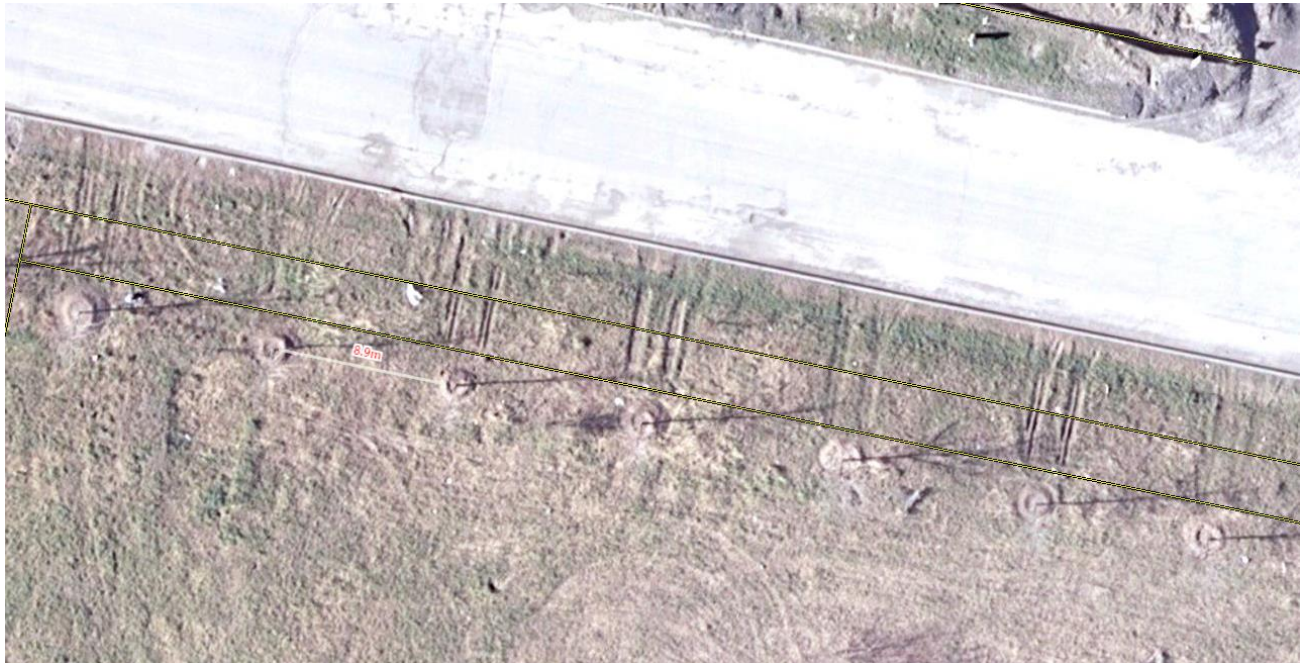
Photo 7 – 2007 aerial photography showing street planting locations to the south of the Bill Leatham Drive allowance (represented by yellow lines)

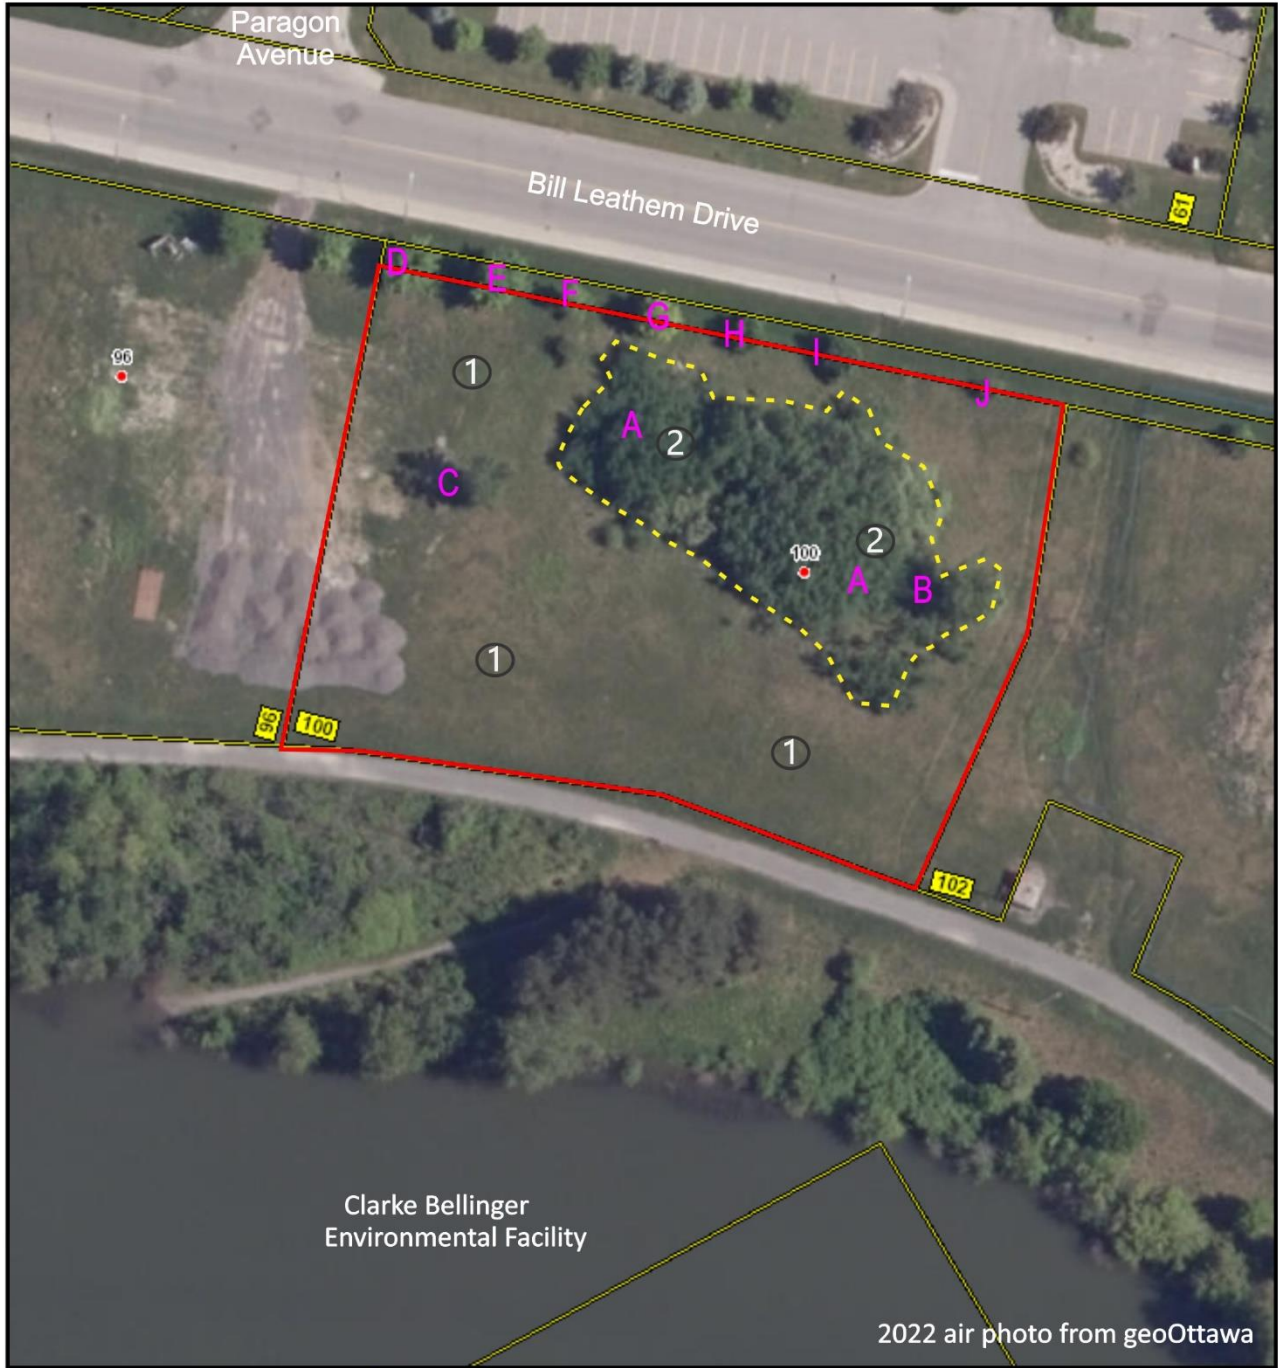
Map 1

Table 1 – Description of Trees (located on Map 1)

EXISTING CONDITIONS

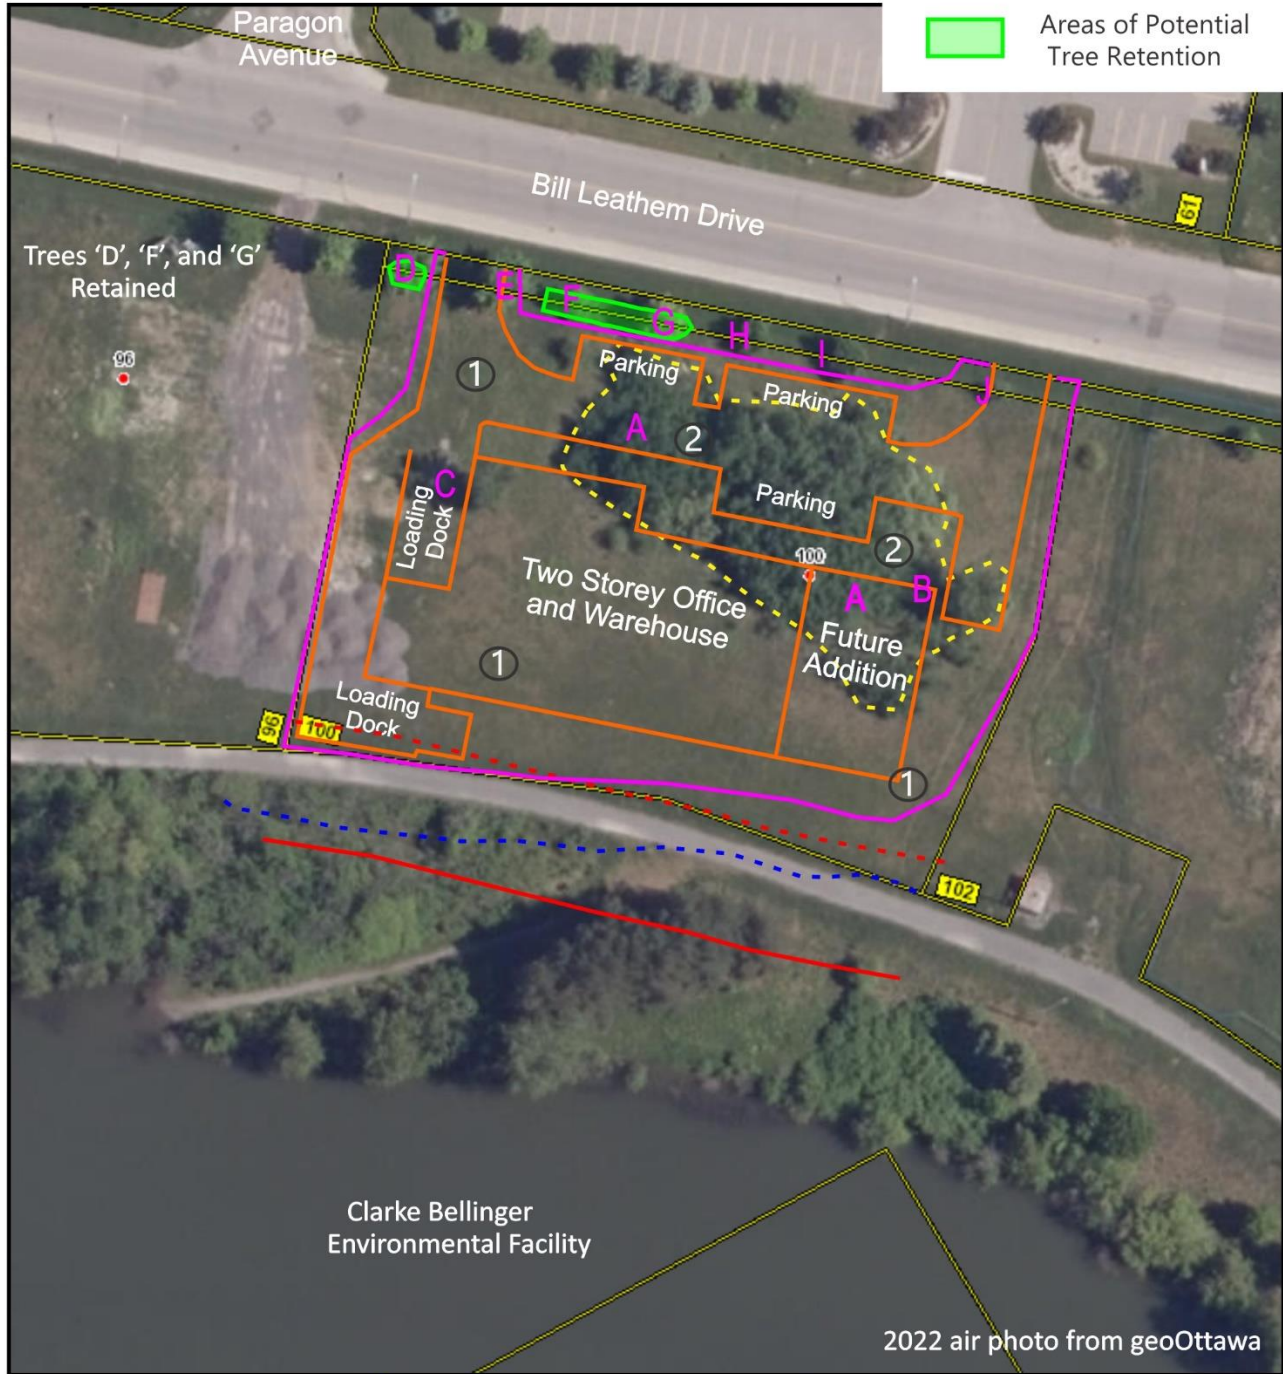
Map 2

The 30 metre setback from the top of bank does not extend onto the site. As shown on Map 2, the 15 metre setback from the top of stable slope does extend slightly, up to 1.5 metres onto the south edge of the site. The closest portion of the office/warehouse will be approximately 2.5 metres to the north of the 15 metre setback, with portion of a loading dock and a short, about 5 metres, retaining wall within the outer metre of the 15 metre setback. The function and features to the south of the site are not anticipated to be impacted by the proposed development and moving the loading dock and retaining wall completely outside of the 15 metre top of stable slope setback is not anticipated to provide a detectable improvement in environmental protection due to:

PROPOSED CONSERVED VEGETATION

The silt fencing (pink line on Map 2) will assist in sediment and erosion control as well as protecting the adjacent trees to be retained and isolating the work area from wildlife. It is important that the fencing be properly installed and maintained. Signs, notices or posters are not to be attached to any tree. No grading, heavy machinery traffic, stockpiling of material, machinery maintenance and refueling or other activities that may cause soil compaction to occur within the critical root zones of the trees to be retained and protected. The root system, trunk or branches of the trees to be retained are to be protected and not damaged. If any roots of trees to be retained are exposed during site alterations, the roots shall be immediately reburied with soil or covered with filter cloth, burlap or woodchips and kept moist until the roots can be buried permanently. A covering of plastic should be used to retain moisture during an extended period when watering may not be possible. Any roots that must be cut are to be cut cleanly to facilitate healing and as far from the tree as possible. Exhaust fumes from all equipment during construction will not be directed towards the canopy of the retained trees.
