December 17, 2024, (Revised March 6, 2025)

Our File Ref.: 220487

Subject: Hydrogeological Assessment & Terrain Analysis –  
Proposed Warehouse Development  
363 Entrepreneur Crescent, Ottawa, Ontario

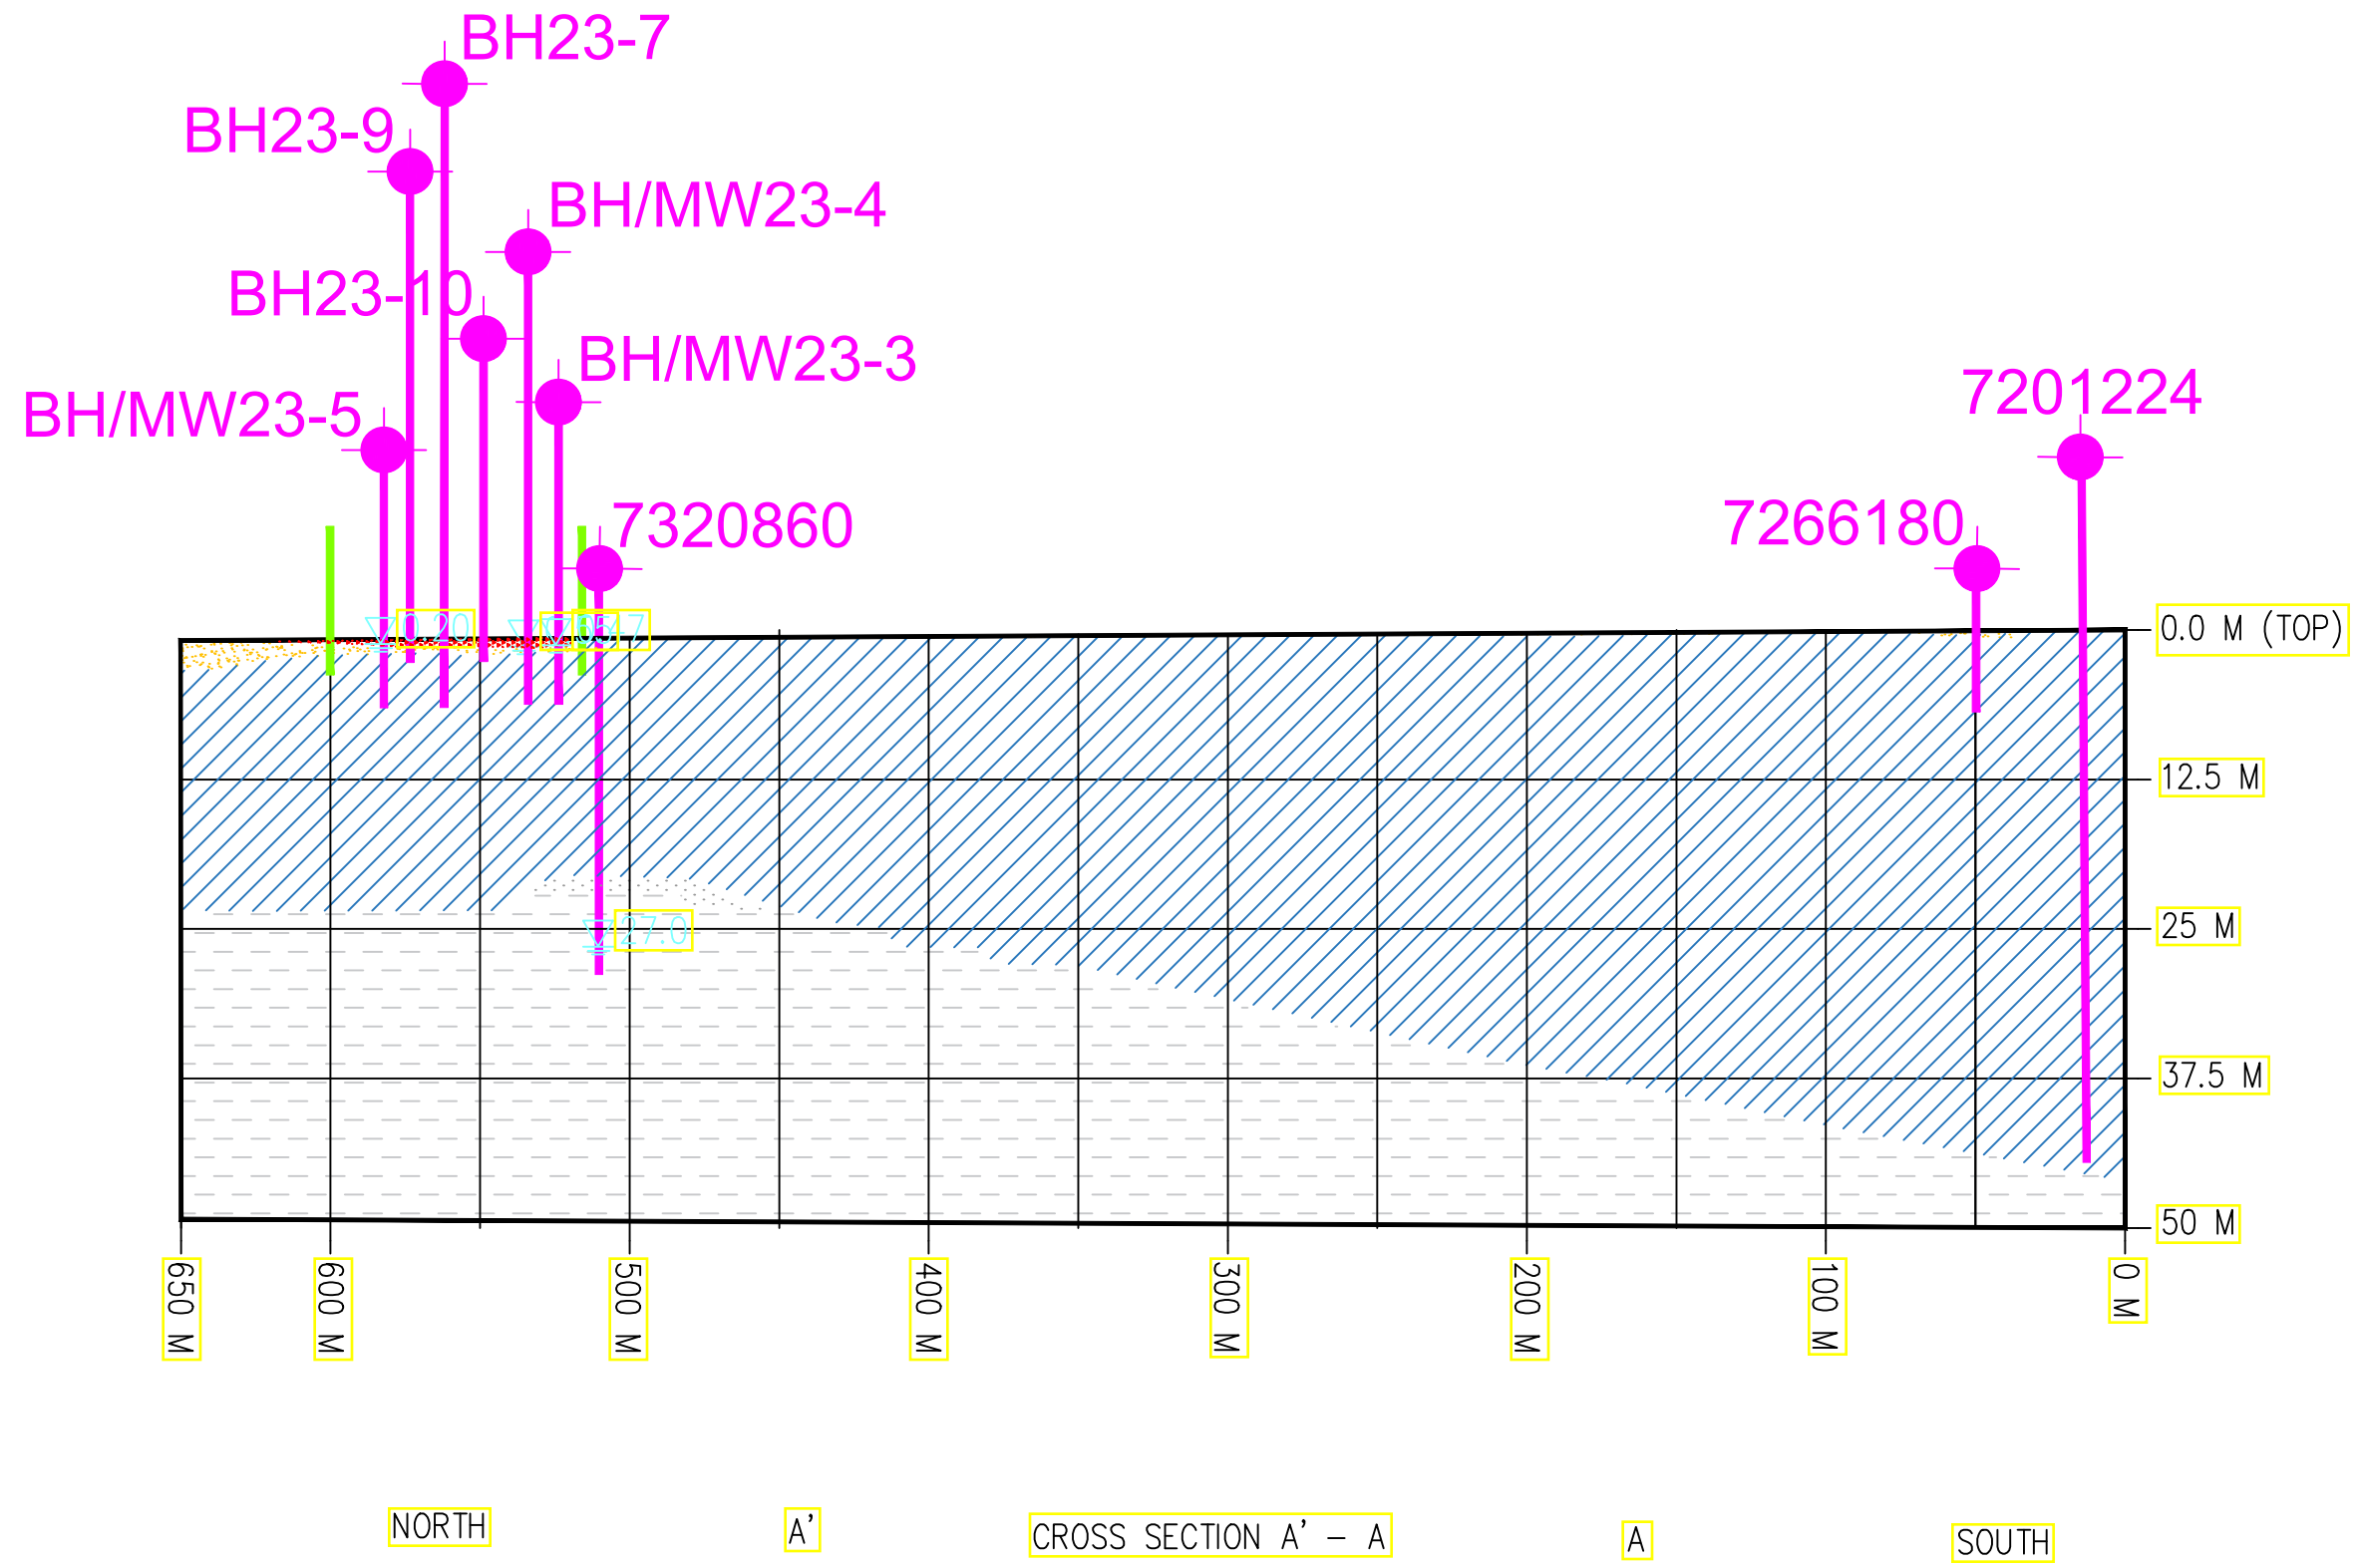
A search was conducted of the well records from the MECP Water Well Information System (WWIS) department. The search by UTM coordinates covered a 750 m radius from the Site. The search returned 30 water well records, however, several of which did not have any details available related to the construction or subsurface conditions encountered. Nine (9) of the water well records retrieved was for a test well. A copy of those WWRs which included relevant details related to the hydrogeological and subsurface features are included in **Attachment D** and their approximately locations are presented in **Figure 4**.

Inferred subsurface profiles cross sections are presented in **Figure 5A** through **Figure 5B** and include select wells in the vicinity of the cross-section segments as shown in **Figure 4**. The general overburden conditions encountered in the wells, where details were available, within 750 m of the Site are as follows:

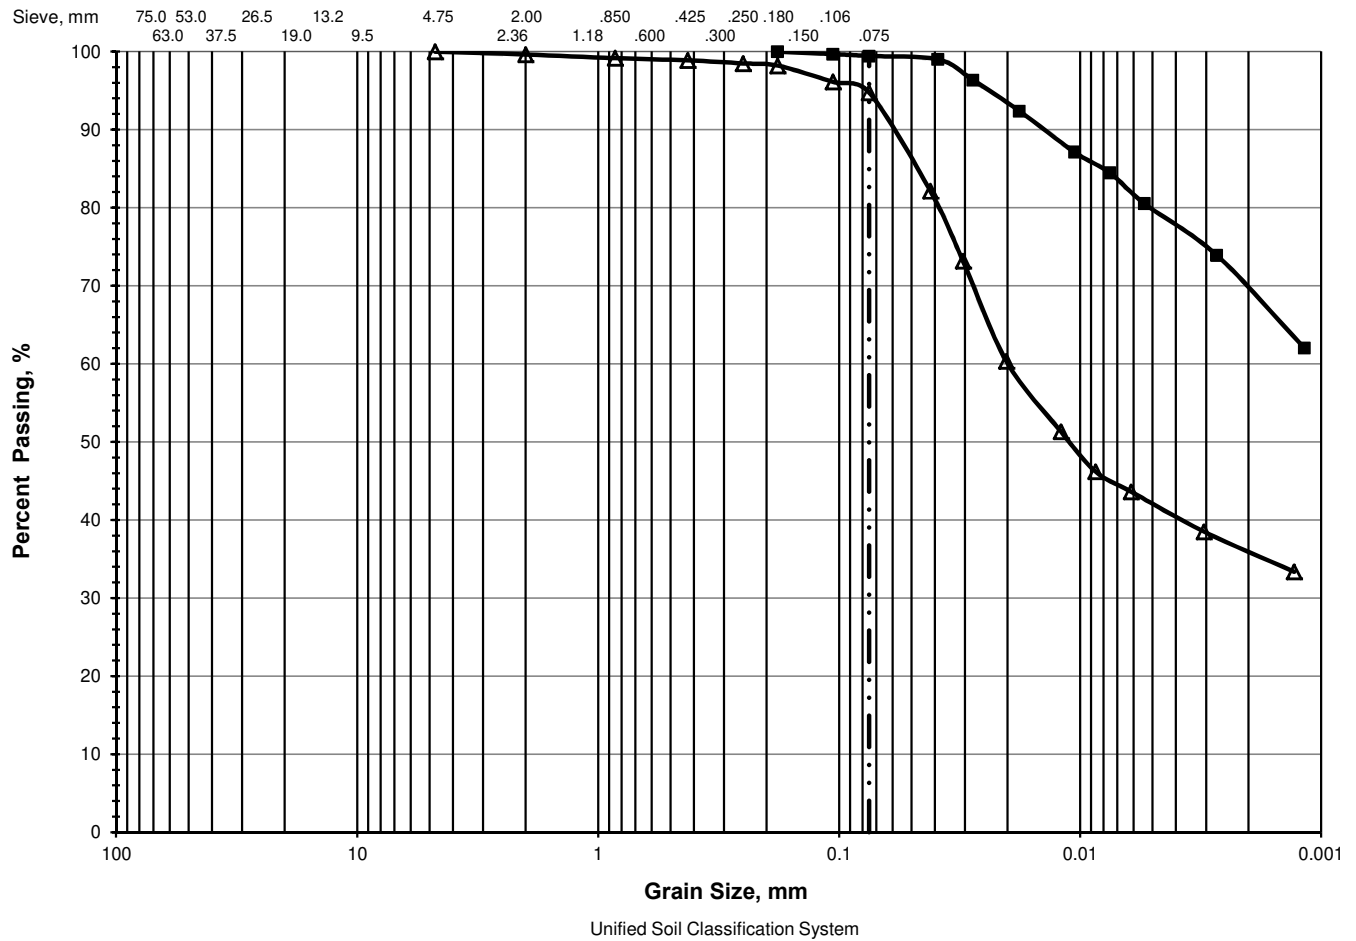
**Date:** November 17, 2022

% GRAVEL		% SAND			% FINES	
	Coarse	Fine	Coarse	Medium	Fine	Silt	Clay
△	0.0	0.0	0.4	0.8	4.1	59.3	35.4
■	0.0	0.0	0.0	0.0	0.6	31.0	68.4

Atterberg limits and moisture contents were conducted on two (2) split spoon soil samples. A summary of these values is provided below in **Table B**.

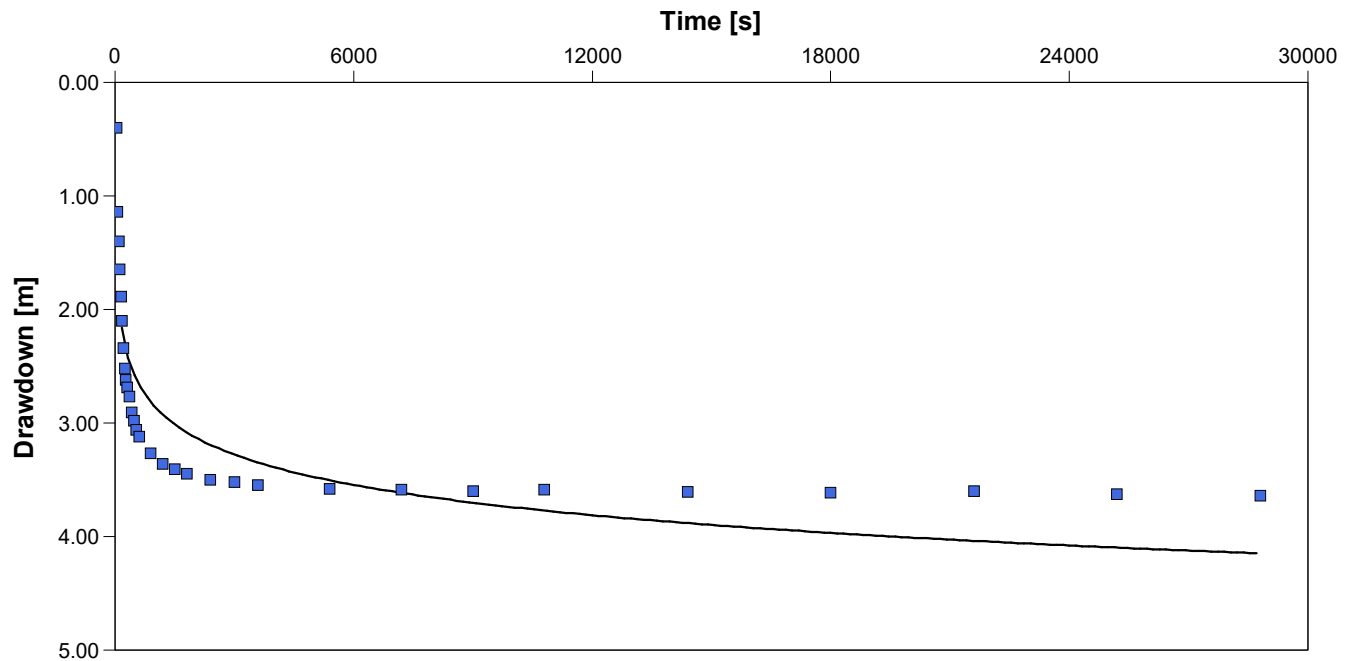
Discharge Rate: 0.022 [m<sup>3</sup>/min]

Calculation using Theis

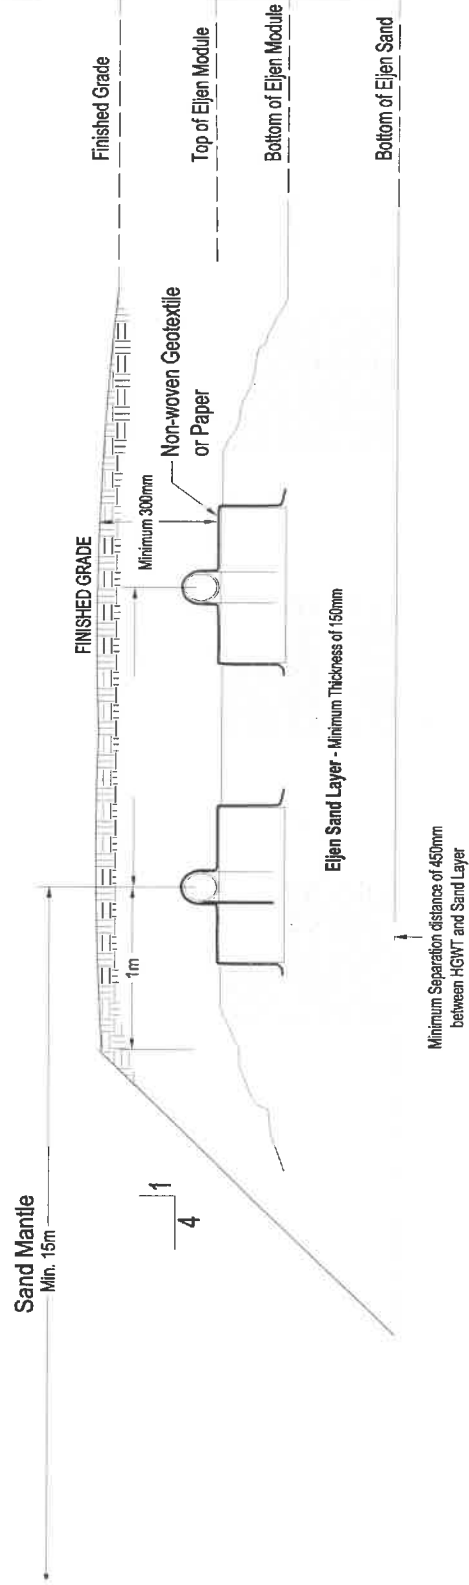
## Cross-Section Profile

Proposed Installation Grades	Approved Installation Grades	Existing Grade

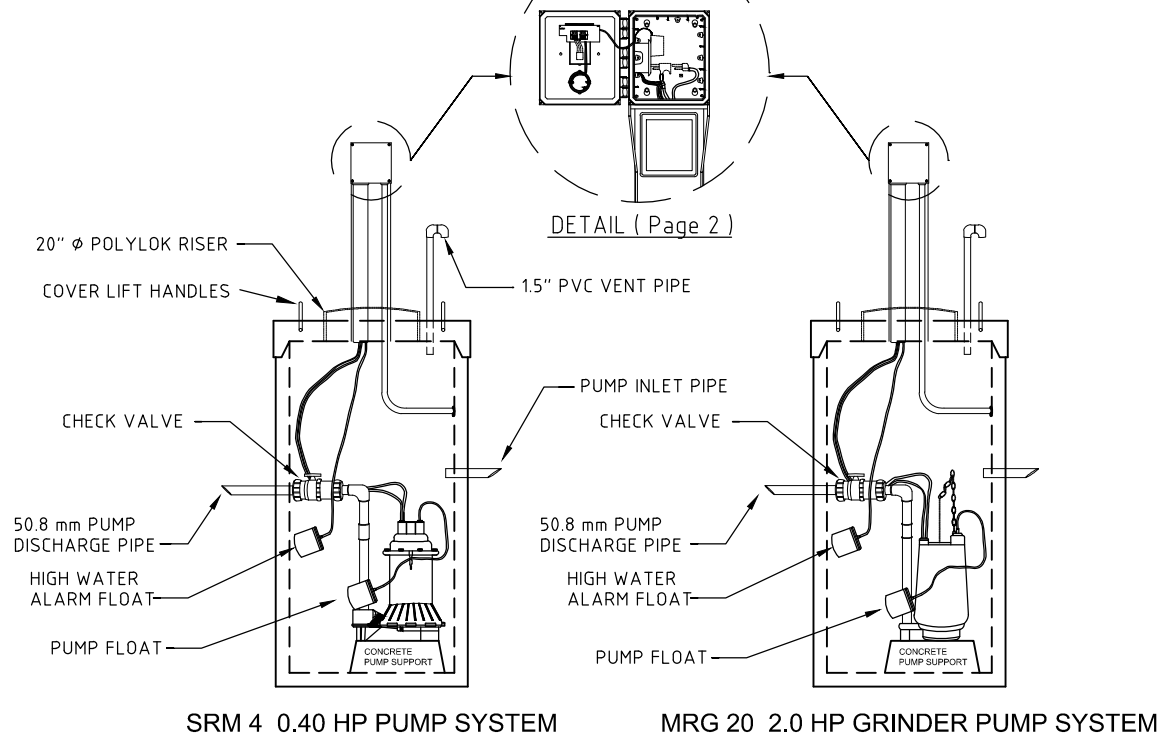
ALARMS, ELECTRICAL BOXES AND CHECK VALVES MAY DIFFERS FROM ONE PUMP STATION SYSTEMS TO ANOTHER. SIMPLEX AND DUPLEX TIME DOSING CONTROL PANEL AVAILABLE.

BOTH PUMP SHOWN ARE 250 GAL / 1135 L PUMP STATIONS, NOT TO SCALE

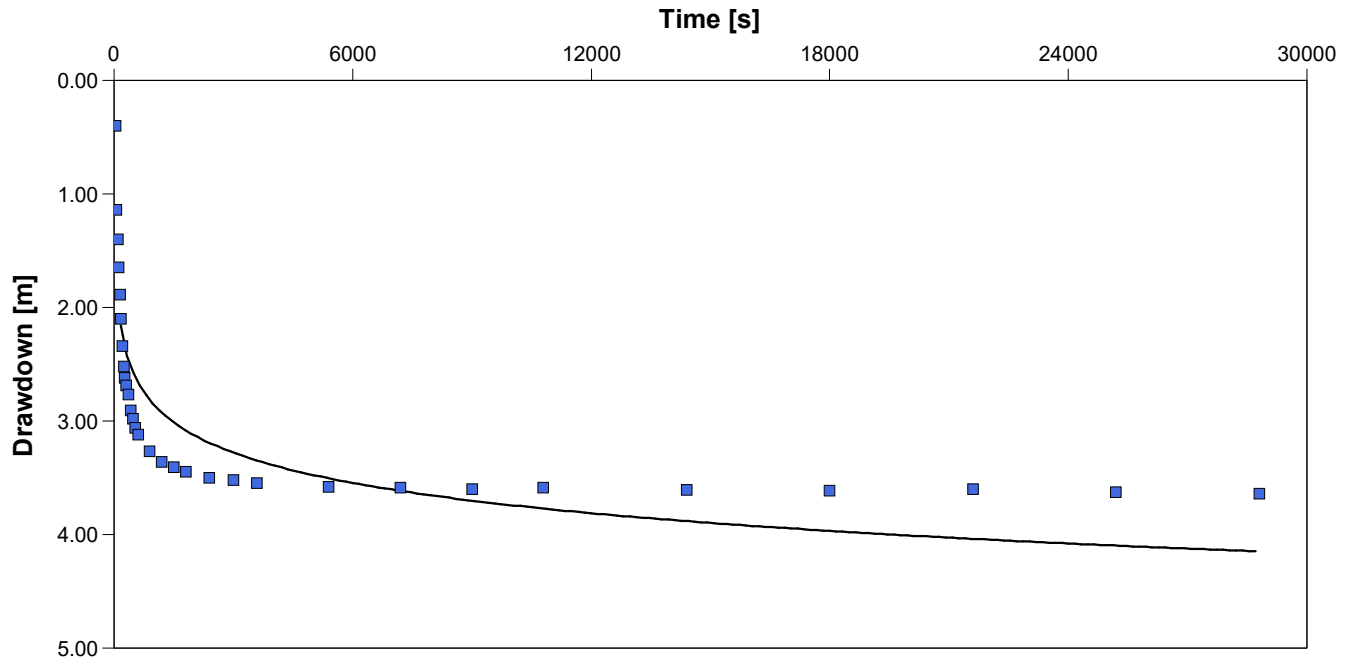
Location: 363 Entrepreneur Cresnet	Pumping Test: Pumping Test 1	Pumping Well: Well 1
Test Conducted by: LRL Engineering		Test Date: 2023-08-30
Analysis Performed by: LRL Engineering	Draw Down - August 30 2023	Analysis Date: 2023-09-07
Aquifer Thickness:	Discharge Rate: 0.022 [m³/min]

Calculation using Theis

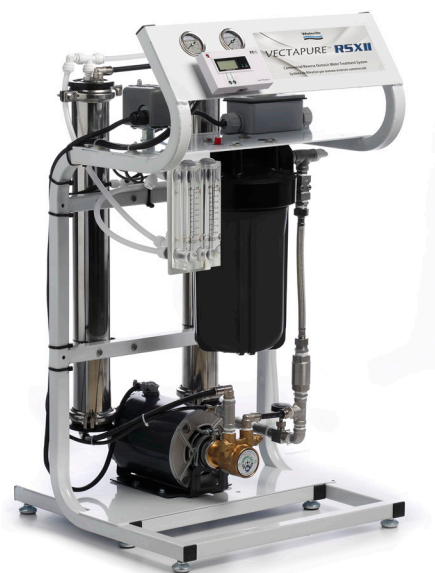
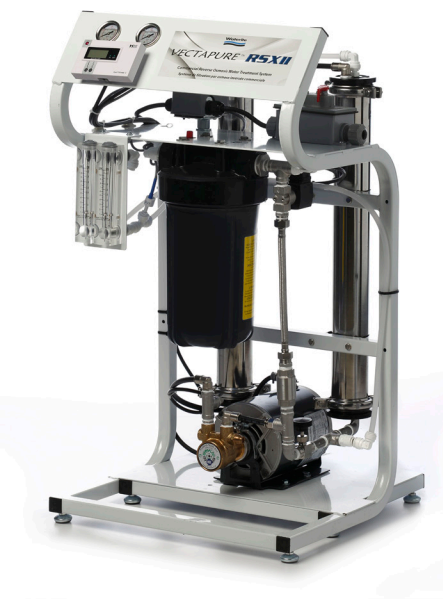
## VECTAPURE **RSXII™** (Nominal 350-700 GPD)

Vectapure RSX™ systems include as standard features: stainless membrane housings, heavy duty rotary vane pumps, stainless steel needle valves, 10" Big Blue 5 micron polyspun prefilter and a powder coated aluminum frame for corrosion resistance.

MODEL	RSX350	RSX700	RSX800LB
MEMBRANE SIZE	2.5 X 21	2.5 X 21	3 X 13
# OF MEMBRANES	1	2	2
MEMBRANE MANUFACTURER RATED PRODUCTION	350	700	800
OPERATING PRESSURE (PSI)	150	150	Min. 50
MAX RECOVERY RATE	60% @ 1500 TDS		50% @ 500 TDS
OPERATING VOLTAGE	115 v	115 v	NOT REQUIRED
SOURCE WATER	Tap	Tap	Tap
INLET (INCH)	3/8 QC	3/8 QC	3/8 QC
PERMEATE (INCH)	3/8 QC	3/8 QC	3/8 QC
UNIT DIM. (DxWxH)	19.5"x19"x34.25"	19.5"x19"x34.25"	19.5"x19"x34.25"
WEIGHT	46	56	30

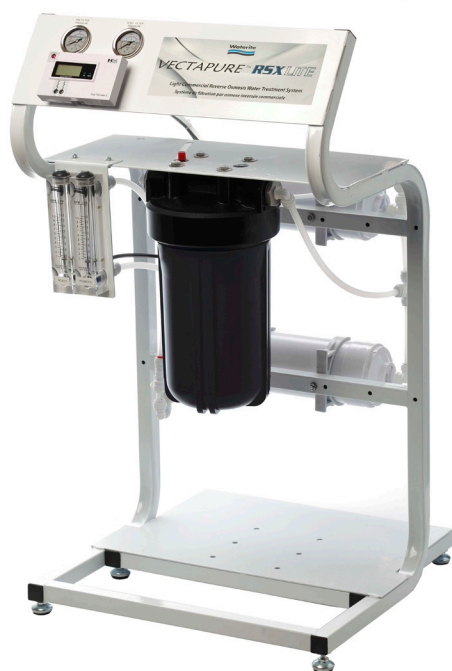
## VECTAPURE **RSX Lite™** (Nominal 800 GPD)

Vectapure RSX Lite™ models are equipped with two fully encapsulated 400 GPD TFC membranes, 10" Big Blue 5 micron polyspun filter, dual flow meters, dual TDS meters and a powder coated aluminum frame for corrosion resistance dual pressure gauges.

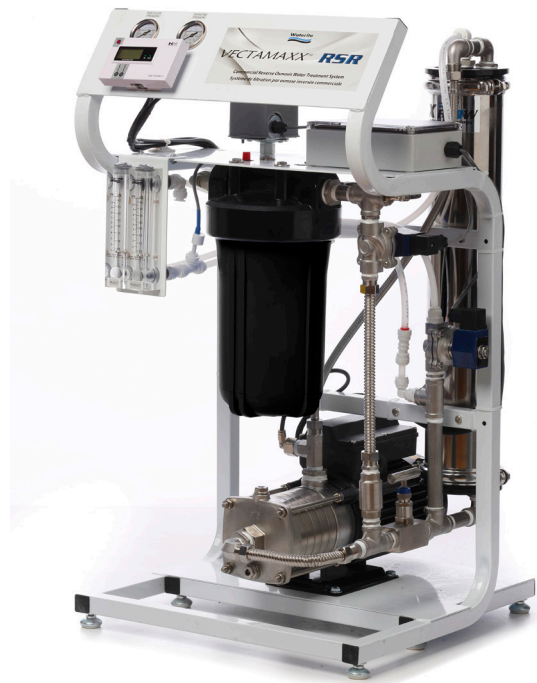
## **VECTAMAXX *RSR*™** (Nominal 1,200-2,400 GPD)

VECTAMAXX RSR™ systems include a powder coated aluminum frame for superior corrosion resistance, whisper quiet multi-stage stainless drive pump, stainless steel piping, dual flow meters, 10" Big Blue 5 micron polyspun prefilter, factory programmed micro controller with auto flush, dual TDS meters and dual pressure gauges.

MODEL	RSR1200	RSR2400
MEMBRANE SIZE	4 X 21	4 x 40
# OF MEMBRANES	1	1
MEMBRANE MANUFACTURER RATED PRODUCTION	1200	2400
OPERATING PRESSURE (PSI)	135	135
MAX RECOVERY RATE	60% @ 1000 TDS	
OPERATING VOLTAGE	115 v	115 v
SOURCE WATER	Tap / Brackish	Tap / Brackish
INLET (INCH)	1/2 QC	1/2 QC
PERMEATE (INCH)	3/8 QC	3/8 QC
UNIT DIM. (DxWxH)	19.5"x19"x34.5"	19.5"x19"x52"
WEIGHT	84	92

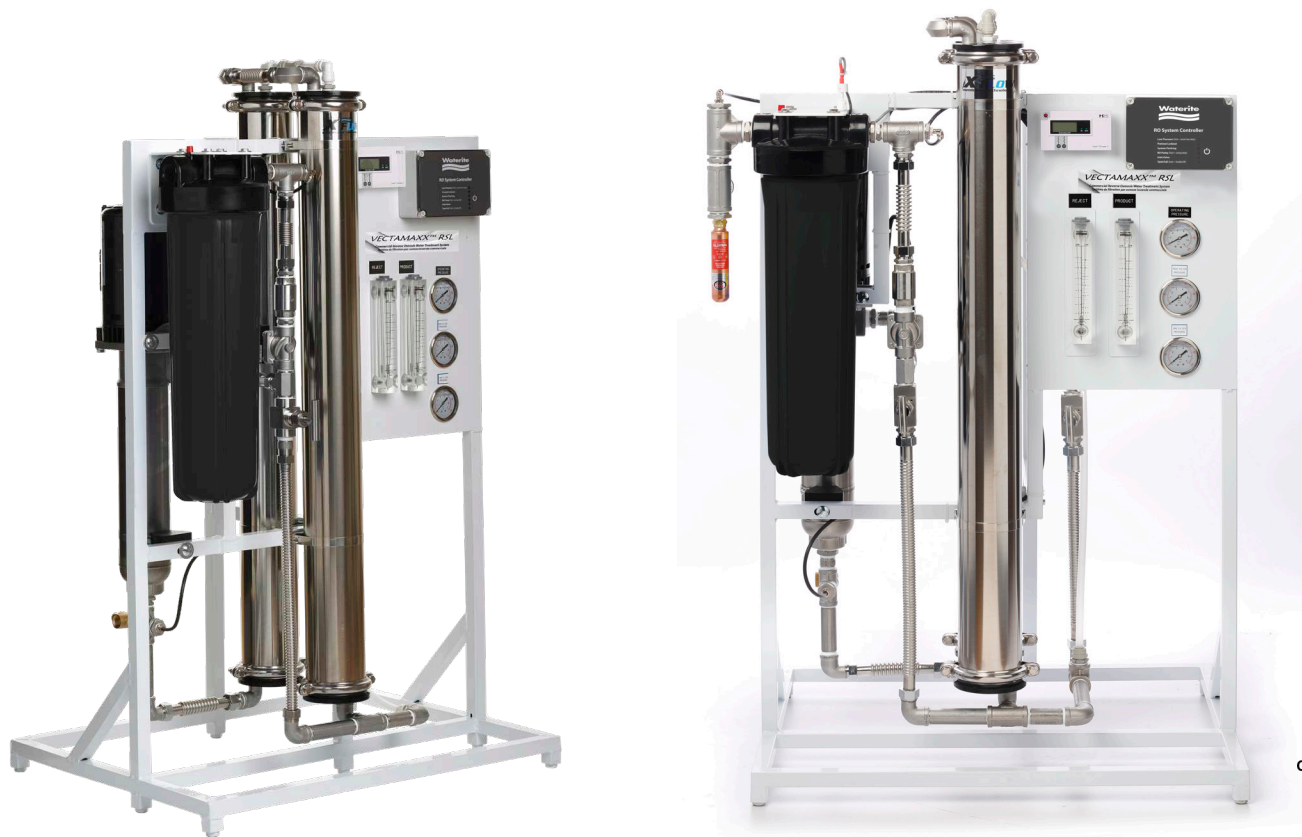
**VECTAMAXX RSL™** (Nominal 2,400-9,600 GPD)

VECTAMAXX RSL™ systems include as standard features: stainless membrane housings, stainless drive pumps, 20" Big Blue 5 micron polyspun prefilter, stainless steel piping, factory programmed micro controller with auto flush, pressure gauges, dual TDS meters and a powder coated aluminum frame for superior corrosion resistance. For brackish water, the RSL™ is available in high pressure models (RSLHP™).

MODEL	RSL2400 RSL2400HP	RSL4800 RSL4800HP	RSL7200 RSL7200HP	RSL9600 RSL9600HP
MEMBRANE SIZE	4 X 40	4 X 40	4 X 40	4 X 40
# OF MEMBRANES	1	2	3	4
MEMBRANE MANUFACTURER RATED PRODUCTION	2400	4800	7200	9600
OPERATING PRESSURE (PSI)	130 230	130 230	140 230	130 230
MAX RECOVERY RATE	60% @ <1000 TDS, 40% @ >1000 TDS 60% @ <2000 TDS, 40% @ >4000 TDS			
OPERATING VOLTAGE	230 v	230 v	230 v	230 v
SOURCE WATER	Tap or brackish	Tap or brackish	Tap or brackish	Tap or brackish
INLET (INCH)	1 FNPT	1 FNPT	1 FNPT	1 FNPT
PERMEATE (INCH)	1/2 QC	1/2 QC	1/2 QC	1/2 QC
UNIT DIM. (DxWxH)	24"x31"x50"	24"x31"x50"	24"x31"x50"	24"x31"x50"
WEIGHT	96/124	114/142	132/160	154/178

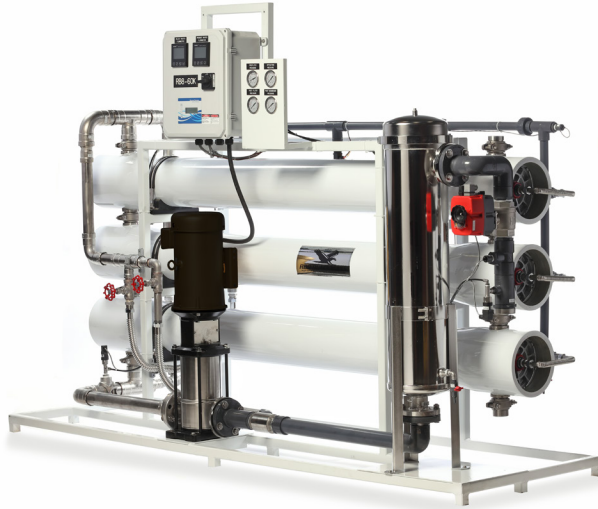
**RB8 BLACKMAXX®** (Nominal 20,000-120,000 GPD)

RB8 BLACKMAXX® systems include as standard features: stainless drive pumps, stainless steel pump prefilter housing and high pressure piping, digital flow and TDS monitors, factory programmed micro controller with auto flush, CIP-ready (CIP not included). Everything to assure simplicity, dependability and rugged performance.

MODEL	RB820K RB8HP20K	RB830K RB8HP30K	RB840K RB8HP40K	RB860K RB8HP60K	RB880K RB8HP80K	RB8120K RB8HP120K
MEMBRANE SIZE	8 x 40	8 x 40	8 x 40	8 x 40	8 x 40	8 x 40
# OF MEMBRANES	2	3	4	6	8	12
MEMBRANE MANUFACTURER RATED PRODUCTION	20,000	30,000	40,000	60,000	80,000	120,000
OPERATING PRESSURE (PSI)	135/225	135/225	135/225	135/225	135/225	135/225
MAX RECOVERY RATE	Based on feed water quality					
OPERATING VOLTAGE	230VAC 3PH	230VAC 3PH	230VAC 3PH	230VAC 3PH	230VAC 3PH	230VAC 3PH
SOURCE WATER	Tap or brackish	Tap or brackish	Tap or brackish	Tap or brackish	Tap or brackish	Tap or brackish
INLET (INCH)	1.5 FPT	1.5 FPT	1.5 FPT	2 FPT	2 FPT	2 FPT
PERMEATE (INCH)	1 FPT	1 FPT	1 FPT	1.25 FPT	1.25 FPT	1.5 FPT
UNIT DIM. (DxWxH)	30"x64.75"x67.5"	30"x64.75"x67.5"	30"x64.75"x67.5"	32"x105"x67.5"	32"x105"x67.5"	32"x150"x67.5"
WEIGHT	Determined at time of order

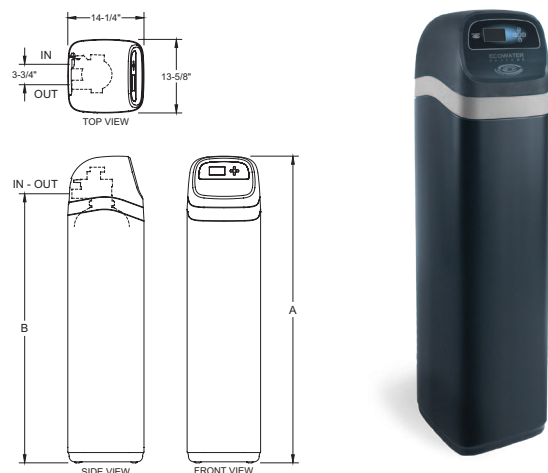
## DIMENSIONS

ETF2300 AIV10	ETF2300 AIV12	ETF2300 EIV10	ETF2300 EIV12
Nominal Resin Tank Size	10" Diam. x 47"	12" Diam. x 54"	10" Diam. x 47"	12" Diam. x 54"
A	57"	62.5"	57"	62.5"
B	50"	55.75"	50"	55.75"

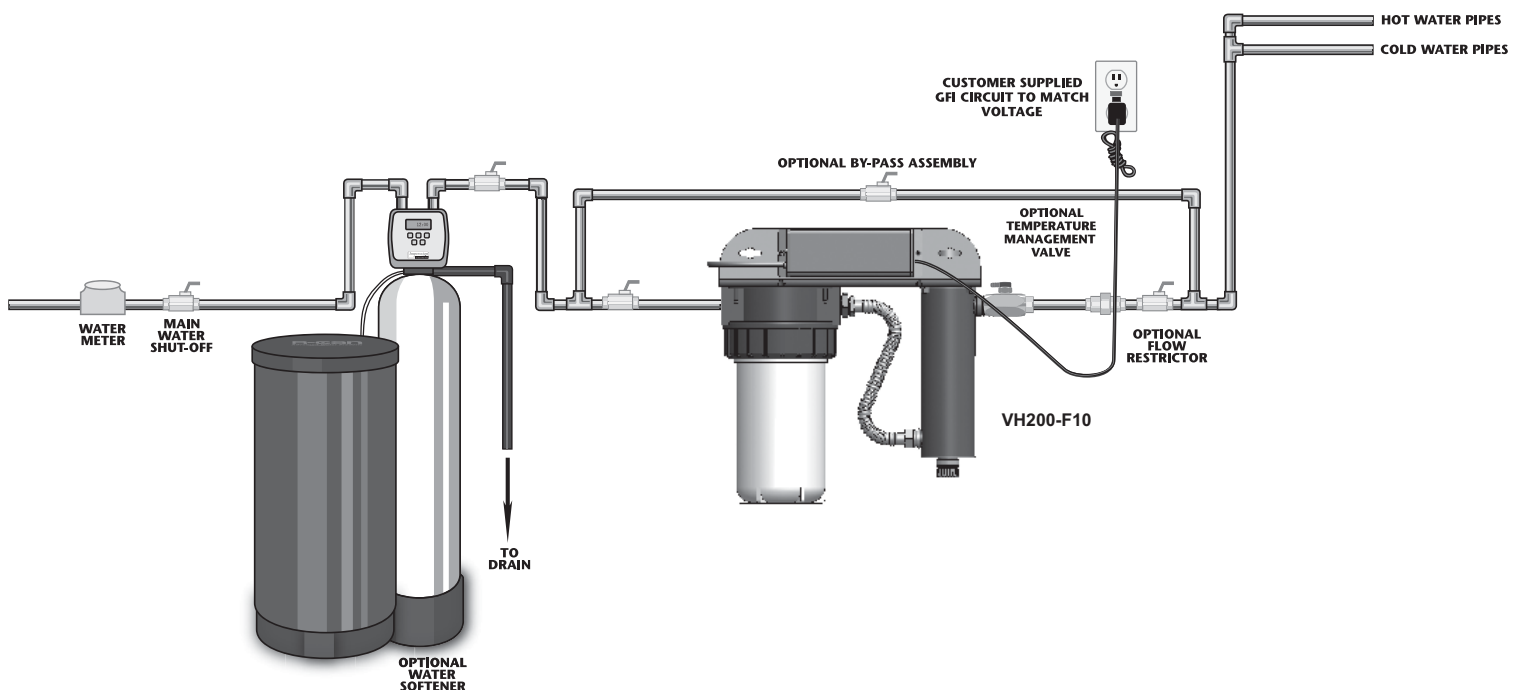
Figure 2 Disinfection System

- [Figure 2](#) shows the installation of a typical drinking water system and the related components that may be used for the installation. The use of a bypass assembly is recommended in case the system requires “off-line” maintenance. If this is the case, it must be noted that the system will require supplementary disinfection of the distribution system if any water is used during this bypass condition. In addition, during bypass, the water will NOT be disinfected and a “DO NOT CONSUME THE WATER” tag should be physically installed on the bypass assembly until such time as the system is sanitized and returned to service. Please refer to [Section 3.2](#) for the complete disinfection procedure. If the water is to be consumed while the system is off-line, the water must be boiled for two minutes prior to consumption.

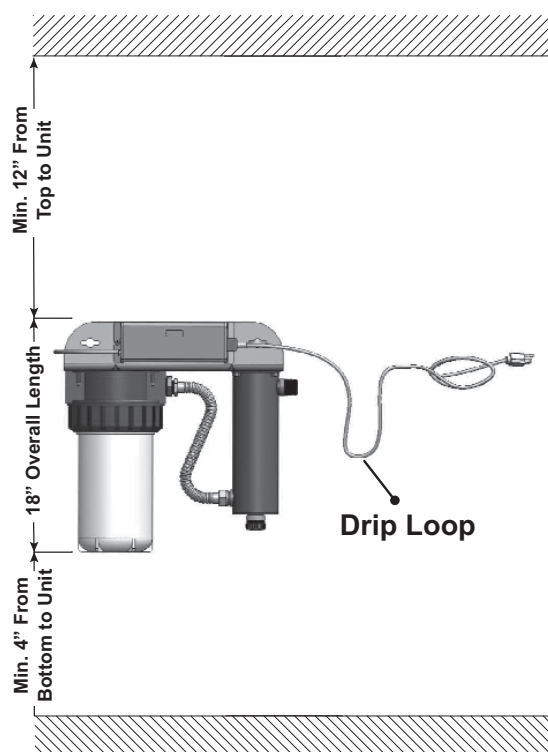
Figure 3 Disinfection Installation

2. Select a suitable location for the disinfection system and its related components. As it is recommended to install a ground fault protected circuit (GFCI), make sure that this is taken into consideration prior to any installation. When selecting a mounting location, enough space must be left to allow for the removal of the UV lamp sleeve, as well as enough space to change out the filter cartridges. See [Figure 3](#) for typical clearance dimensions.

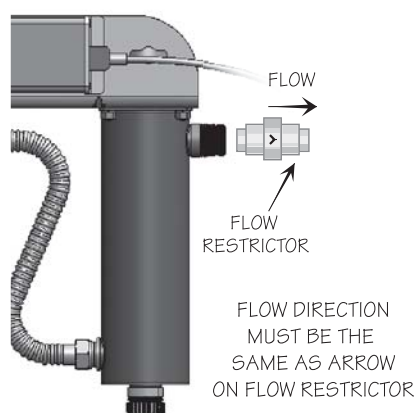
Figure 4 Flow Restrictor

**Note:** DO NOT solder connections while attached to the system as this could damage the O-ring seals.

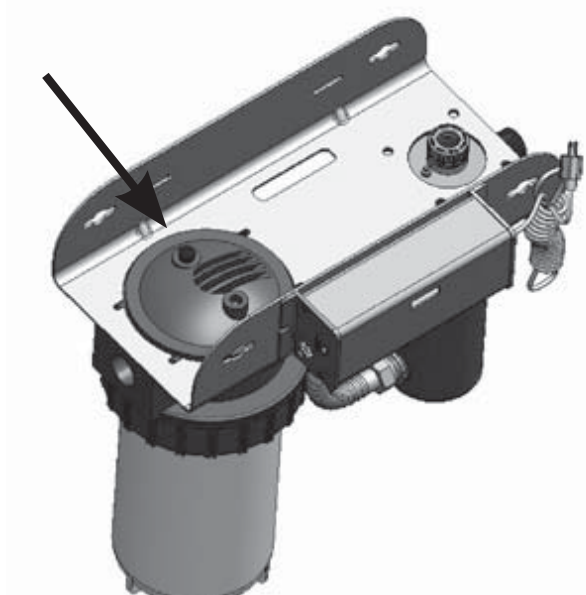
Figure 5 Pressure Relief Button

1. Shut-off the water flow to the unit, depress pressure relief button on top of the filter head to relieve pressure in the filter. Refer to [Figure 5](#).

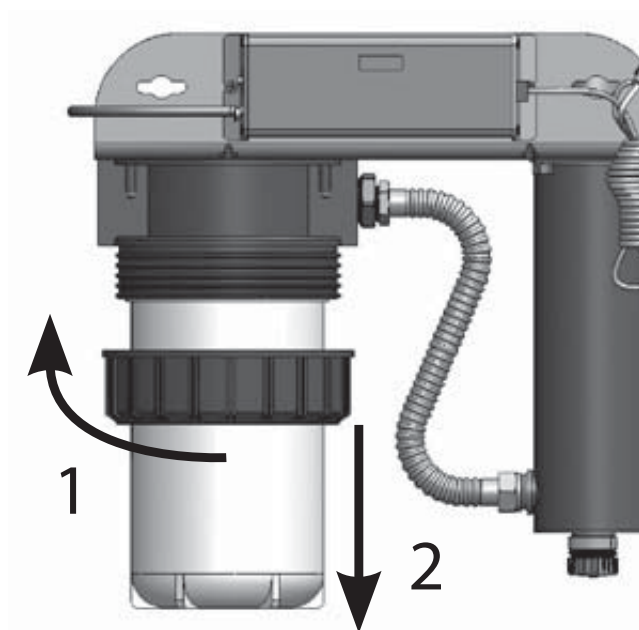
Figure 6 Removing Filter Housing

2. Place a bucket or pail under the stainless steel chamber. Remove retaining nut to drain system.
3. Remove the filter housing from the unit by turning the blue collar counter-clockwise until it falls free from the head. Pull down the white filter housing (be careful as it will be full of water and will be heavy). Refer to [Figure 6](#).

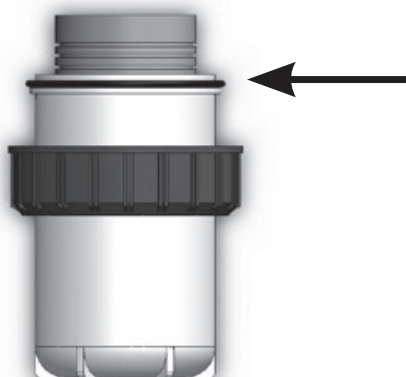
Figure 7 O-ring on Sump

4. Discard the used cartridge and clean the sump housing as required. Make sure to thoroughly rinse the sump with water to remove any cleaning agents. Before installing a new cartridge, please ensure that the o-ring seals are properly seated on the shoulders at the top of the sump (Refer to [Figure 7](#)), if there is any visible damage on the o-rings please replace them (P/N: OR40-50). Reapply a generous amount of lubricant to the O-ring when reinstalling sumps.

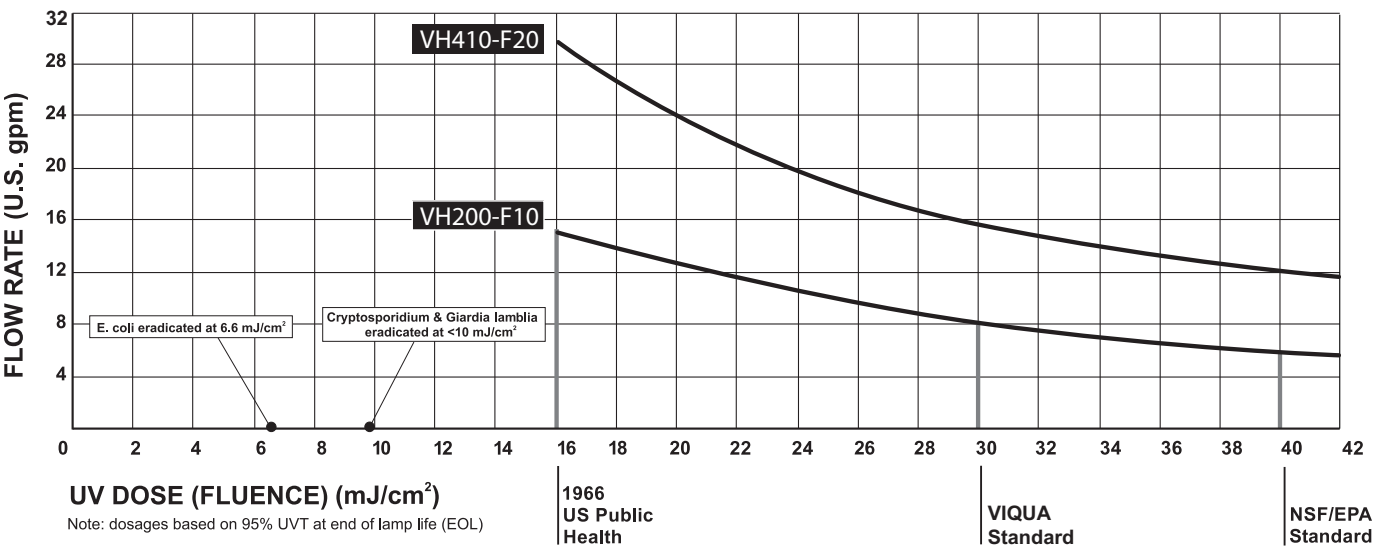
Figure 9 Dose Flow Chart

Section 7 Manufacturer's Dose Flow Chart
