Phase One Environmental Site Assessment

193 Norice Street
Ottawa, Ontario

Prepared for:

2707120 Ontario Inc.
549 De Mazenod Avenue
Ottawa, Ontario
K1S 5H3

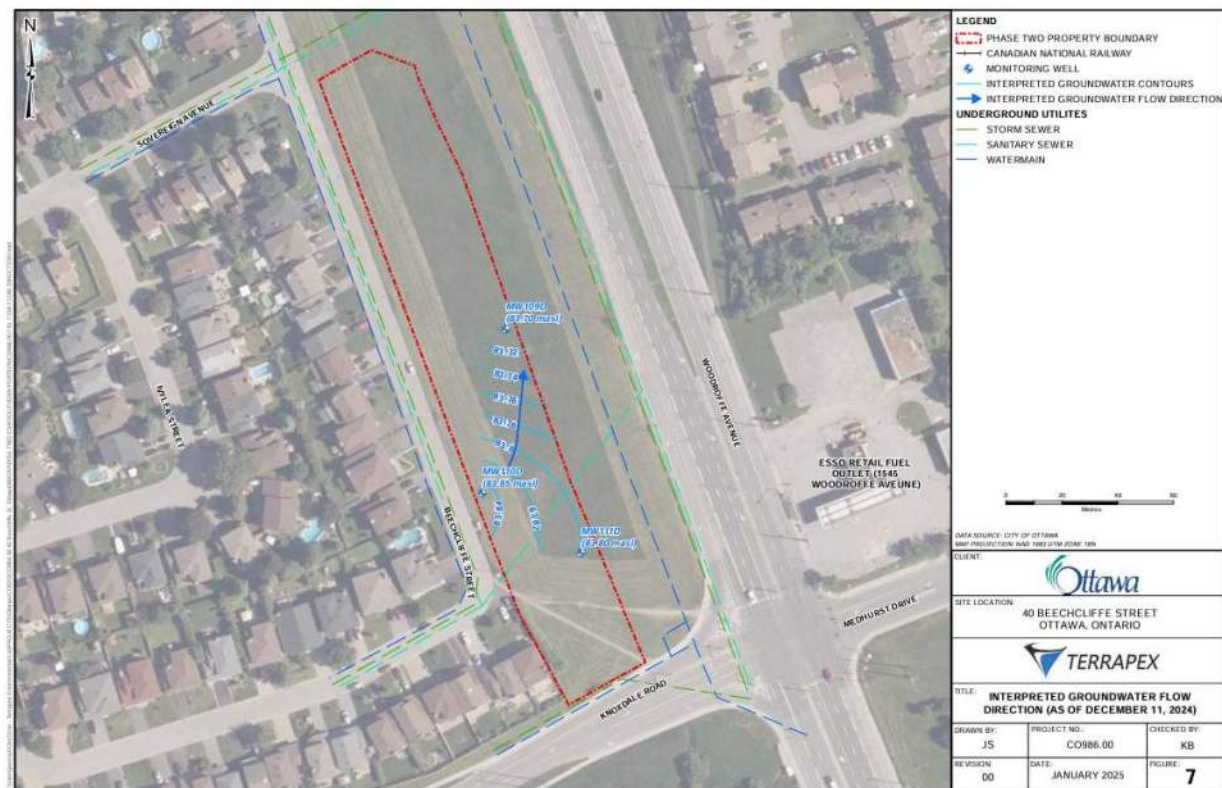
The geological conditions on the Site, as documented by Terrapex, included fill material to depths of between 0.0 and 3.0 m below grade, or native silty clay from between 1.0 and 4.1 m below grade, generally over sand from depths of between 3.0 and 6.1 m below grade, where the instructions were terminated. December 2024 groundwater levels collected as part of this assessment revealed that groundwater was identified at depths of between approximately 4.6 and 4.8 m below grade. Groundwater elevations were depicted in an included Figure, which demonstrated a generally northerly groundwater flow direction which is found to correspond with the findings of this Phase One Environmental Site Assessment.

The Figure included in the report is depicted below for reference.

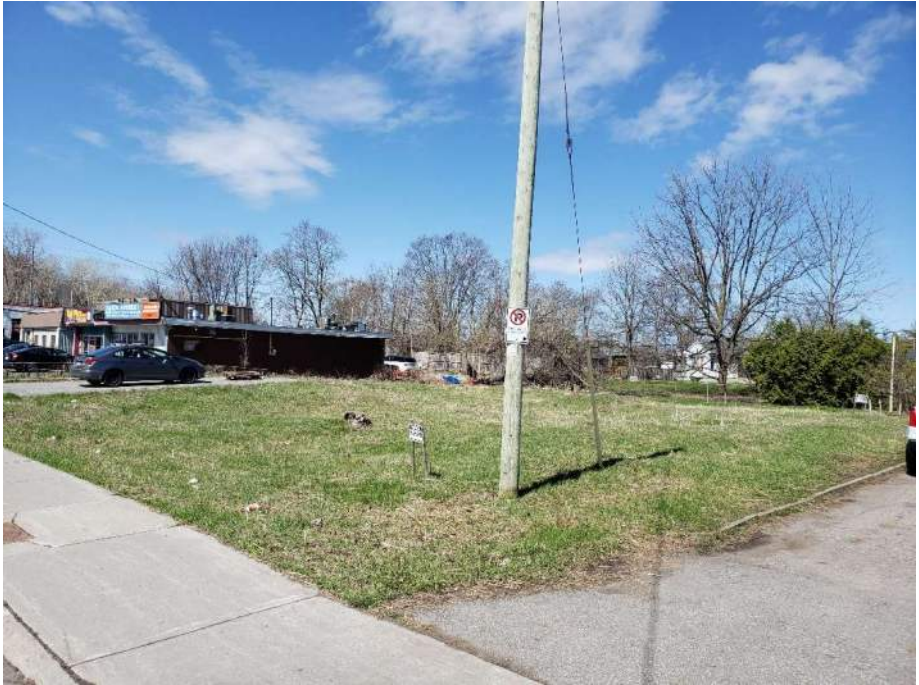
Photograph No. 1

Date: 4/22/2024	
Description From southeast facing north west across the subject Site.	
Photograph No. 2

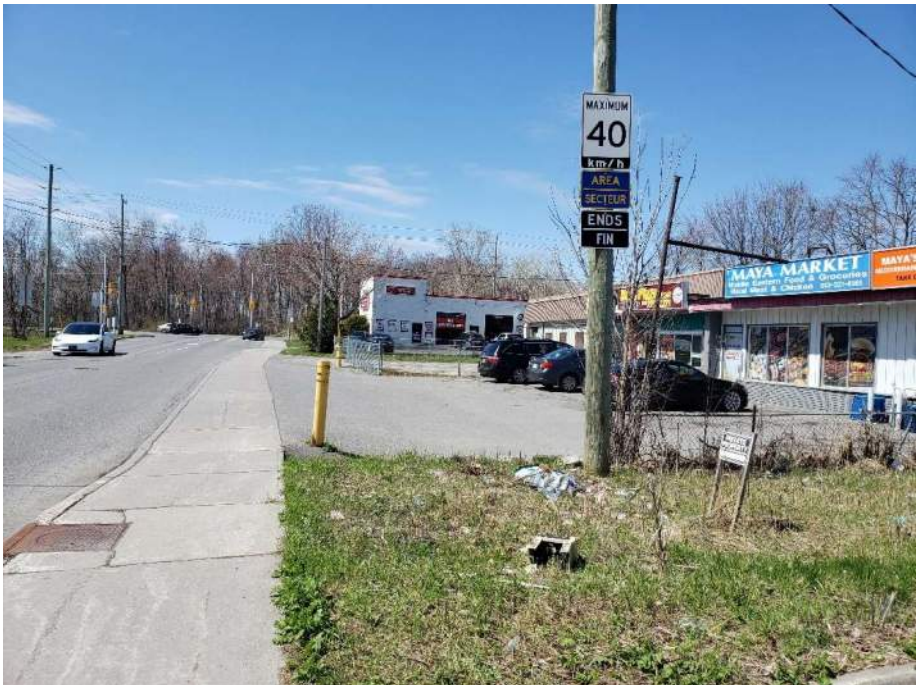
Date: 4/22/2024	
Description Facing west along Norice Street. Neighbouring commercial developments are present in the background.
