# Phase One Environmental Site Assessment Undeveloped Property

8900 Jeanne d'Arc Boulevard and  
100 Inlet Private  
Ottawa, Ontario

Brigil Construction Inc.

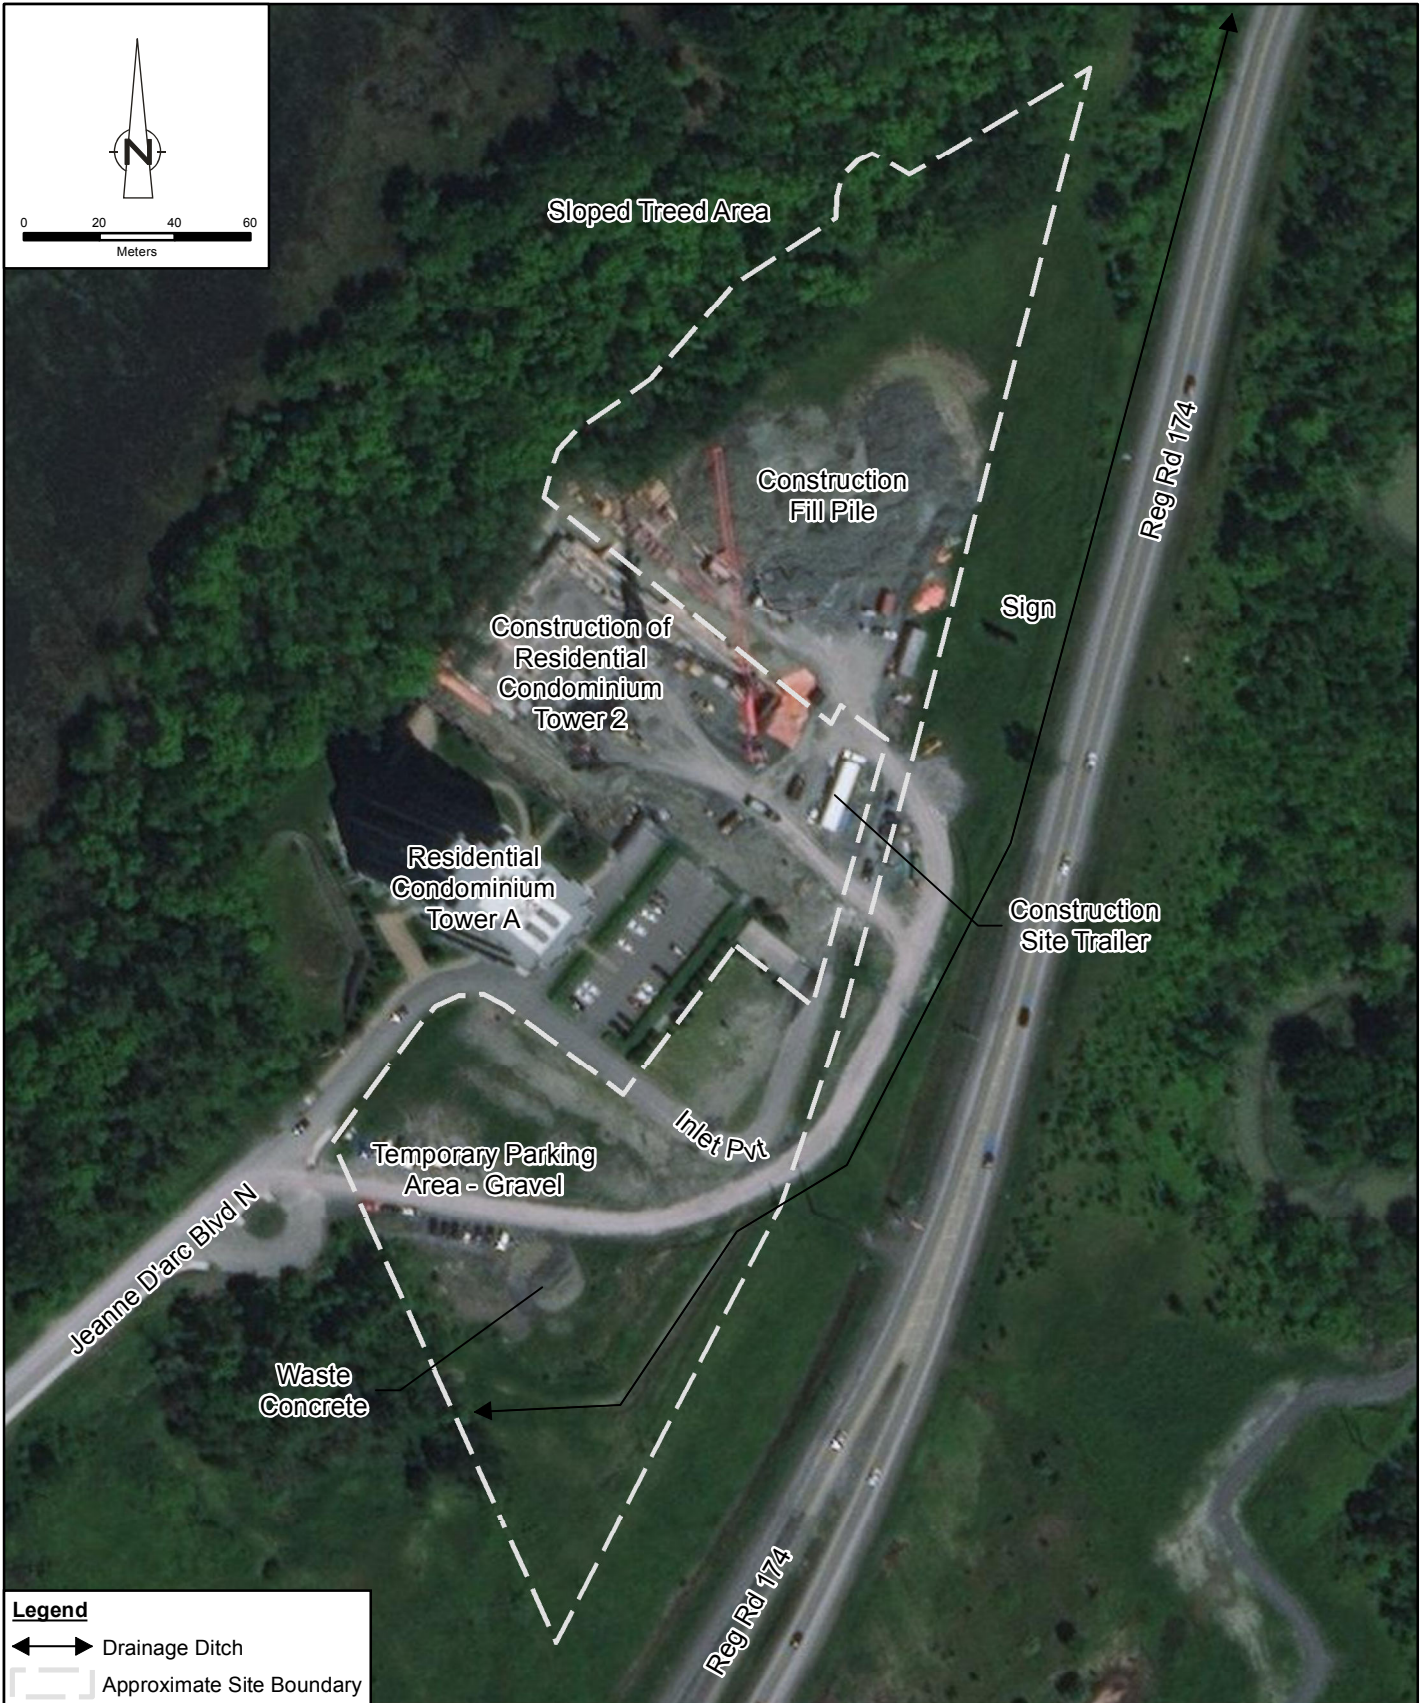
**FIGURE 2**

**SITE PLAN**

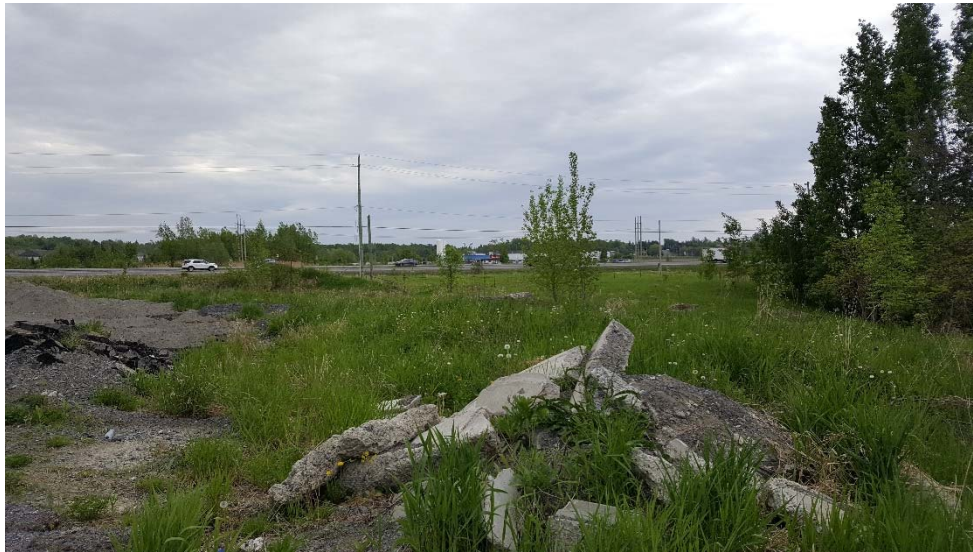
Photo 1 - View of the south portion of the Site facing south. View depicts temporary piles of construction debris and overgrown vegetation.

the concrete construction debris and fill pile was piled at the Site during development of the adjacent properties to the north by the Client. Based on observations and discussion with the Client, the fill consists of stripped topsoil and excavated material from foundations of buildings on the adjacent property to the north, which have been constructed by the Client. The presence of imported fill material is not suspected on the Site.

The Site has surface cover of grass vegetation with the exception of a temporary gravel parking area on the west portion of the Site for undergoing construction activities at the adjacent property to the north. The Site is approximately level with Jeanne d'Arc Boulevard to the west, and Regional Road 174 to the south. A pile of concrete construction debris was observed on the south portion of the Site as well as stockpiled fill material was observed on the east portion of the Site; however, it was suspected that the concrete construction debris and fill pile at the Site as a result of development of the adjacent properties by the Client. It is suspected that the fill was stripped topsoil, and presence of imported fill material is not suspected on the Site; the Client representative confirmed that the fill would be removed as part of Site development.

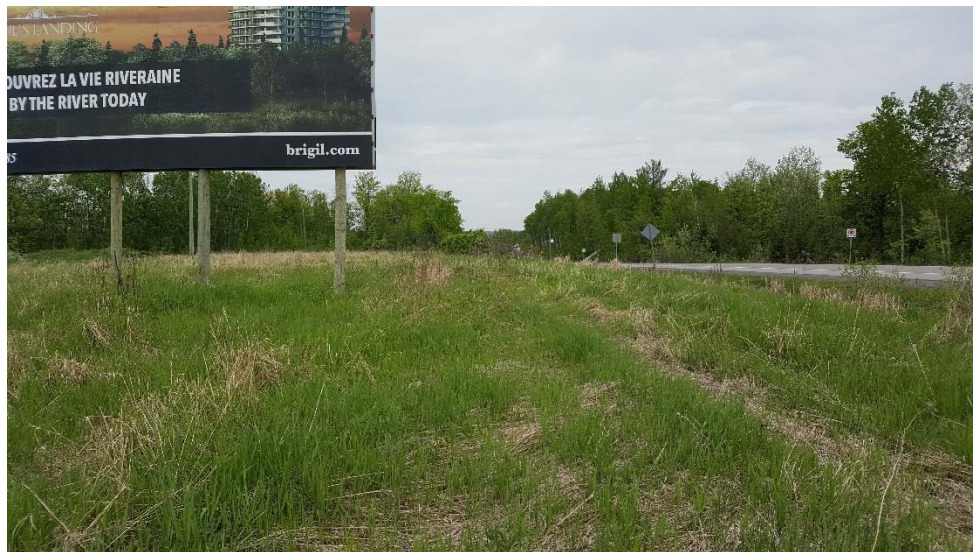
Photo 2 - View of the east portion of the Site facing east. View depicts overgrown vegetation area.

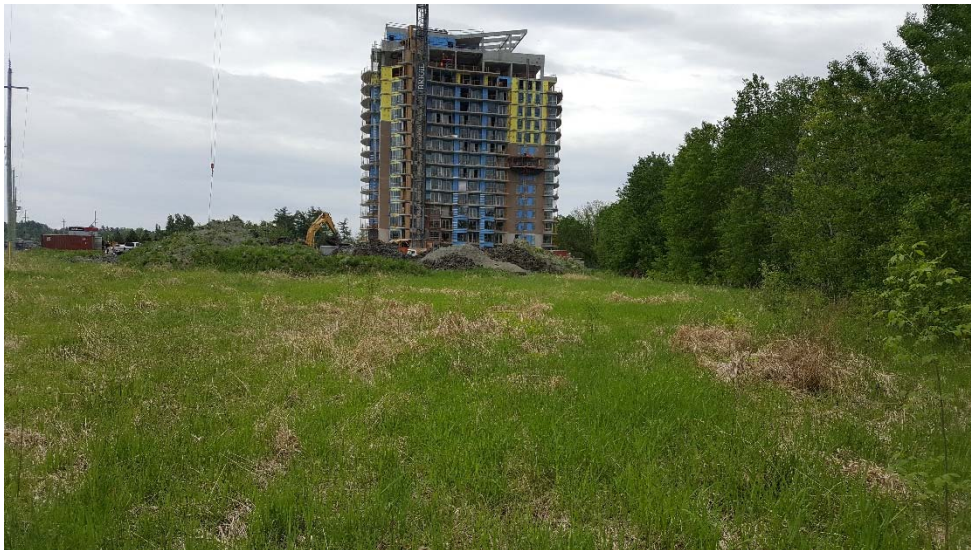
Photo 3 - View of the west portion of the Site facing west. View depicts overgrown vegetation and neighboring properties to the north under construction (residential condos).

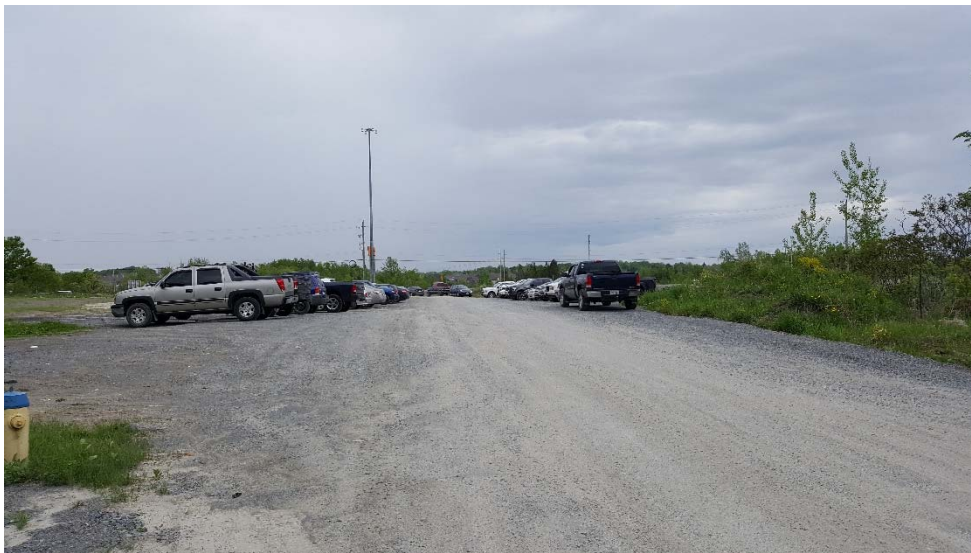
Photo 4 - View of the north portion of the Site facing east. View depicts temporary granular gravel fill as construction parking area.

The Site has surface cover of grass/tree/scrub vegetation with a surficial granular gravel fill area used as a temporary construction parking area on the west portion of the Site; this parking area is being used for the ongoing construction activities on the adjacent property to the north. The Site is approximately level with Jeanne D'Arc Boulevard to the west, and Regional Road 174 to the south. A pile of concrete construction debris was observed on the south portion of the Site as well as stockpiled fill material was observed on the east portion of the Site; however, it was suspected that

The Site was undeveloped and unoccupied at the time of Site visit with the exception a granular gravel surfaced area on the west portion of the Site, which was used as a temporary parking area for the ongoing construction activities on the adjacent property to the north. The overall topography of the Site was sloped downward to the north, towards the Ottawa River. The Site was overgrown with grass vegetation. No areas of potential environmental concerns were noted on the Site at the time of Site visit.

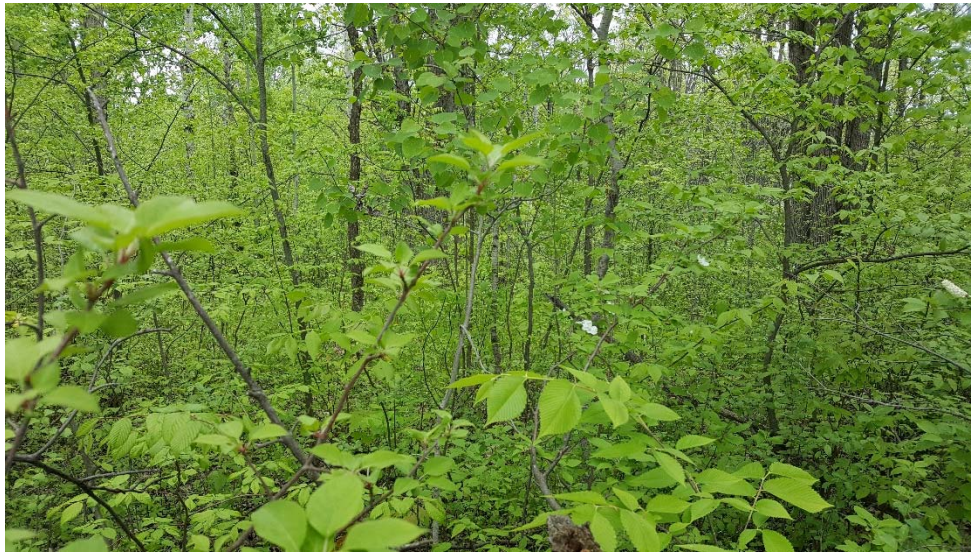
Photo 5 - View of the northeast portion of the Site. View depicts sloped forested area towards the Ottawa River; view is facing north.

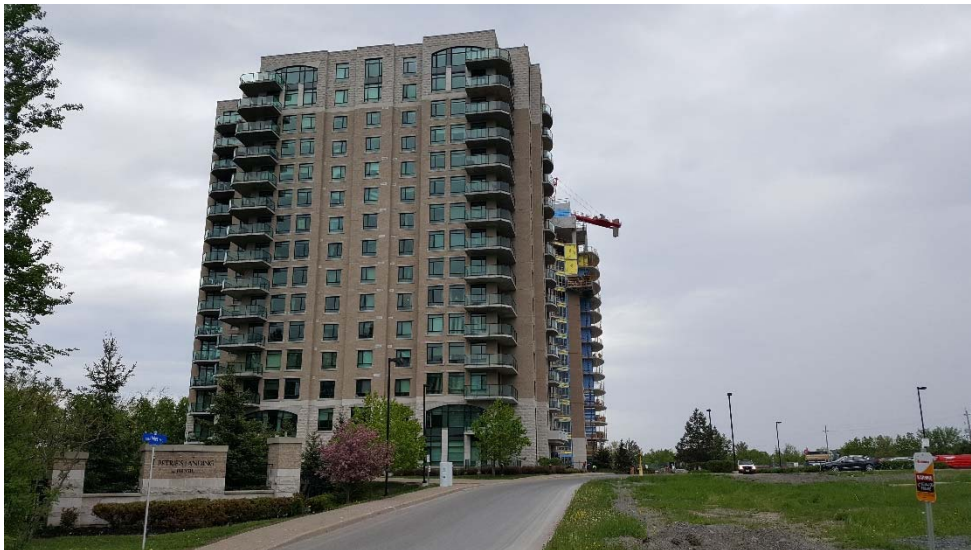
Photo 6 - View of the north portion of the Site. View depicts the neighboring properties to the north (residential condos); view is facing east.
