Re: OTT-21004743-CO Addendum - Phase I Environmental Site Assessment 2983 Navan Road, Ottawa, Ontario

EXP Services Inc. (EXP) was retained by 12714001 Canada Inc. to prepare an addendum to a Phase One Environmental Site Assessment (ESA) for the property located at 2983 Navan Road, Ottawa, Ontario hereinafter referred to as the 'Phase One property'. EXP prepared a report entitled *Phase One Environmental Site Assessment, 2983 Navan Road, Ottawa, Ontario* dated July 16, 2021 for 12714001 Canada Inc.

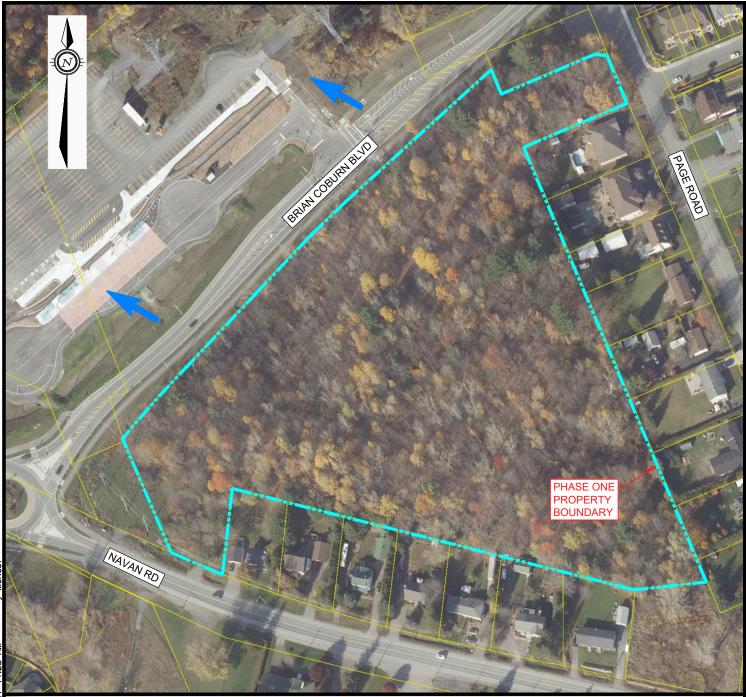
MARCH 2021		12714001 CANADA INC.	OTT-21004744-A0
DESIGN	CHECKED		scale
LW	PS	SITE LOCATION PLAN	~1:15,000
DRAWN BY		SITE EGGATION LAN	
Т	М	2983 NAVAN ROAD, ORLEANS, ONTARIO	FIG 1

The Phase One property has the municipal address 2983 Navan Road in Ottawa, Ontario. The Phase One property is located on the west side of Navan Road, immediately south of Brian Coburn Boulevard and is currently vacant. The Phase One property is irregular in shape with an area of approximately 11.2 acres (4.5 hectares). A site location plan is provided as Figure 1 and a site plan is provided as Figure 2.

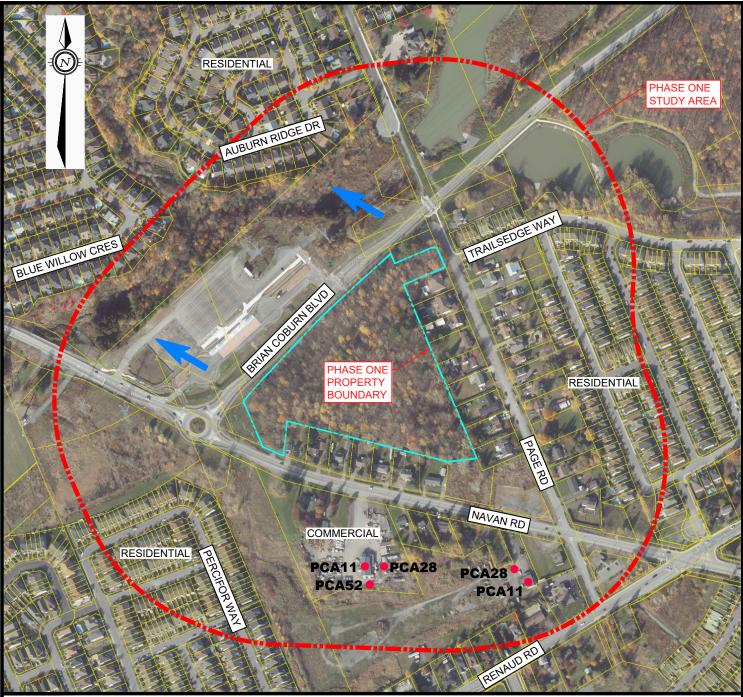
MARC	CH 2021	12714001 CANADA INC.	OTT-21004744-A0	
DESIGN	CHECKED		scale	
LW	PS	TITLE: SITE PLAN	1:2,000	
DRAWN BY			FIG 2	
Т	.М.	2983 NAVAN ROAD, ORLEANS, ONTARIO	FIG 2

PROPERTY BOUNDARY
INFERRED GROUNDWATER
FLOW DIRECTION

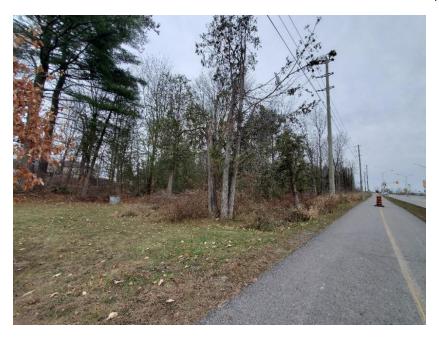
Photograph No. 1

- EXP did not observe any evidence of chemical or hazardous materials storage during the site reconnaissance. EXP did not observe any stained soil, pavement, or stressed vegetation during the site reconnaissance. EXP did not observe any on-site aboveground storage tanks, or evidence of underground storage tanks, during the site reconnaissance.

View of the northwest corner of the Phase One property looking south.

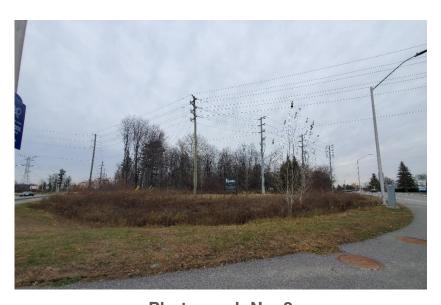
Photograph No. 2

View of the southwest corner of the Phase One property looking north/northeast.

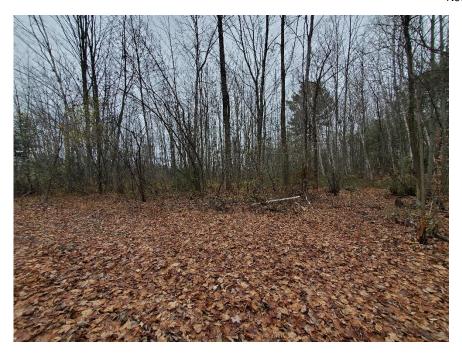
Photograph No. 3

View of the southeast portion of the Phase One property looking east.

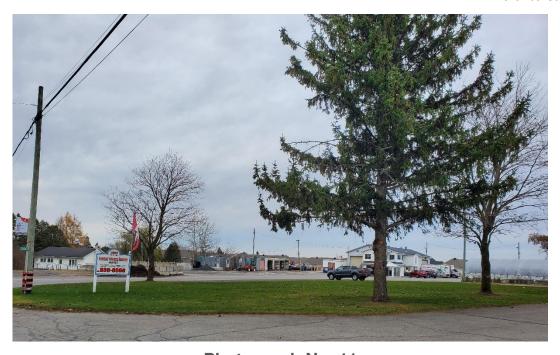
On November 27, 2023, the MECP Access Environment website was searched for postings in the vicinity of the site. Three Environmental Compliance Approvals (ECA) issued to Laurent Leblanc Ltd. for waste management systems were identified, as well as five records for municipal and private sewer works in the Phase One study area. Two Permits to Take Water (PTTW) and one Environmental Activity and Sector registry (EASR) records for water taking related to construction were identified in the Phase One study area. One Record of Site Condition (RSC) for 6102 Renaud Road, approximately 190 m southeast of the Phase One property, was filed in July 2023; however, there is no evidence that this RSC has been acknowledged by the MECP. As established in EXP's 2021 Phase I ESA, none of the works described in the ECA are likely to pose an environmental concern to the site.

Photograph No. 11
View of Laurent Leblanc Ltd. at 3000 Navan Road.
