# 1Door4Care: CHEO Integrated Treatment Centre - Geotechnical Investigation Report (1Door4Care)

Children's Hospital of Eastern Ontario  
Campus, 401 and 407 Smyth Road,  
Ottawa, Ontario

Infrastructure Ontario Project # 182-OCTC

25 October 2022

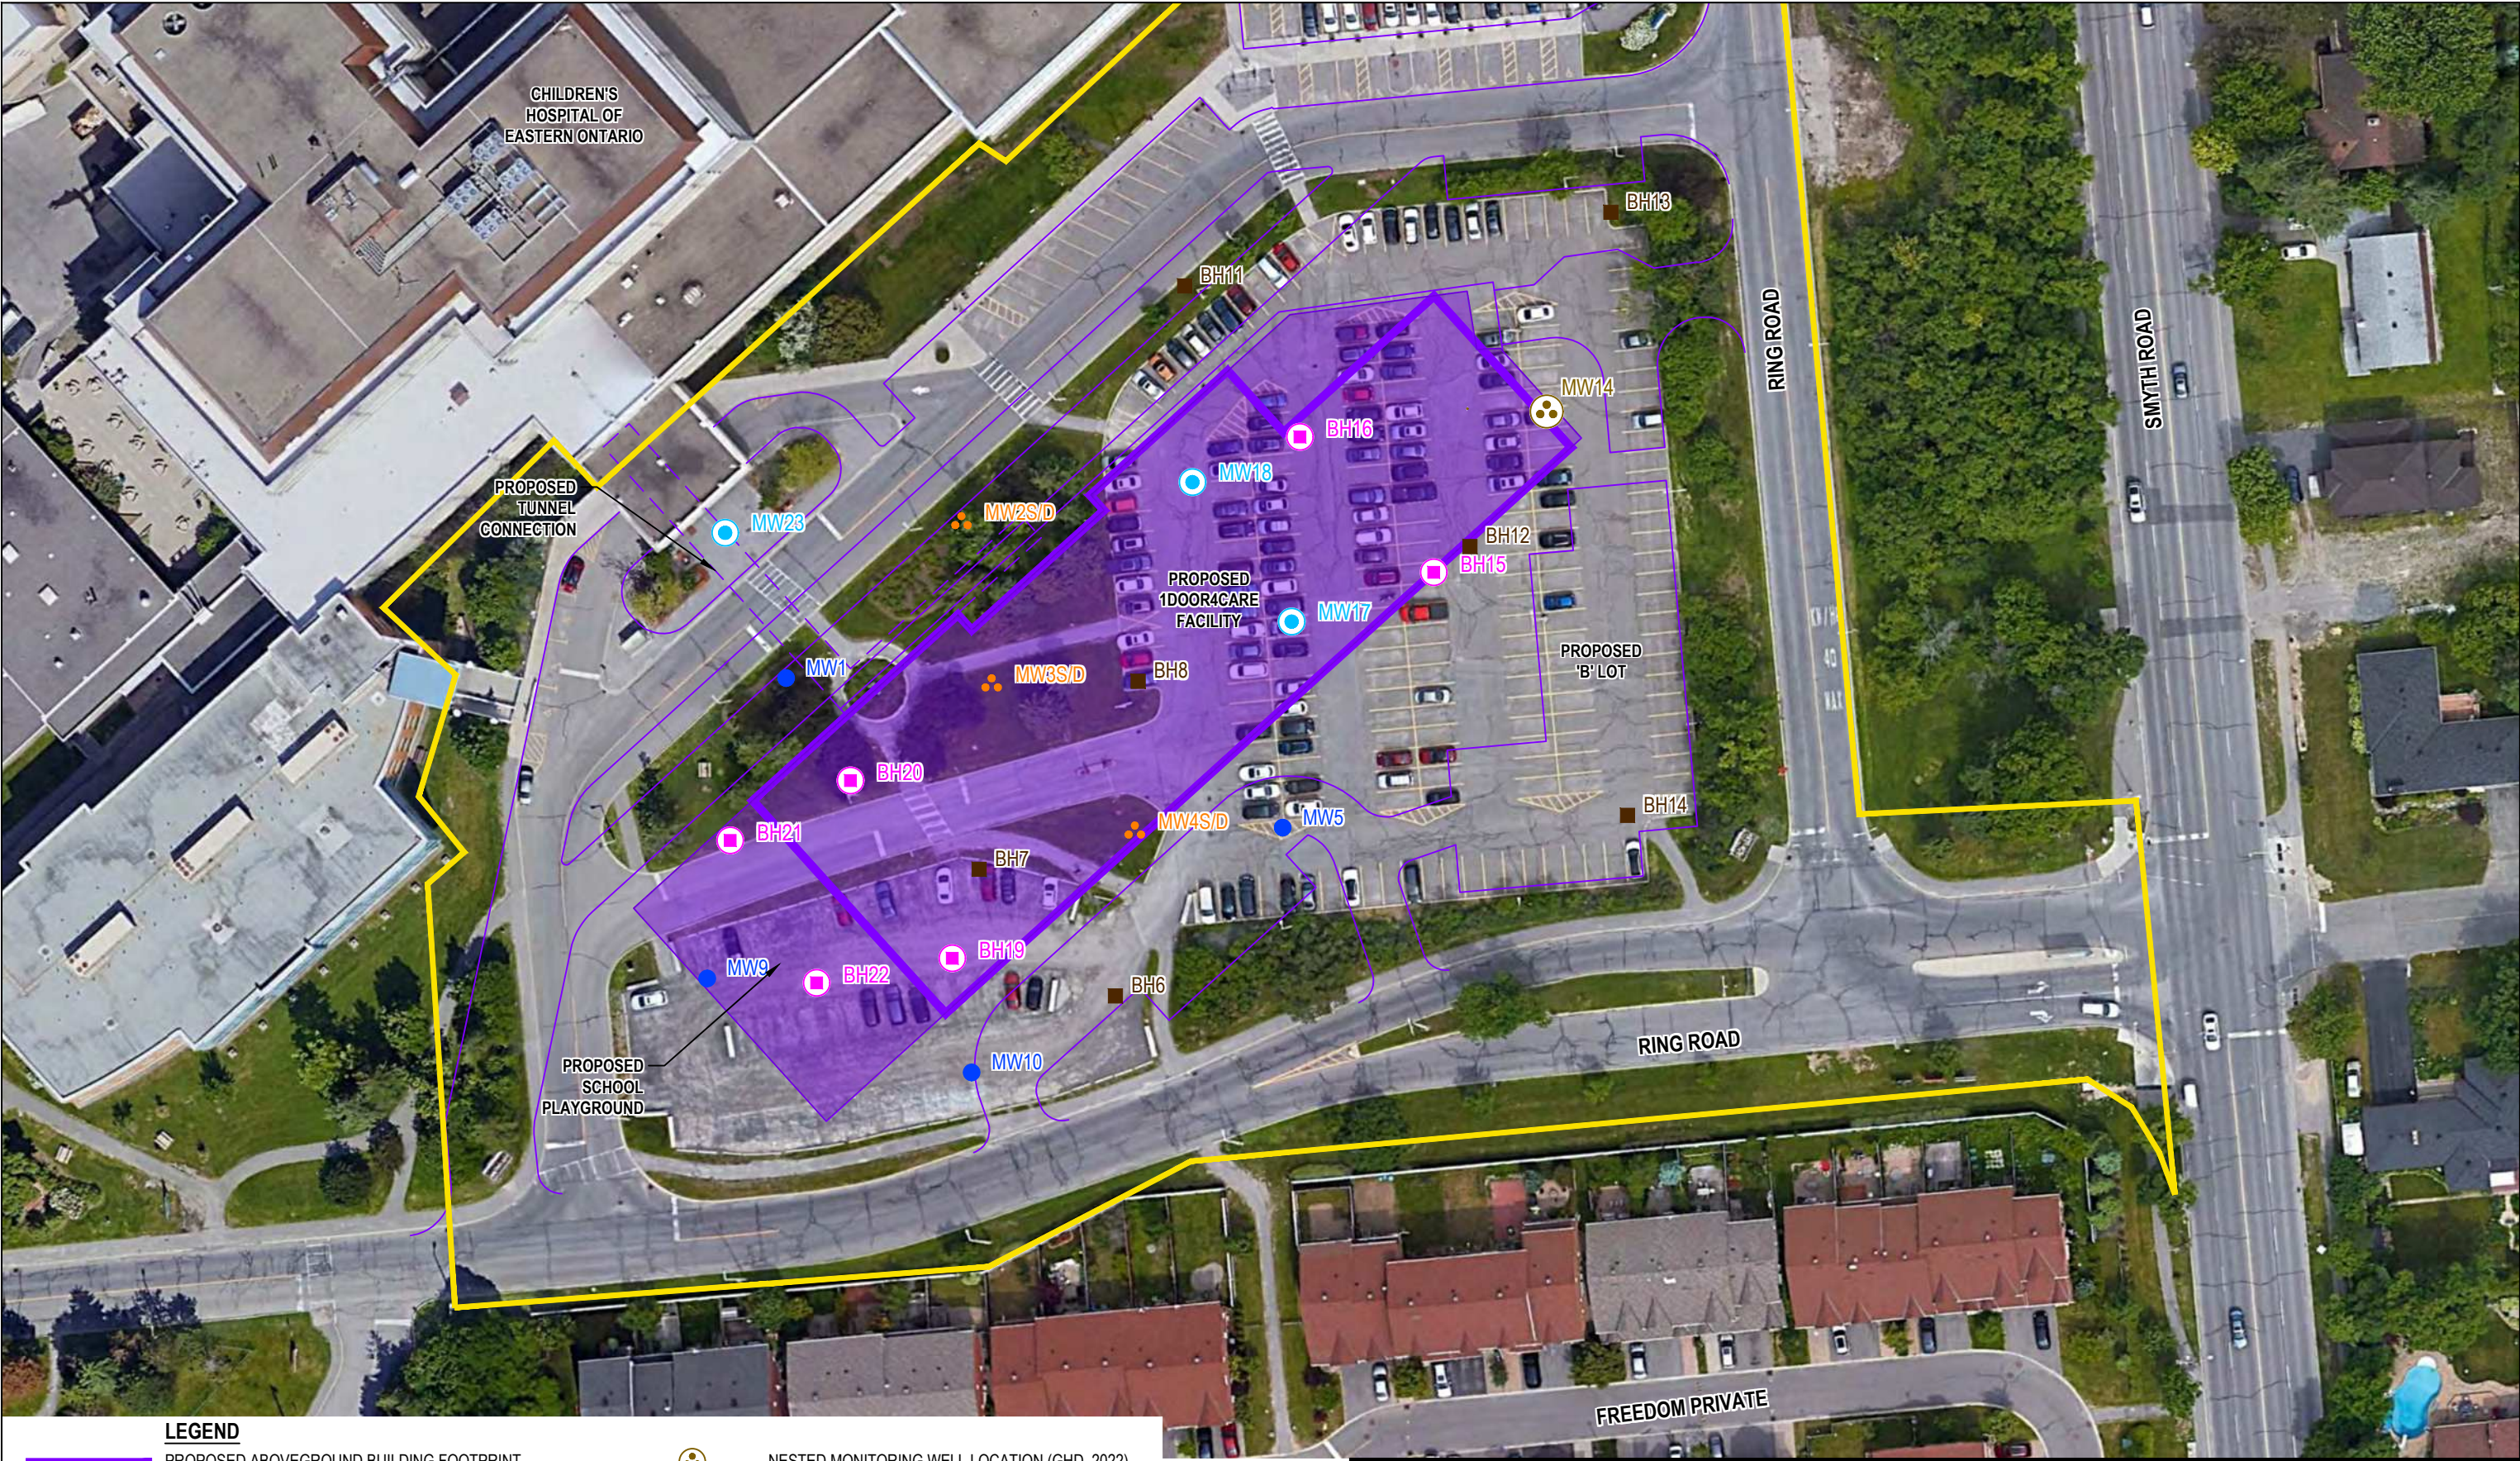
FIGURE 1

- PROPOSED ABOVEGROUND BUILDING FOOTPRINT
- PROPOSED BELOWGROUND BUILDING FOOTPRINT
- PROPOSED PARKING AREA OR SITE FEATURE
- PROPOSED PROJECT AREA FOR SITE DUE DILIGENCE BOUNDARY
- BOREHOLE LOCATION (GHD, 2022)
- SHALLOW OVERBURDEN/BEDROCK MONITORING WELL LOCATION (GHD, 2022)

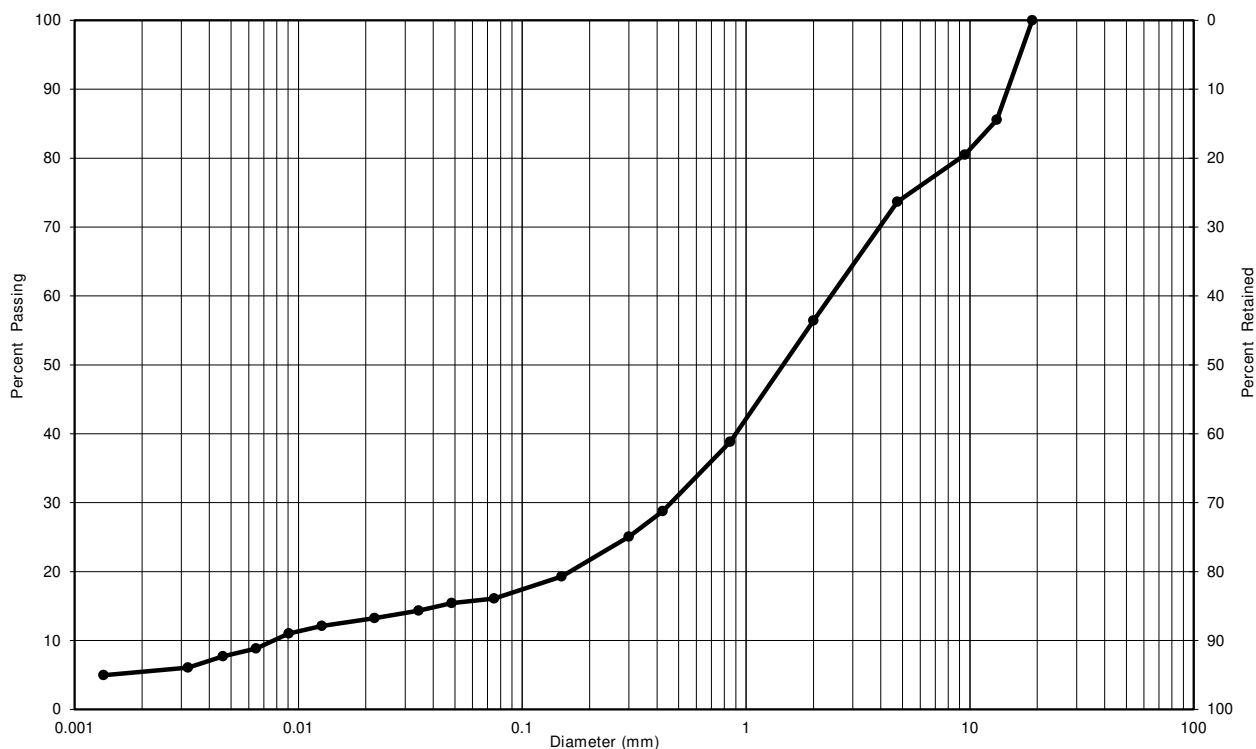
Borehole No.: MW1 Sample No.: SS3 + SS4  
Depth: 1.5m-2.1m / 2.3m - 2.9m Enclosure:

Soil Description	Gravel (%)	Sand (%)	Clay & Silt (%)
Silty Sand with Gravel, Trace Clay	26	58	16

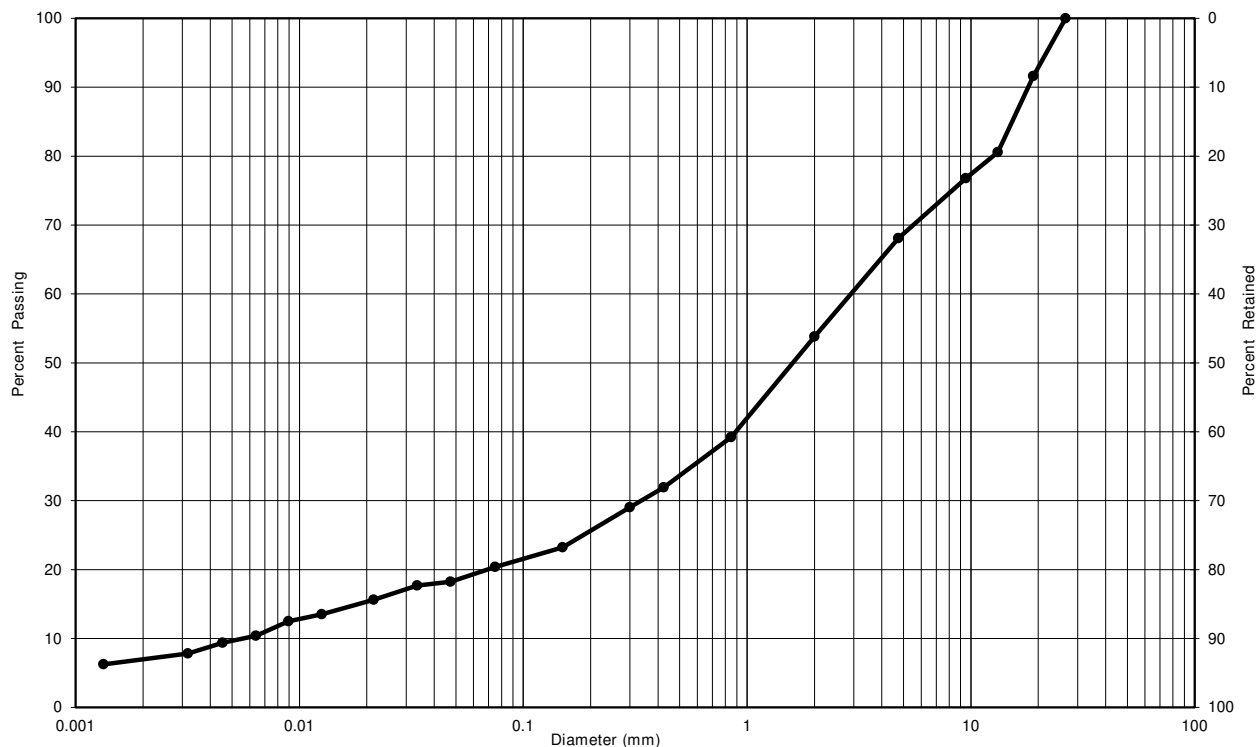
Borehole No.: MW2 Sample No.: SS3 + SS4  
Depth: 1.5m-2.1m / 2.3m - 2.9m Enclosure: \_\_\_\_\_

Soil Description	Gravel (%)	Sand (%)	Clay & Silt (%)
Silty Sand with Gravel, Trace Clay	32	48	20

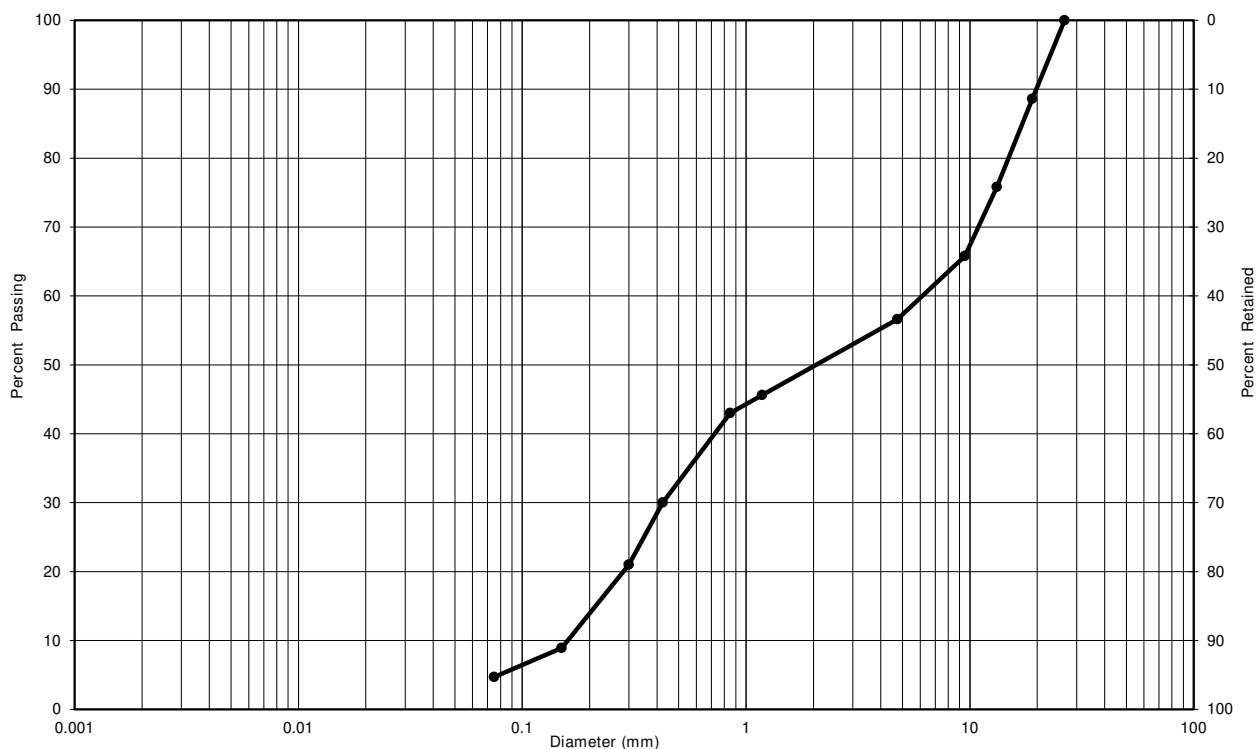
Borehole No.: MW3 Sample No.: SS2  
Depth: 0.8m - 1.4m Enclosure: \_\_\_\_\_

Soil Description	Gravel (%)	Sand (%)	Clay & Silt (%)
Sand with Gravel and Silt	43	52	5

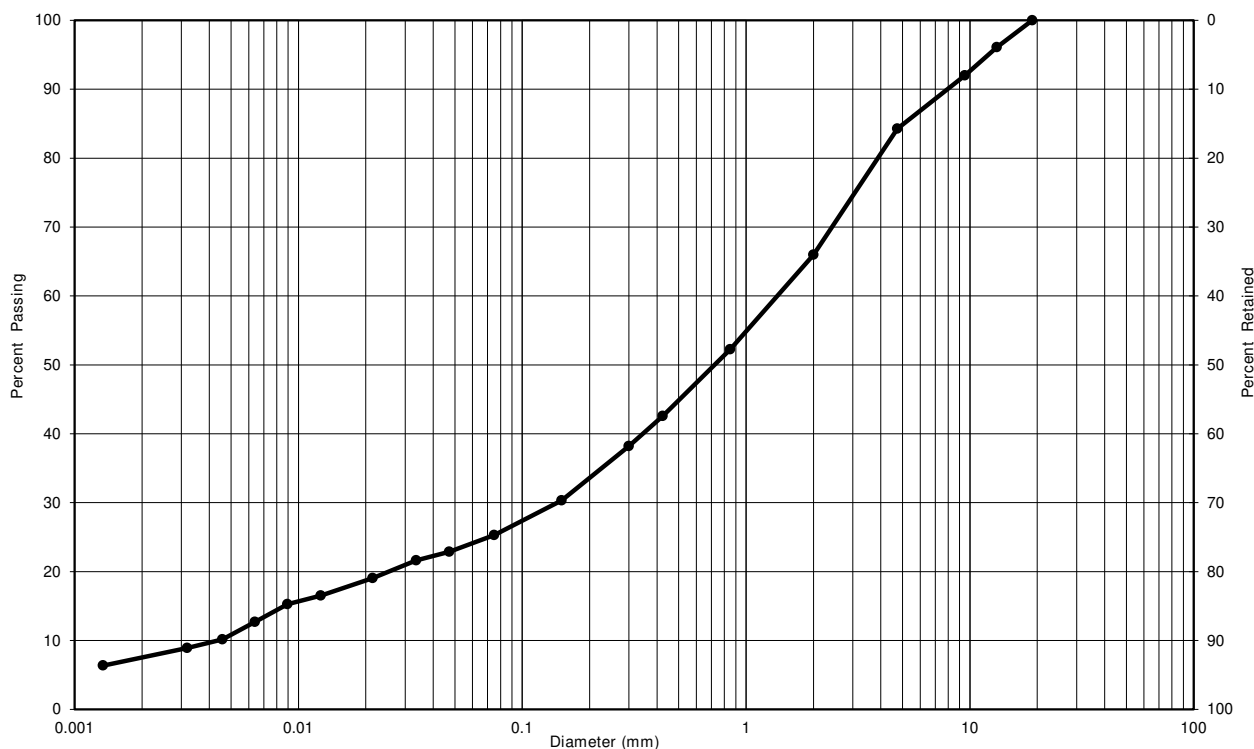
Borehole No.: MW3 Sample No.: SS4  
 Depth: 2.3m - 2.9m Enclosure:

Silty Clay	Sand			Gravel	
	Fine	Medium	Coarse	Fine	Coarse

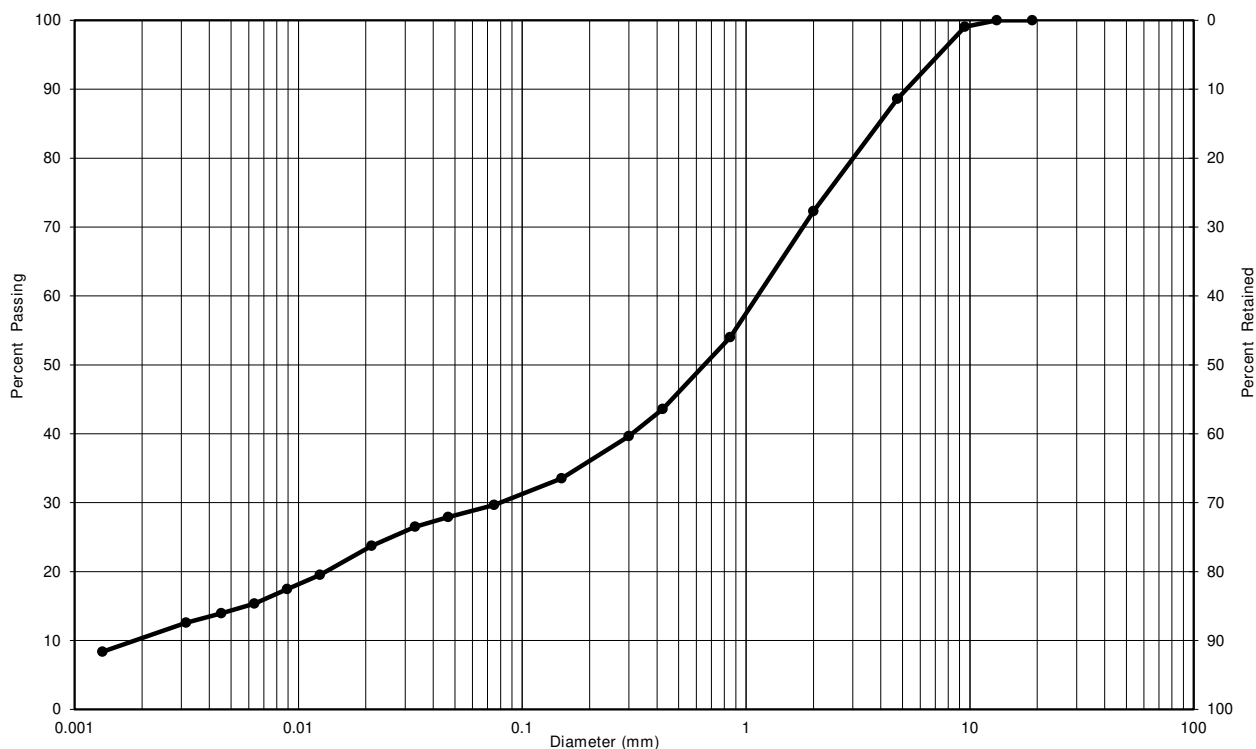
Borehole No.: MW4 Sample No.: SS2  
Depth: 0.8m-1.4m Enclosure: \_\_\_\_\_

Soil Description	Gravel (%)	Sand (%)	Clay & Silt (%)
Silty Sand, Some Gravel, Trace Clay	11	59	30

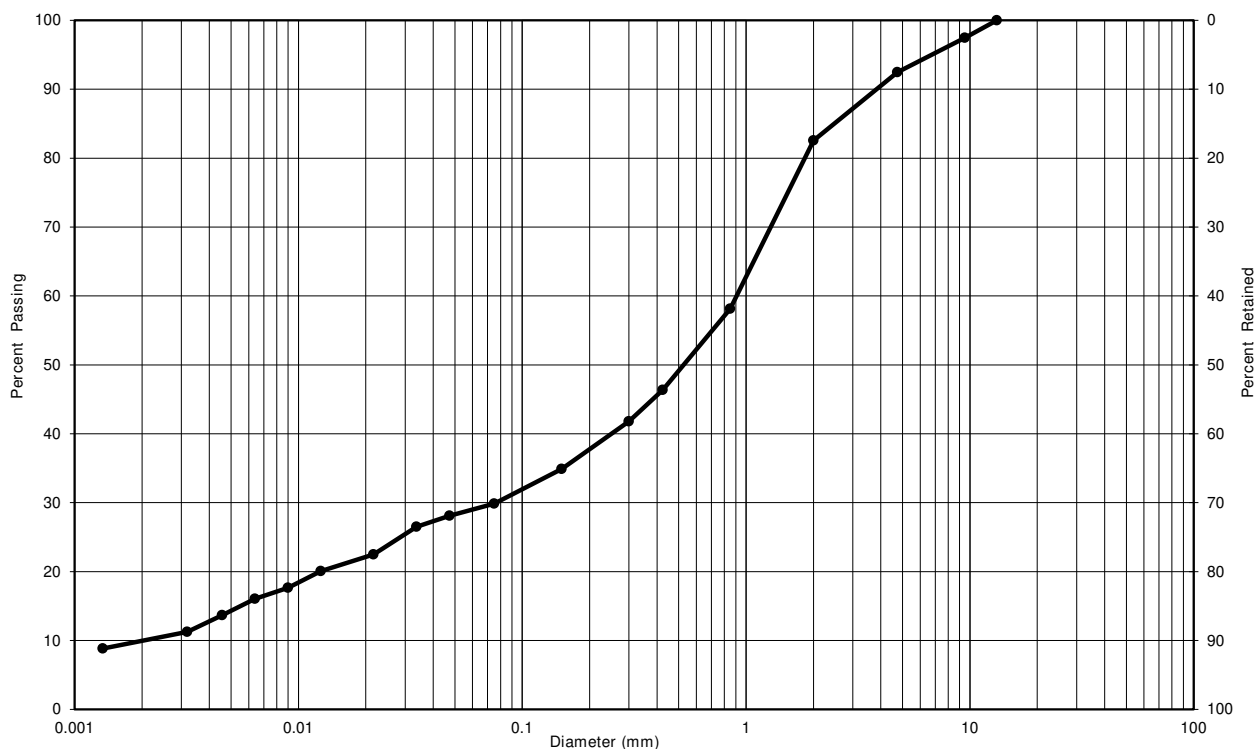
Borehole No.: MW5-19 Sample No.: SS2 + SS3  
Depth: 0.9m-1.2m / 1.5m-1.7m Enclosure:

Soil Description	Gravel (%)	Sand (%)	Clay & Silt (%)
Silty Sand, Trace Gravel, Trace Clay	8	62	30

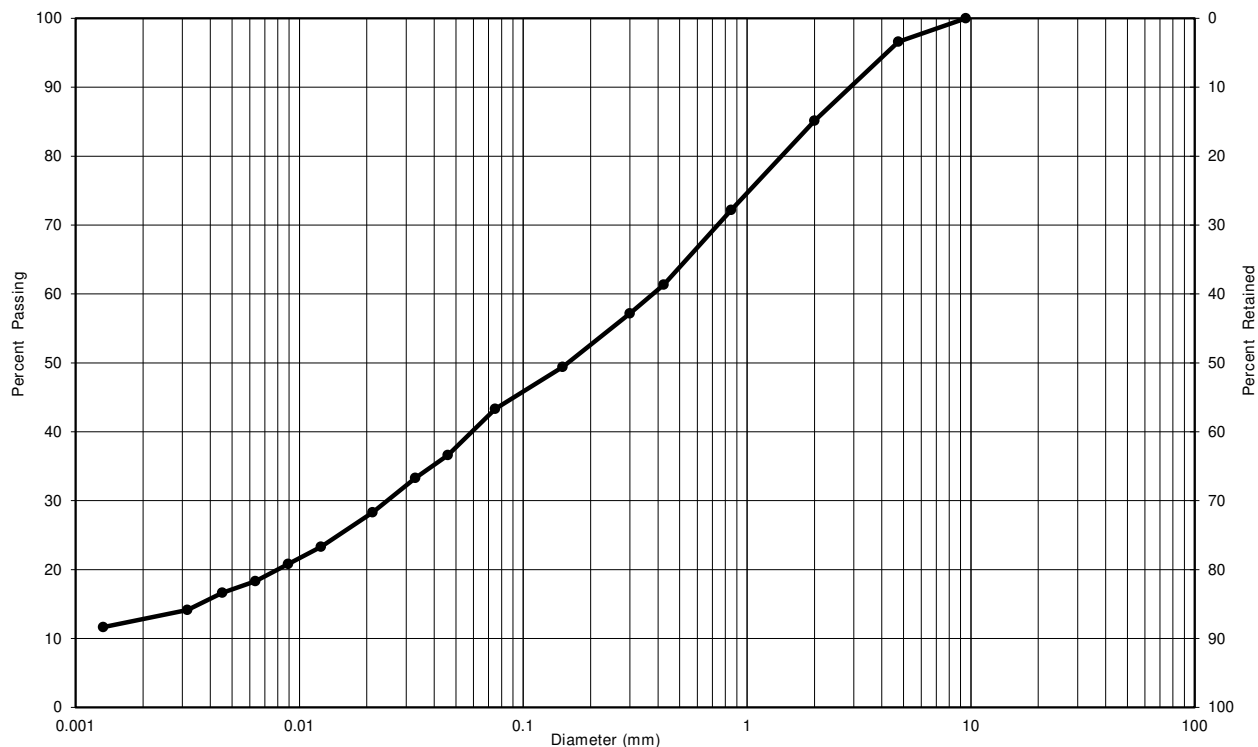
Borehole No.: MW7 Sample No.: SS2  
Depth: 0.8m - 1.4m Enclosure: \_\_\_\_\_

Soil Description	Gravel (%)	Sand (%)	Clay & Silt (%)
Silty Sand, Some Clay , Trace Gravel	3	54	43

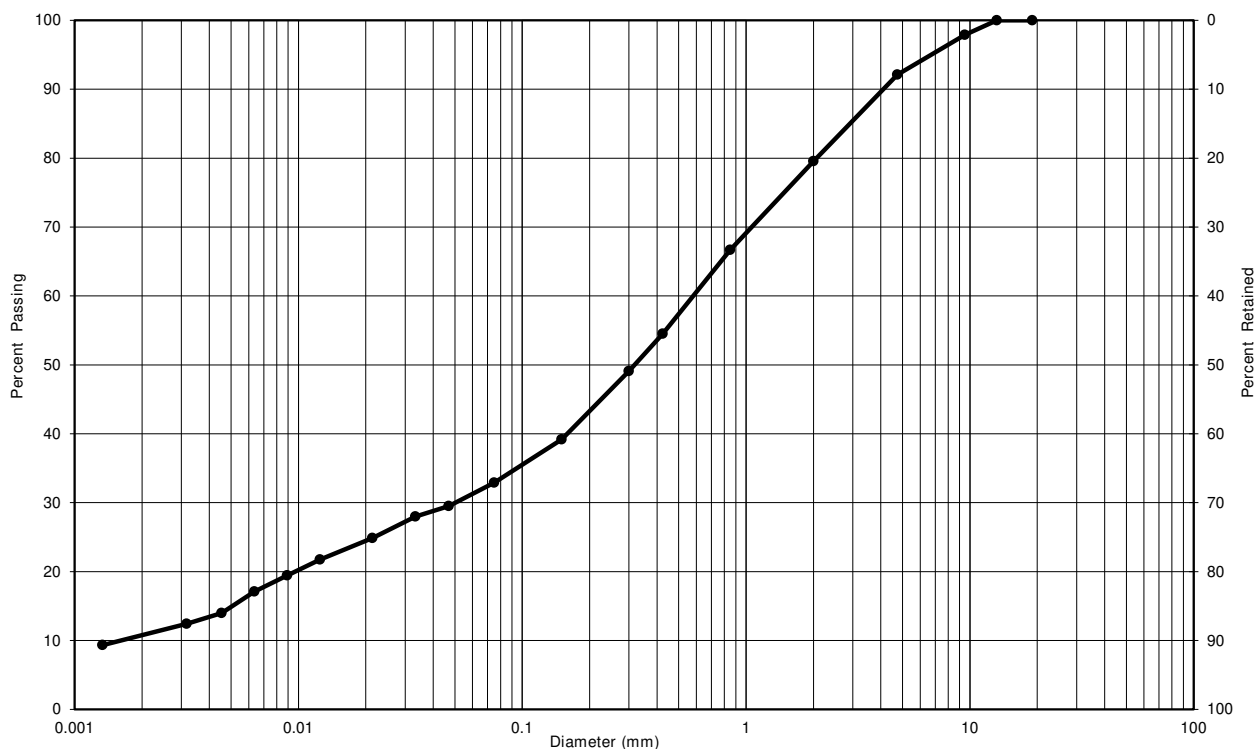
Borehole No.: BH8 Sample No.: SS2  
Depth: 0.8m - 1.4m Enclosure: \_\_\_\_\_

Soil Description	Gravel (%)	Sand (%)	Clay & Silt (%)
Silty Sand, Some Clay , Trace Gravel	8	59	33

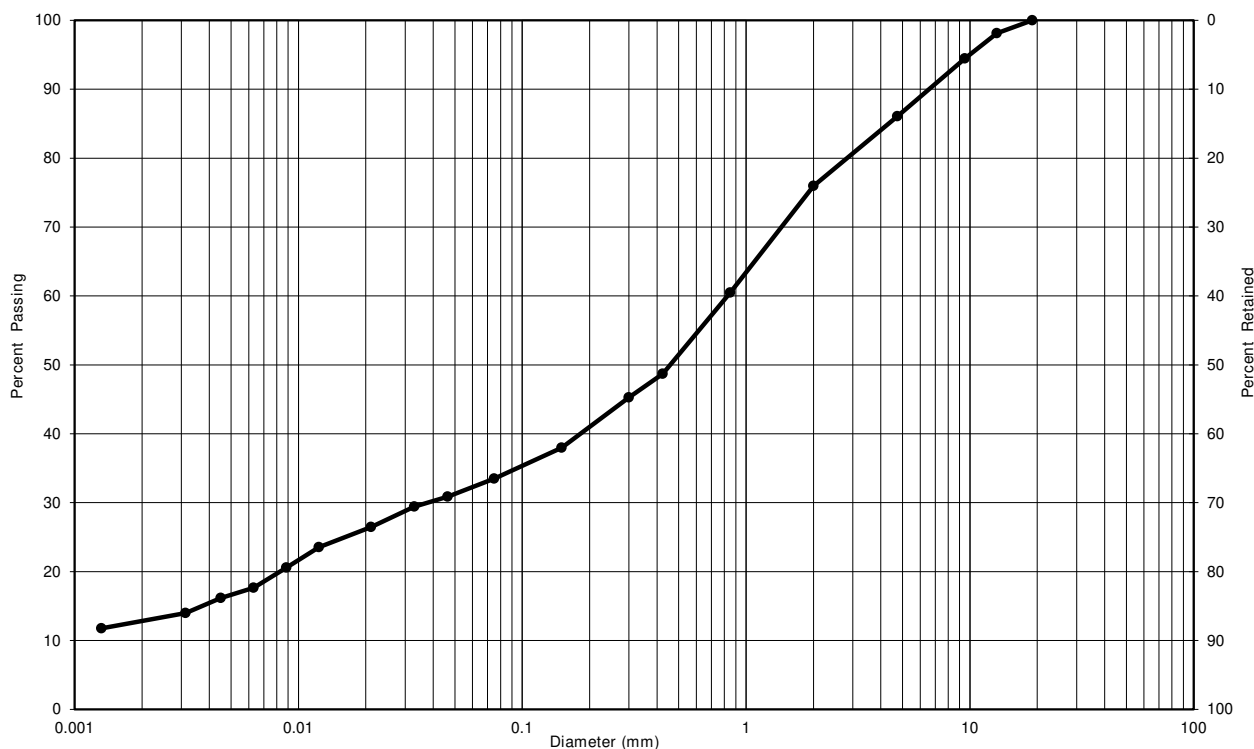
Borehole No.: MW9 Sample No.: SS2 + SS3  
 Depth: 0.8m-1.4m / 1.5m-2.0m Enclosure: \_\_\_\_\_

Soil Description	Gravel (%)	Sand (%)	Clay & Silt (%)
Silty Sand, Some Gravel, Some Clay	14	53	33

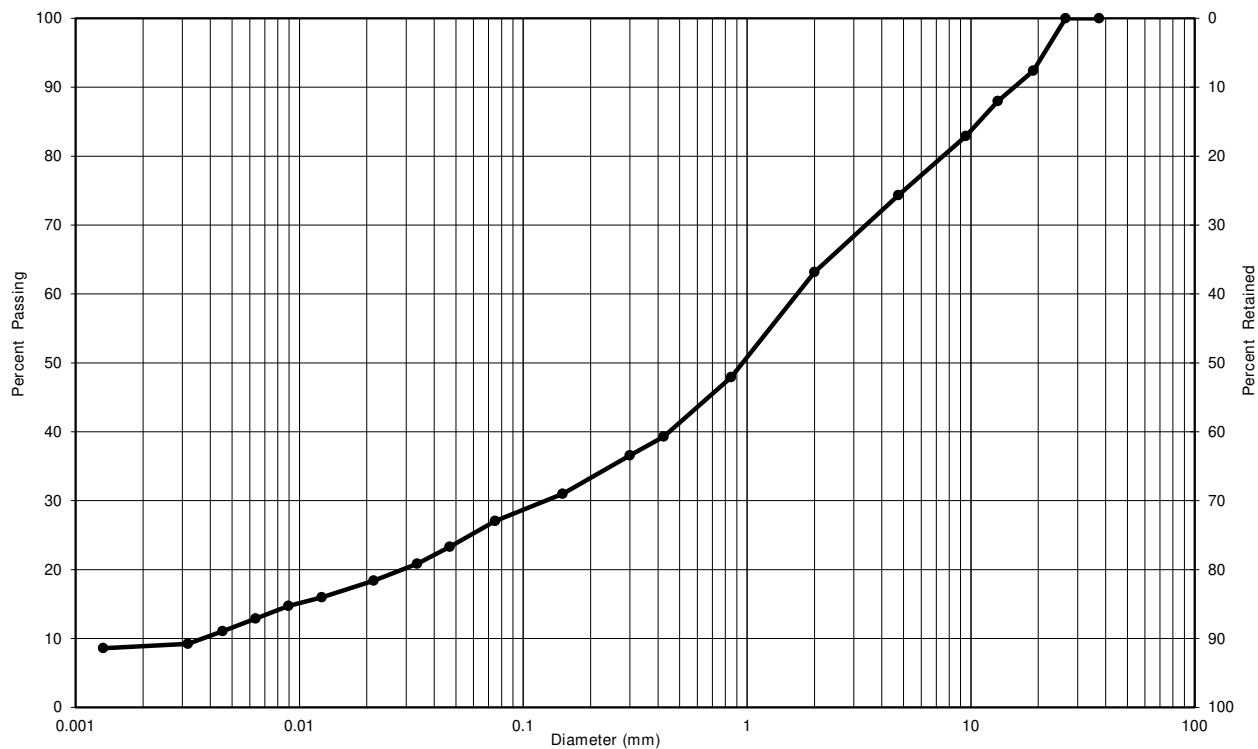
Borehole No.: MW10 Sample No.: SS2  
Depth: 0.8m-1.4m Enclosure: \_\_\_\_\_

Soil Description	Gravel (%)	Sand (%)	Clay & Silt (%)
Silty Sand with Gravel, Trace Clay	26	47	27

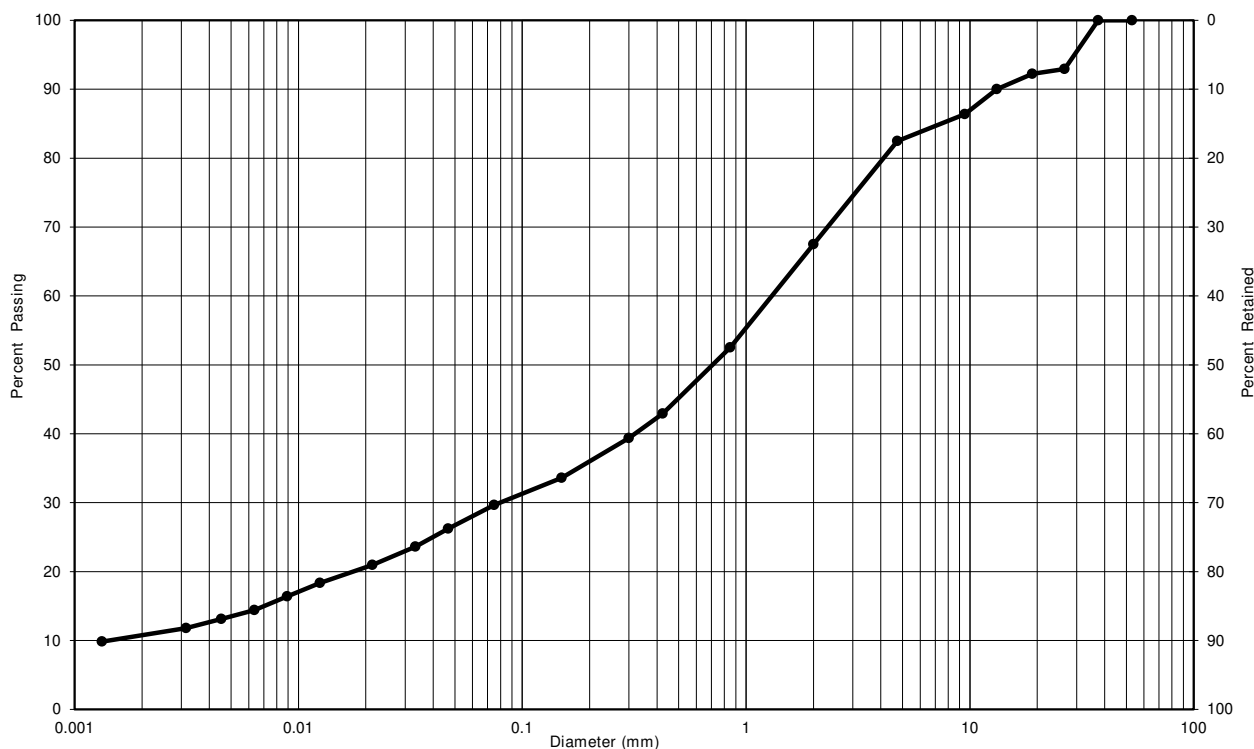
Borehole No.: BH12 Sample No.: SS2 + SS3  
 Depth: 0.8m-1.4m / 1.5m-2.1m Enclosure:

Soil Description	Gravel (%)	Sand (%)	Clay & Silt (%)
Silty Sand with Gravel, Some Clay	18	52	30

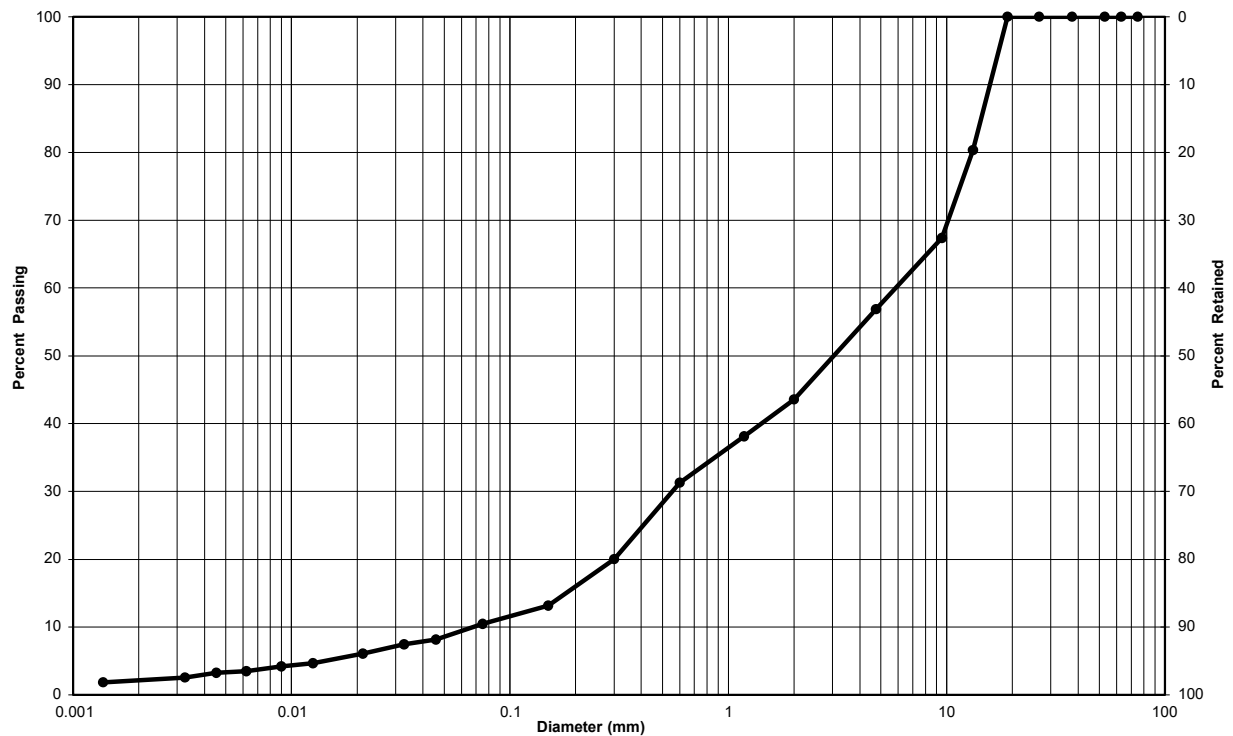
**Borehole No.:** BH-15 **Sample No.:** SS-1

Soil Description	Gravel (%)	Sand (%)	Clay & Silt (%)
Sand and Gravel, Traces of Silt and Clay	43	47	10
Silt-size particles (%) :	8		
Clay-size particles (%) (<0.002 mm):	2

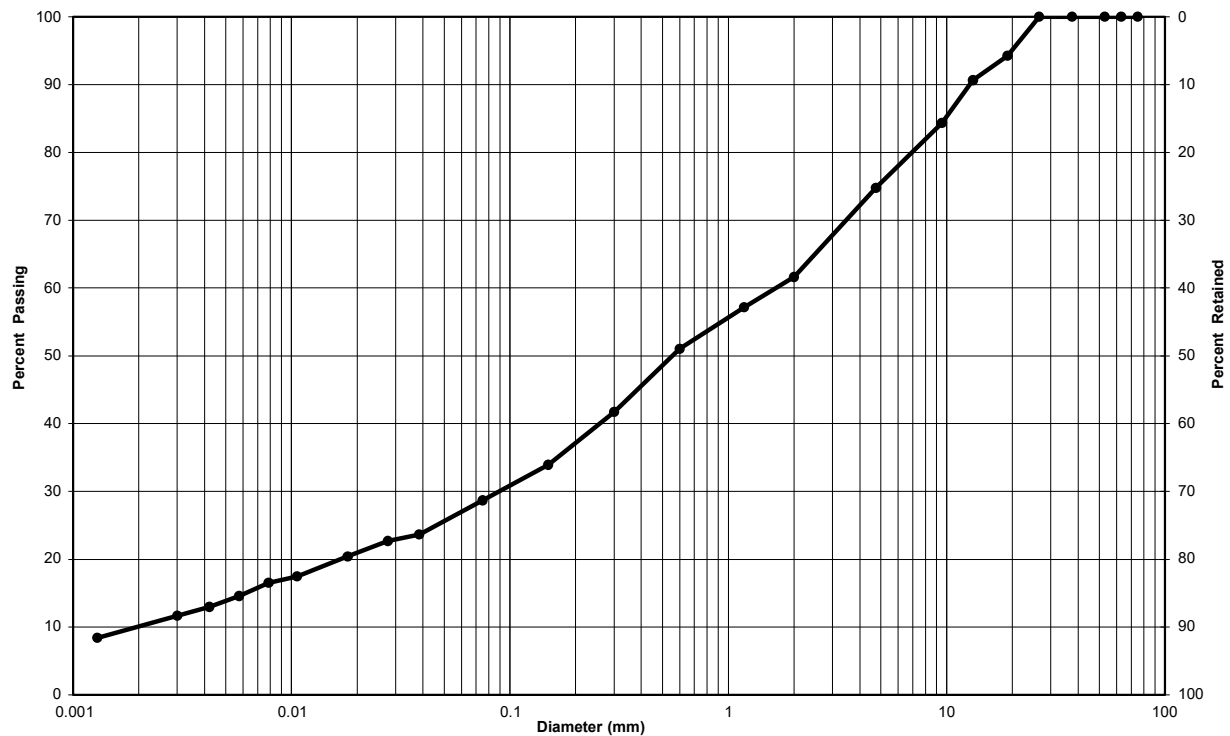
**Borehole No.:** BH-15 **Sample No.:** SS-2

Soil Description	Gravel (%)	Sand (%)	Clay & Silt (%)
Gravelly Sand, with Some Silt and Some Clay	25	46	29
Silt-size particles (%) :	19		
Clay-size particles (%) (<0.002 mm):	10

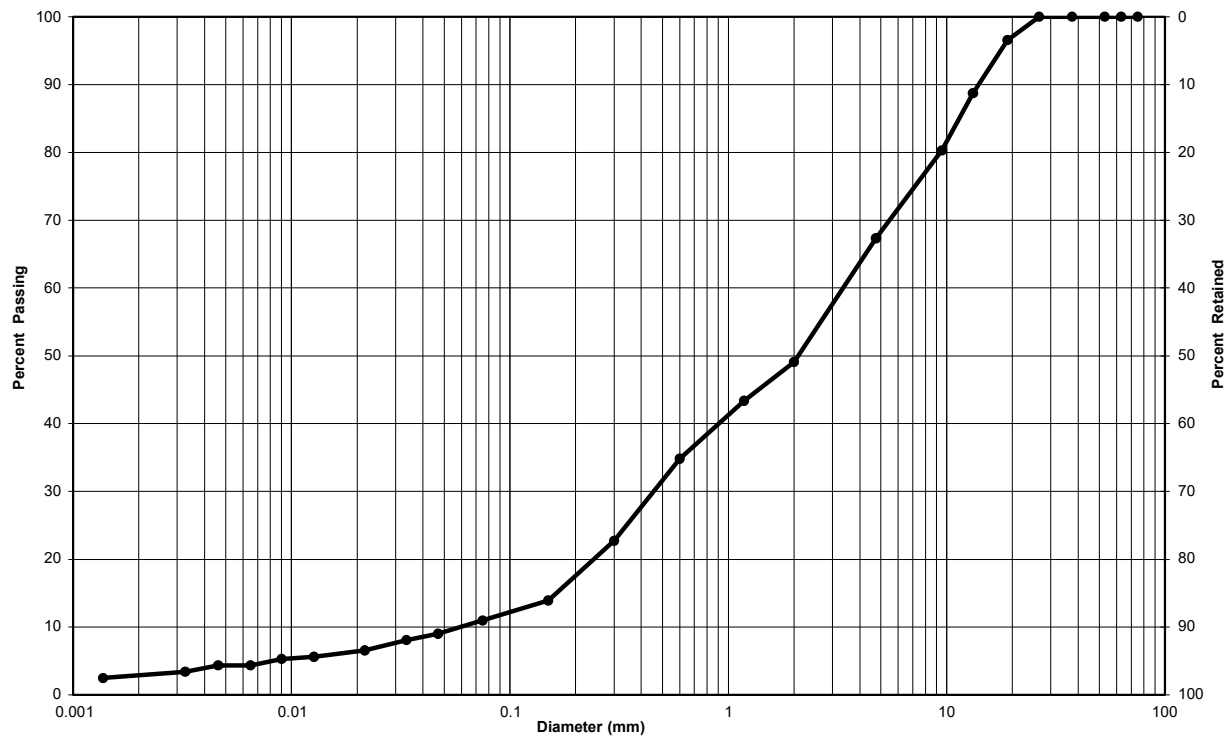
**Borehole No.:** BH-16 **Sample No.:** SS-1

Soil Description	Gravel (%)	Sand (%)	Clay & Silt (%)
Gravelly Sand, with Traces of Silt and Clay	33	56	11
Silt-size particles (%) :	8		
Clay-size particles (%) (<0.002 mm):	3

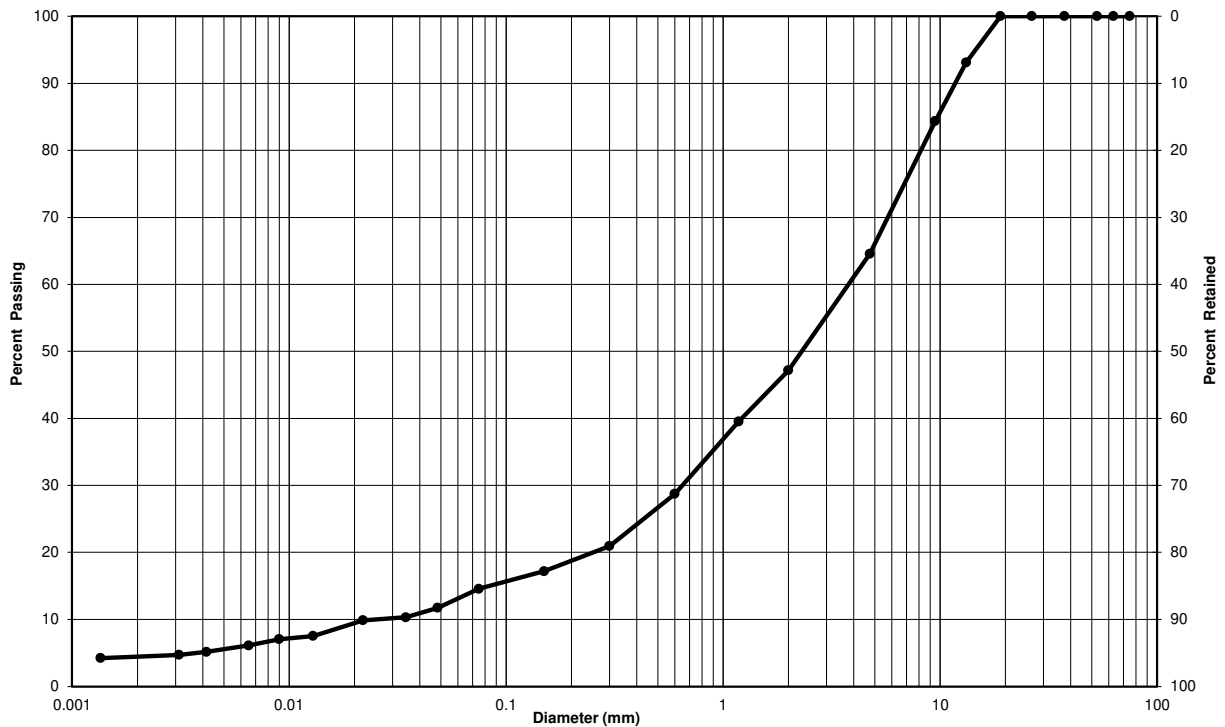
Client:	Infrastructure Ontario	Lab No.:	G-22-03
Project, Site:	Children Hospital	Project No.:	11205379
Borehole No.:	MW-18	Sample No.:	SS-3
Depth:	1,22 - 1,83 m	Enclosure:	-

Soil Description	Gravel (%)	Sand (%)	Clay & Silt (%)
Sand and Gravel, with Some Silt and Traces of Clay	35	50	15
Silt-size particles (%) :	11		
Clay-size particles (%) (<0.002 mm):	4

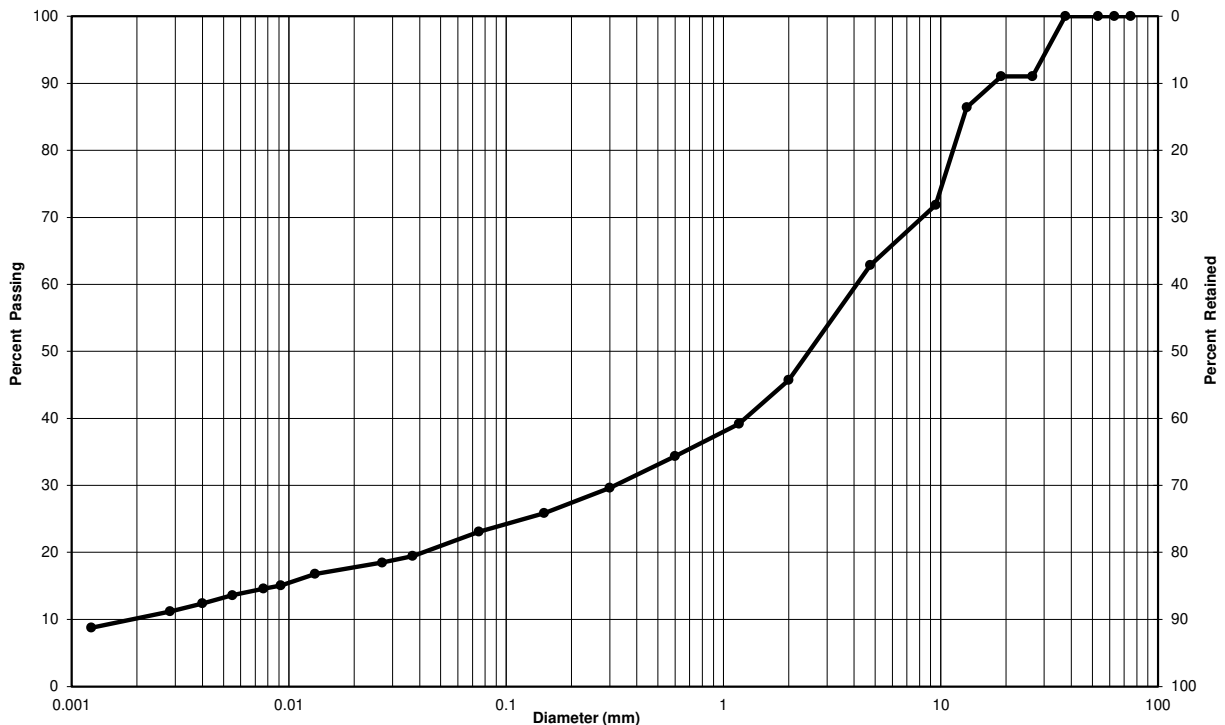
Borehole No.: BH19 Sample No.: SS-2  
Depth: 0,76 - 1,37 m Enclosure: -

Soil Description	Gravel (%)	Sand (%)	Clay & Silt (%)
Sand and Gravel, with Some Silt and Clay	37	40	23
Silt-size particles (%) :	13		
Clay-size particles (%) (<0.002 mm):	10

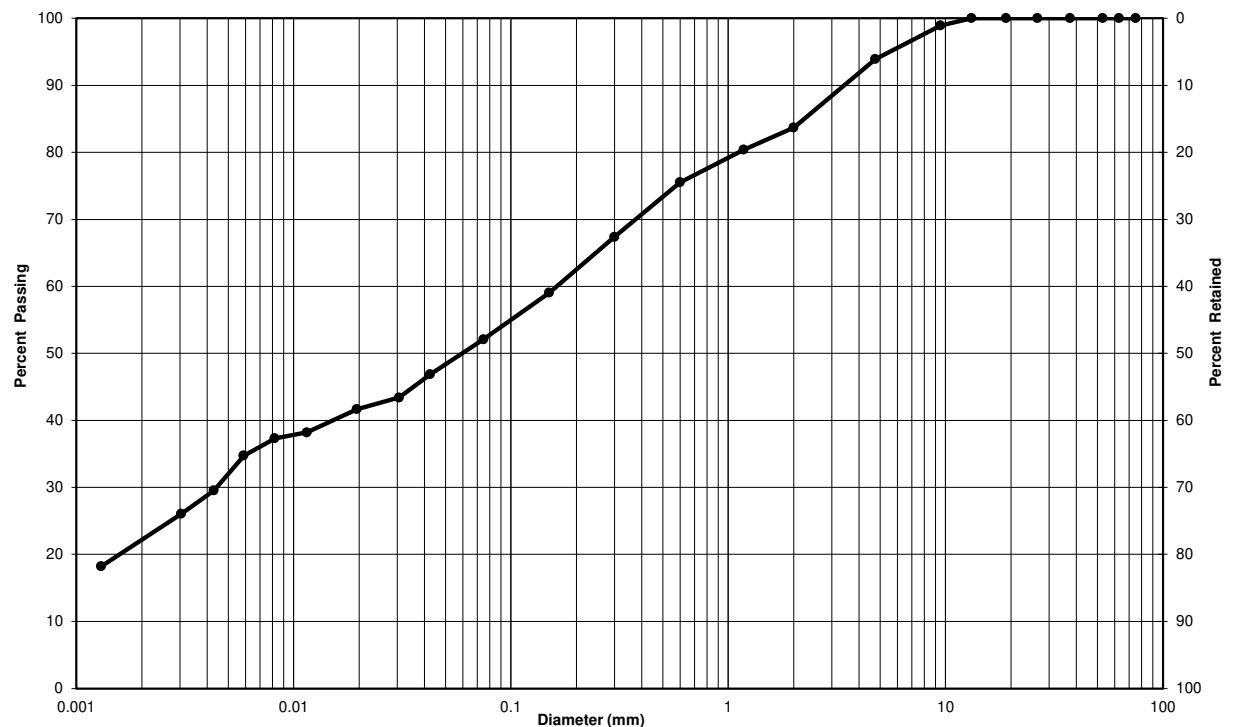
Borehole No.: BH-20 Sample No.: SS-3  
Depth: 1,22 - 1,83 m Enclosure: -

Soil Description	Gravel (%)	Sand (%)	Clay & Silt (%)
Silty and Clayey Sand, with Traces of Gravel	6	42	52
Silt-size particles (%) :	31		
Clay-size particles (%) (<0.002 mm):	21

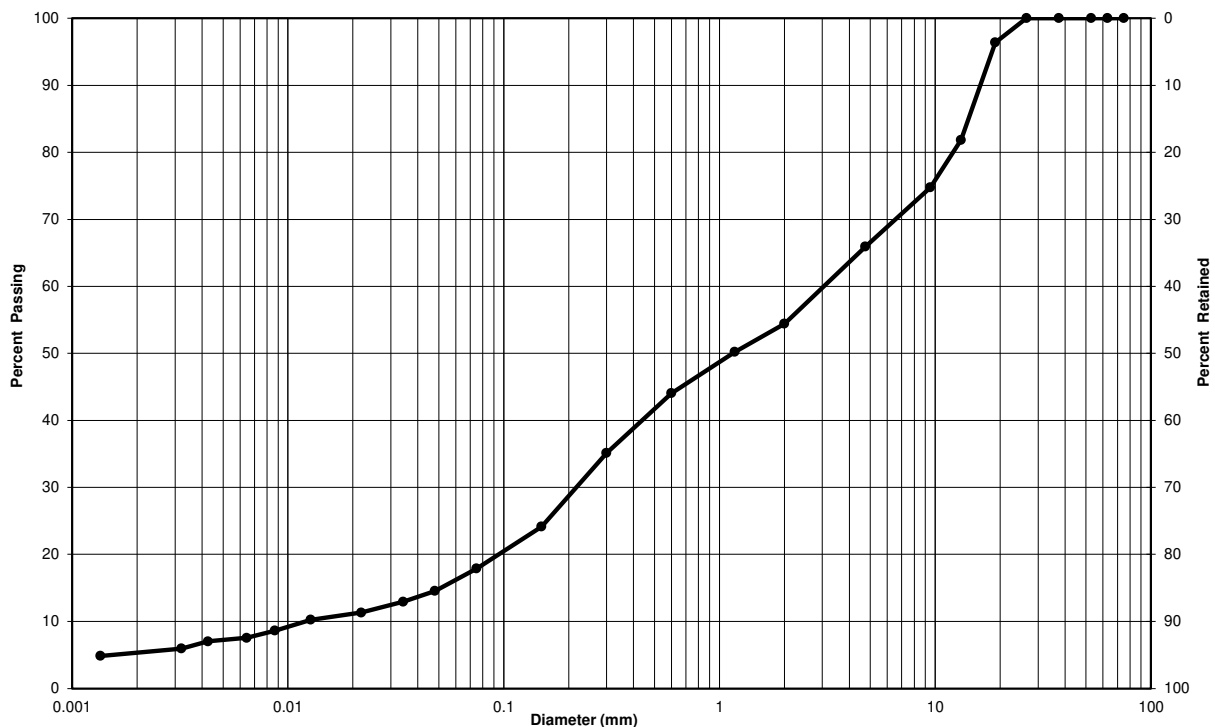
Client:	Infrastructure Ontario	Lab No.:	G-22-03
Project, Site:	Children Hospital	Project No.:	11205379
Borehole No.:	MW-23	Sample No.:	SS-3
Depth:	1,37 - 1,98 m	Enclosure:	-

Soil Description	Gravel (%)	Sand (%)	Clay & Silt (%)
Gravelly Sand, With some Silt and Traces of Clay	34	48	18
Silt-size particles (%) :	13		
Clay-size particles (%) (<0.002 mm):	5

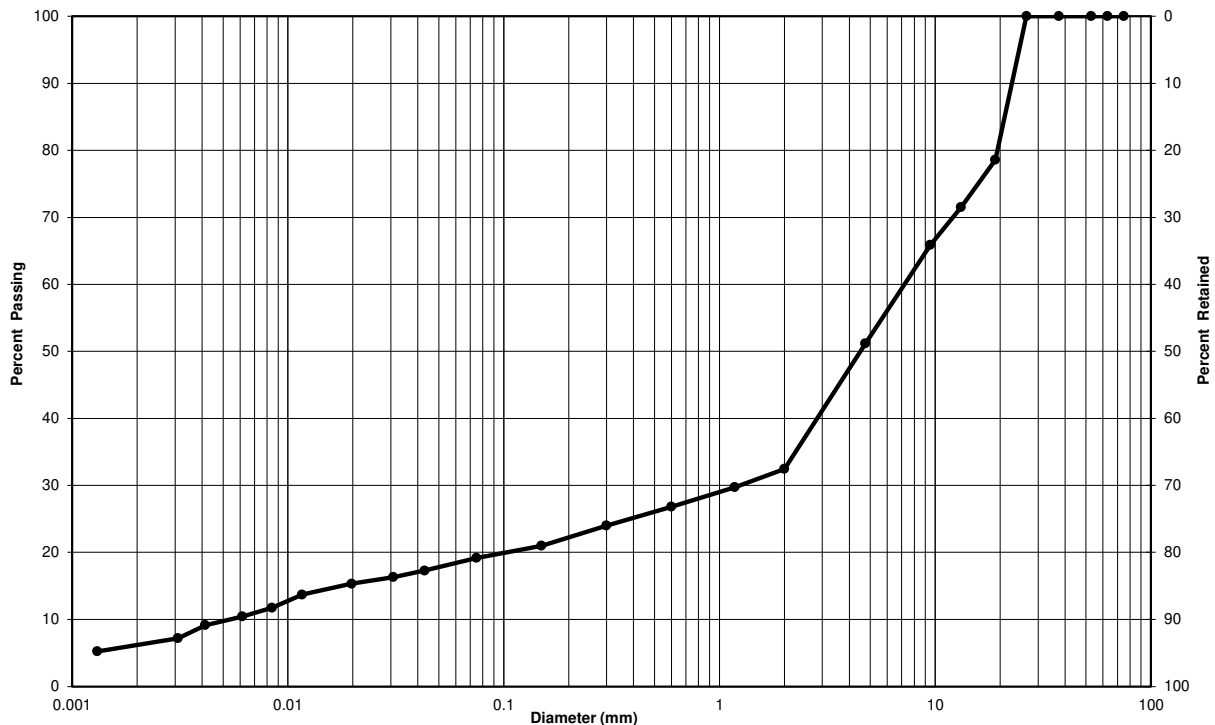
Client:	Infrastructure Ontario	Lab No.:	G-22-03
Project, Site:	Children Hospital	Project No.:	11205379
Borehole No.:	MW23	Sample No.:	SS-6
Depth:	3,20 - 3,81 m	Enclosure:	-

Soil Description	Gravel (%)	Sand (%)	Clay & Silt (%)
Sandy Gravel, with Some Silt and Traces of Clay	49	32	19
Silt-size particles (%) :	13		
Clay-size particles (%) (<0.002 mm):	6
