# 1Door4Care: CHEO Integrated Treatment Centre - Geotechnical Investigation Report (1Door4Care)

Children's Hospital of Eastern Ontario  
Campus, 401 and 407 Smyth Road,  
Ottawa, Ontario

Infrastructure Ontario Project # 182-OCTC

25 October 2022

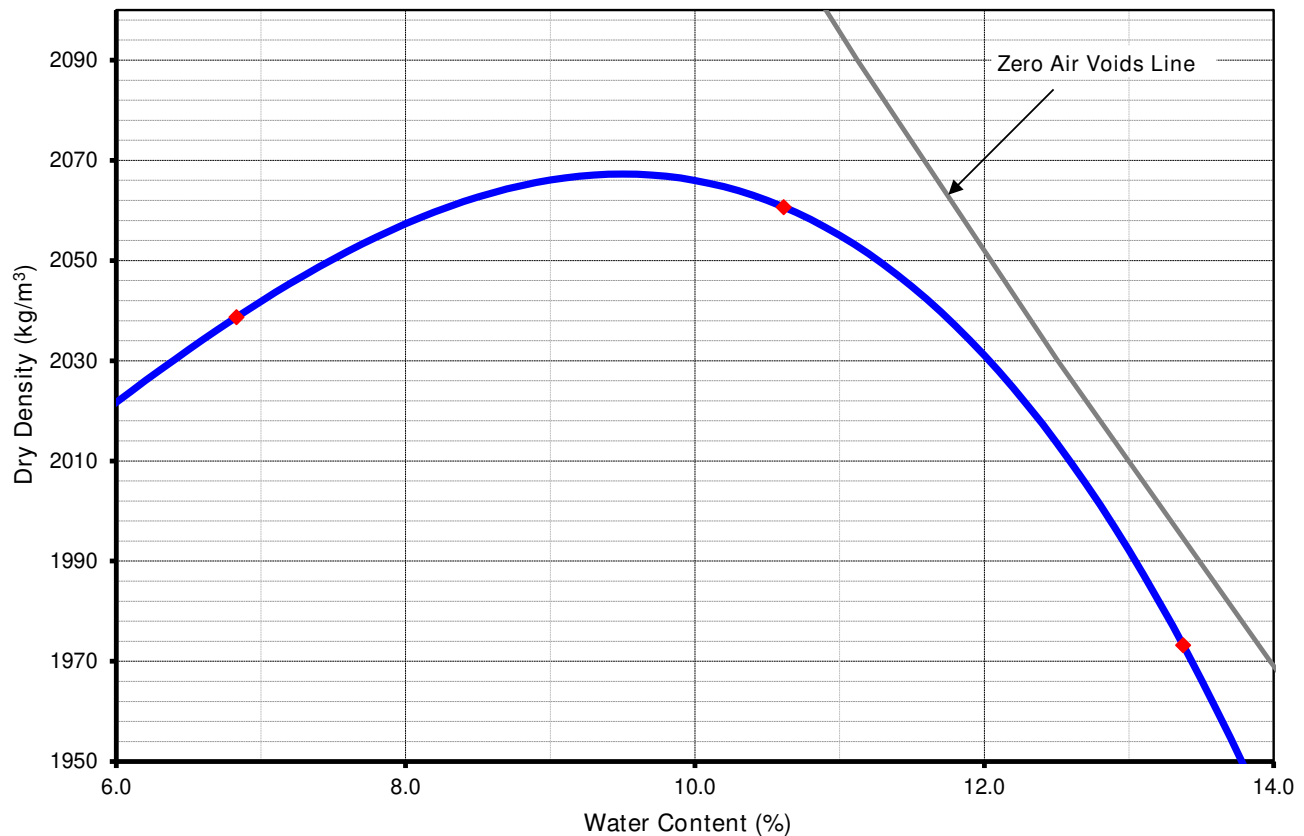
Prepared Sample: Dry ☒ Moist ☐ Assumed  $G_s$ : 2.80  
ASTM D698 Test Method: A ☒ B ☐ C ☐ Type of Hammer: Manual

Soil Type: Fill  
Material: Augured Material  
Proposed Use: N/A  
Sample Identification: MW1  
Sample Location: N/A  
Aggregate Supplier / Pit Name: N/A  
Sample Date: December 9, 2019  
Sampled By: S.H.

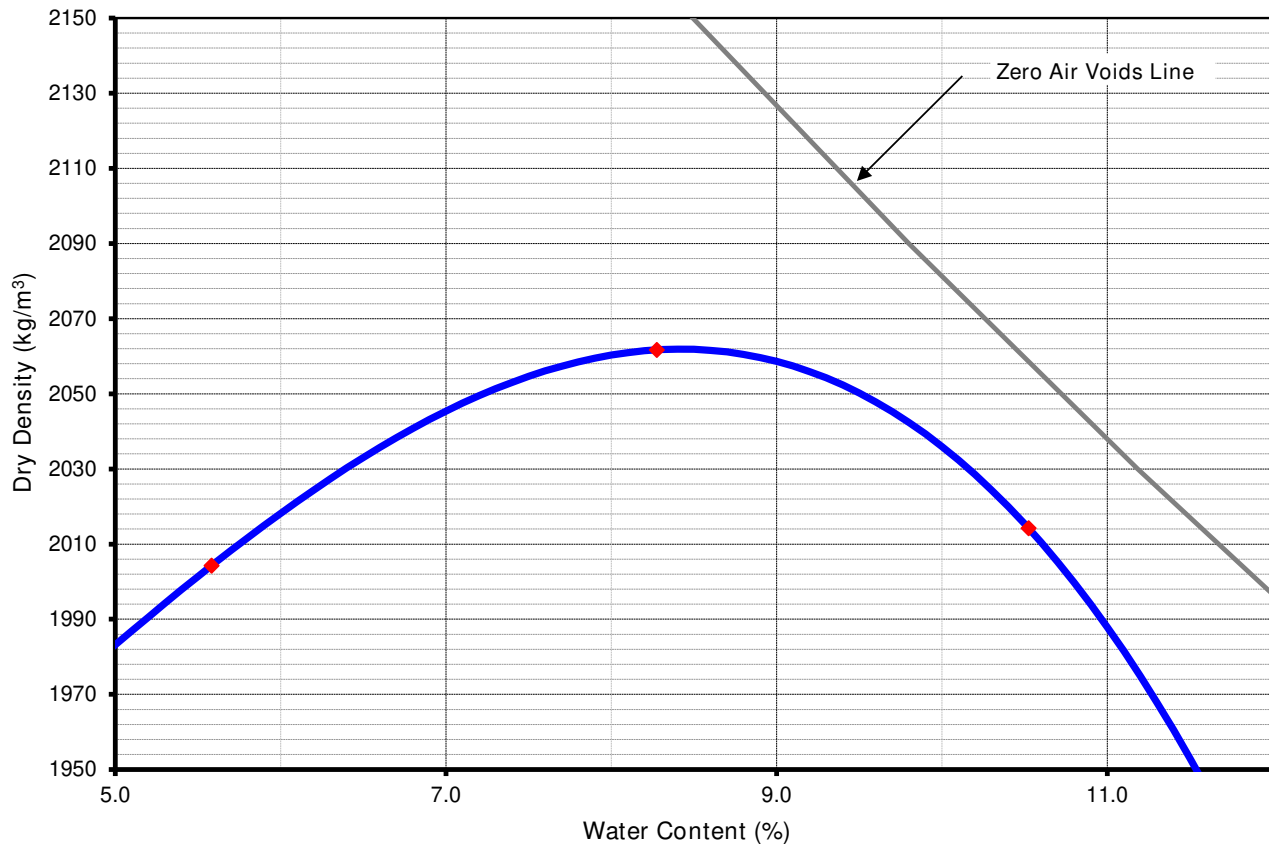
Prepared Sample: Dry ☒ Moist ☐ Assumed  $G_s$ : 2.70  
ASTM D698 Test Method: A ☒ B ☐ C ☐ Type of Hammer: Manual

Soil Type: Sandy Silt, Trace Gravel  
Material: Augured Material  
Proposed Use: N/A  
Sample Identification: MW3-19  
Sample Location: N/A  
Aggregate Supplier / Pit Name: N/A  
Sample Date: December 9, 2019  
Sampled By: S.H.

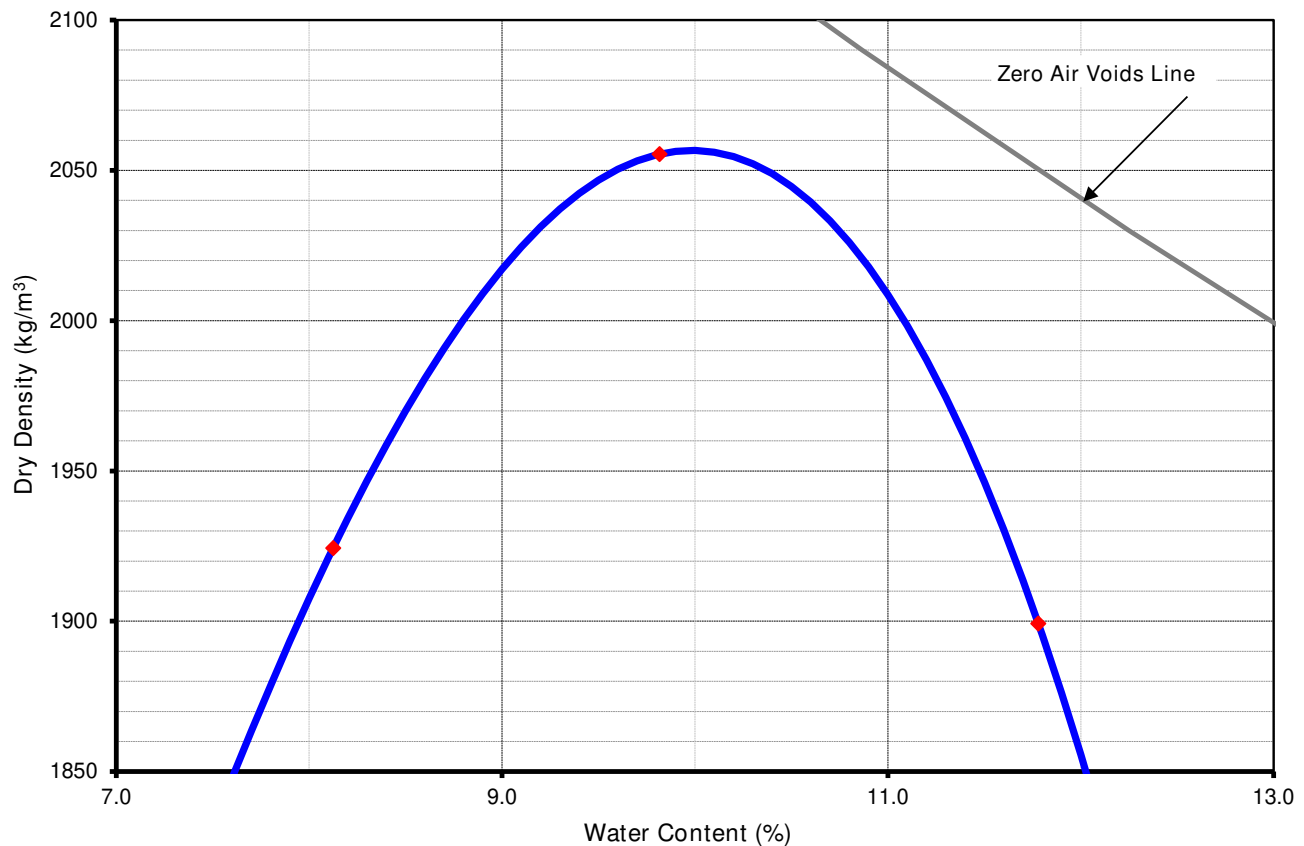
Prepared Sample: Dry ☒ Moist ☐ Assumed  $G_s$ : 2.80  
ASTM D698 Test Method: A ☒ B ☐ C ☐ Type of Hammer: Manual

Soil Type: Fill  
Material: Augured Sample  
Proposed Use: N/A  
Sample Identification: MW5  
Sample Location: N/A  
Aggregate Supplier / Pit Name: N/A  
Sample Date: December 9, 2019  
Sampled By: S.H

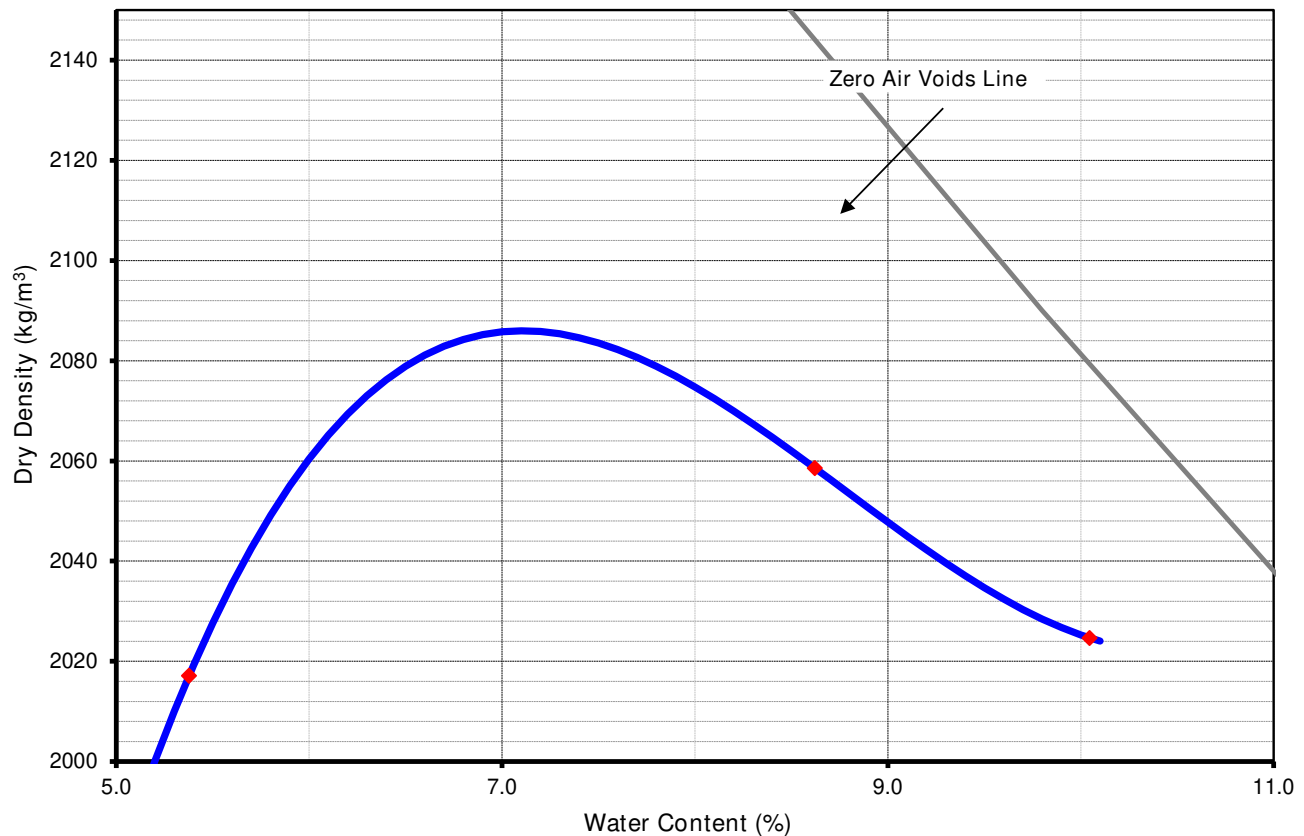
Prepared Sample: Dry ☒ Moist ☐ Assumed  $G_s$ : 2.80  
ASTM D698 Test Method: A ☒ B ☐ C ☐ Type of Hammer: Manual

Soil Type: Fill  
Material: Augured Material  
Proposed Use: N/A  
Sample Identification: BH6  
Sample Location:   
Aggregate Supplier / Pit Name: N/A  
Sample Date: December 9, 2019  
Sampled By: S.H

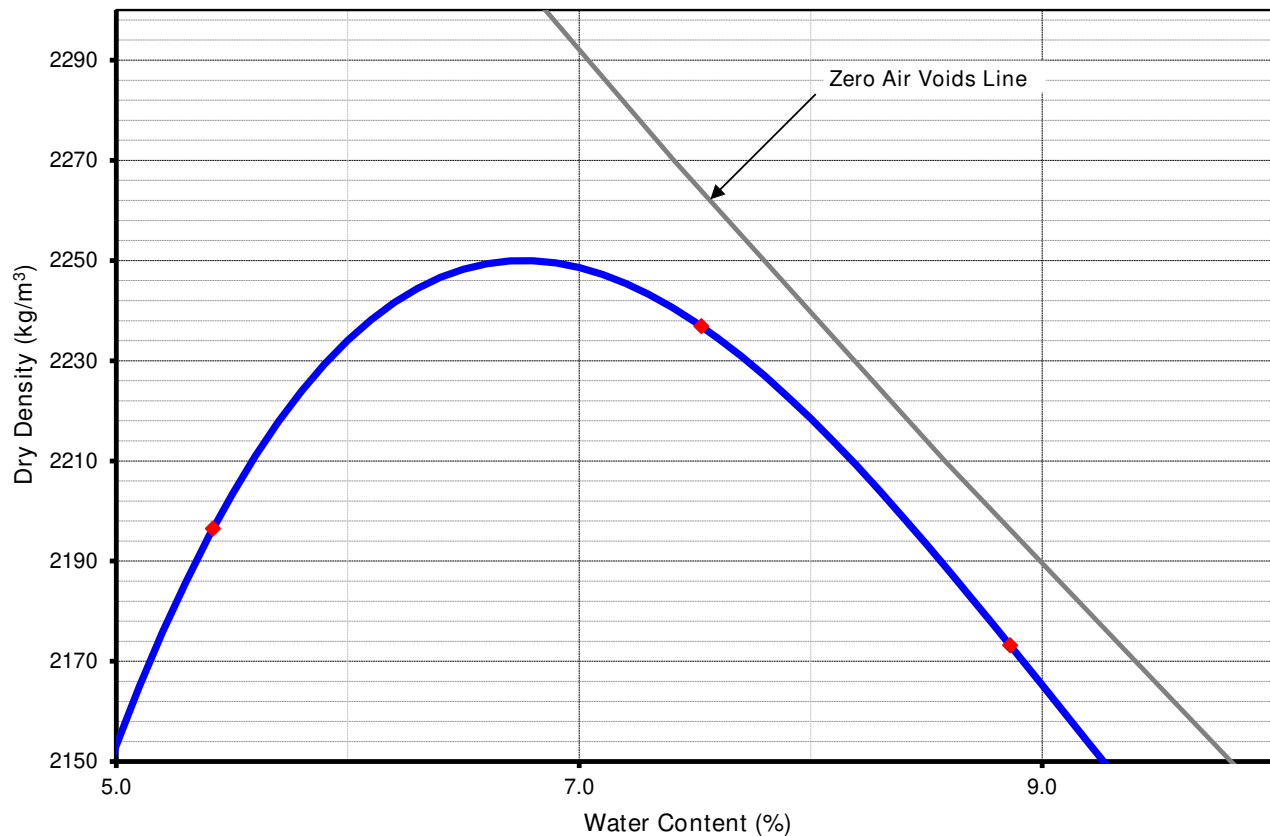
Prepared Sample: Dry ☒ Moist ☐ Assumed  $G_s$ : 2.80  
ASTM D698 Test Method: A ☒ B ☐ C ☐ Type of Hammer: Manual

Soil Type: Fill  
Material: Augured Material  
Proposed Use: N/A  
Sample Identification: BH12  
Sample Location:   
Aggregate Supplier / Pit Name: N/A  
Sample Date: December 9, 2019  
Sampled By: S.H

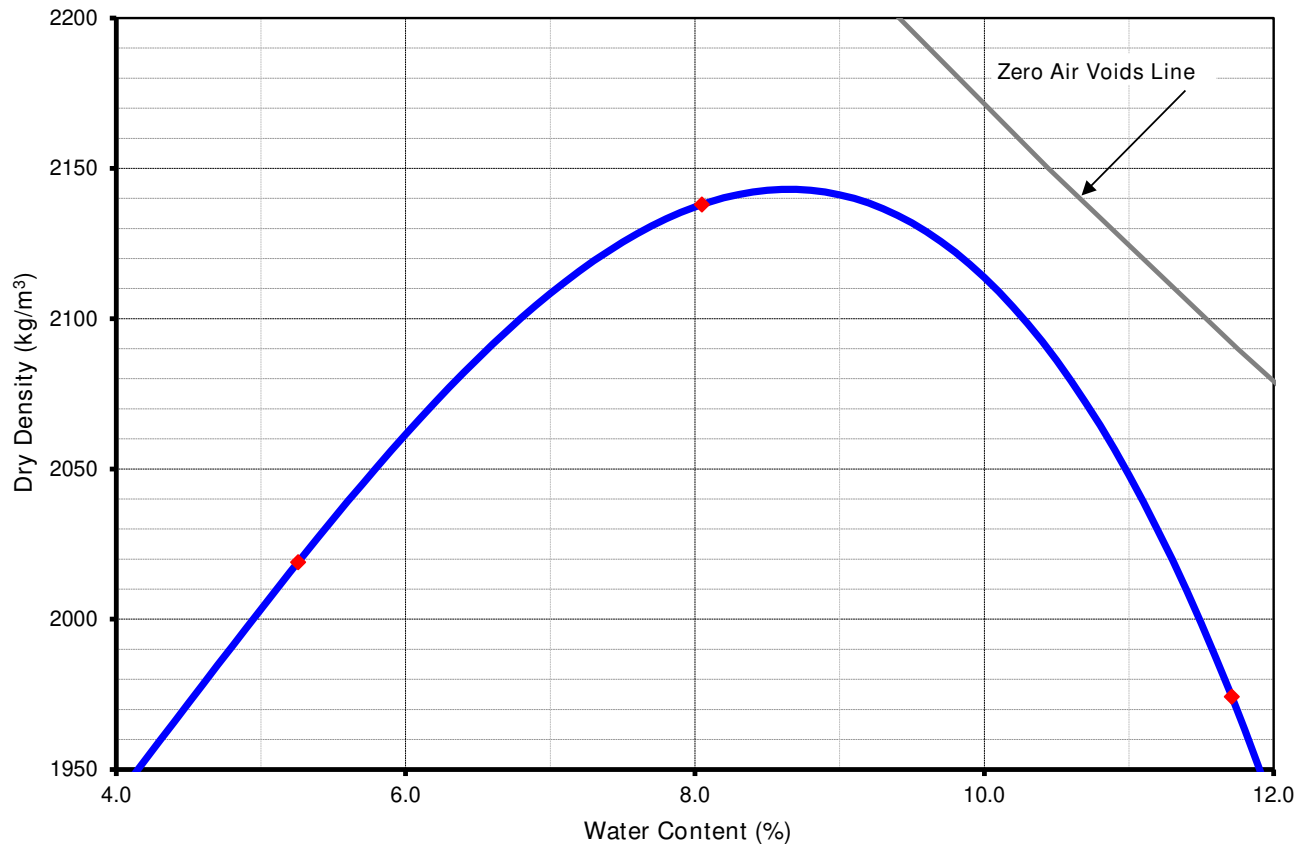
Prepared Sample: Dry ☒ Moist ☐ Assumed  $G_s$ : 2.80  
ASTM D698 Test Method: A ☒ B ☐ C ☐ Type of Hammer: Manual

Soil Type: Fill  
Material: Augured Material  
Proposed Use: N/A  
Sample Identification: BH13  
Sample Location:   
Aggregate Supplier / Pit Name: N/A  
Sample Date: December 12, 2019  
Sampled By: Simon

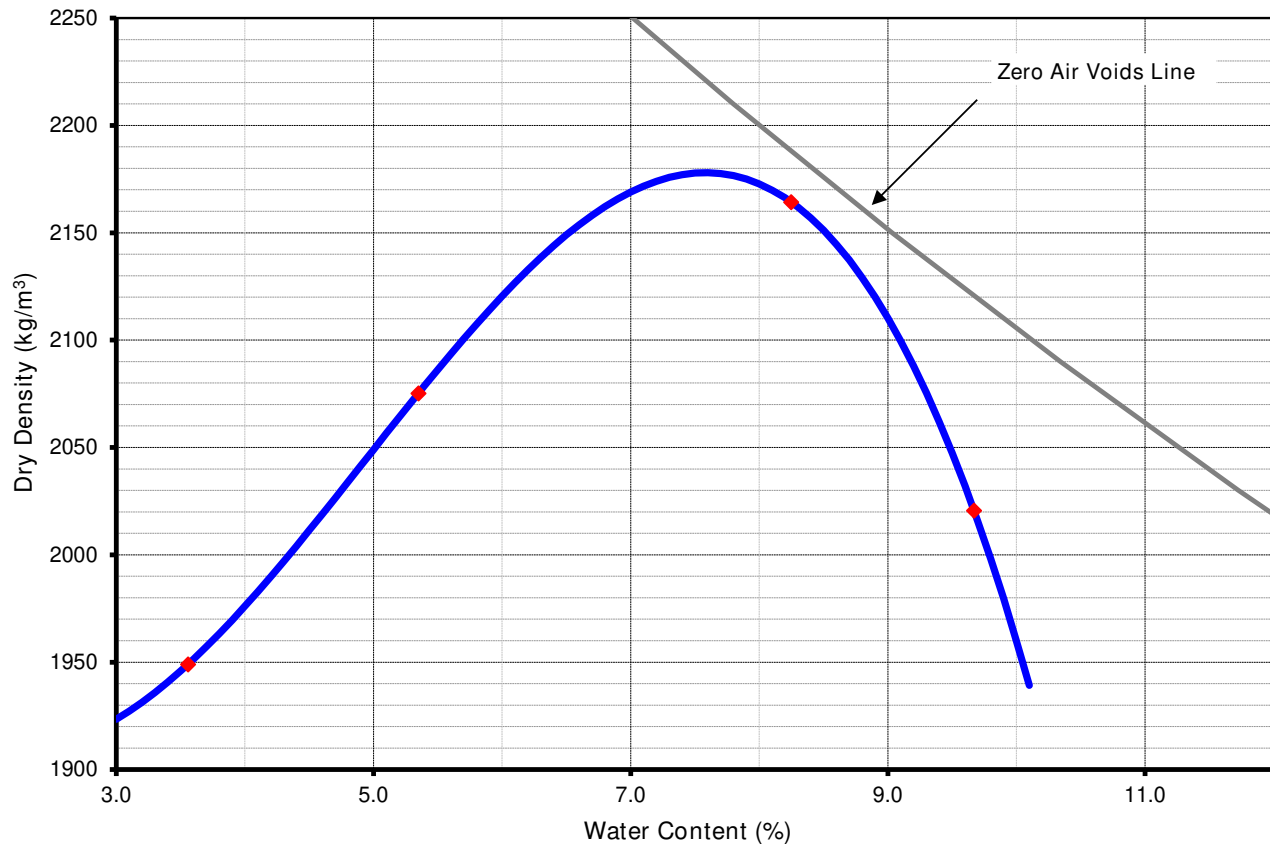
Project/Site : Preliminary Geotechnical Investigation – Children's  
Hospital of Eastern Ontario Campus

Prepared Sample: Dry ☒ Moist ☐ Assumed  $G_s$ : 2.80

ASTM D698 Test Method: A ☒ B ☐ C ☐ Type of Hammer: Manual

Ten (10) laboratory Standard Proctor compaction tests were conducted on bulk samples of the auger cuttings extracted from the surficial fill at the Site to determine the maximum dry density and optimum moisture content of the fill. The purpose of the testing was to assess the compactability during construction. The results are summarized below and are also provided in Appendix B.

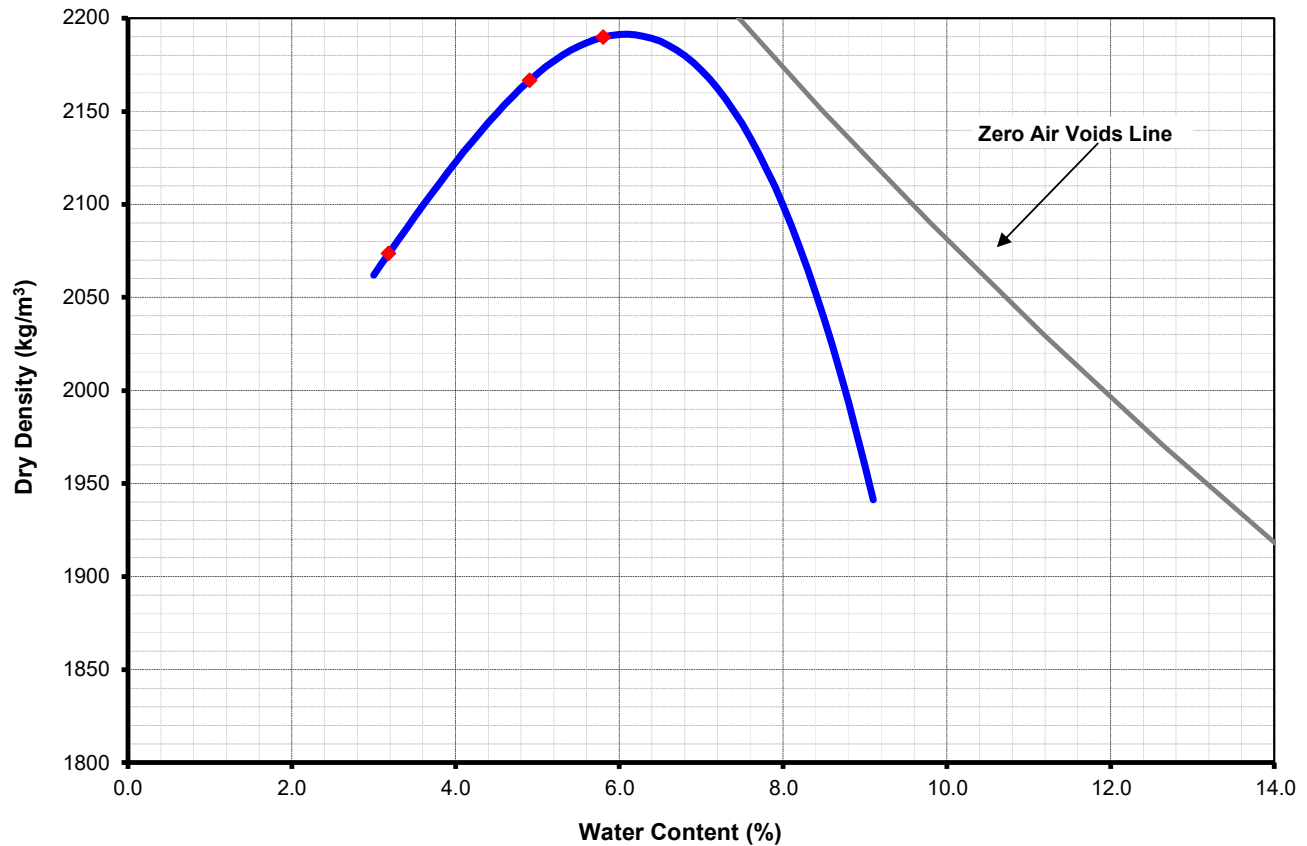
Project/Site : Children Hospital

Prepared Sample: Dry ☐ 0 Moist ☒ x Assumed  $G_s$ : 2.70

ASTM D698 Test Method: A ☐ 0 B ☐ 0 C ☒ x Type of Hammer: Manual  
4.75 mm 9.50 mm 19.0 mm

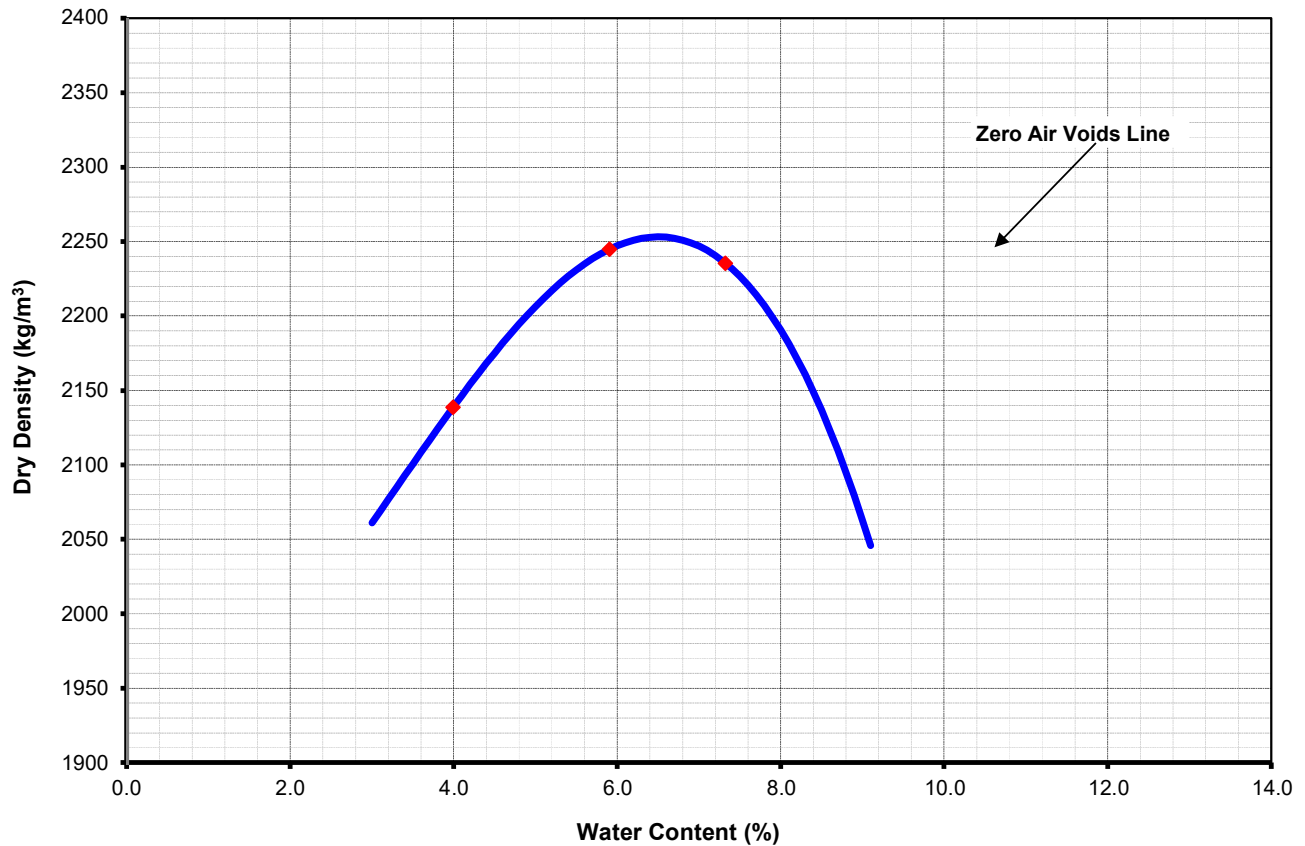
Project/Site : Children Hospital

Prepared Sample: Dry ☐ 0 Moist ☒ x Assumed  $G_s$ : 2.70

ASTM D698 Test Method: A ☐ 0 B ☐ 0 C ☒ x Type of Hammer: Mechanical  
4.75 mm 9.50 mm 19.0 mm

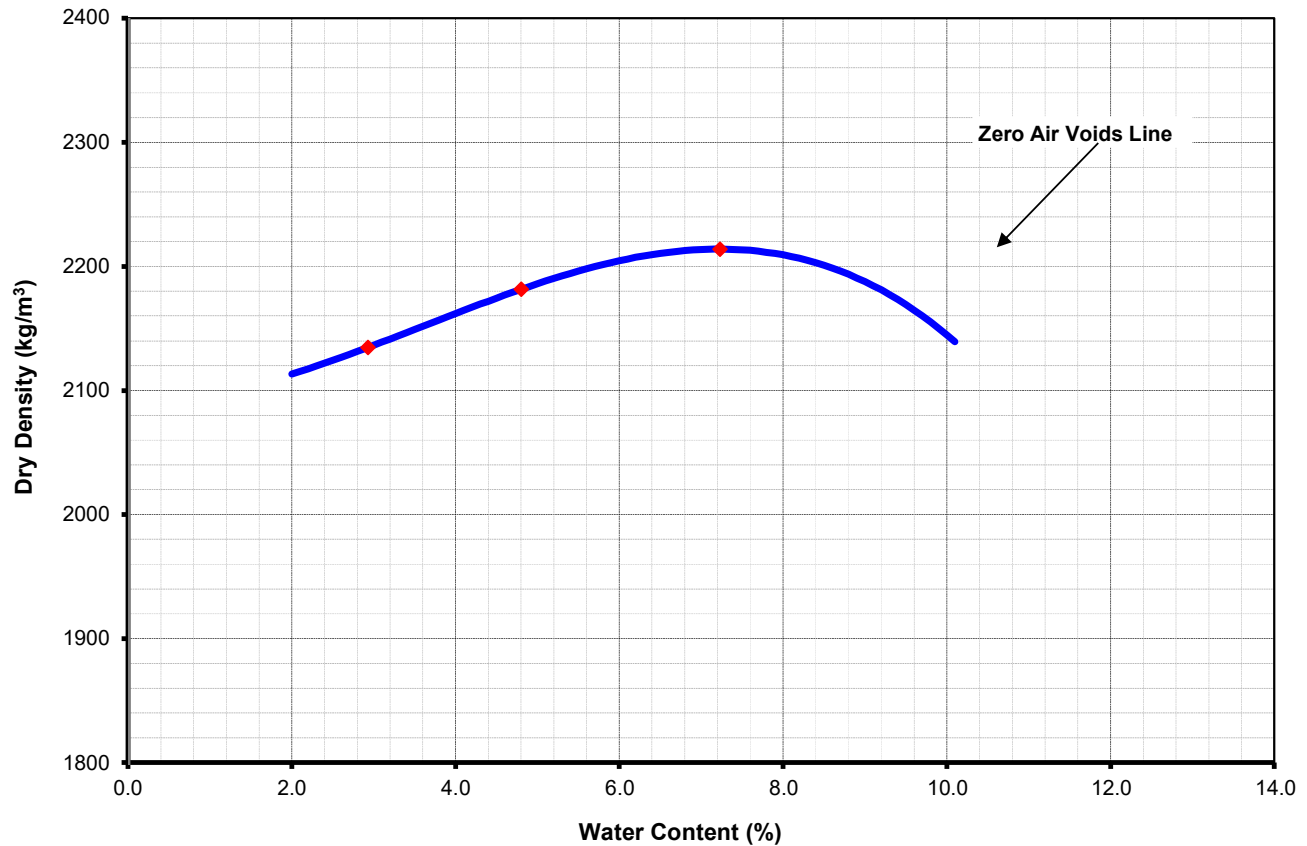
Project/Site : Children Hospital

Prepared Sample: Dry ☐ 0 Moist ☒ x Assumed  $G_s$ : 2.70

ASTM D698 Test Method: A ☐ 0 B ☐ 0 C ☒ x Type of Hammer: Mechanical  
4.75 mm 9.50 mm 19.0 mm

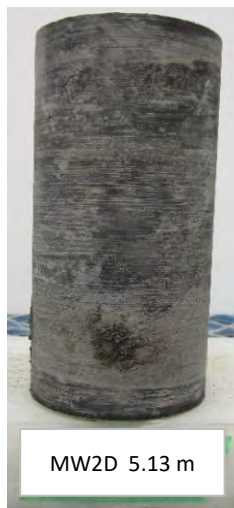
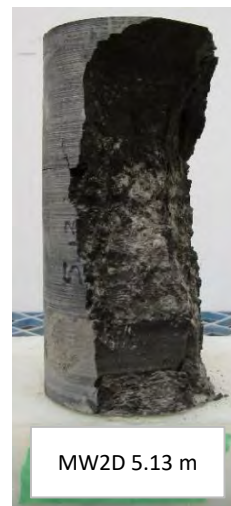
Maximum Applied Load, kN	110.3
Compressive Strength, MPa	35.9

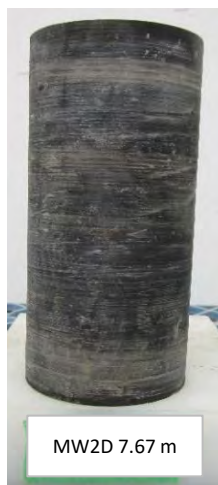
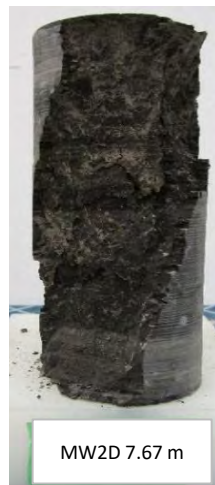
Maximum Applied Load, kN	96.2
Compressive Strength, MPa	31.4

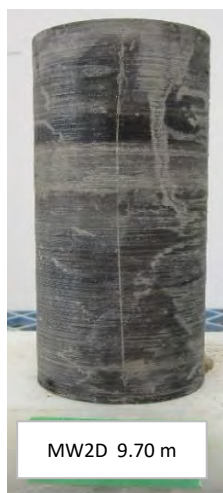
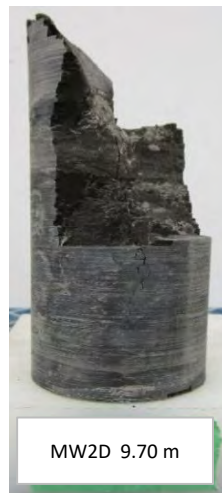
Maximum Applied Load, kN	75.0
Compressive Strength, MPa	24.4

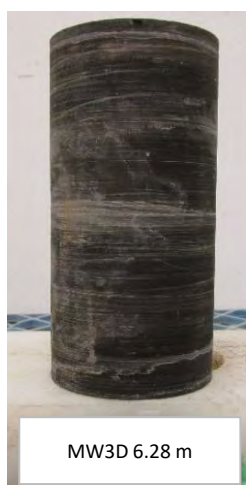
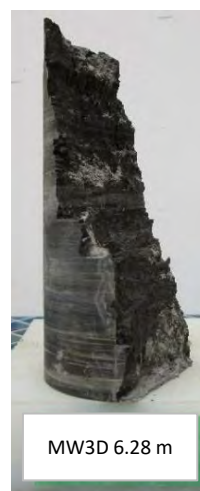
Maximum Applied Load, kN	87.2
Compressive Strength, MPa	28.4

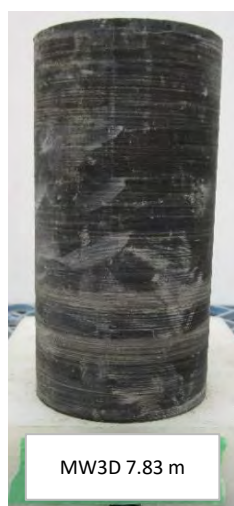
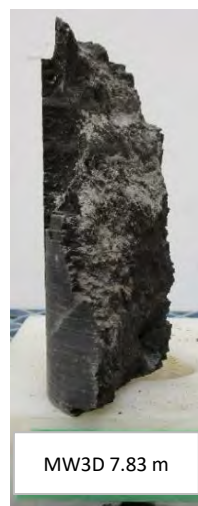
Maximum Applied Load, kN	103.2
Compressive Strength, MPa	33.5

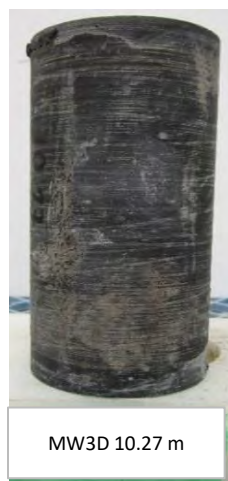
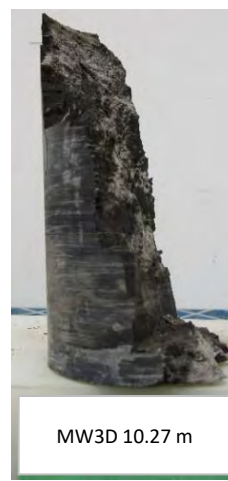
Maximum Applied Load, kN	109.0
Compressive Strength, MPa	35.4

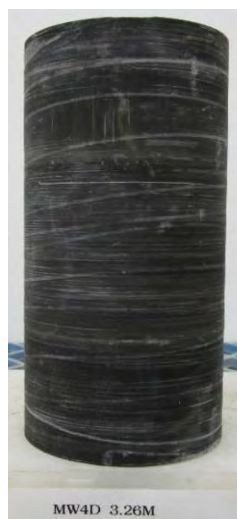
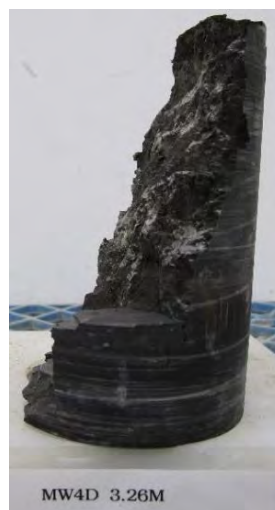
Maximum Applied Load, kN	128.0
Compressive Strength, MPa	41.8

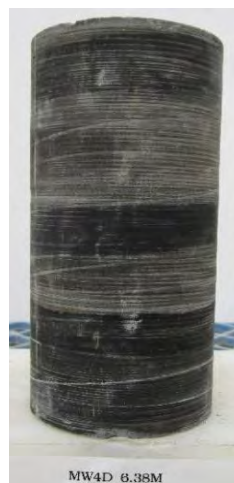
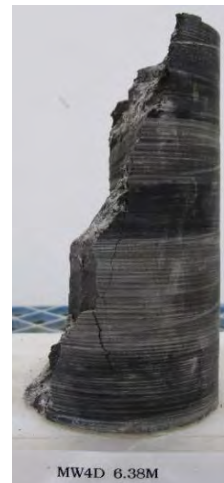
Maximum Applied Load, kN	87.5
Compressive Strength, MPa	28.5

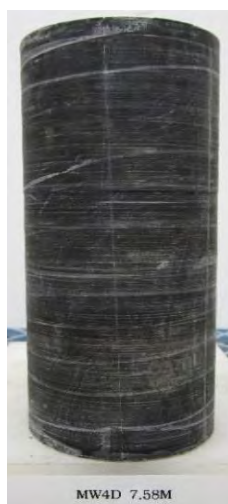
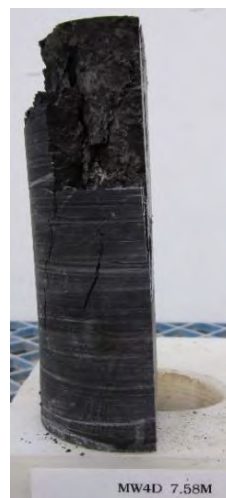
Maximum Applied Load, kN	93.5
Compressive Strength, MPa	30.5

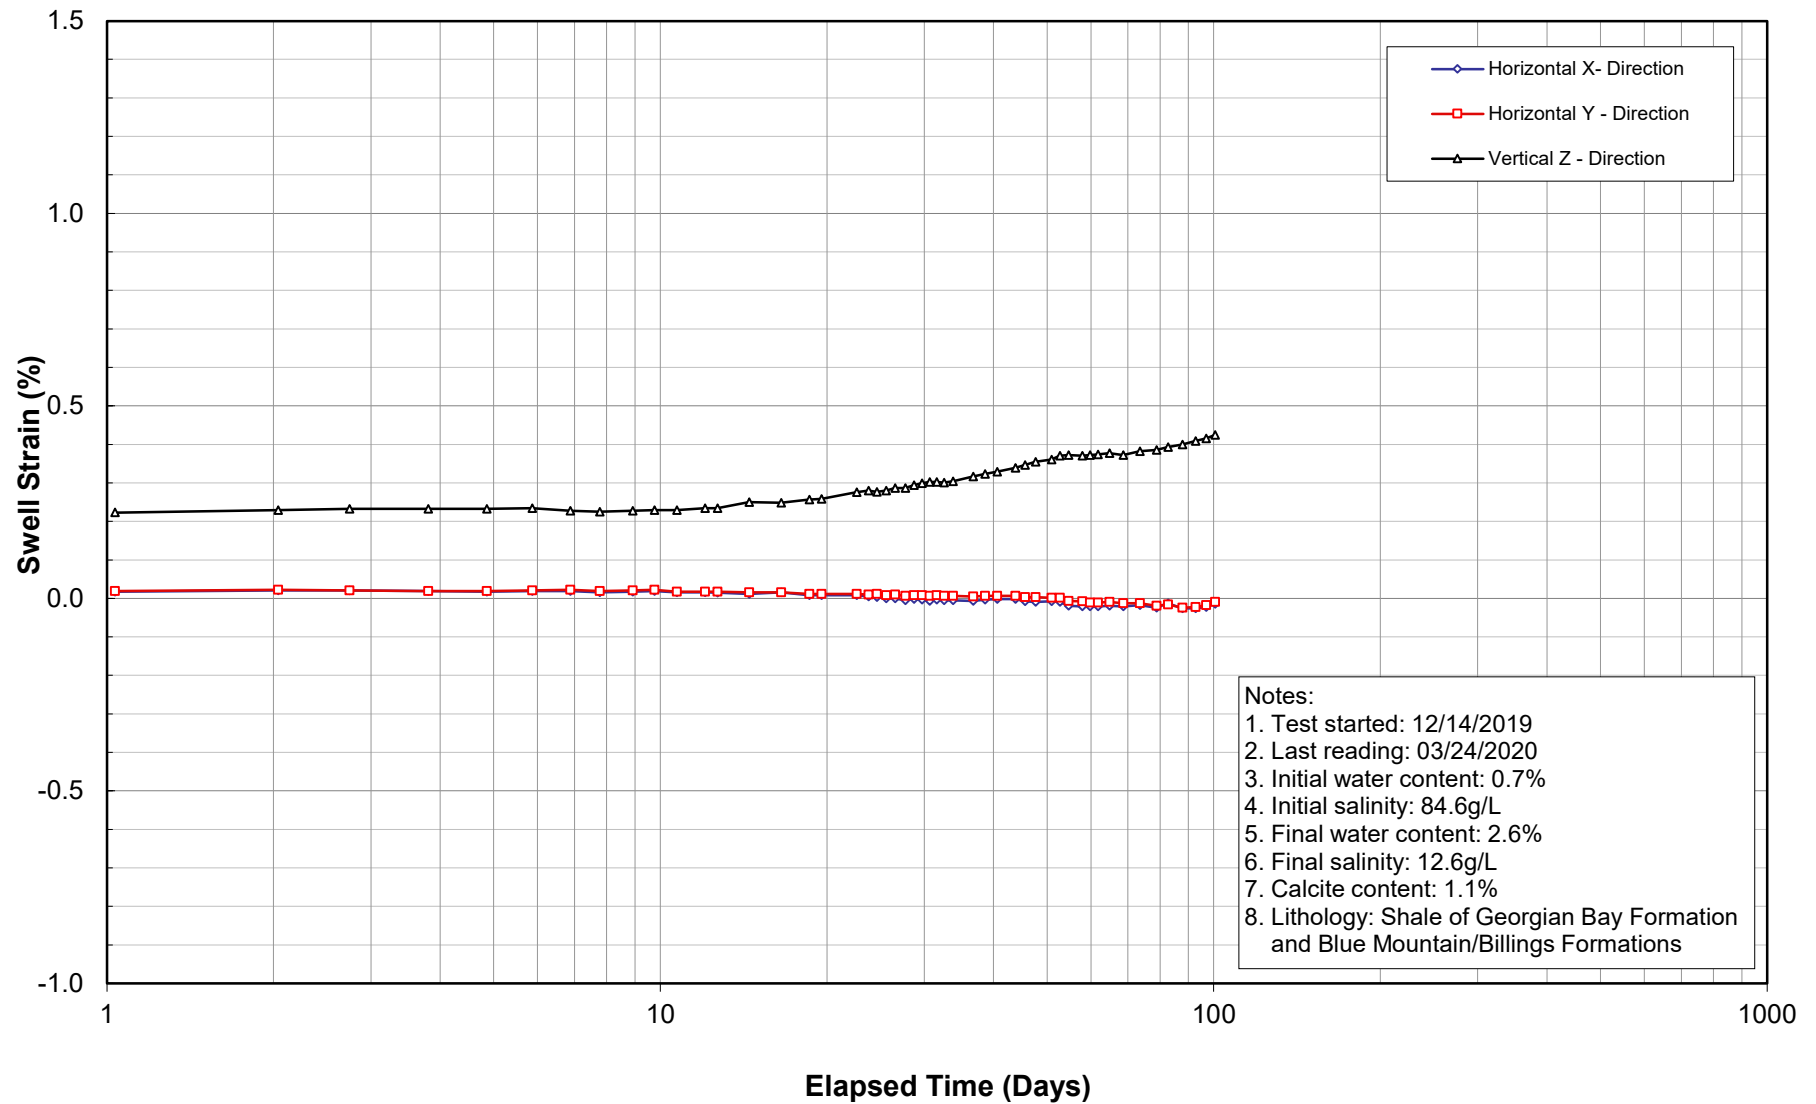
**BH: MW2D; Depth: 4.38m - 4.44m**

Free Swell Test  
Children's Hospital of Eastern Ontario Campus -  
Preliminary Geotechnical Investigation, Ottawa

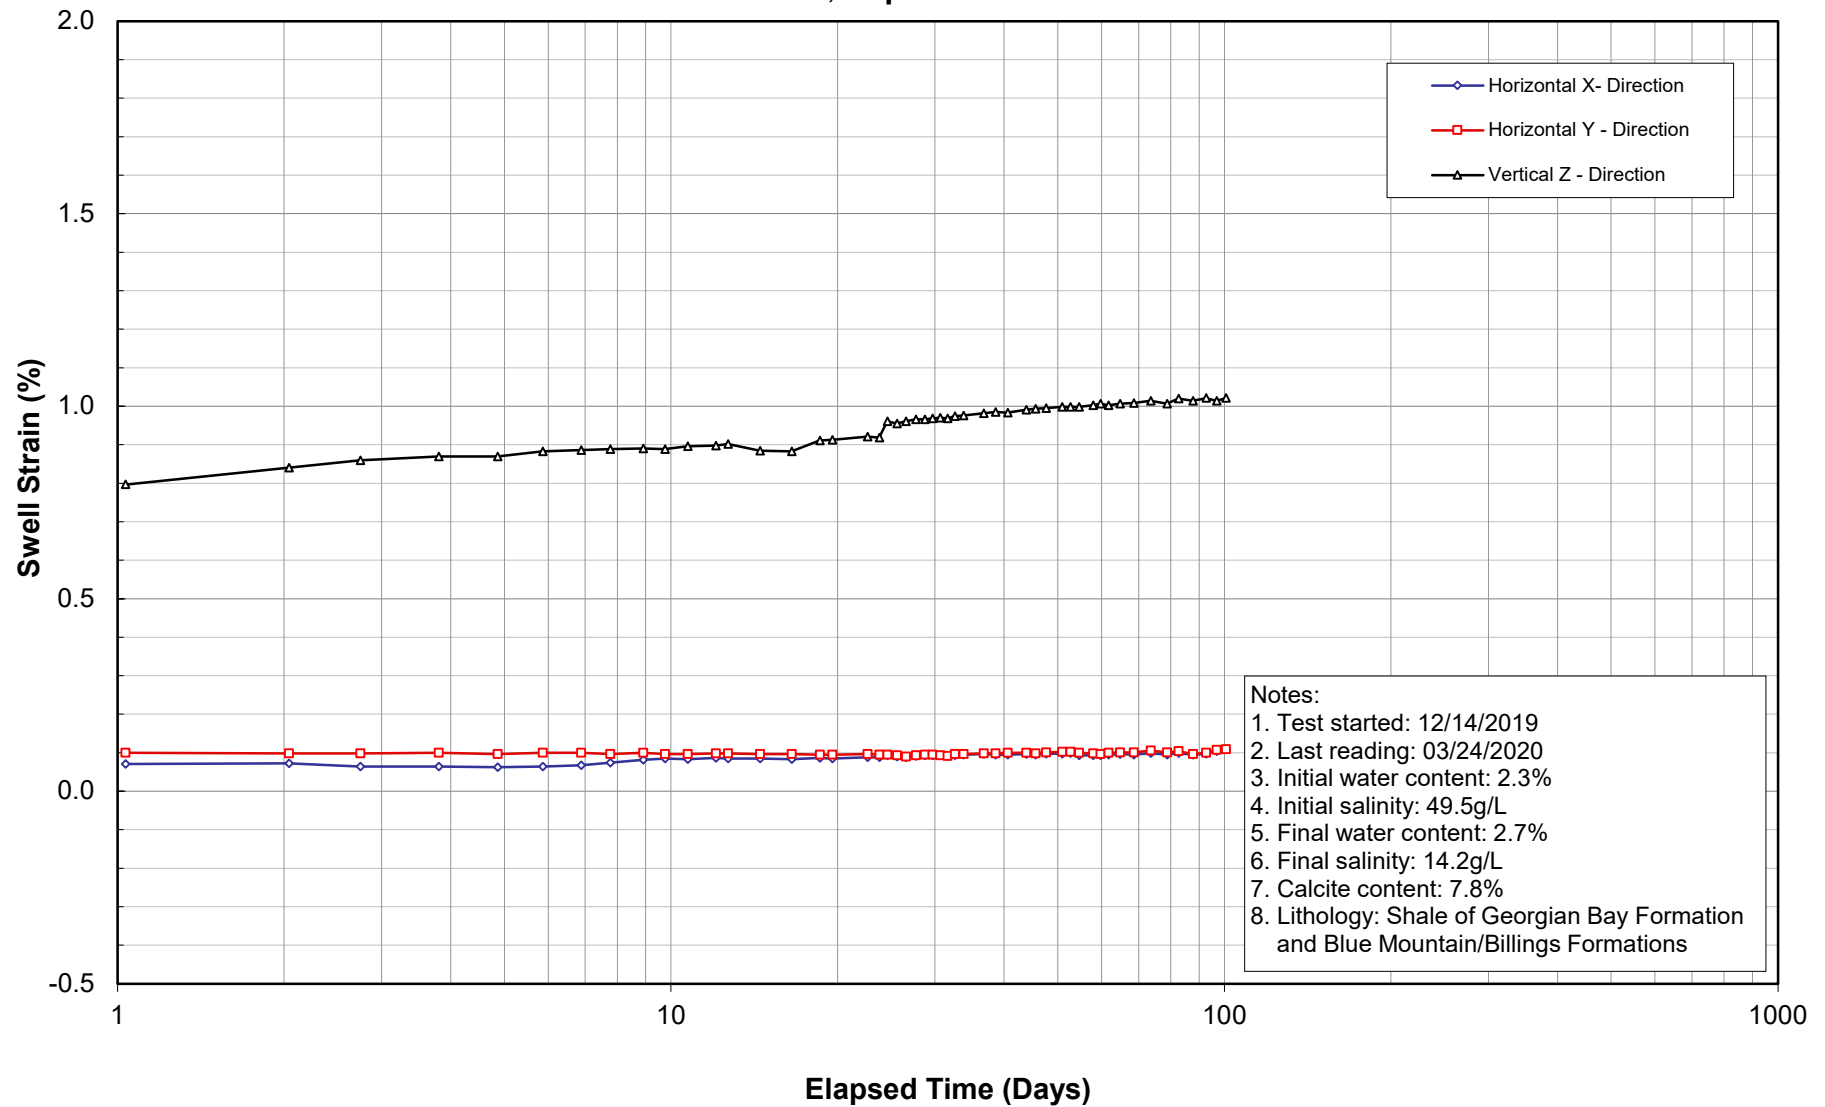
Free Swell Test  
Children's Hospital of Eastern Ontario Campus -  
Preliminary Geotechnical Investigation, Ottawa  
**FST-MW4D-1**  
**BH: MW4D; Depth: 4.51m - 4.60m**

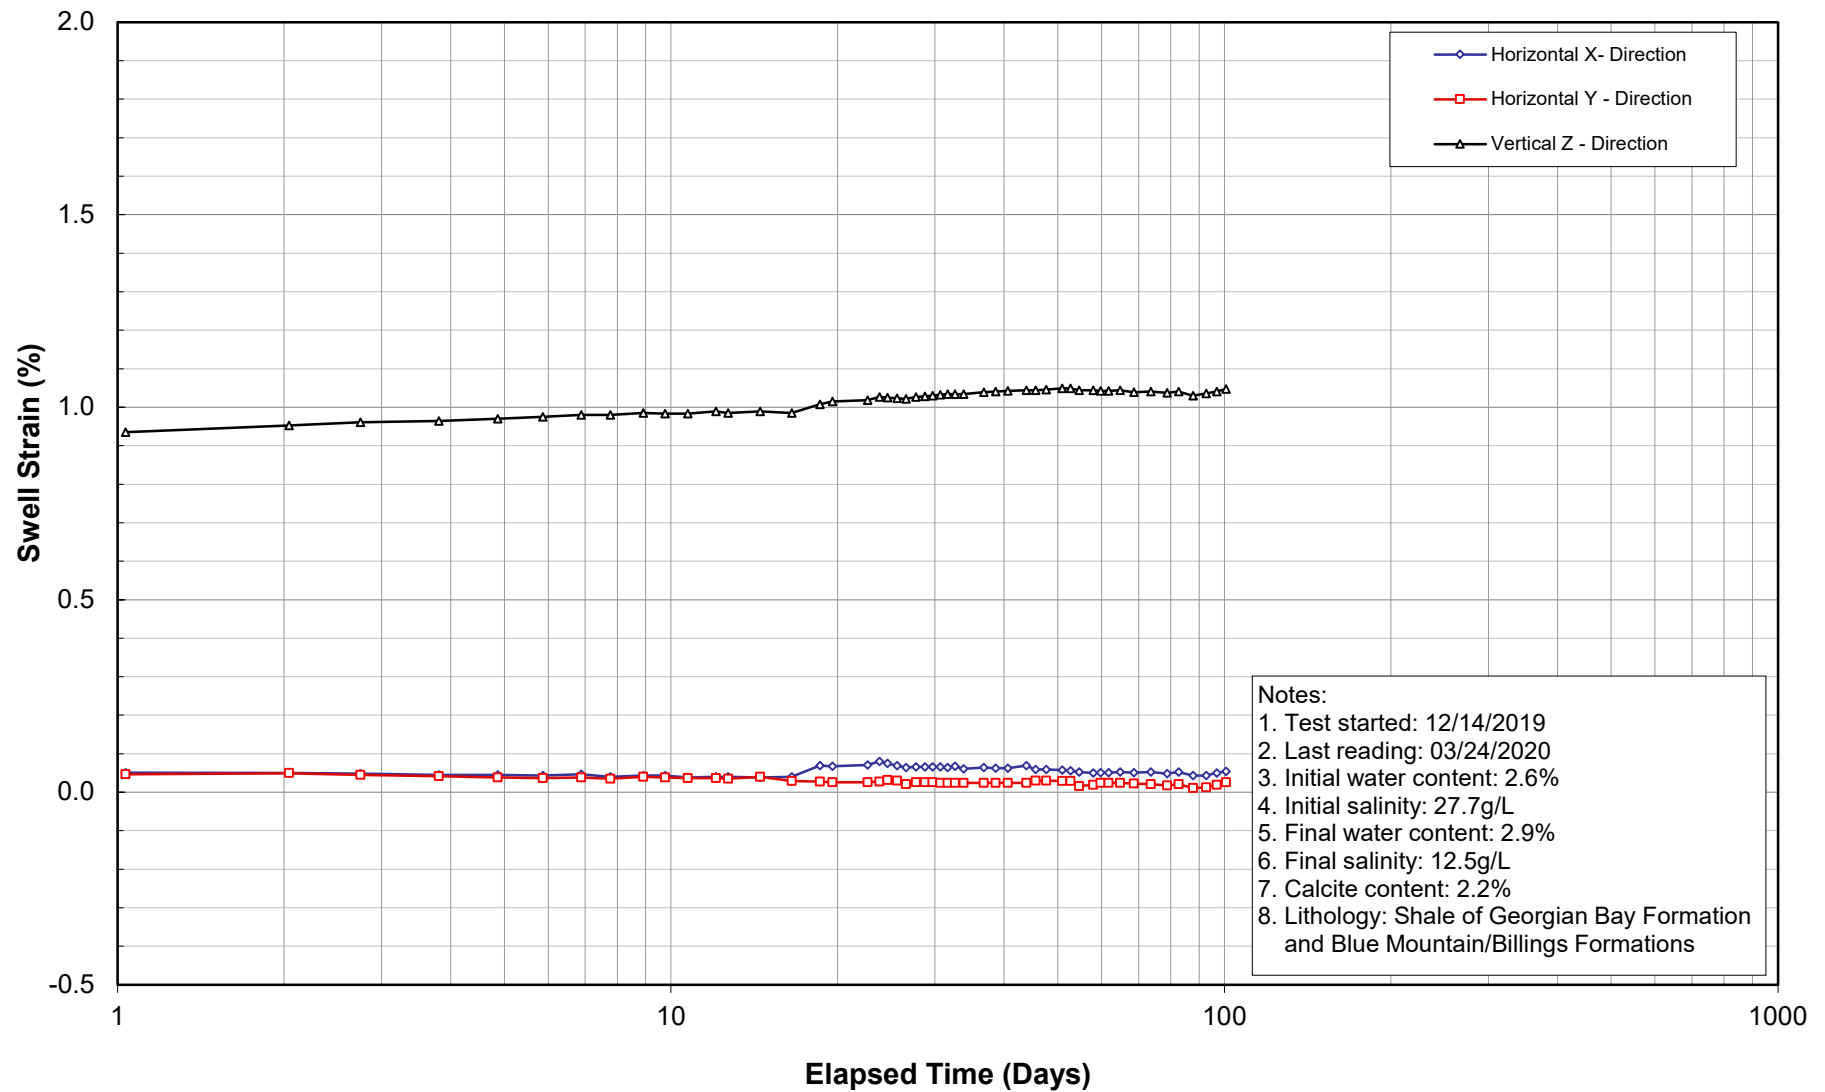
Free Swell Test  
Children's Hospital of Eastern Ontario Campus -  
Preliminary Geotechnical Investigation, Ottawa  
**FST-MW4D-2**  
**BH: MW4D; Depth: 4.84m - 4.90m**

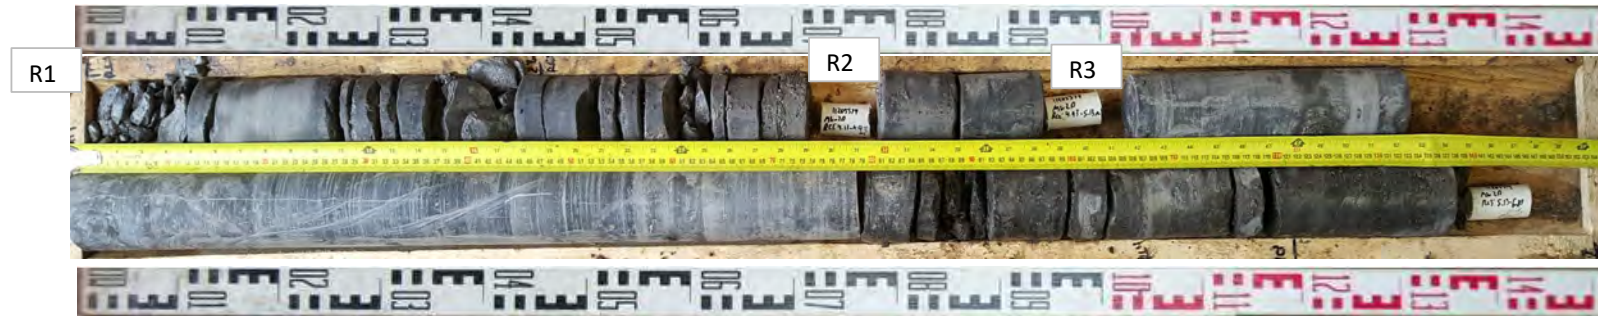
## Rock Core Photo Log MW2

R1 (RUN 1): 4.12 m - 4.93 m

R2 (RUN 2): 4.93 m - 5.13 m

The Total Core Recovery (TCR) achieved with the HQ size core bit ranged from approximately 64 to 100% and the Solid Core Recovery (SCR) ranged from 59 to 100 %. The Rock Quality Designation (RQD) ranged from 0 to 100% with the lower values of RQD observed near the surface of the rock and percentages generally increased with depth.

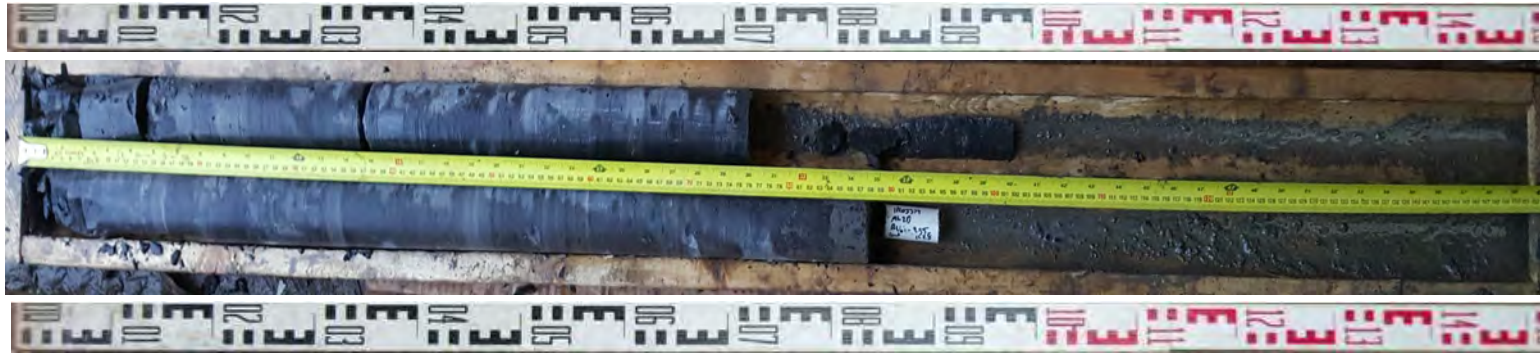
## Rock Core Photo Log MW2

R6 (RUN 6): 9.55 m - 11.28 m

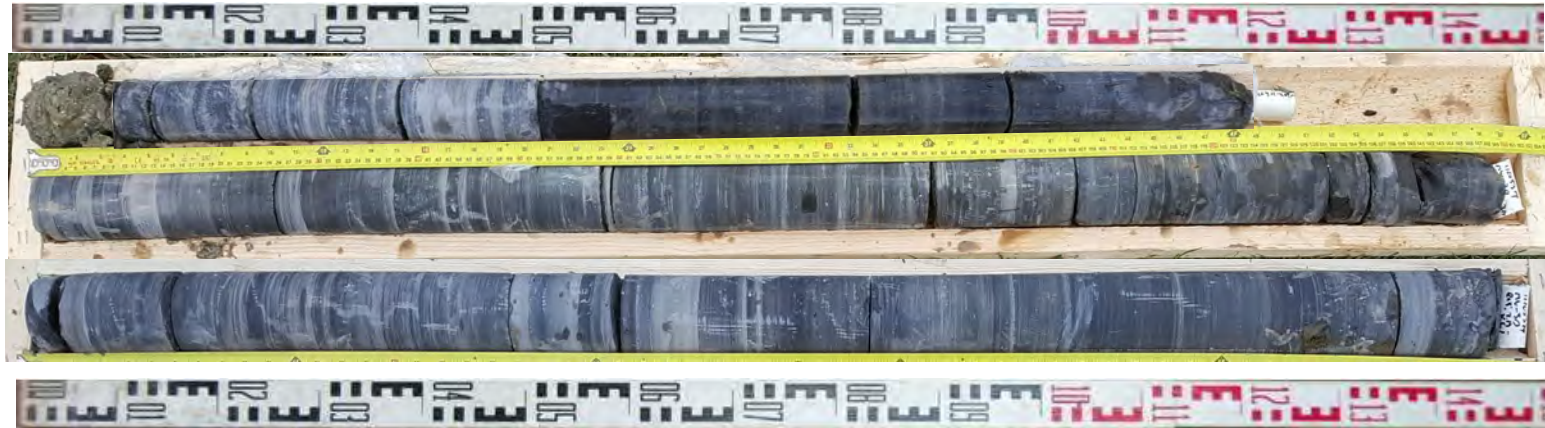
## Rock Core Photo Log MW3

R1 (RUN 1): 4.11 m - 5.64 m

R2 (RUN 2): 5.64 m - 7.13 m

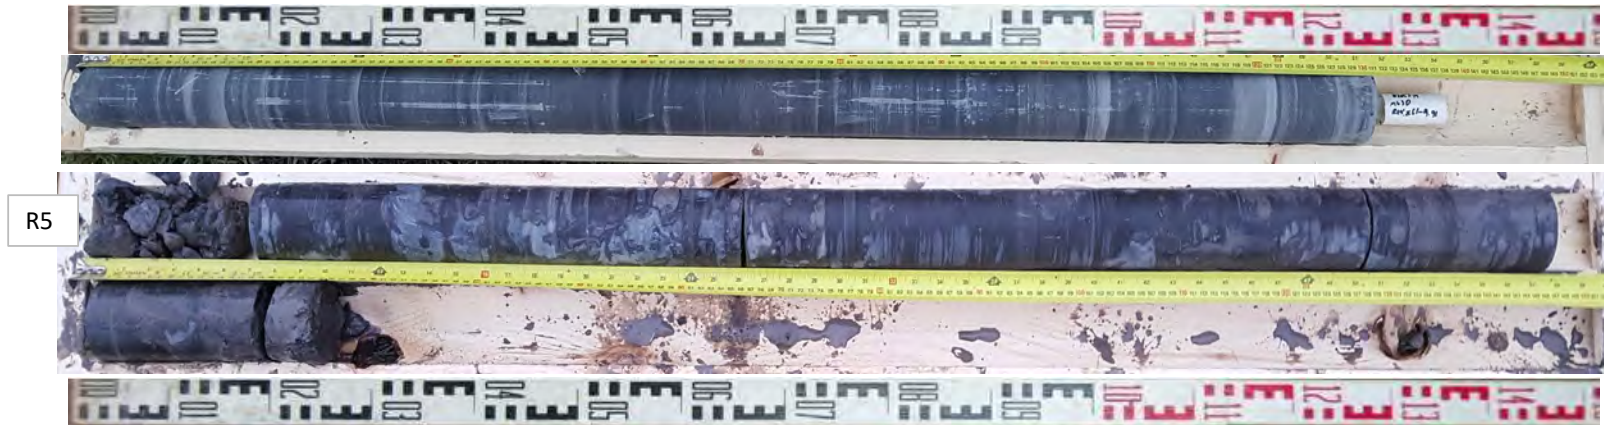
## Rock Core Photo Log MW3

R4 (RUN 4): 8.62 m - 9.91 m  
R5 (RUN 5): 9.91 m - 11.43 m
